Profile/Ph	oto Observatio	n Report			RedZone
Date: Pipe Length (ft P.O.#: Customer:	04/12/2018): 144.4	Weather: Owner: Surveyor: Clean Date:	NA Jen Costello 01/01/1900	Coding: Pre Clean: PSR: Shape:	PACP 6.0 No Pre-Cleaning P-407-005-006 C
Street:	LAKESIDE DR		Flow Control:	Not Controlle	d
City:	Hobart, IN		Year Renewed:		
Location:	Yard		Tape/Media #:		
Purpose:	Routine Assessme	ent	Dia/Height:	10"	
Use:	Sanitary		Material:	PVC	
Drain Area:	NA		Lining:		
Category:	NA				
Comment:	Flow direction is r	Flow direction is marked wrong.			
Location Detai	ls:		Direction of Surv	vey: Upstream	
US MH:	M-407-006	DS MH:	M-407-005	Total Length Surveyed (ft	:): 135.3
D&M Index:	0.00	O&M Quick:	000	0 O&M Rating:	0.00
Structural Index:	0.00	Structural Q	uick: 000		0.00
Overall Index:	0.00	Overall Quic	k: 000	0 Overall Rating:	0.00

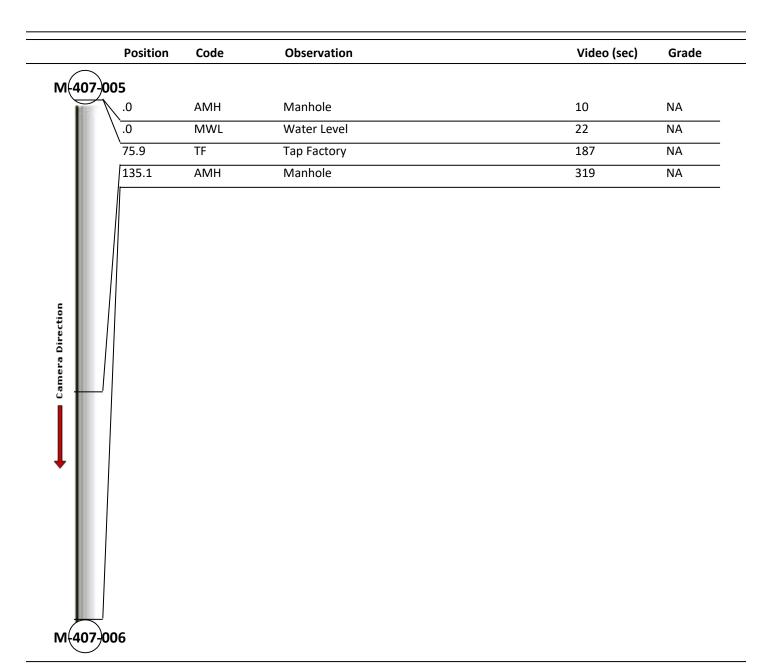
Code: Description:	AMH Manhole
Distance (ft):	.0
Structural Grade:	0
O&M Grade:	0
Clock Start/From:	
Clock To:	
1st Value:	
2nd Value:	
Value Percent:	
Continuous Index:	
Within 8" of Joint:	NO
Remarks:	M-407-005
