Profile/Photo Observation Report

Street:	W 11TH PL	Flow Control:	Not Controlled
City:	Hobart, IN	Year Renewed:	
Location:	Light Highway	Tape/Media #:	
Purpose:	Routine Assessment	Dia/Height:	10"
Use:	Sanitary	Material:	PVC
Drain Area:	NA	Lining:	
Category:	NA		
Comment:	P_C at 17 ft debris . Flow direction wrong		
Location Details:		Direction of Survey:	Downstream
US MH:	M-407-010	DS MH:	M-407-009
		Total Length Surveyed (ft):	18.9

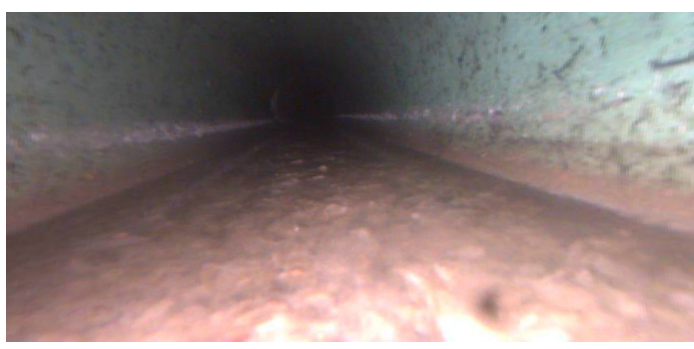
Code: **AMH**
Description: **Manhole**

Distance (ft): **.0**
Structural Grade: **0**
O&M Grade: **0**
Clock Start/From:
Clock To:
1st Value:
2nd Value:
Value Percent:
Continuous Index:
Within 8" of Joint: **NO**
Remarks: **M-407-010**

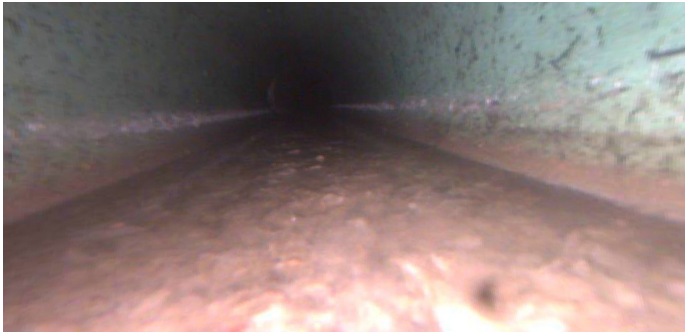
Code:	MWL
Description:	Water Level

Distance (ft):	.0
Structural Grade:	0
O&M Grade:	0
Clock Start/From:	
Clock To:	
1st Value:	
2nd Value:	
Value Percent:	5.000
Continuous Index:	
Within 8" of Joint:	NO
Remarks:

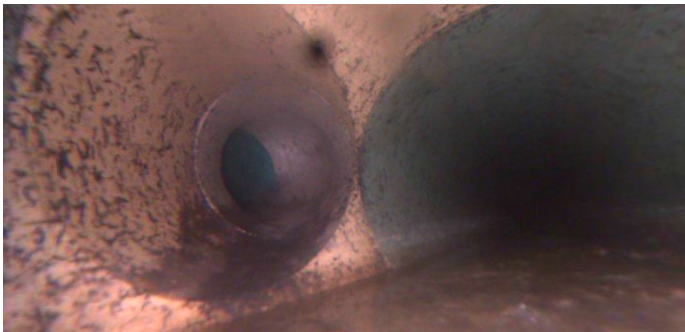
Code:	TF
Description:	Tap Factory

Distance (ft):	4.4
Structural Grade:	0
O&M Grade:	0
Clock Start/From:	9
Clock To:	
1st Value:	4.000
2nd Value:	
Value Percent:	
Continuous Index:	
Within 8" of Joint:	
Remarks:

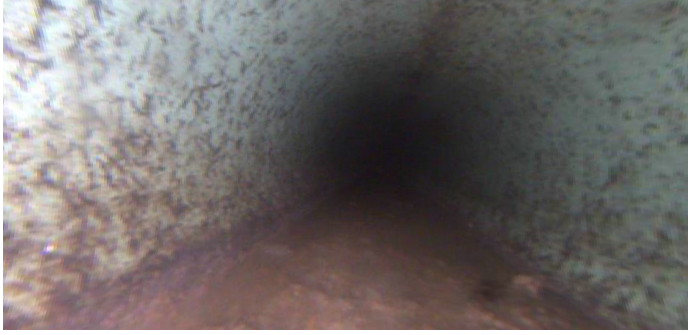
Code:	MSA
Description:	Abandoned Survey
Distance (ft):	18.9
Structural Grade:	0
O&M Grade:	0
Clock Start/From:	
Clock To:	
1st Value:	
2nd Value:	
Value Percent:	
Continuous Index:	
Within 8" of Joint:	NO
Remarks:	camera stopped
