Profile/Photo Observation Report

Street:	FOXCROFT STREET	Flow Control:	Not Controlled
City:	Hobart, IN	Year Renewed:	
Location:	Light Highway	Tape/Media #:	
Purpose:	Routine Assessment	Dia/Height:	10"
Use:	Sanitary	Material:	PVC
Drain Area:	NA	Lining:	
Category:	NA		
Comment:	P_C at 17 ft debris . Flow direction wrong		
Location Details:		Direction of Survey:	Downstream
US MH:	M-407-010	DS MH:	M-407-009
		Total Length Surveyed (ft):	18.9

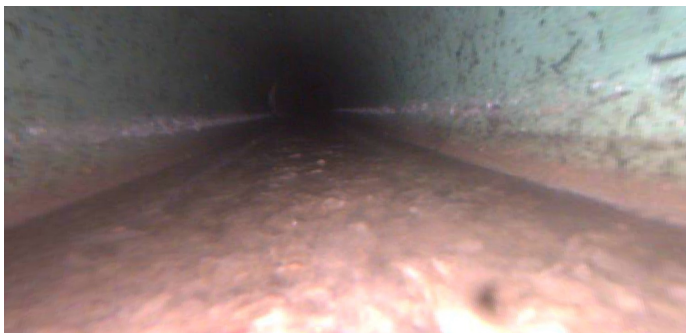
Code: **AMH**
Description: **Manhole**

Distance (ft): **.0**
Structural Grade: **0**
O&M Grade: **0**
Clock Start/From:
Clock To:
1st Value:
2nd Value:
Value Percent:
Continuous Index:
Within 8" of Joint: **NO**
Remarks: **M-407-010**

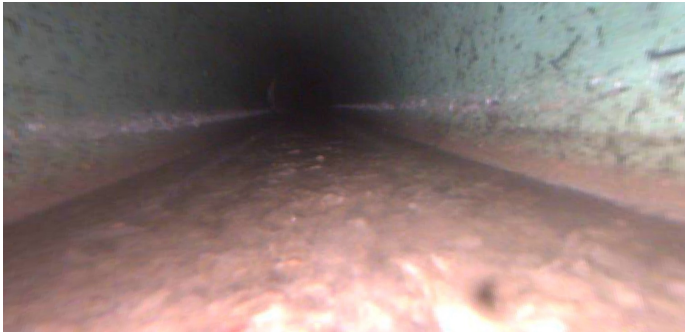
Code:	MWL
Description:	Water Level

Distance (ft):	.0
Structural Grade:	0
O&M Grade:	0
Clock Start/From:	
Clock To:	
1st Value:	
2nd Value:	
Value Percent:	5.000
Continuous Index:	
Within 8" of Joint:	NO
Remarks:

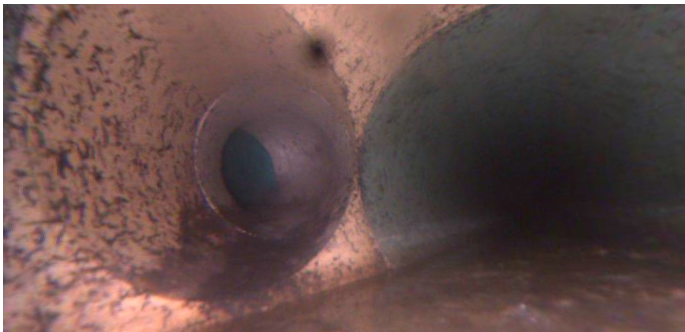
Code:	TF
Description:	Tap Factory

Distance (ft):	4.4
Structural Grade:	0
O&M Grade:	0
Clock Start/From:	9
Clock To:	
1st Value:	4.000
2nd Value:	
Value Percent:	
Continuous Index:	
Within 8" of Joint:	
Remarks:

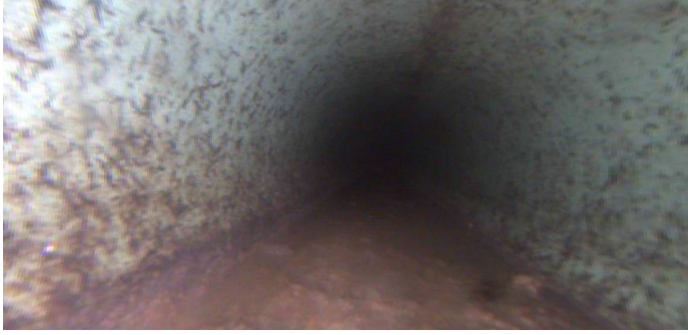
Code:	MSA
Description:	Abandoned Survey
Distance (ft):	18.9
Structural Grade:	0
O&M Grade:	0
Clock Start/From:	
Clock To:	
1st Value:	
2nd Value:	
Value Percent:	
Continuous Index:	
Within 8" of Joint:	NO
Remarks:	camera stopped
