## Profile/Photo Observation Report

Street:	<b>LAKESIDE DR</b>	Flow Control:	<b>Not Controlled</b>
City:	<b>Hobart, IN</b>	Year Renewed:	
Location:	<b>Light Highway</b>	Tape/Media #:	
Purpose:	<b>Routine Assessment</b>	Dia/Height:	<b>10"</b>
Use:	<b>Sanitary</b>	Material:	<b>PVC</b>
Drain Area:	<b>NA</b>	Lining:	
Category:	<b>NA</b>		
Comment:	<b>R_M at 161 ft rocks in the tracks. Flow direction wrong</b>		
Location Details:		Direction of Survey:	<b>Downstream</b>
US MH:	<b>M-407-012</b>	DS MH:	<b>M-407-008</b>
		Total Length Surveyed (ft):	<b>162.6</b>

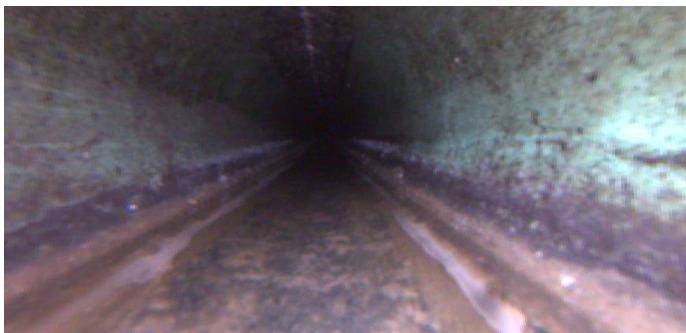
Code: **AMH**  
Description: **Manhole**

Distance (ft): **.0**  
Structural Grade: **0**  
O&M Grade: **0**  
Clock Start/From:  
Clock To:  
1st Value:  
2nd Value:  
Value Percent:  
Continuous Index:  
Within 8" of Joint: **NO**  
Remarks: **M-407-012**

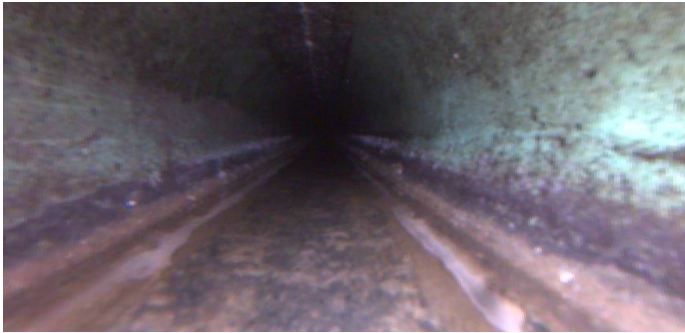
Code:	<b>MWL</b>
Description:	<b>Water Level</b>

Distance (ft):	<b>.0</b>
Structural Grade:	<b>0</b>
O&M Grade:	<b>0</b>
Clock Start/From:	
Clock To:	
1st Value:	
2nd Value:	
Value Percent:	<b>5.000</b>
Continuous Index:	
Within 8" of Joint:	<b>NO</b>
Remarks:

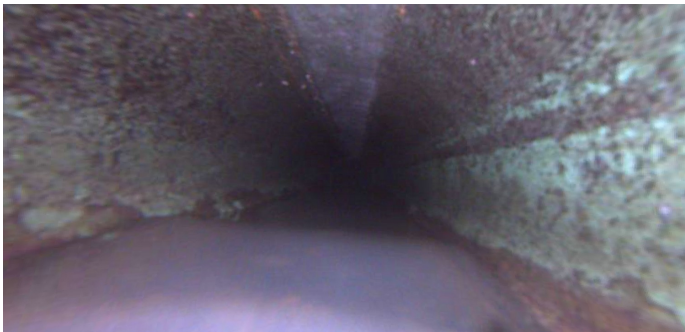
Code:	<b>MWL</b>
Description:	<b>Water Level</b>

Distance (ft):	<b>83.4</b>
Structural Grade:	<b>0</b>
O&M Grade:	<b>0</b>
Clock Start/From:	
Clock To:	
1st Value:	
2nd Value:	
Value Percent:	<b>30.000</b>
Continuous Index:	
Within 8" of Joint:	<b>NO</b>
Remarks:

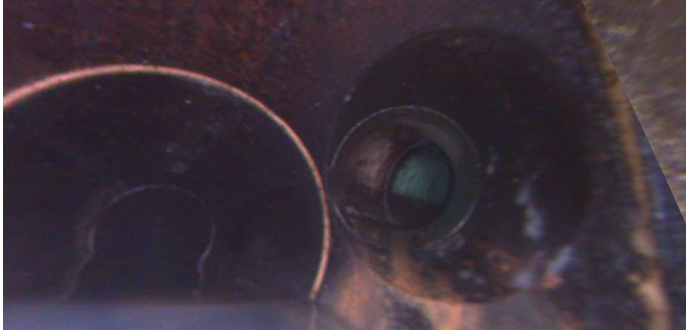
Code: **TF**  
Description: **Tap Factory**

Distance (ft): **108.6**  
Structural Grade: **0**  
O&M Grade: **0**  
Clock Start/From: **3**  
Clock To:  
1st Value: **4.000**  
2nd Value:  
Value Percent:  
Continuous Index:  
Within 8" of Joint:  
Remarks:

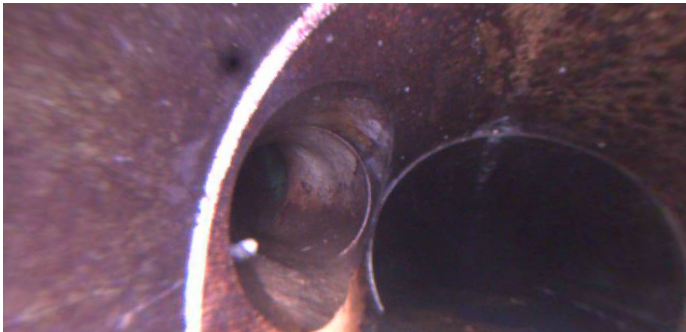
Code: **TF**  
Description: **Tap Factory**

Distance (ft): **110.5**  
Structural Grade: **0**  
O&M Grade: **0**  
Clock Start/From: **9**  
Clock To:  
1st Value: **4.000**  
2nd Value:  
Value Percent:  
Continuous Index:  
Within 8" of Joint:  
Remarks:

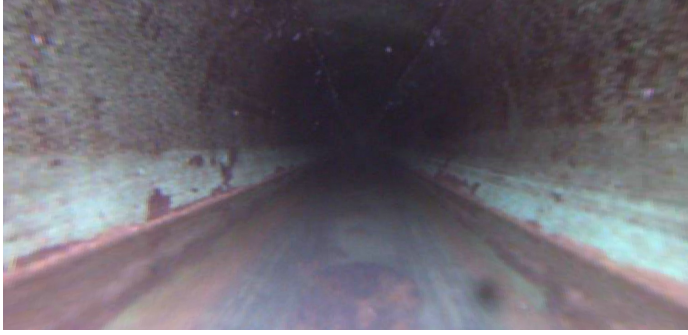
Code:	<b>MSA</b>
Description:	<b>Abandoned Survey</b>
Distance (ft):	<b>162.6</b>
Structural Grade:	<b>0</b>
O&M Grade:	<b>0</b>
Clock Start/From:	
Clock To:	
1st Value:	
2nd Value:	
Value Percent:	
Continuous Index:	
Within 8" of Joint:	<b>NO</b>
Remarks:	<b>camera stopped</b>
