## Profile/Photo Observation Report

Street:	<b>FOXCROFT STREET</b>	Flow Control:	<b>Not Controlled</b>
City:	<b>Hobart, IN</b>	Year Renewed:	
Location:	<b>Light Highway</b>	Tape/Media #:	
Purpose:	<b>Routine Assessment</b>	Dia/Height:	<b>10"</b>
Use:	<b>Sanitary</b>	Material:	<b>PVC</b>
Drain Area:	<b>NA</b>	Lining:	
Category:	<b>NA</b>		
Comment:	<b>R_M at 161 ft rocks in the tracks. Flow direction wrong</b>		
Location Details:		Direction of Survey:	<b>Downstream</b>
US MH:	<b>M-407-012</b>	DS MH:	<b>M-407-008</b>
		Total Length Surveyed (ft):	<b>162.6</b>

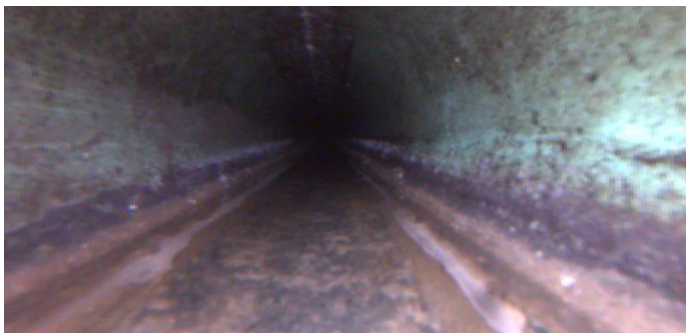
Code: **AMH**  
Description: **Manhole**

Distance (ft): **.0**  
Structural Grade: **0**  
O&M Grade: **0**  
Clock Start/From:  
Clock To:  
1st Value:  
2nd Value:  
Value Percent:  
Continuous Index:  
Within 8" of Joint: **NO**  
Remarks: **M-407-012**

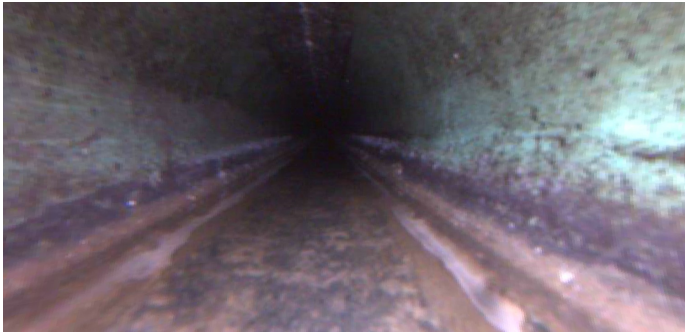
Code:	<b>MWL</b>
Description:	<b>Water Level</b>

Distance (ft):	<b>.0</b>
Structural Grade:	<b>0</b>
O&M Grade:	<b>0</b>
Clock Start/From:	
Clock To:	
1st Value:	
2nd Value:	
Value Percent:	<b>5.000</b>
Continuous Index:	
Within 8" of Joint:	<b>NO</b>
Remarks:

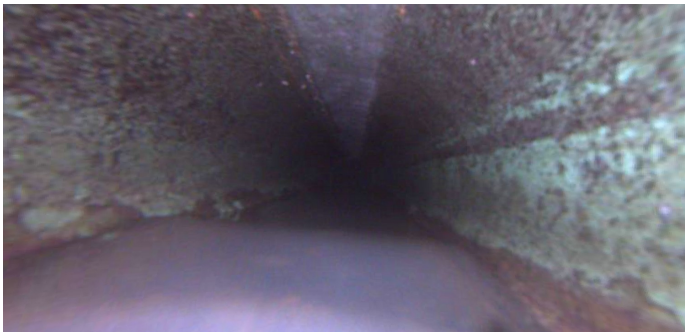
Code:	<b>MWL</b>
Description:	<b>Water Level</b>

Distance (ft):	<b>83.4</b>
Structural Grade:	<b>0</b>
O&M Grade:	<b>0</b>
Clock Start/From:	
Clock To:	
1st Value:	
2nd Value:	
Value Percent:	<b>30.000</b>
Continuous Index:	
Within 8" of Joint:	<b>NO</b>
Remarks:

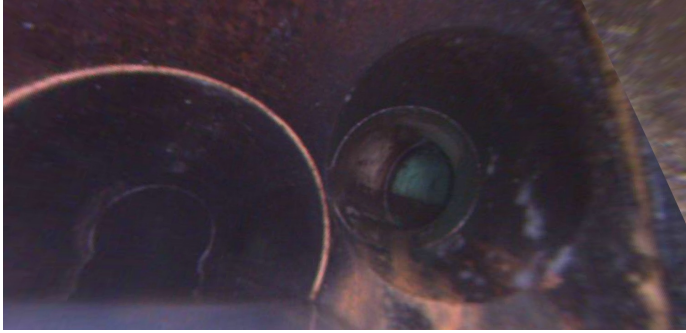
Code: **TF**  
Description: **Tap Factory**

Distance (ft): **108.6**  
Structural Grade: **0**  
O&M Grade: **0**  
Clock Start/From: **3**  
Clock To:  
1st Value: **4.000**  
2nd Value:  
Value Percent:  
Continuous Index:  
Within 8" of Joint:  
Remarks:

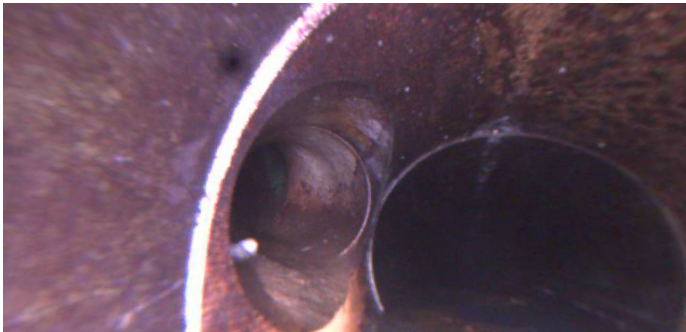
Code: **TF**  
Description: **Tap Factory**

Distance (ft): **110.5**  
Structural Grade: **0**  
O&M Grade: **0**  
Clock Start/From: **9**  
Clock To:  
1st Value: **4.000**  
2nd Value:  
Value Percent:  
Continuous Index:  
Within 8" of Joint:  
Remarks:

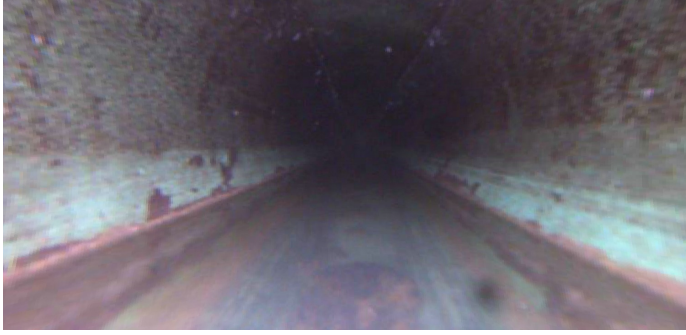
Code:	<b>MSA</b>
Description:	<b>Abandoned Survey</b>
Distance (ft):	<b>162.6</b>
Structural Grade:	<b>0</b>
O&M Grade:	<b>0</b>
Clock Start/From:	
Clock To:	
1st Value:	
2nd Value:	
Value Percent:	
Continuous Index:	
Within 8" of Joint:	<b>NO</b>
Remarks:	<b>camera stopped</b>
