## Profile/Photo Observation Report

Street:	<b>LAKESIDE DR</b>	Flow Control:	<b>Not Controlled</b>
City:	<b>Hobart, IN</b>	Year Renewed:	
Location:	<b>Light Highway</b>	Tape/Media #:	
Purpose:	<b>Routine Assessment</b>	Dia/Height:	<b>10"</b>
Use:	<b>Sanitary</b>	Material:	<b>PVC</b>
Drain Area:	<b>NA</b>	Lining:	
Category:	<b>NA</b>		
Comment:	<b>P_C at 240 rock in the tracks .Flow direction wrong</b>		
Location Details:		Direction of Survey:	<b>Upstream</b>
US MH:	<b>M-407-012</b>	DS MH:	<b>M-407-008</b>
		Total Length Surveyed (ft):	<b>241.5</b>

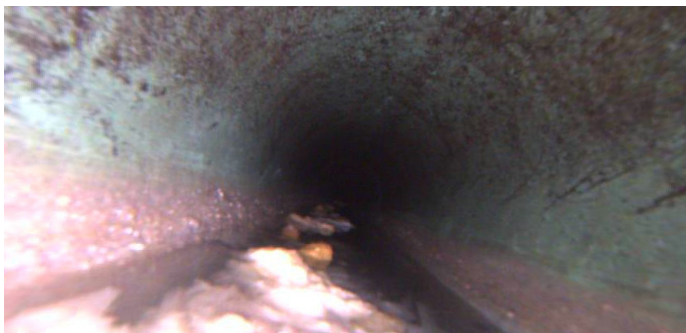
Code: **DAGS**  
Description: **Deposits Attached Grease**

Distance (ft): **.0**  
Structural Grade: **0**  
O&M Grade: **2**  
Clock Start/From: **8**  
Clock To: **4**  
1st Value:  
2nd Value:  
Value Percent: **5.000**  
Continuous Index: **S01**  
Within 8" of Joint: **NO**  
Remarks:

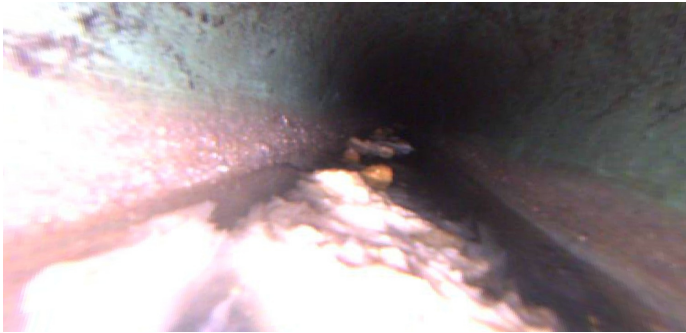
Code:	<b>AMH</b>
Description:	<b>Manhole</b>

Distance (ft):	<b>.0</b>
Structural Grade:	<b>0</b>
O&M Grade:	<b>0</b>
Clock Start/From:	
Clock To:	
1st Value:	
2nd Value:	
Value Percent:	
Continuous Index:	
Within 8" of Joint:	<b>NO</b>
Remarks:	<b>M-407-008</b>

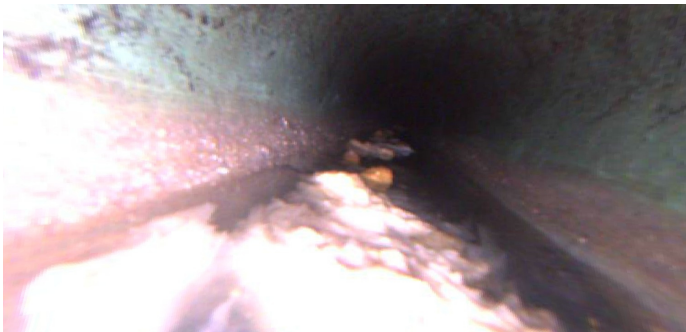
Code:	<b>MWL</b>
Description:	<b>Water Level</b>

Distance (ft):	<b>.0</b>
Structural Grade:	<b>0</b>
O&M Grade:	<b>0</b>
Clock Start/From:	
Clock To:	
1st Value:	
2nd Value:	
Value Percent:	<b>5.000</b>
Continuous Index:	
Within 8" of Joint:	<b>NO</b>
Remarks:

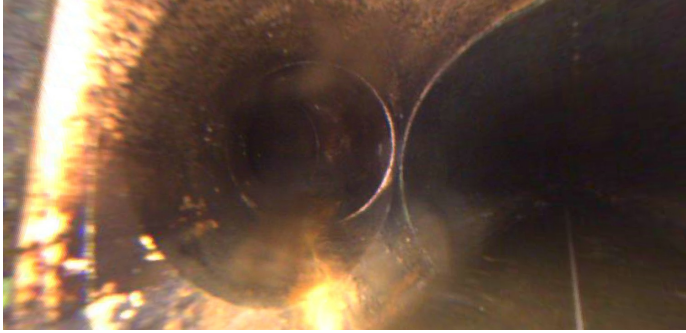
Code: **TF**  
Description: **Tap Factory**

Distance (ft): **100.2**  
Structural Grade: **0**  
O&M Grade: **0**  
Clock Start/From: **3**  
Clock To:  
1st Value: **4.000**  
2nd Value:  
Value Percent:  
Continuous Index:  
Within 8" of Joint:  
Remarks:

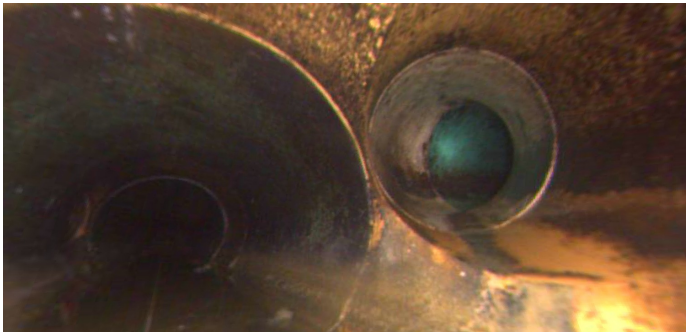
Code: **TF**  
Description: **Tap Factory**

Distance (ft): **102.1**  
Structural Grade: **0**  
O&M Grade: **0**  
Clock Start/From: **9**  
Clock To:  
1st Value: **4.000**  
2nd Value:  
Value Percent:  
Continuous Index:  
Within 8" of Joint:  
Remarks:

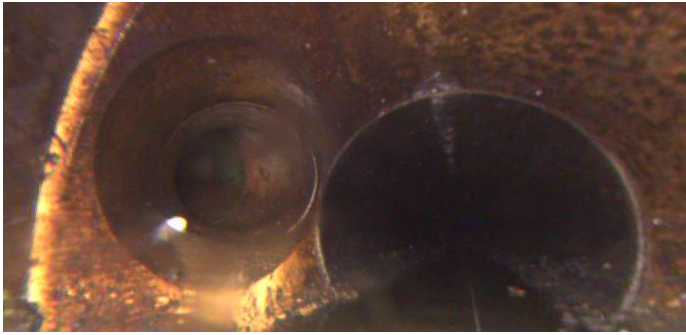
Code: **TF**  
Description: **Tap Factory**

Distance (ft): **166.9**  
Structural Grade: **0**  
O&M Grade: **0**  
Clock Start/From: **3**  
Clock To:  
1st Value: **4.000**  
2nd Value:  
Value Percent:  
Continuous Index:  
Within 8" of Joint:  
Remarks:

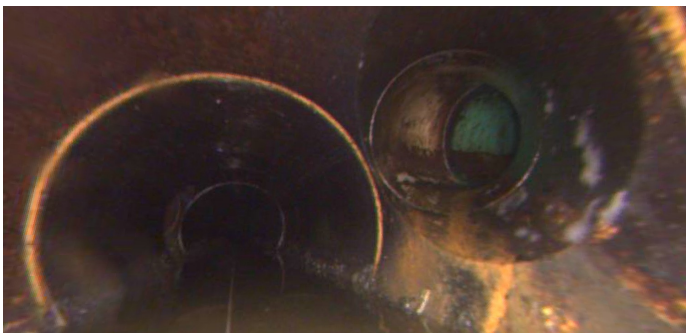
Code: **TF**  
Description: **Tap Factory**

Distance (ft): **168.8**  
Structural Grade: **0**  
O&M Grade: **0**  
Clock Start/From: **9**  
Clock To:  
1st Value: **4.000**  
2nd Value:  
Value Percent:  
Continuous Index:  
Within 8" of Joint:  
Remarks:

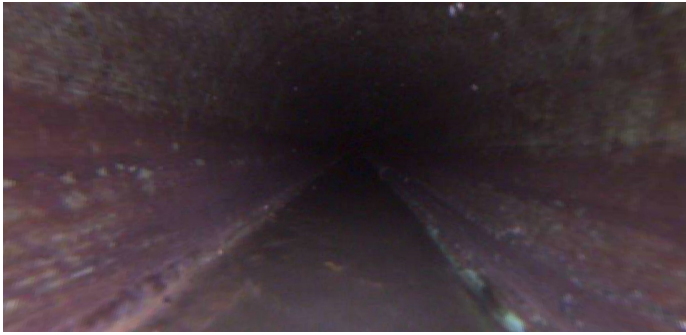
Code: **MSA**  
Description: **Abandoned Survey**

Distance (ft): **241.5**  
Structural Grade: **0**  
O&M Grade: **0**  
Clock Start/From:  
Clock To:  
1st Value:  
2nd Value:  
Value Percent:  
Continuous Index:  
Within 8" of Joint: **NO**  
Remarks: **UNKNOWN**

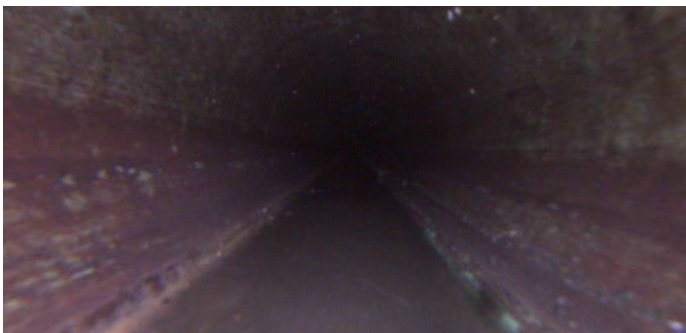
Code: **DAGS**  
Description: **Deposits Attached Grease**

Distance (ft): **241.5**  
Structural Grade: **0**  
O&M Grade: **2**  
Clock Start/From: **8**  
Clock To: **4**  
1st Value:  
2nd Value:  
Value Percent: **5.000**  
Continuous Index: **F01**  
Within 8" of Joint: **NO**  
Remarks:
