Profile/Photo Observation Report

Date:	03/28/2018	Weather:		Coding:	PACP 6.0
Pipe Length (ft):	278.2	Owner:	NA	Pre Clean:	No Pre-Cleaning
P.O.#:		Surveyor:	Selasie Honu	PSR:	P-407-008-012
Customer:		Clean Date:	01/01/1900	Shape:	C

Street:	FOXCROFT STREET	Flow Control:	Not Controlled
City:	Hobart, IN	Year Renewed:	
Location:	Light Highway	Tape/Media #:	
Purpose:	Routine Assessment	Dia/Height:	10"
Use:	Sanitary	Material:	PVC
Drain Area:	NA	Lining:	
Category:	NA		
Comment:	P_C at 240 rock in the tracks .Flow direction wrong		
Location Details:		Direction of Survey:	Upstream
US MH:	M-407-012	DS MH:	M-407-008
		Total Length Surveyed (ft):	241.5

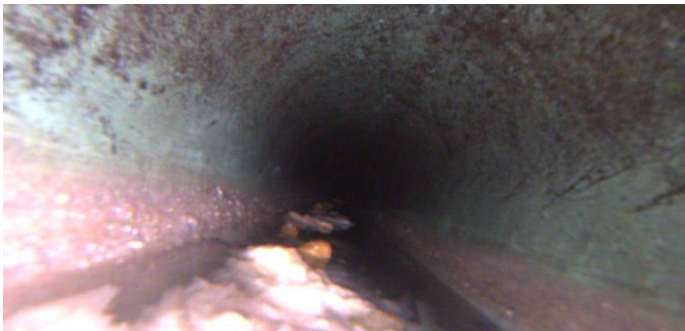
Code: **DAGS**
Description: **Deposits Attached Grease**

Distance (ft): **.0**
Structural Grade: **0**
O&M Grade: **2**
Clock Start/From: **8**
Clock To: **4**
1st Value:
2nd Value:
Value Percent: **5.000**
Continuous Index: **S01**
Within 8" of Joint: **NO**
Remarks:

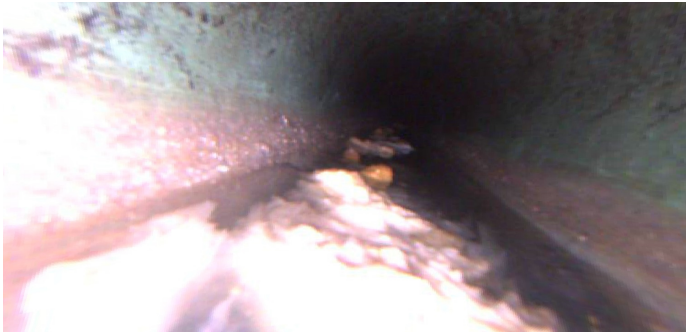
Code:	AMH
Description:	Manhole

Distance (ft):	.0
Structural Grade:	0
O&M Grade:	0
Clock Start/From:	
Clock To:	
1st Value:	
2nd Value:	
Value Percent:	
Continuous Index:	
Within 8" of Joint:	NO
Remarks:	M-407-008

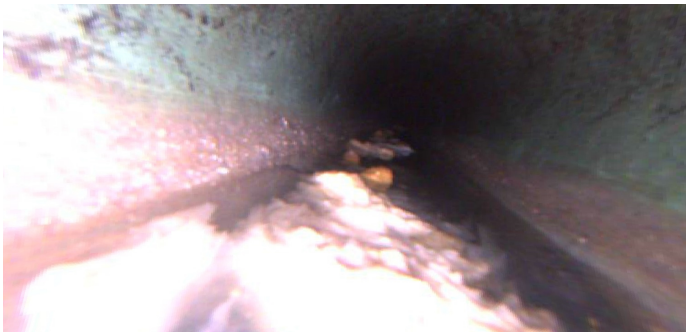
Code:	MWL
Description:	Water Level

Distance (ft):	.0
Structural Grade:	0
O&M Grade:	0
Clock Start/From:	
Clock To:	
1st Value:	
2nd Value:	
Value Percent:	5.000
Continuous Index:	
Within 8" of Joint:	NO
Remarks:

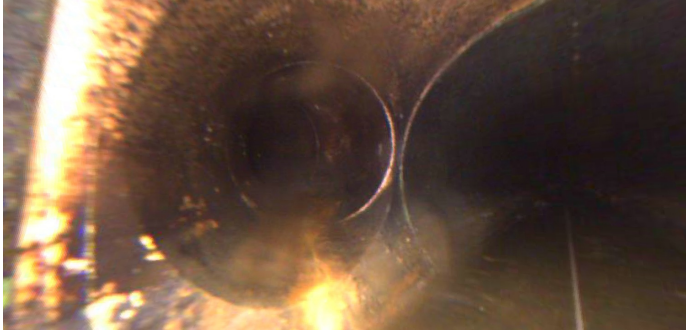
Code: **TF**
Description: **Tap Factory**

Distance (ft): **100.2**
Structural Grade: **0**
O&M Grade: **0**
Clock Start/From: **3**
Clock To:
1st Value: **4.000**
2nd Value:
Value Percent:
Continuous Index:
Within 8" of Joint:
Remarks:

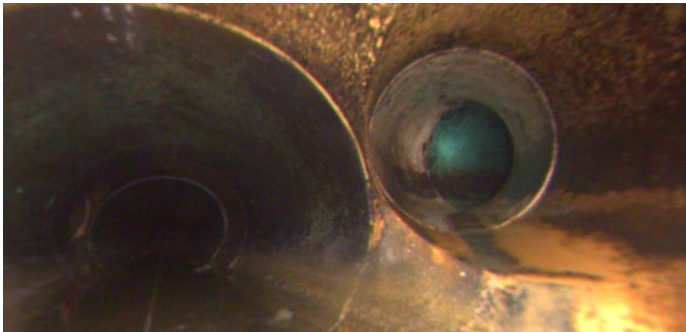
Code: **TF**
Description: **Tap Factory**

Distance (ft): **102.1**
Structural Grade: **0**
O&M Grade: **0**
Clock Start/From: **9**
Clock To:
1st Value: **4.000**
2nd Value:
Value Percent:
Continuous Index:
Within 8" of Joint:
Remarks:

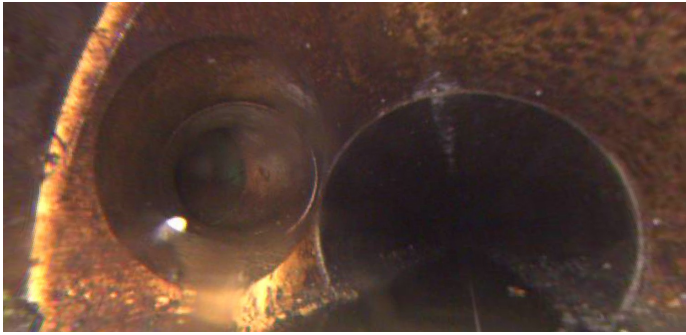
Code: **TF**
Description: **Tap Factory**

Distance (ft): **166.9**
Structural Grade: **0**
O&M Grade: **0**
Clock Start/From: **3**
Clock To:
1st Value: **4.000**
2nd Value:
Value Percent:
Continuous Index:
Within 8" of Joint:
Remarks:

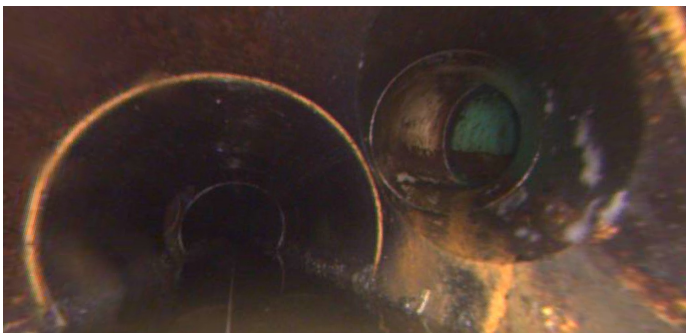
Code: **TF**
Description: **Tap Factory**

Distance (ft): **168.8**
Structural Grade: **0**
O&M Grade: **0**
Clock Start/From: **9**
Clock To:
1st Value: **4.000**
2nd Value:
Value Percent:
Continuous Index:
Within 8" of Joint:
Remarks:

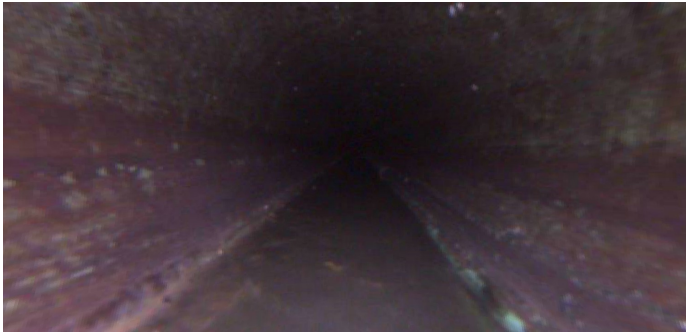
Code: **MSA**
Description: **Abandoned Survey**

Distance (ft): **241.5**
Structural Grade: **0**
O&M Grade: **0**
Clock Start/From:
Clock To:
1st Value:
2nd Value:
Value Percent:
Continuous Index:
Within 8" of Joint: **NO**
Remarks: **UNKNOWN**

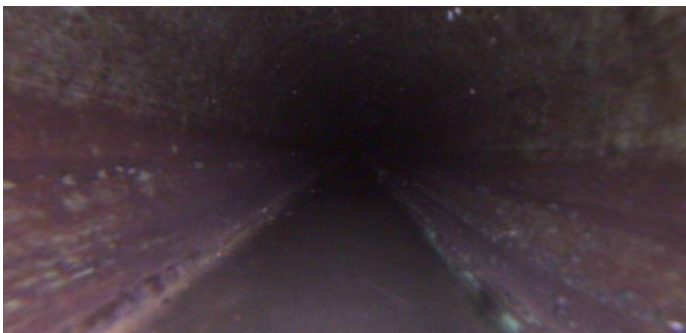
Code: **DAGS**
Description: **Deposits Attached Grease**

Distance (ft): **241.5**
Structural Grade: **0**
O&M Grade: **2**
Clock Start/From: **8**
Clock To: **4**
1st Value:
2nd Value:
Value Percent: **5.000**
Continuous Index: **F01**
Within 8" of Joint: **NO**
Remarks:
