Profile/Photo Observation Report

Date:	03/28/2018	Weather:		Coding:	PACP 6.0
Pipe Length (ft):	331.8	Owner:	NA	Pre Clean:	No Pre-Cleaning
P.O.#:		Surveyor:	Selasie Honu	PSR:	P-407-010-011
Customer:		Clean Date:	01/01/1900	Shape:	C

Street:	W 11TH PL	Flow Control:	Not Controlled
City:	Hobart, IN	Year Renewed:	
Location:	Light Highway	Tape/Media #:	
Purpose:	Routine Assessment	Dia/Height:	10"
Use:	Sanitary	Material:	PVC
Drain Area:	NA	Lining:	
Category:	NA		
Comment:	F_S_P_C at 6 ft debris. Flow direction wrong		
Location Details:		Direction of Survey:	Upstream
US MH:	M-4074-011	DS MH:	M-407-010
		Total Length Surveyed (ft):	8.0

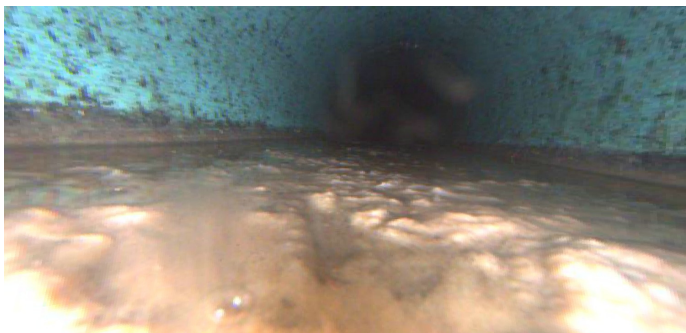
Code: **AMH**
Description: **Manhole**

Distance (ft): **.0**
Structural Grade: **0**
O&M Grade: **0**
Clock Start/From:
Clock To:
1st Value:
2nd Value:
Value Percent:
Continuous Index:
Within 8" of Joint: **NO**
Remarks: **M-407-010**

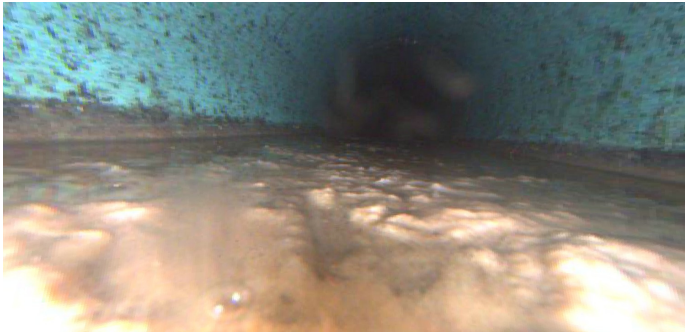
Code:	MWL
Description:	Water Level

Distance (ft):	.0
Structural Grade:	0
O&M Grade:	0
Clock Start/From:	
Clock To:	
1st Value:	
2nd Value:	
Value Percent:	5.000
Continuous Index:	
Within 8" of Joint:	NO
Remarks:

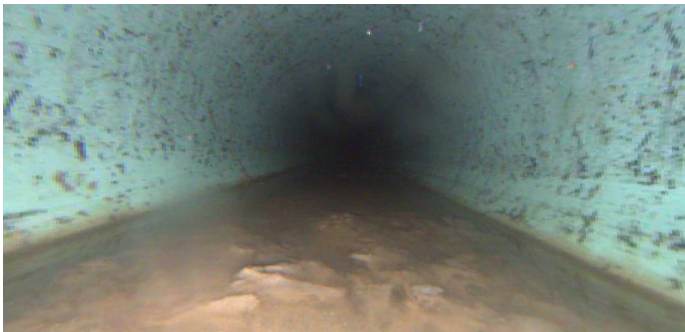
Code:	MSA
Description:	Abandoned Survey

Distance (ft):	8.0
Structural Grade:	0
O&M Grade:	0
Clock Start/From:	
Clock To:	
1st Value:	
2nd Value:	
Value Percent:	
Continuous Index:	
Within 8" of Joint:	NO
Remarks:	camera stopped
