Profile/Photo Observation Report

Date:	03/28/2018	Weather:		Coding:	PACP 6.0
Pipe Length (ft):	331.8	Owner:	NA	Pre Clean:	No Pre-Cleaning
P.O.#:		Surveyor:	Selasie Honu	PSR:	P-407-010-011
Customer:		Clean Date:	01/01/1900	Shape:	C

Street:	FOXCROFT STREET	Flow Control:	Not Controlled
City:	Hobart, IN	Year Renewed:	
Location:	Light Highway	Tape/Media #:	
Purpose:	Routine Assessment	Dia/Height:	10"
Use:	Sanitary	Material:	PVC
Drain Area:	NA	Lining:	
Category:	NA		
Comment:	F_S_P_C at 6 ft debris. Flow direction wrong		
Location Details:		Direction of Survey:	Upstream
US MH:	M-4074-011	DS MH:	M-407-010
		Total Length Surveyed (ft):	8.0

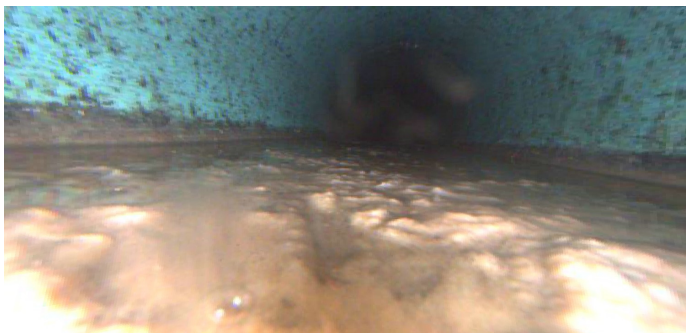
Code: **AMH**
Description: **Manhole**

Distance (ft): **.0**
Structural Grade: **0**
O&M Grade: **0**
Clock Start/From:
Clock To:
1st Value:
2nd Value:
Value Percent:
Continuous Index:
Within 8" of Joint: **NO**
Remarks: **M-407-010**

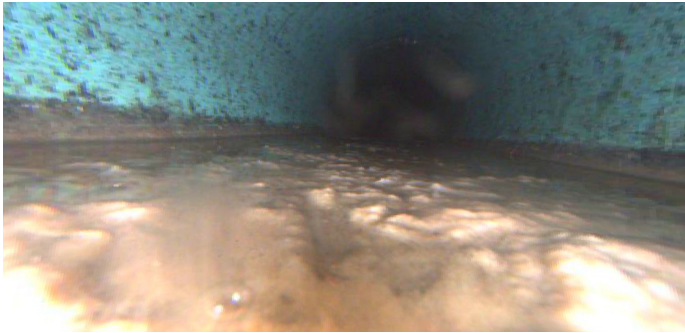
Code:	MWL
Description:	Water Level

Distance (ft):	.0
Structural Grade:	0
O&M Grade:	0
Clock Start/From:	
Clock To:	
1st Value:	
2nd Value:	
Value Percent:	5.000
Continuous Index:	
Within 8" of Joint:	NO
Remarks:

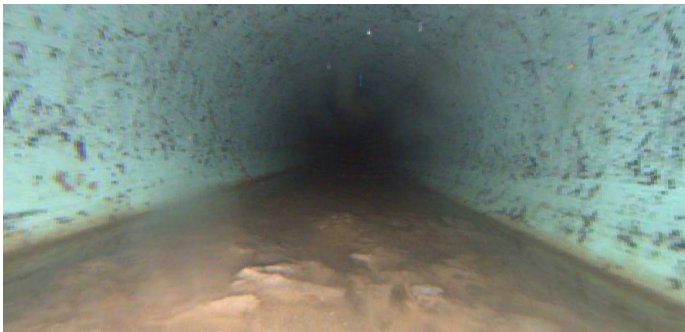
Code:	MSA
Description:	Abandoned Survey

Distance (ft):	8.0
Structural Grade:	0
O&M Grade:	0
Clock Start/From:	
Clock To:	
1st Value:	
2nd Value:	
Value Percent:	
Continuous Index:	
Within 8" of Joint:	NO
Remarks:	camera stopped
