Profile/Photo Observation Report

Street:	W 11TH PL	Flow Control:	Not Controlled
City:	Hobart, IN	Year Renewed:	
Location:	Light Highway	Tape/Media #:	
Purpose:	Routine Assessment	Dia/Height:	10"
Use:	Sanitary	Material:	PVC
Drain Area:	NA	Lining:	
Category:	NA		
Comment:	R_M at 231 ft debris .Flow direction wrong		
Location Details:		Direction of Survey:	Downstream
US MH:	M-4074-011	DS MH:	M-407-010
		Total Length Surveyed (ft):	232.9

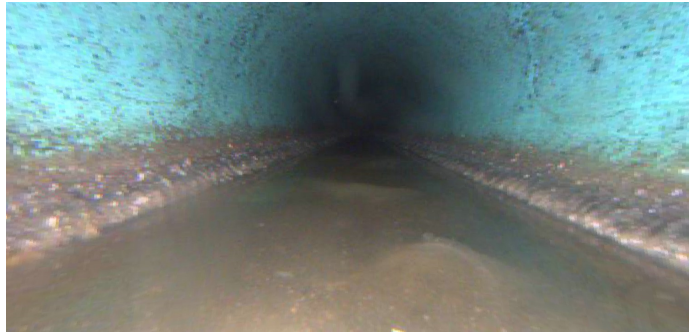
Code: **AMH**
Description: **Manhole**

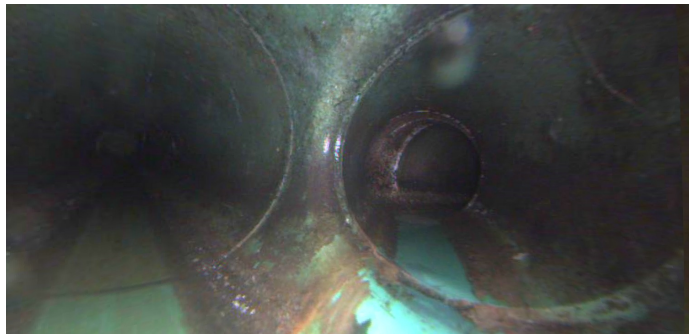
Code: **MWL**
Description: **Water Level**

Distance (ft): **.0**
Structural Grade: **0**
O&M Grade: **0**
Clock Start/From:
Clock To:
1st Value:
2nd Value:
Value Percent: **5.000**
Continuous Index:
Within 8" of Joint: **NO**
Remarks:

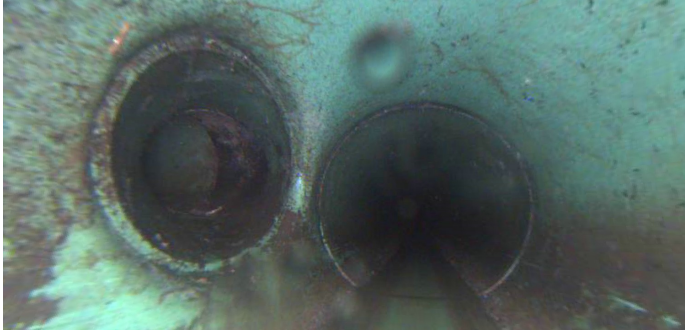
Code: **TFA**
Description: **Tap Factory Active**

Distance (ft): **28.2**
Structural Grade: **0**
O&M Grade: **0**
Clock Start/From: **3**
Clock To:
1st Value: **4.000**
2nd Value:
Value Percent:
Continuous Index:
Within 8" of Joint:
Remarks:

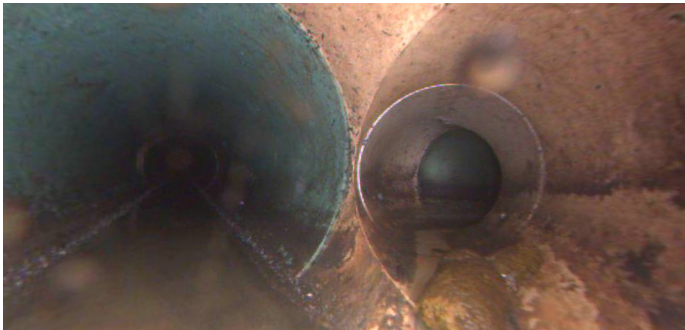
Code: **TF**
Description: **Tap Factory**

Distance (ft): **33.4**
Structural Grade: **0**
O&M Grade: **0**
Clock Start/From: **9**
Clock To:
1st Value: **4.000**
2nd Value:
Value Percent:
Continuous Index:
Within 8" of Joint:
Remarks:

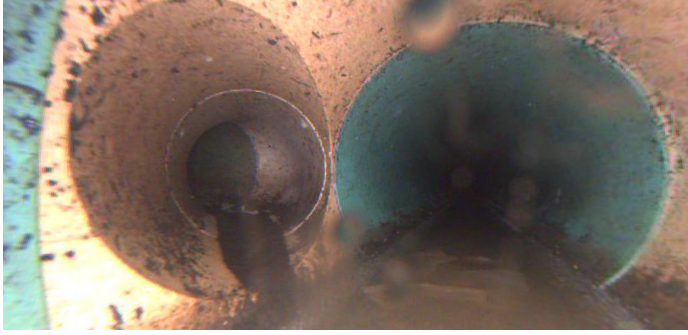
Code: **TF**
Description: **Tap Factory**

Distance (ft): **80.7**
Structural Grade: **0**
O&M Grade: **0**
Clock Start/From: **3**
Clock To:
1st Value: **4.000**
2nd Value:
Value Percent:
Continuous Index:
Within 8" of Joint:
Remarks:

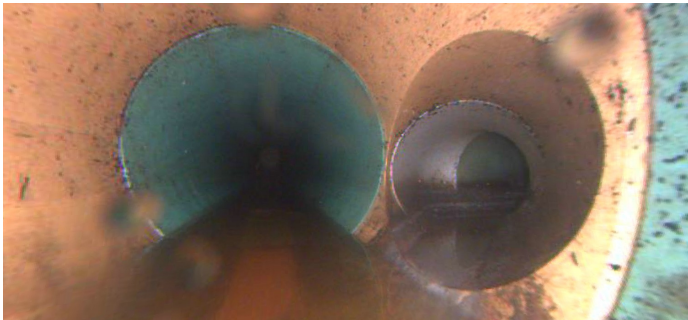
Code: **TF**
Description: **Tap Factory**

Distance (ft): **84.0**
Structural Grade: **0**
O&M Grade: **0**
Clock Start/From: **9**
Clock To:
1st Value: **4.000**
2nd Value:
Value Percent:
Continuous Index:
Within 8" of Joint:
Remarks:

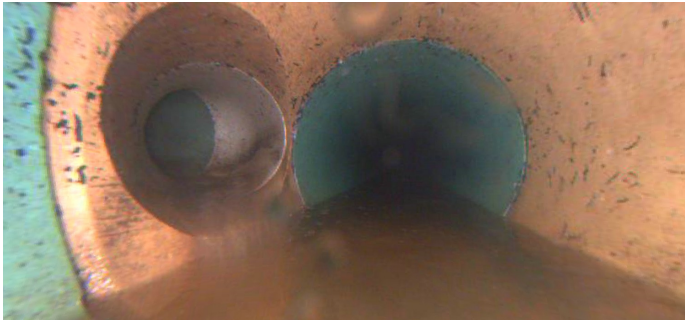
Code: **TFA**
Description: **Tap Factory Active**

Distance (ft): **172.6**
Structural Grade: **0**
O&M Grade: **0**
Clock Start/From: **3**
Clock To:
1st Value: **4.000**
2nd Value:
Value Percent:
Continuous Index:
Within 8" of Joint:
Remarks:

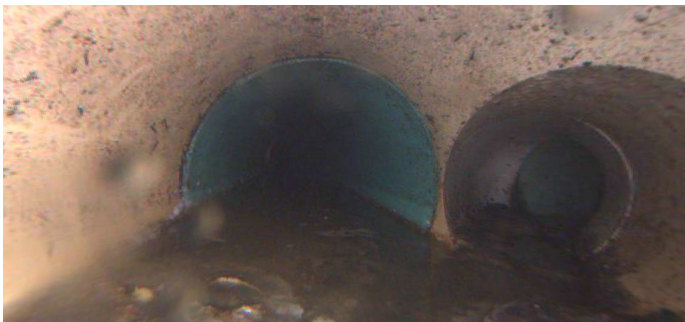
Code: **TF**
Description: **Tap Factory**

Distance (ft): **180.3**
Structural Grade: **0**
O&M Grade: **0**
Clock Start/From: **9**
Clock To:
1st Value: **4.000**
2nd Value:
Value Percent:
Continuous Index:
Within 8" of Joint:
Remarks:

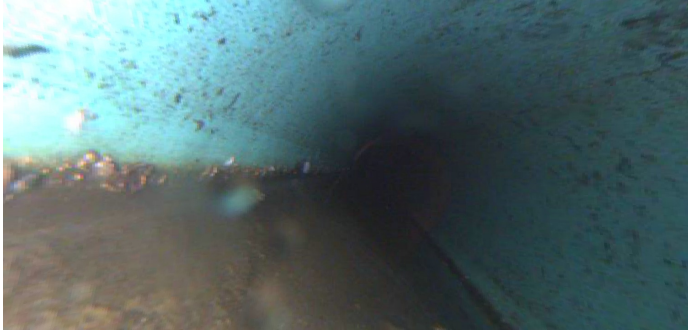
Code: **TFA**
Description: **Tap Factory Active**

Distance (ft): **231.5**
Structural Grade: **0**
O&M Grade: **0**
Clock Start/From: **3**
Clock To:
1st Value: **4.000**
2nd Value:
Value Percent:
Continuous Index:
Within 8" of Joint:
Remarks:
