## Profile/Photo Observation Report

Street:	<b>FOXCROFT STREET</b>	Flow Control:	<b>Not Controlled</b>
City:	<b>Hobart, IN</b>	Year Renewed:	
Location:	<b>Light Highway</b>	Tape/Media #:	
Purpose:	<b>Routine Assessment</b>	Dia/Height:	<b>10"</b>
Use:	<b>Sanitary</b>	Material:	<b>PVC</b>
Drain Area:	<b>NA</b>	Lining:	
Category:	<b>NA</b>		
Comment:	<b>R_M at 231 ft debris .Flow direction wrong</b>		
Location Details:		Direction of Survey:	<b>Downstream</b>
US MH:	<b>M-4074-011</b>	DS MH:	<b>M-407-010</b>
		Total Length Surveyed (ft):	<b>232.9</b>

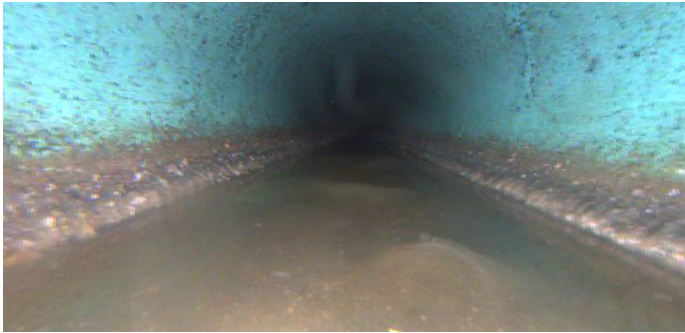
Code:	<b>MWL</b>
Description:	<b>Water Level</b>

Distance (ft):	<b>.0</b>
Structural Grade:	<b>0</b>
O&M Grade:	<b>0</b>
Clock Start/From:	
Clock To:	
1st Value:	
2nd Value:	
Value Percent:	<b>5.000</b>
Continuous Index:	
Within 8" of Joint:	<b>NO</b>
Remarks:

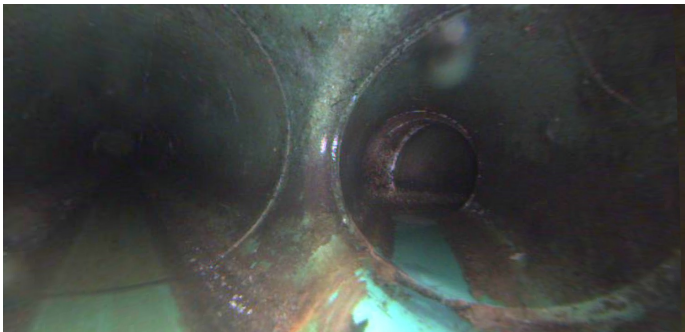
Code:	<b>TFA</b>
Description:	<b>Tap Factory Active</b>

Distance (ft):	<b>28.2</b>
Structural Grade:	<b>0</b>
O&M Grade:	<b>0</b>
Clock Start/From:	<b>3</b>
Clock To:	
1st Value:	<b>4.000</b>
2nd Value:	
Value Percent:	
Continuous Index:	
Within 8" of Joint:	
Remarks:

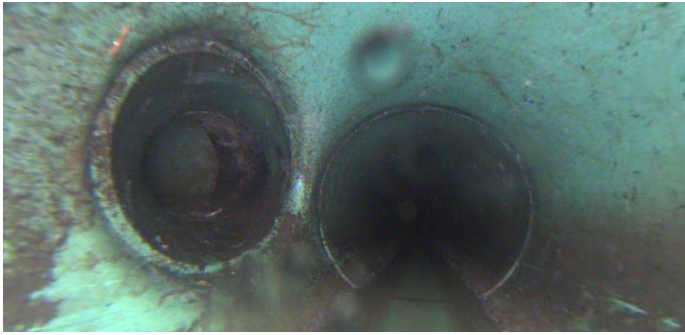
Code: **TF**  
Description: **Tap Factory**

Distance (ft): **33.4**  
Structural Grade: **0**  
O&M Grade: **0**  
Clock Start/From: **9**  
Clock To:  
1st Value: **4.000**  
2nd Value:  
Value Percent:  
Continuous Index:  
Within 8" of Joint:  
Remarks:

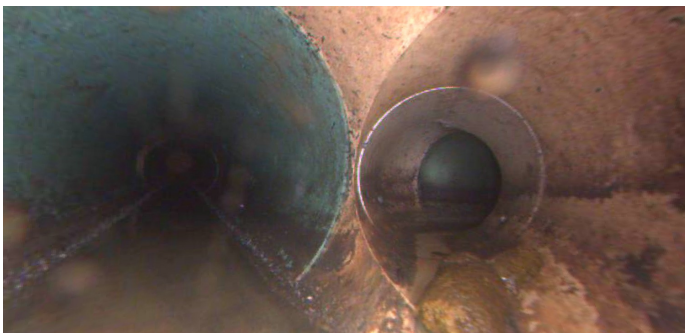
Code: **TF**  
Description: **Tap Factory**

Distance (ft): **80.7**  
Structural Grade: **0**  
O&M Grade: **0**  
Clock Start/From: **3**  
Clock To:  
1st Value: **4.000**  
2nd Value:  
Value Percent:  
Continuous Index:  
Within 8" of Joint:  
Remarks:

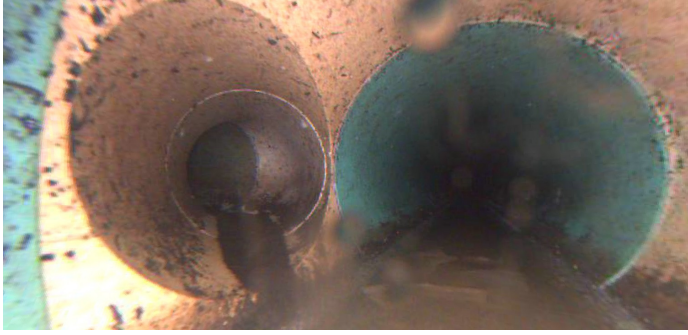
Code: **TF**  
Description: **Tap Factory**

Distance (ft): **84.0**  
Structural Grade: **0**  
O&M Grade: **0**  
Clock Start/From: **9**  
Clock To:  
1st Value: **4.000**  
2nd Value:  
Value Percent:  
Continuous Index:  
Within 8" of Joint:  
Remarks:

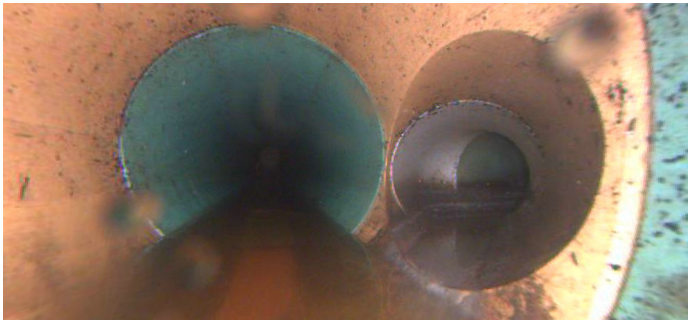
Code: **TFA**  
Description: **Tap Factory Active**

Distance (ft): **172.6**  
Structural Grade: **0**  
O&M Grade: **0**  
Clock Start/From: **3**  
Clock To:  
1st Value: **4.000**  
2nd Value:  
Value Percent:  
Continuous Index:  
Within 8" of Joint:  
Remarks:

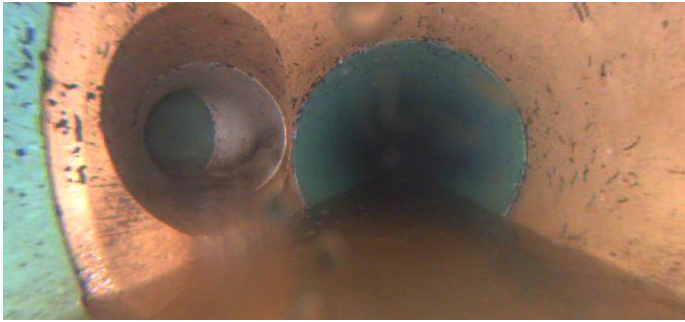
Code: **TF**  
Description: **Tap Factory**

Distance (ft): **180.3**  
Structural Grade: **0**  
O&M Grade: **0**  
Clock Start/From: **9**  
Clock To:  
1st Value: **4.000**  
2nd Value:  
Value Percent:  
Continuous Index:  
Within 8" of Joint:  
Remarks:

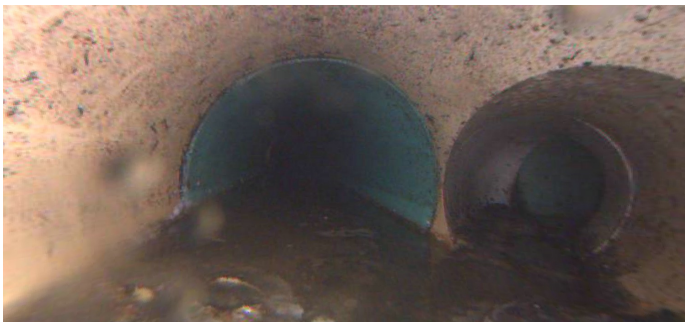
Code: **TFA**  
Description: **Tap Factory Active**

Distance (ft): **231.5**  
Structural Grade: **0**  
O&M Grade: **0**  
Clock Start/From: **3**  
Clock To:  
1st Value: **4.000**  
2nd Value:  
Value Percent:  
Continuous Index:  
Within 8" of Joint:  
Remarks:

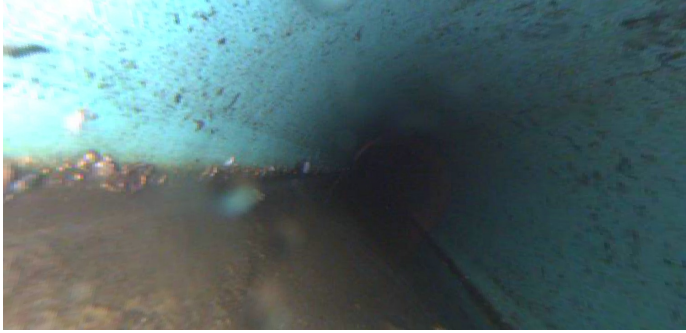
Code:	<b>MSA</b>
Description:	<b>Abandoned Survey</b>
Distance (ft):	<b>232.9</b>
Structural Grade:	<b>0</b>
O&M Grade:	<b>0</b>
Clock Start/From:	
Clock To:	
1st Value:	
2nd Value:	
Value Percent:	
Continuous Index:	
Within 8" of Joint:	<b>NO</b>
Remarks:	<b>camera stopped</b>
