Profile/Photo Observation Report

Date:	04/28/2018	Weather:		Coding:	PACP 6.0
Pipe Length (ft):		Owner:	City of Hobart	Pre Clean:	No Pre-Cleaning
P.O.#:	132	Surveyor:	M. Pielacha	PSR:	P-503-001-001.1
Customer:	City of Hobart	Clean Date:		Shape:	C

Street:	North Wisconsin Street	Flow Control:	Not Controlled
City:	Hobart, IN	Year Renewed:	
Location:	Light Highway	Tape/Media #:	DEP-132
Purpose:	Routine Assessment	Dia/Height:	12"
Use:	Sanitary	Material:	VCP
Drain Area:		Lining:	
Category:	NA		
Comment:	YES501824 Submittal 2		
Location Details:		Direction of Survey:	Downstream
US MH:	M-503-001	DS MH:	M-503-001.1
		Total Length Surveyed (ft):	6.4

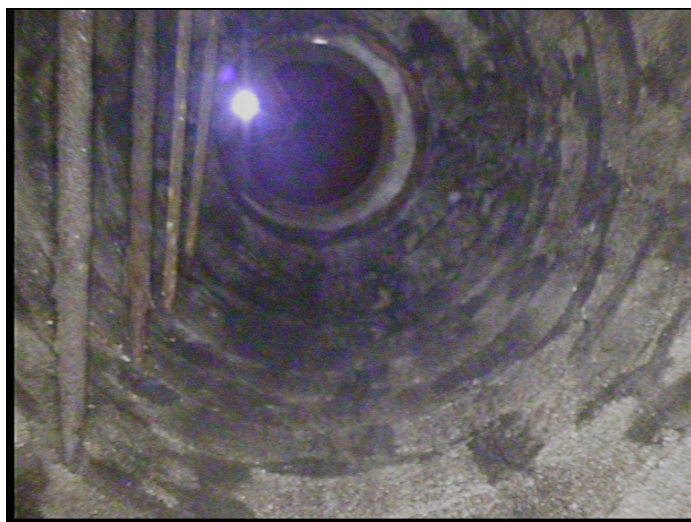
Code: **AMH**
Description: **Manhole**

Distance (ft): **.0**
Structural Grade: **0**
O&M Grade: **0**
Clock Start/From:
Clock To:
1st Value:
2nd Value:
Value Percent:
Continuous Index:
Within 8" of Joint: **NO**
Remarks: **M-503-001**

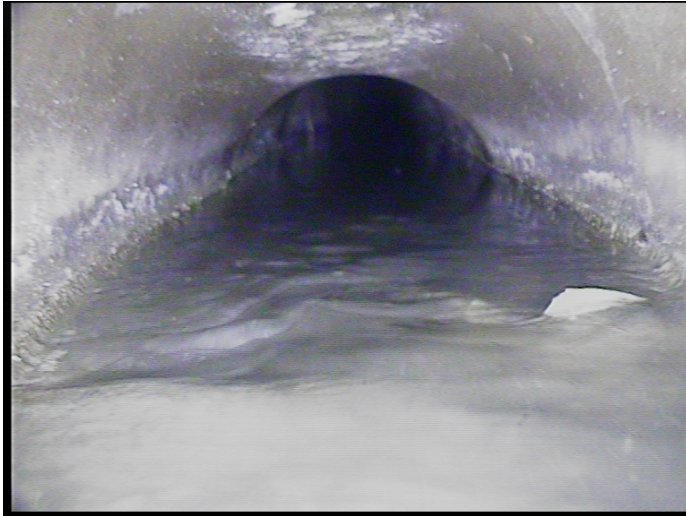
Code: **MWL**
Description: **Water Level**

Distance (ft): **.0**
Structural Grade: **0**
O&M Grade: **0**
Clock Start/From:
Clock To:
1st Value:
2nd Value:
Value Percent: **25.000**
Continuous Index:
Within 8" of Joint: **NO**
Remarks:

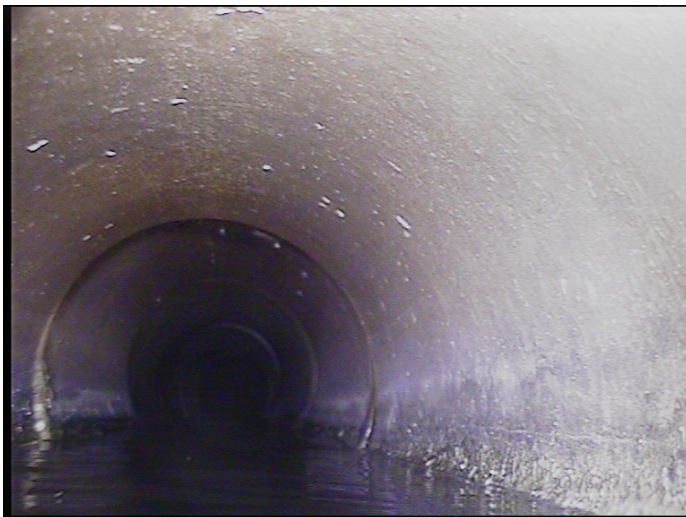
Code: **MSA**
Description: **Abandoned Survey**

Distance (ft): **6.2**
Structural Grade: **0**
O&M Grade: **0**
Clock Start/From:
Clock To:
1st Value:
2nd Value:
Value Percent:
Continuous Index:
Within 8" of Joint: **NO**
Remarks: **Underwater Debris**
