Profile/Photo Observation Report

Date:	04/28/2018	Weather:		Coding:	PACP 6.0
Pipe Length (ft):		Owner:	City of Hobart	Pre Clean:	Not Known
P.O.#:	132	Surveyor:	M. Pielacha	PSR:	P-503-003-002
Customer:	City of Hobart	Clean Date:		Shape:	C

Street:	North Wisconsin Street	Flow Control:	Not Controlled
City:	Hobart, IN	Year Renewed:	
Location:	Light Highway	Tape/Media #:	DEP-132
Purpose:	Routine Assessment	Dia/Height:	12"
Use:	Sanitary	Material:	VCP
Drain Area:		Lining:	
Category:	NA		
Comment:	YES501824 Submittal 2		
Location Details:		Direction of Survey:	Downstream
US MH:	M-503-003	DS MH:	M-503-002
		Total Length Surveyed (ft):	343.1

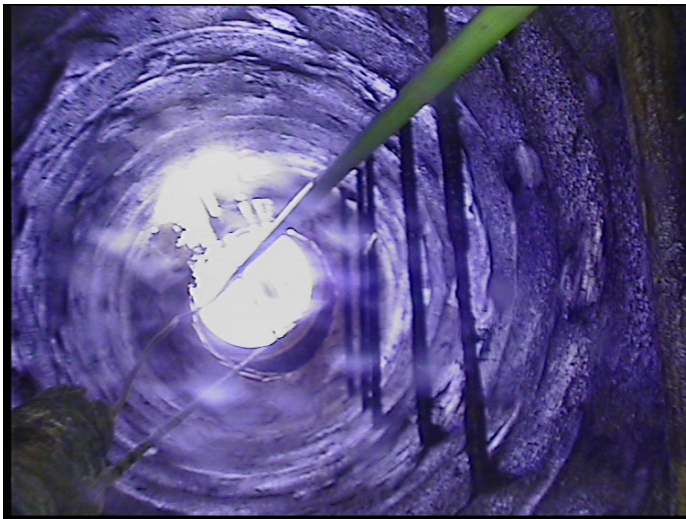
Code: **AMH**
Description: **Manhole**

Distance (ft): **.0**
Structural Grade: **0**
O&M Grade: **0**
Clock Start/From:
Clock To:
1st Value:
2nd Value:
Value Percent:
Continuous Index:
Within 8" of Joint: **NO**
Remarks: **M-503-003**

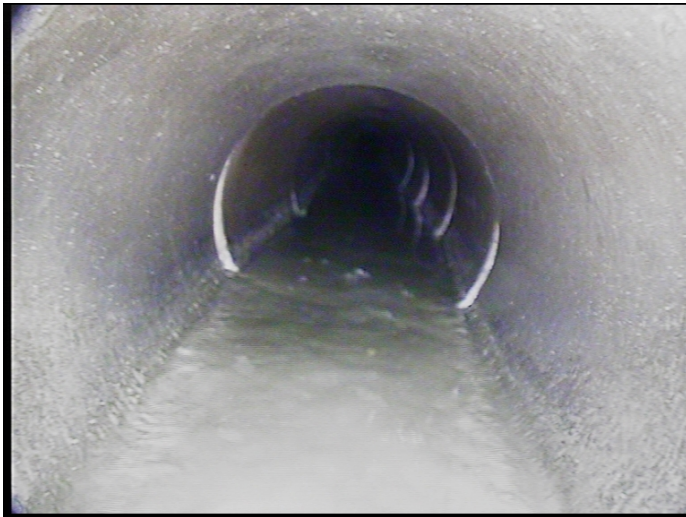
Code:	MWL
Description:	Water Level
Distance (ft):	.0
Structural Grade:	0
O&M Grade:	0
Clock Start/From:	
Clock To:	
1st Value:	
2nd Value:	
Value Percent:	10.000
Continuous Index:	
Within 8" of Joint:	NO
Remarks:

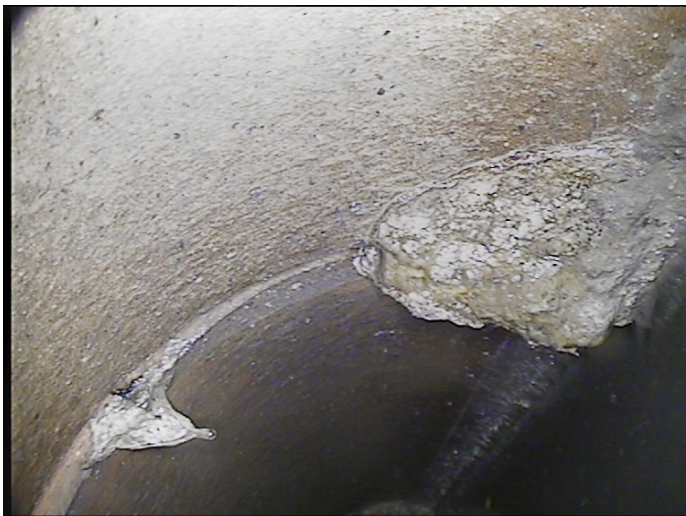
Code:	DAE
Description:	Deposits Attached Encrustation
Distance (ft):	18.9
Structural Grade:	0
O&M Grade:	2
Clock Start/From:	3
Clock To:	5
1st Value:	
2nd Value:	
Value Percent:	5.000
Continuous Index:	S01
Within 8" of Joint:	YES
Remarks:

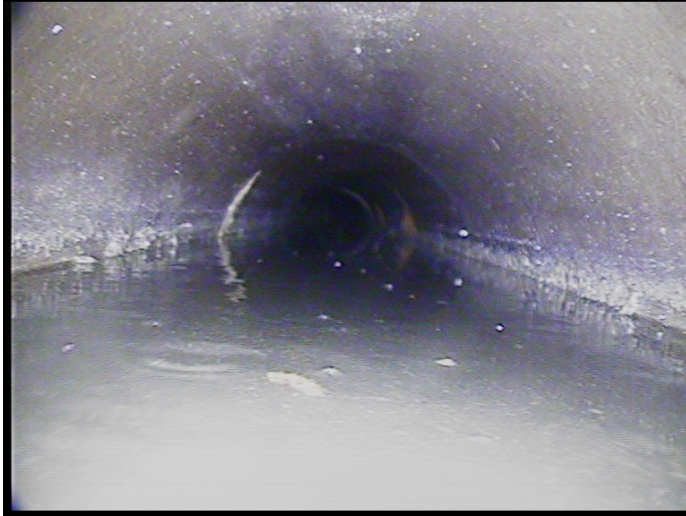
Code:	MWL
Description:	Water Level
Distance (ft):	29.8
Structural Grade:	0
O&M Grade:	0
Clock Start/From:	
Clock To:	
1st Value:	
2nd Value:	
Value Percent:	40.000
Continuous Index:	
Within 8" of Joint:	NO
Remarks:

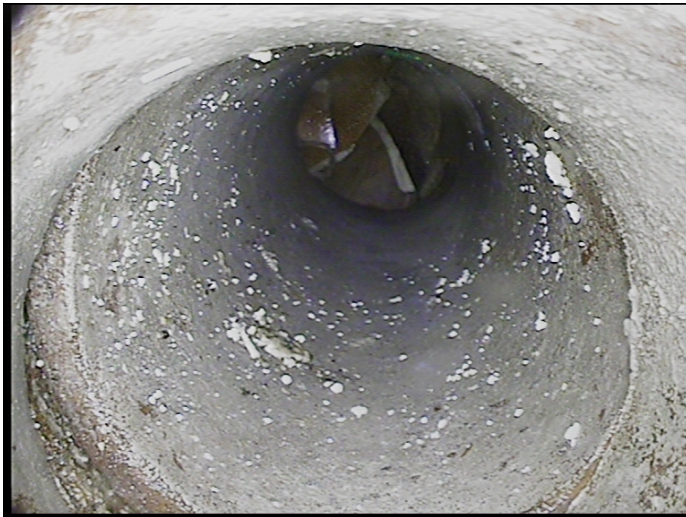
Code:	TF
Description:	Tap Factory
Distance (ft):	43.9
Structural Grade:	0
O&M Grade:	0
Clock Start/From:	2
Clock To:	
1st Value:	4.000
2nd Value:	
Value Percent:	
Continuous Index:	
Within 8" of Joint:	NO
Remarks:

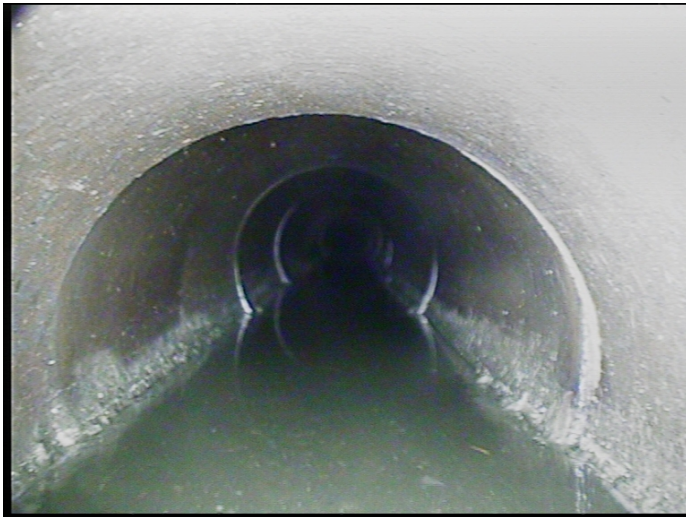
Code: **DAE**
Description: **Deposits Attached Encrustation**

Distance (ft): **43.9**
Structural Grade: **0**
O&M Grade: **2**
Clock Start/From: **3**
Clock To: **5**
1st Value:
2nd Value:
Value Percent: **5.000**
Continuous Index: **F01**
Within 8" of Joint: **NO**
Remarks:

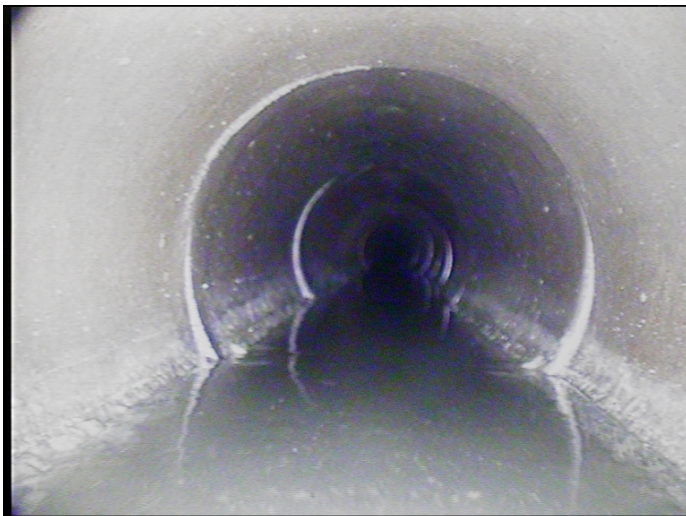
Code: **MWL**
Description: **Water Level**

Distance (ft): **45.9**
Structural Grade: **0**
O&M Grade: **0**
Clock Start/From:
Clock To:
1st Value:
2nd Value:
Value Percent: **15.000**
Continuous Index:
Within 8" of Joint: **NO**
Remarks:

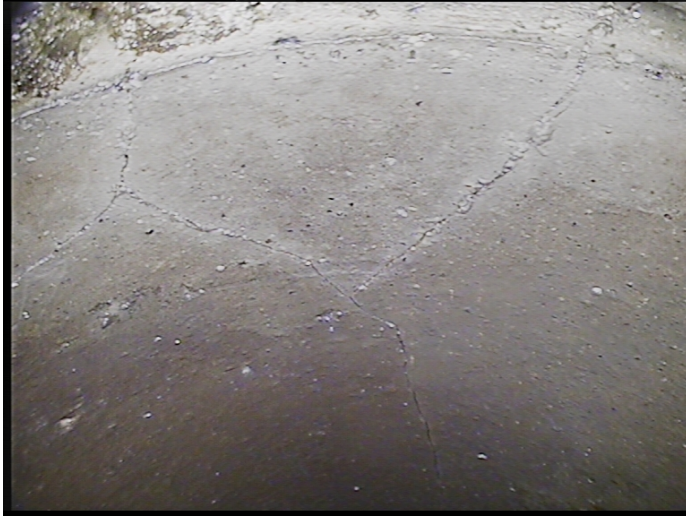
Code: **CM**
Description: **Crack Multiple**

Distance (ft): **50.1**
Structural Grade: **3**
O&M Grade: **0**
Clock Start/From: **10**
Clock To: **1**
1st Value:
2nd Value:
Value Percent:
Continuous Index:
Within 8" of Joint: **YES**
Remarks:

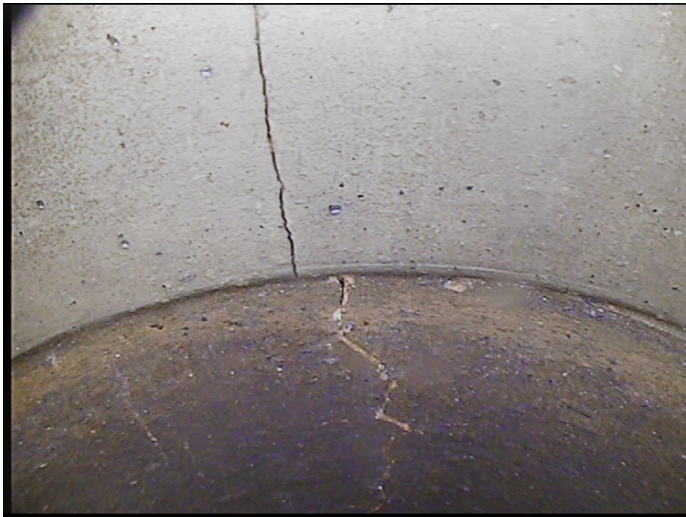
Code: **CL**
Description: **Crack Longitudinal**

Distance (ft): **52.3**
Structural Grade: **2**
O&M Grade: **0**
Clock Start/From: **12**
Clock To:
1st Value:
2nd Value:
Value Percent:
Continuous Index: **S02**
Within 8" of Joint: **YES**
Remarks:

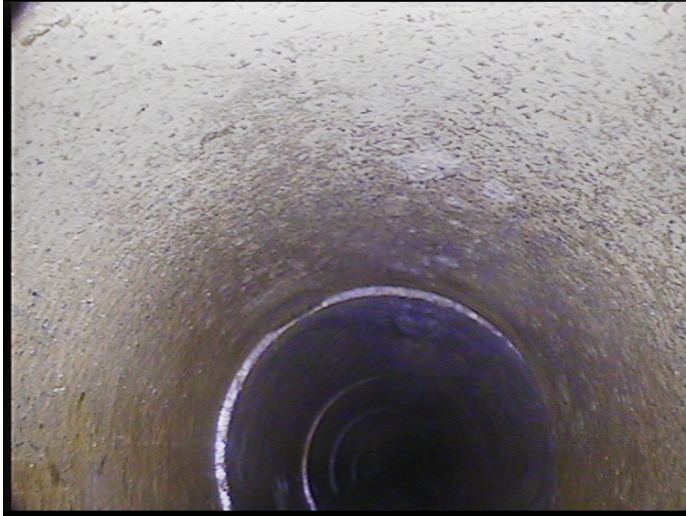
Code: **CL**
Description: **Crack Longitudinal**

Distance (ft): **64.8**
Structural Grade: **2**
O&M Grade: **0**
Clock Start/From: **12**
Clock To:
1st Value:
2nd Value:
Value Percent:
Continuous Index: **F02**
Within 8" of Joint: **NO**
Remarks:

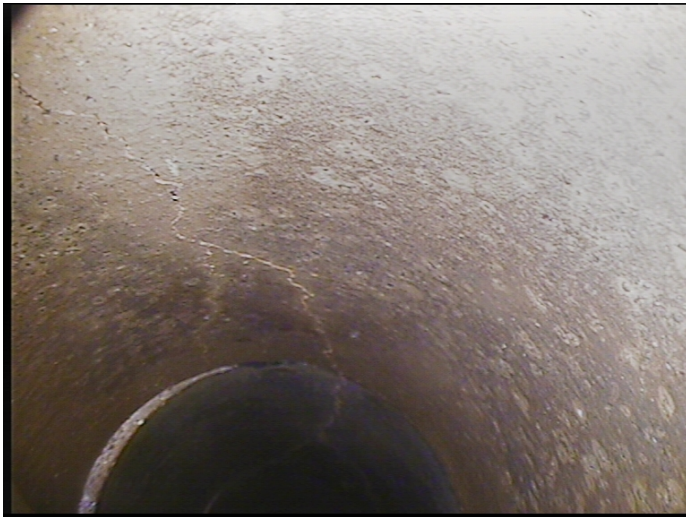
Code: **CL**
Description: **Crack Longitudinal**

Distance (ft): **75.6**
Structural Grade: **2**
O&M Grade: **0**
Clock Start/From: **11**
Clock To:
1st Value:
2nd Value:
Value Percent:
Continuous Index: **S03**
Within 8" of Joint: **NO**
Remarks:

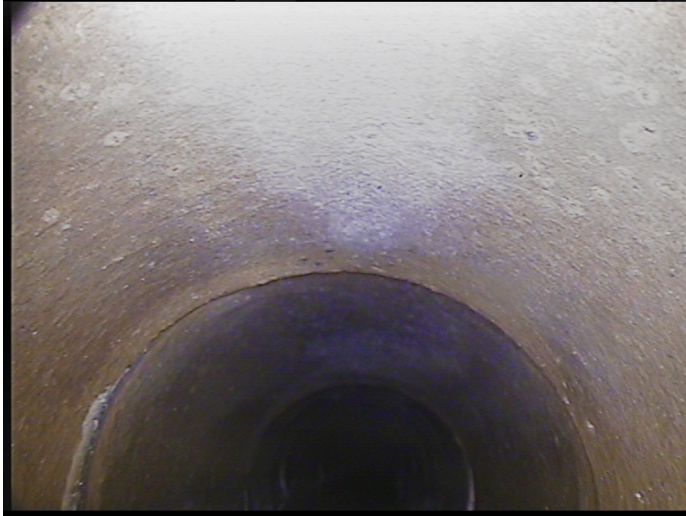
Code: **CL**
Description: **Crack Longitudinal**

Distance (ft): **82.3**
Structural Grade: **2**
O&M Grade: **0**
Clock Start/From: **11**
Clock To:
1st Value:
2nd Value:
Value Percent:
Continuous Index: **F03**
Within 8" of Joint: **NO**
Remarks:

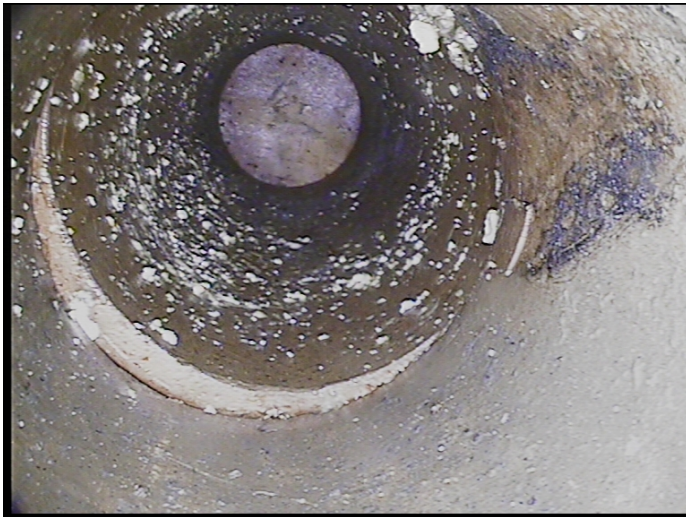
Code: **TFC**
Description: **Tap Factory Capped**

Distance (ft): **108.2**
Structural Grade: **0**
O&M Grade: **0**
Clock Start/From: **2**
Clock To:
1st Value: **4.000**
2nd Value:
Value Percent:
Continuous Index:
Within 8" of Joint: **NO**
Remarks:

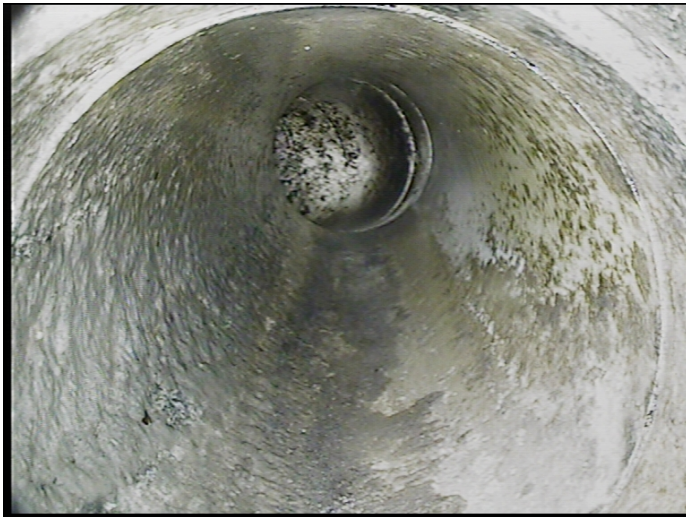
Code: **TFA**
Description: **Tap Factory Active**

Distance (ft): **113.9**
Structural Grade: **0**
O&M Grade: **0**
Clock Start/From: **12**
Clock To:
1st Value: **6.000**
2nd Value:
Value Percent:
Continuous Index:
Within 8" of Joint: **NO**
Remarks:

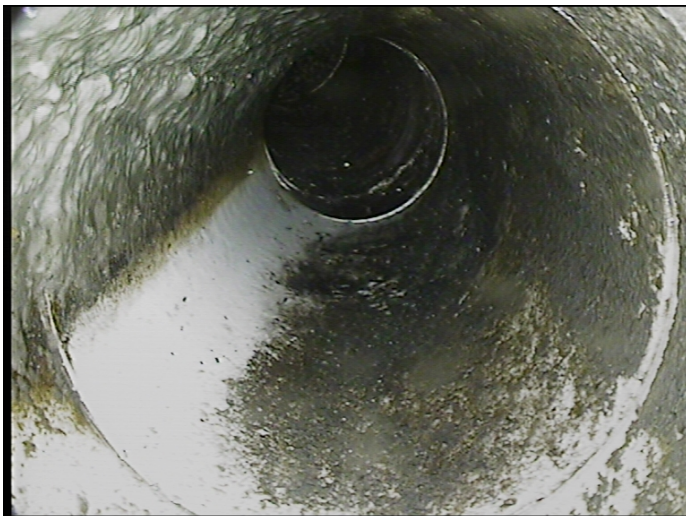
Code: **TFA**
Description: **Tap Factory Active**

Distance (ft): **115.9**
Structural Grade: **0**
O&M Grade: **0**
Clock Start/From: **12**
Clock To:
1st Value: **6.000**
2nd Value:
Value Percent:
Continuous Index:
Within 8" of Joint: **NO**
Remarks:

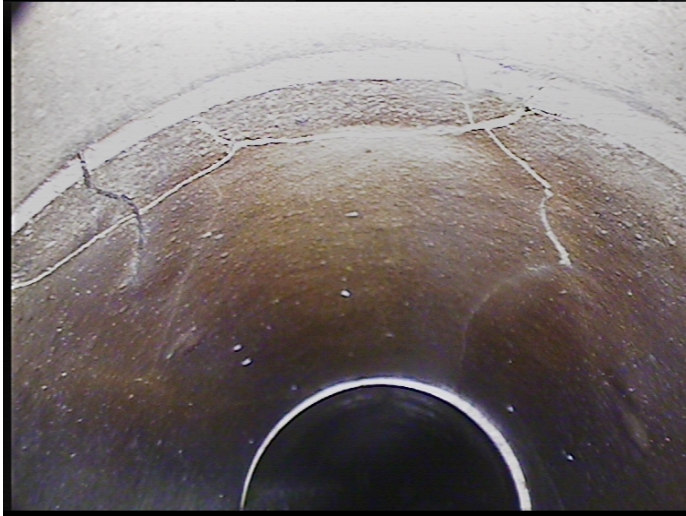
Code: **CM**
Description: **Crack Multiple**

Distance (ft): **136.1**
Structural Grade: **3**
O&M Grade: **0**
Clock Start/From: **10**
Clock To: **2**
1st Value:
2nd Value:
Value Percent:
Continuous Index:
Within 8" of Joint: **YES**
Remarks:

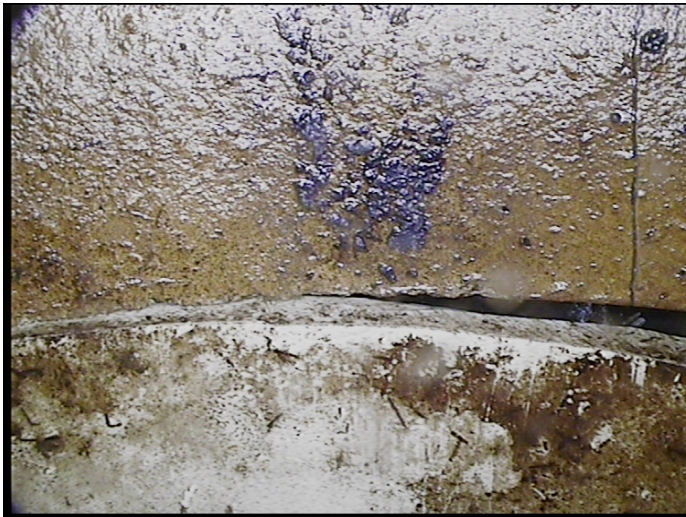
Code: **MMC**
Description: **Material Change**

Distance (ft): **138.4**
Structural Grade: **0**
O&M Grade: **0**
Clock Start/From:
Clock To:
1st Value:
2nd Value:
Value Percent:
Continuous Index:
Within 8" of Joint: **NO**
Remarks: **PVC**

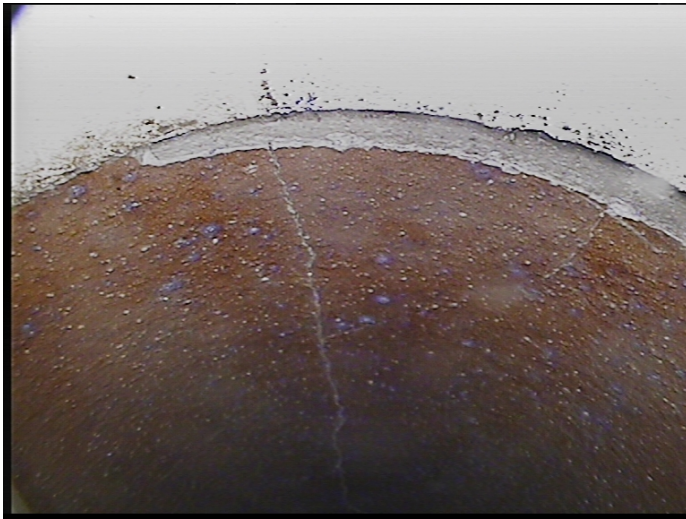
Code: **MMC**
Description: **Material Change**

Distance (ft): **146.5**
Structural Grade: **0**
O&M Grade: **0**
Clock Start/From:
Clock To:
1st Value:
2nd Value:
Value Percent:
Continuous Index:
Within 8" of Joint: **NO**
Remarks: **VCP**

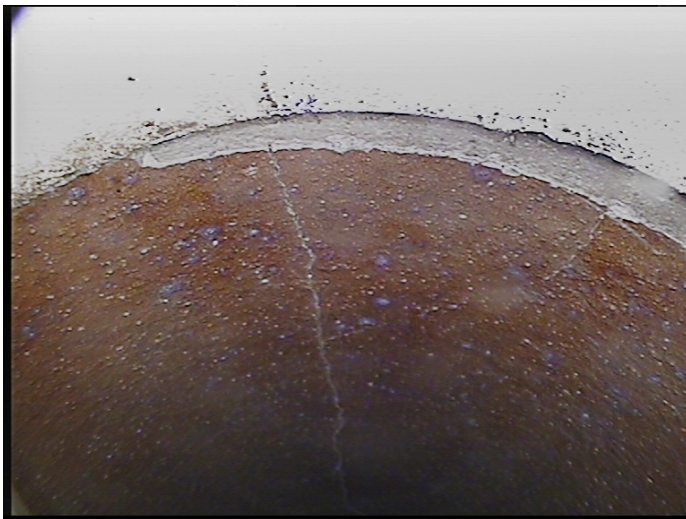
Code: **CL**
Description: **Crack Longitudinal**

Distance (ft): **146.5**
Structural Grade: **2**
O&M Grade: **0**
Clock Start/From: **11**
Clock To:
1st Value:
2nd Value:
Value Percent:
Continuous Index: **S04**
Within 8" of Joint: **YES**
Remarks:

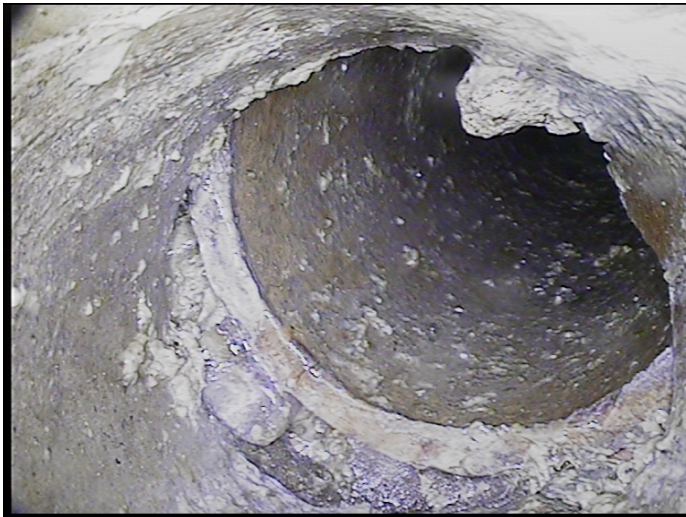
Code: **TF**
Description: **Tap Factory**

Distance (ft): **155.9**
Structural Grade: **0**
O&M Grade: **0**
Clock Start/From: **1**
Clock To:
1st Value: **4.000**
2nd Value:
Value Percent:
Continuous Index:
Within 8" of Joint: **NO**
Remarks:

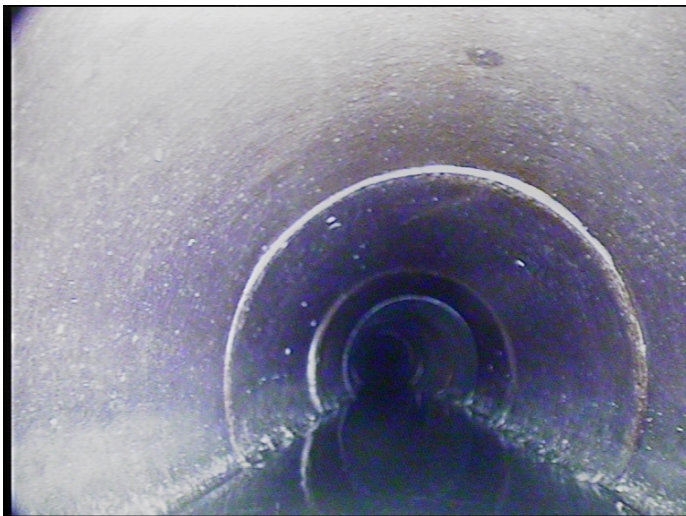
Code: **CL**
Description: **Crack Longitudinal**

Distance (ft): **159.3**
Structural Grade: **2**
O&M Grade: **0**
Clock Start/From: **11**
Clock To:
1st Value:
2nd Value:
Value Percent:
Continuous Index: **F04**
Within 8" of Joint: **NO**
Remarks:

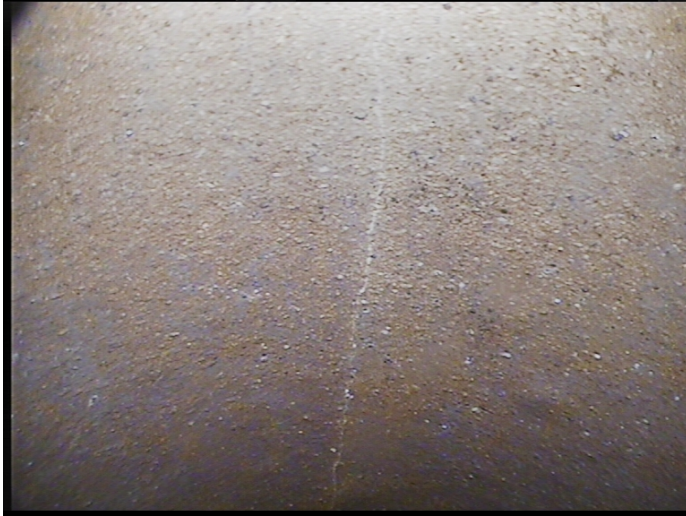
Code: **CL**
Description: **Crack Longitudinal**

Distance (ft): **163.6**
Structural Grade: **2**
O&M Grade: **0**
Clock Start/From: **12**
Clock To:
1st Value:
2nd Value:
Value Percent:
Continuous Index: **S05**
Within 8" of Joint: **YES**
Remarks:

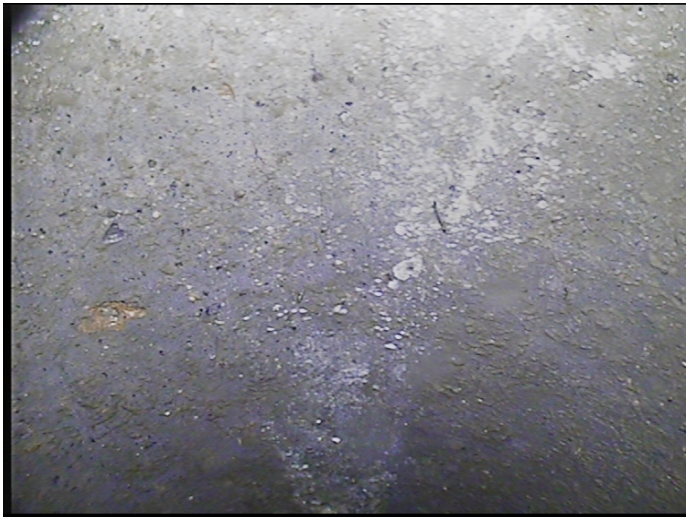
Code: **CL**
Description: **Crack Longitudinal**

Distance (ft): **175.7**
Structural Grade: **2**
O&M Grade: **0**
Clock Start/From: **12**
Clock To:
1st Value:
2nd Value:
Value Percent:
Continuous Index: **F05**
Within 8" of Joint: **NO**
Remarks:

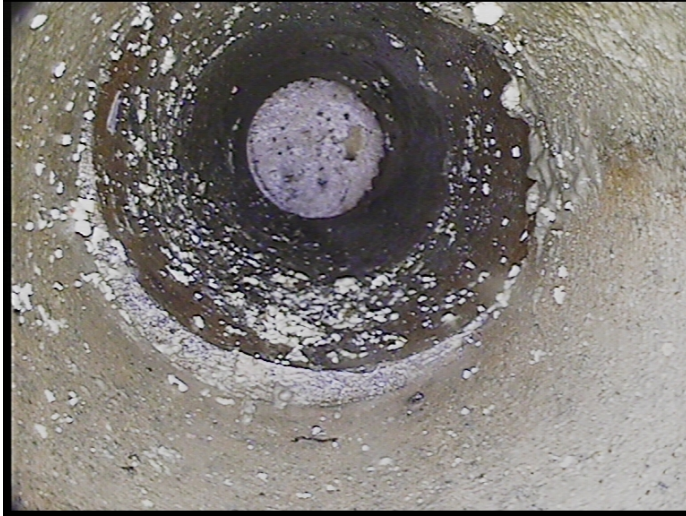
Code: **TFC**
Description: **Tap Factory Capped**

Distance (ft): **184.3**
Structural Grade: **0**
O&M Grade: **0**
Clock Start/From: **1**
Clock To:
1st Value: **4.000**
2nd Value:
Value Percent:
Continuous Index:
Within 8" of Joint: **NO**
Remarks:

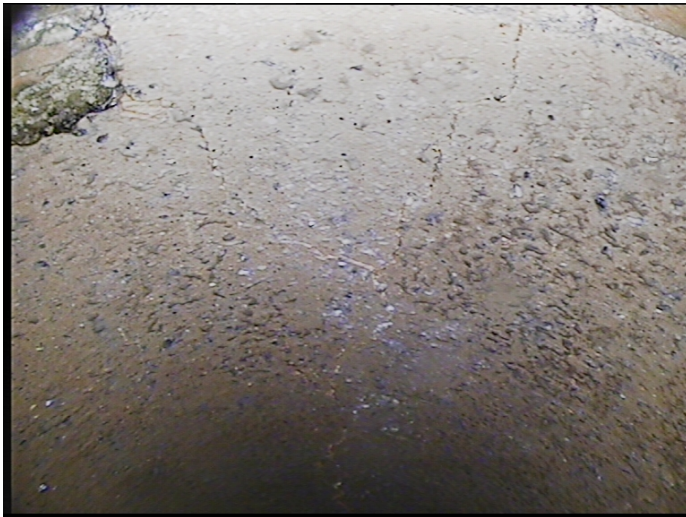
Code: **CL**
Description: **Crack Longitudinal**

Distance (ft): **185.1**
Structural Grade: **2**
O&M Grade: **0**
Clock Start/From: **11**
Clock To:
1st Value:
2nd Value:
Value Percent:
Continuous Index: **S06**
Within 8" of Joint: **NO**
Remarks:

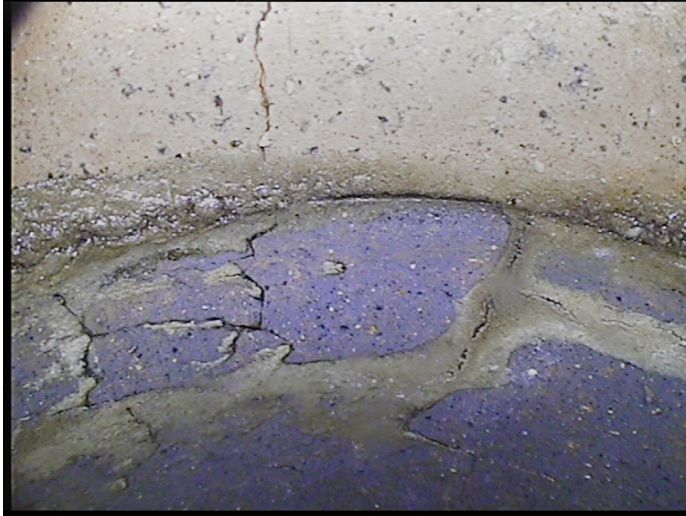
Code: **CM**
Description: **Crack Multiple**

Distance (ft): **197.4**
Structural Grade: **3**
O&M Grade: **0**
Clock Start/From: **10**
Clock To: **1**
1st Value:
2nd Value:
Value Percent:
Continuous Index:
Within 8" of Joint: **NO**
Remarks:

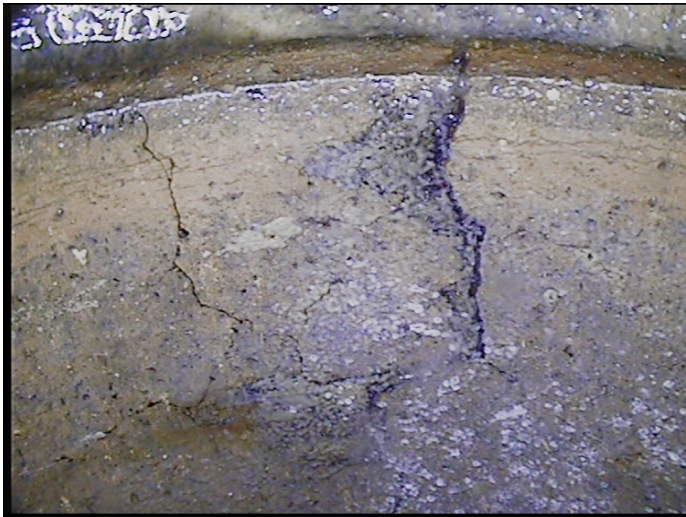
Code: **CM**
Description: **Crack Multiple**

Distance (ft): **205.7**
Structural Grade: **3**
O&M Grade: **0**
Clock Start/From: **10**
Clock To: **11**
1st Value:
2nd Value:
Value Percent:
Continuous Index:
Within 8" of Joint: **YES**
Remarks:

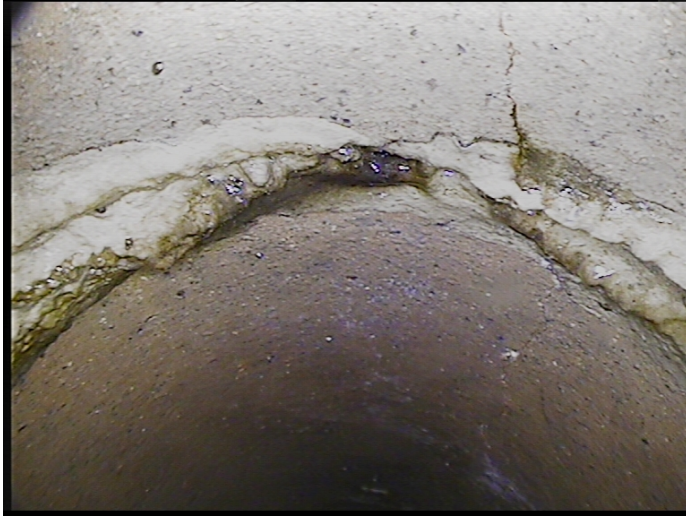
Code: **ID**
Description: **Infil Dripper**

Distance (ft): **213.7**
Structural Grade: **0**
O&M Grade: **3**
Clock Start/From: **12**
Clock To:
1st Value:
2nd Value:
Value Percent:
Continuous Index:
Within 8" of Joint: **YES**
Remarks:

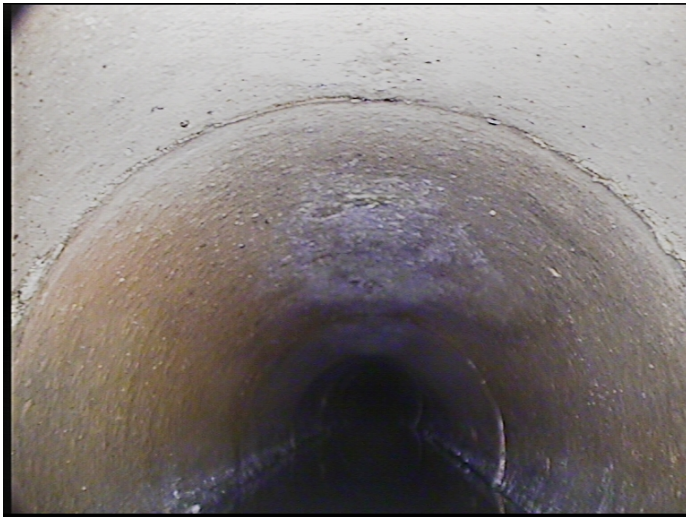
Code: **CL**
Description: **Crack Longitudinal**

Distance (ft): **215.2**
Structural Grade: **2**
O&M Grade: **0**
Clock Start/From: **11**
Clock To:
1st Value:
2nd Value:
Value Percent:
Continuous Index: **F06**
Within 8" of Joint: **NO**
Remarks:

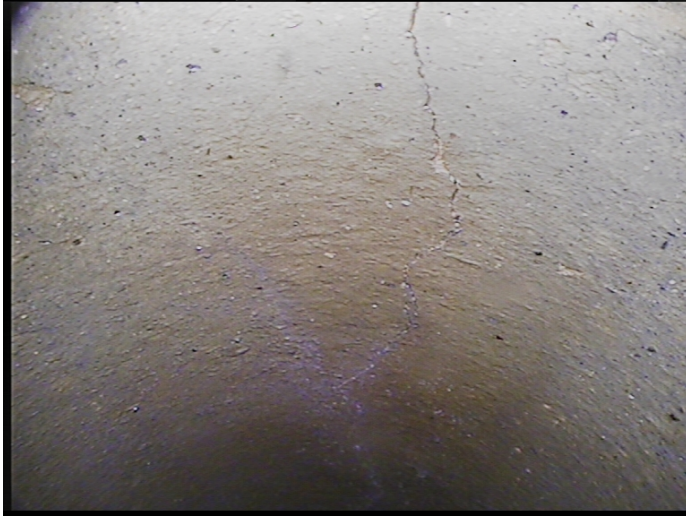
Code: **CL**
Description: **Crack Longitudinal**

Distance (ft): **224.2**
Structural Grade: **2**
O&M Grade: **0**
Clock Start/From: **11**
Clock To:
1st Value:
2nd Value:
Value Percent:
Continuous Index: **S07**
Within 8" of Joint: **YES**
Remarks:

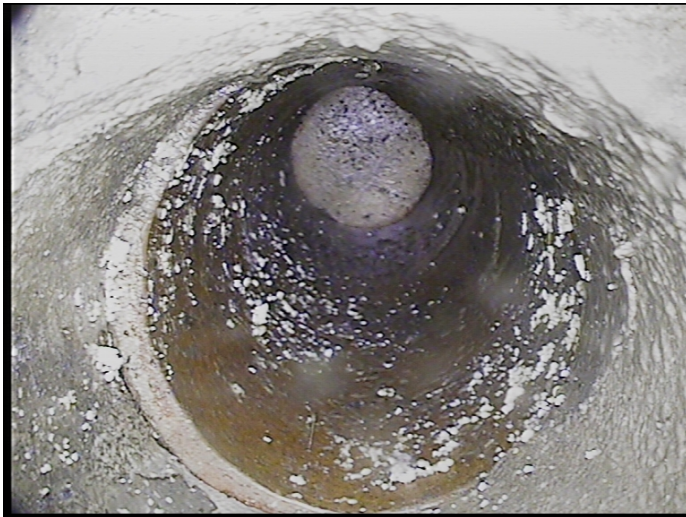
Code: **TFC**
Description: **Tap Factory Capped**

Distance (ft): **235.3**
Structural Grade: **0**
O&M Grade: **0**
Clock Start/From: **1**
Clock To:
1st Value: **4.000**
2nd Value:
Value Percent:
Continuous Index:
Within 8" of Joint: **NO**
Remarks:

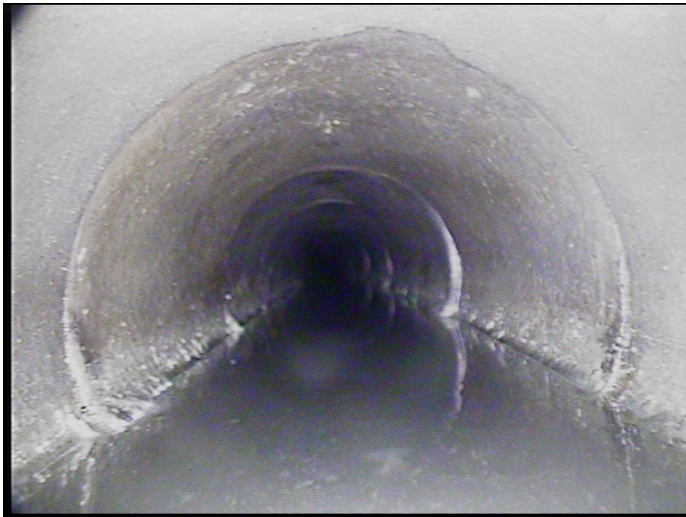
Code: **CL**
Description: **Crack Longitudinal**

Distance (ft): **249.7**
Structural Grade: **2**
O&M Grade: **0**
Clock Start/From: **11**
Clock To:
1st Value:
2nd Value:
Value Percent:
Continuous Index: **F07**
Within 8" of Joint: **NO**
Remarks:

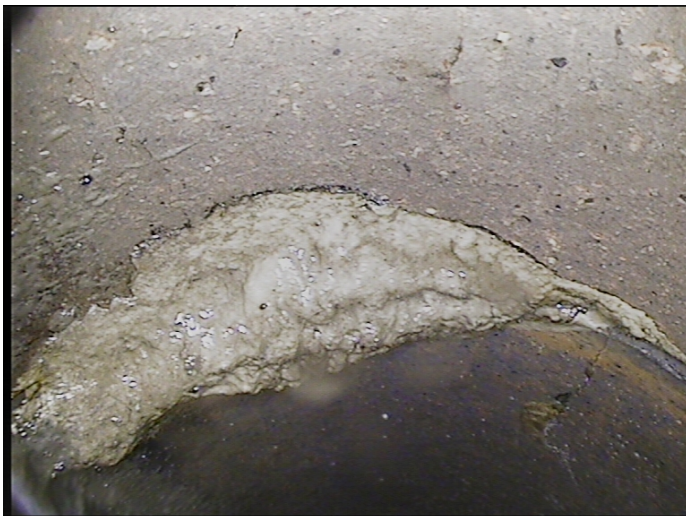
Code: **DAE**
Description: **Deposits Attached Encrustation**

Distance (ft): **262.7**
Structural Grade: **0**
O&M Grade: **2**
Clock Start/From: **8**
Clock To: **10**
1st Value:
2nd Value:
Value Percent: **5.000**
Continuous Index:
Within 8" of Joint: **YES**
Remarks:

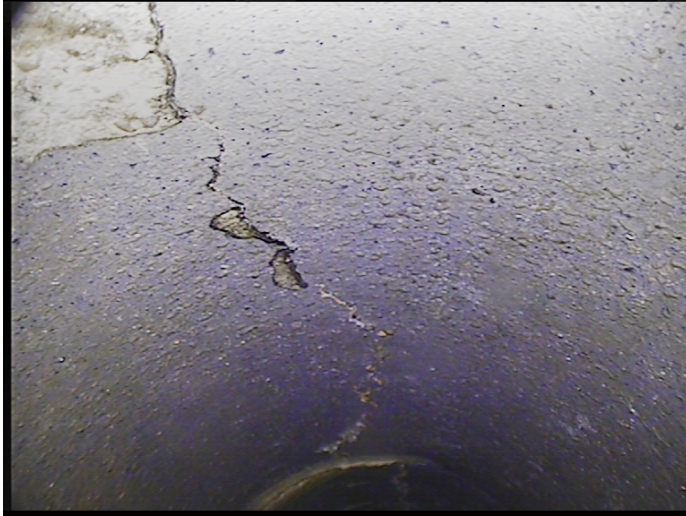
Code: **CL**
Description: **Crack Longitudinal**

Distance (ft): **267.2**
Structural Grade: **2**
O&M Grade: **0**
Clock Start/From: **12**
Clock To:
1st Value:
2nd Value:
Value Percent:
Continuous Index: **S08**
Within 8" of Joint: **YES**
Remarks:

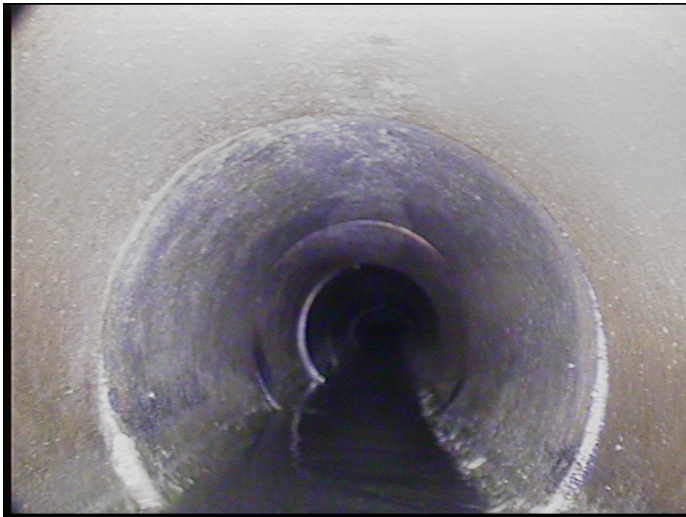
Code: **CL**
Description: **Crack Longitudinal**

Distance (ft): **305.1**
Structural Grade: **2**
O&M Grade: **0**
Clock Start/From: **12**
Clock To:
1st Value:
2nd Value:
Value Percent:
Continuous Index: **F08**
Within 8" of Joint: **NO**
Remarks:

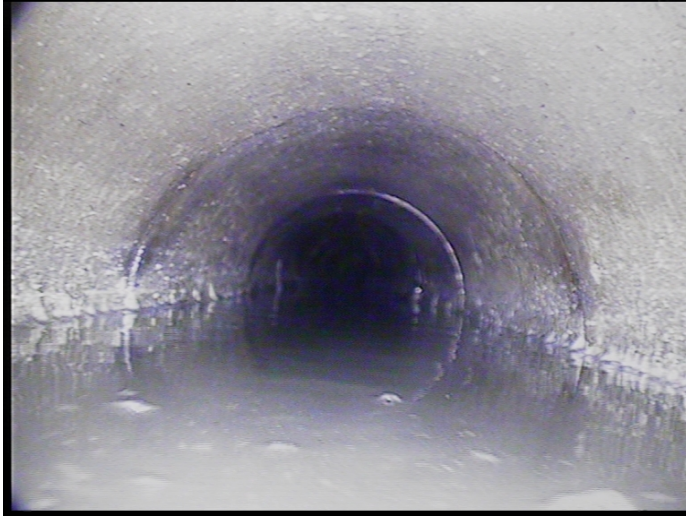
Code:	MWL
Description:	Water Level
Distance (ft):	322.3
Structural Grade:	0
O&M Grade:	0
Clock Start/From:	
Clock To:	
1st Value:	
2nd Value:	
Value Percent:	35.000
Continuous Index:	
Within 8" of Joint:	NO
Remarks:

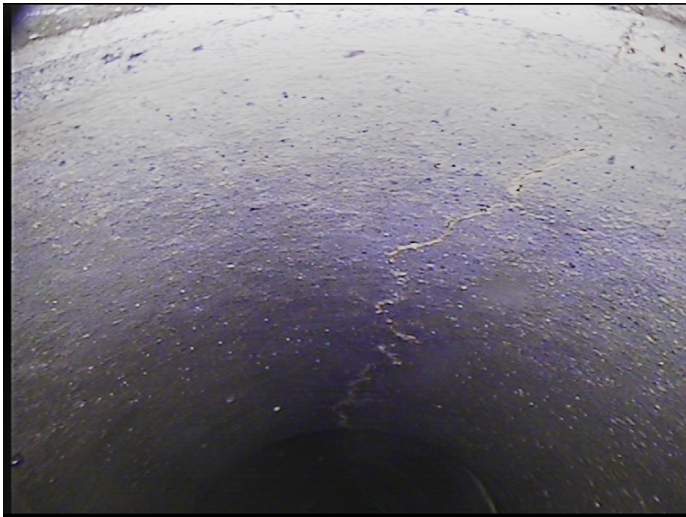
Code:	CL
Description:	Crack Longitudinal
Distance (ft):	325.9
Structural Grade:	2
O&M Grade:	0
Clock Start/From:	1
Clock To:	
1st Value:	
2nd Value:	
Value Percent:	
Continuous Index:	S09
Within 8" of Joint:	YES
Remarks:

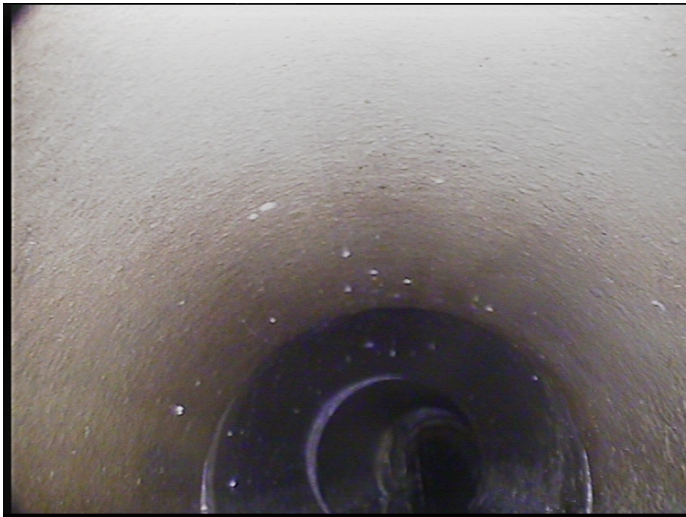
Code: **CL**
Description: **Crack Longitudinal**

Distance (ft): **335.2**
Structural Grade: **2**
O&M Grade: **0**
Clock Start/From: **1**
Clock To:
1st Value:
2nd Value:
Value Percent:
Continuous Index: **F09**
Within 8" of Joint: **NO**
Remarks:

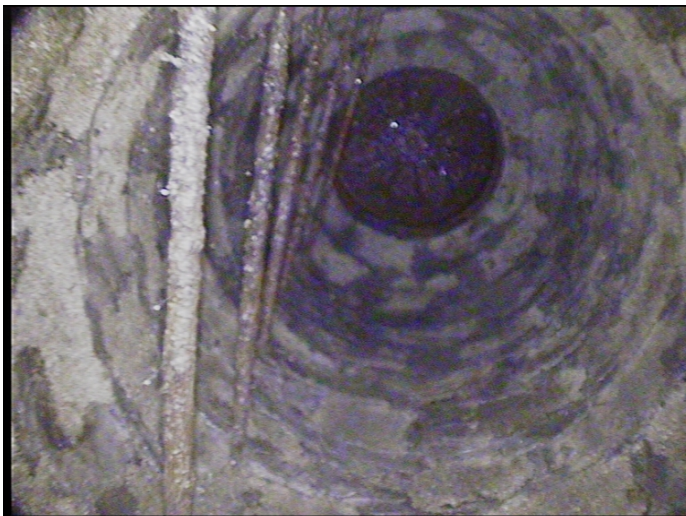
Code: **AMH**
Description: **Manhole**

Distance (ft): **343.1**
Structural Grade: **0**
O&M Grade: **0**
Clock Start/From:
Clock To:
1st Value:
2nd Value:
Value Percent:
Continuous Index:
Within 8" of Joint: **NO**
Remarks: **M-503-001**
