## Profile/Photo Observation Report

Street:	<b>North Wisconsin Street</b>	Flow Control:	<b>Not Controlled</b>
City:	<b>Hobart, IN</b>	Year Renewed:	
Location:	<b>Alley</b>	Tape/Media #:	
Purpose:	<b>Routine Assessment</b>	Dia/Height:	<b>12"</b>
Use:	<b>Sanitary Sewage Pipe</b>	Material:	<b>VCP</b>
Drain Area:		Lining:	<b>None</b>
Category:	<b>NA</b>		
Comment:

Location Details:		Direction of Survey:	<b>Downstream</b>
US MH:	<b>M-503-004</b>	DS MH:	<b>M-503-003</b>
		Total Length Surveyed (ft):	<b>7.9</b>

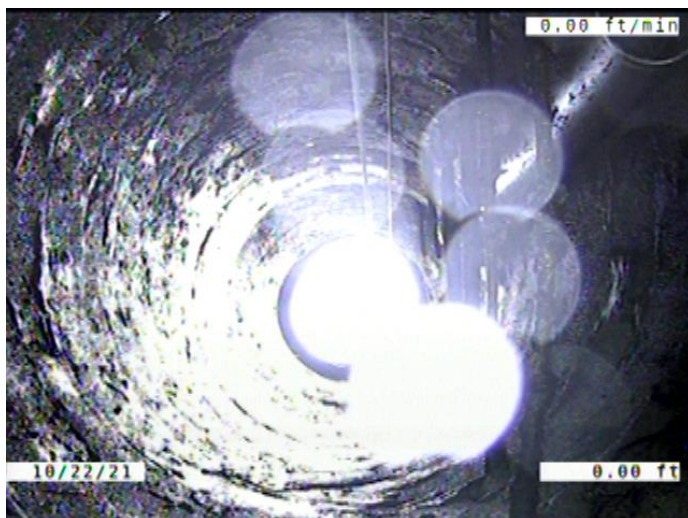
Code: **AMH**  
 Description: **Manhole**

Distance (ft): **.0**  
 Structural Grade: **0**  
 O&M Grade: **0**  
 Clock Start/From:  
 Clock To:  
 1st Value:  
 2nd Value:  
 Value Percent:  
 Continuous Index:  
 Within 8" of Joint: **NO**  
 Remarks: **M-503-004**

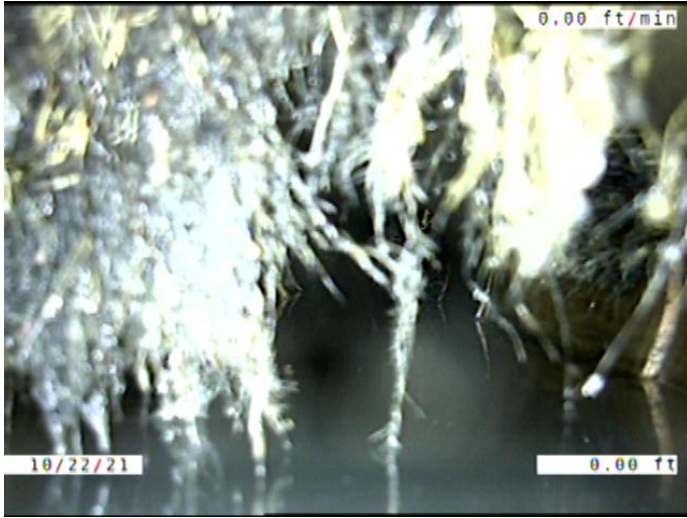
Code: **MWL**  
Description: **Miscellaneous Water Level**

Distance (ft): **.0**  
Structural Grade: **0**  
O&M Grade: **0**  
Clock Start/From:  
Clock To:  
1st Value:  
2nd Value:  
Value Percent: **10.000**  
Continuous Index:  
Within 8" of Joint: **NO**  
Remarks:

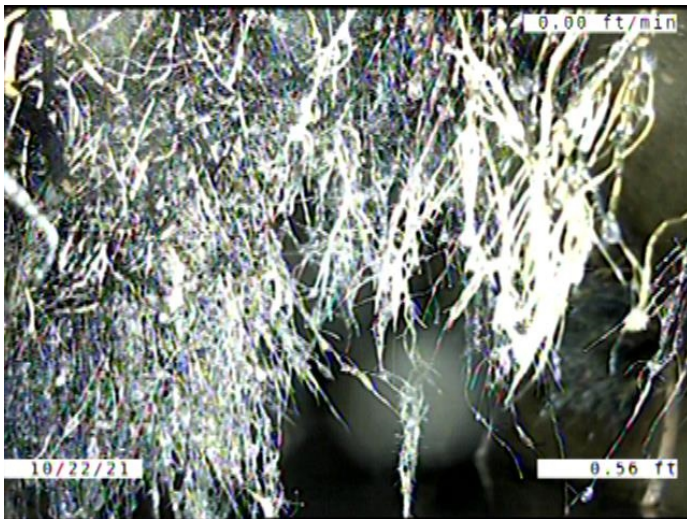
Code: **RMJ**  
Description: **Roots Medium Joint**

Distance (ft): **.6**  
Structural Grade: **0**  
O&M Grade: **3**  
Clock Start/From: **8**  
Clock To: **4**  
1st Value:  
2nd Value:  
Value Percent: **50.000**  
Continuous Index:  
Within 8" of Joint: **YES**  
Remarks:

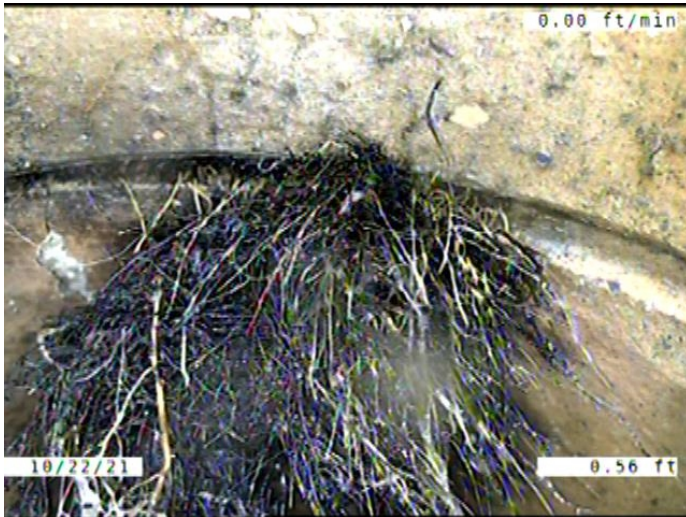
Code: **RMJ**  
Description: **Roots Medium Joint**

Distance (ft): **.6**  
Structural Grade: **0**  
O&M Grade: **3**  
Clock Start/From: **8**  
Clock To: **4**  
1st Value:  
2nd Value:  
Value Percent: **20.000**  
Continuous Index: **S01**  
Within 8" of Joint: **YES**  
Remarks:

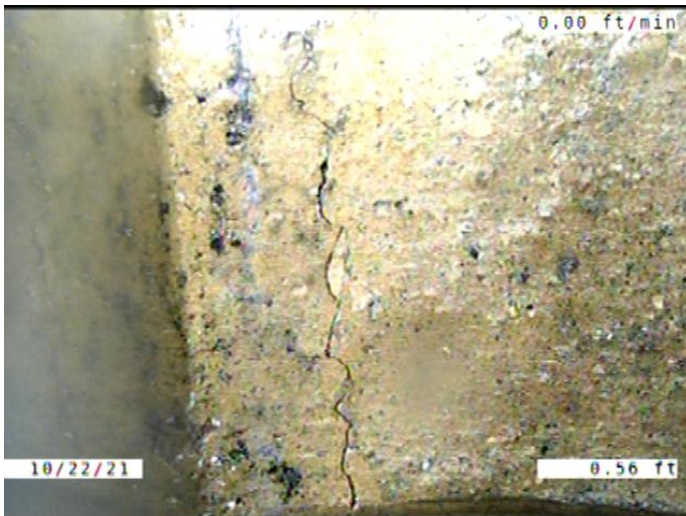
Code: **CL**  
Description: **Crack Longitudinal**

Distance (ft): **.6**  
Structural Grade: **2**  
O&M Grade: **0**  
Clock Start/From: **9**  
Clock To:  
1st Value:  
2nd Value:  
Value Percent:  
Continuous Index:  
Within 8" of Joint: **YES**  
Remarks:

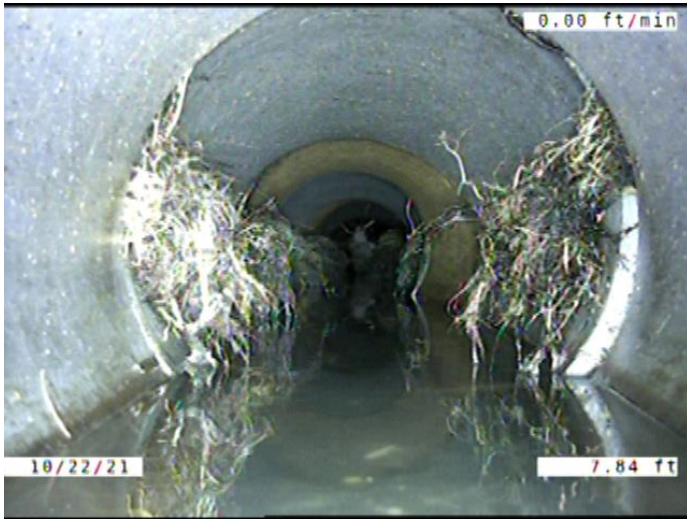
Code: **RMJ**  
 Description: **Roots Medium Joint**

Distance (ft): **7.8**  
 Structural Grade: **0**  
 O&M Grade: **3**  
 Clock Start/From: **8**  
 Clock To: **4**  
 1st Value:  
 2nd Value:  
 Value Percent: **20.000**  
 Continuous Index: **F01**  
 Within 8" of Joint: **YES**  
 Remarks:

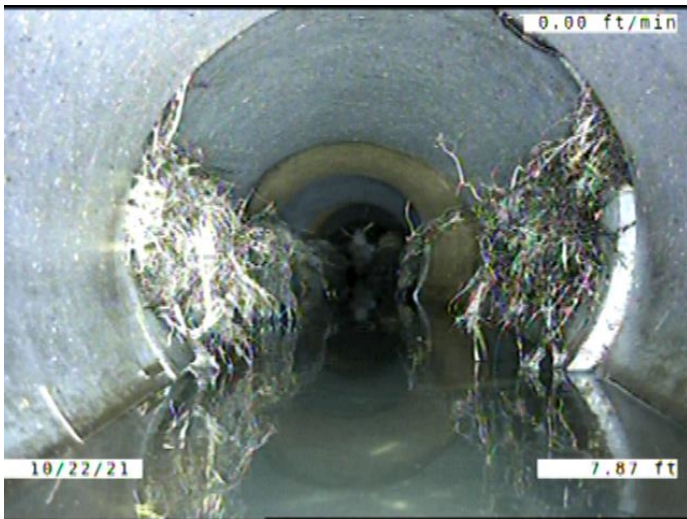
Code: **MSA**  
 Description: **Miscellaneous Survey Abandoned**

Distance (ft): **7.9**  
 Structural Grade: **0**  
 O&M Grade: **0**  
 Clock Start/From:  
 Clock To:  
 1st Value:  
 2nd Value:  
 Value Percent:  
 Continuous Index:  
 Within 8" of Joint: **NO**  
 Remarks: **CAMERA CANT MAKE IT PAST ROOTS.**
