Profile/Photo Observation Report

Date:	10/22/2021	Weather:		Coding:	PACP 7.0
Pipe Length (ft):	146.0	Owner:	City of Hobart	Pre Clean:	Heavy Cleaning
P.O.#:	YES502259	Surveyor:	S. Bucklin	PSR:	P-503-004-003
Customer:	City of Hobart	Clean Date:	10/21/2021	Shape:	C

Street:	North Wisconsin Street	Flow Control:	Not Controlled
City:	Hobart, IN	Year Renewed:	
Location:	Alley	Tape/Media #:	
Purpose:	Routine Assessment	Dia/Height:	12"
Use:	Sanitary Sewage Pipe	Material:	VCP
Drain Area:		Lining:	None
Category:	NA		
Comment:

Location Details:		Direction of Survey:	Downstream
US MH:	M-503-004	DS MH:	M-503-003
		Total Length Surveyed (ft):	7.9

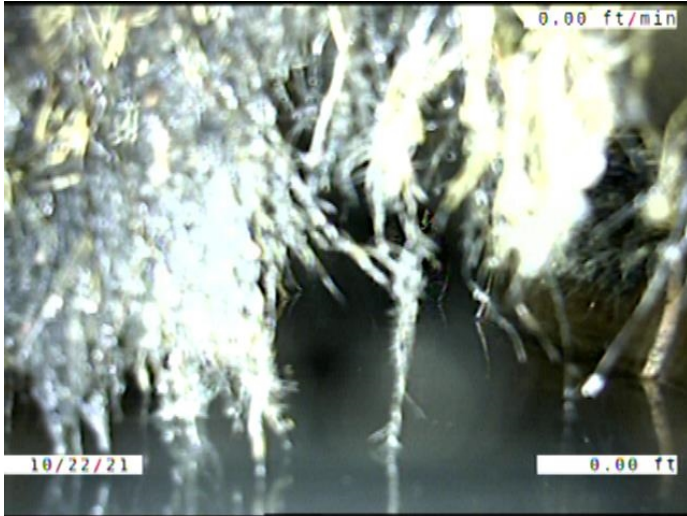
Code: **MWL**
Description: **Miscellaneous Water Level**

Distance (ft): **.0**
Structural Grade: **0**
O&M Grade: **0**
Clock Start/From:
Clock To:
1st Value:
2nd Value:
Value Percent: **10.000**
Continuous Index:
Within 8" of Joint: **NO**
Remarks:

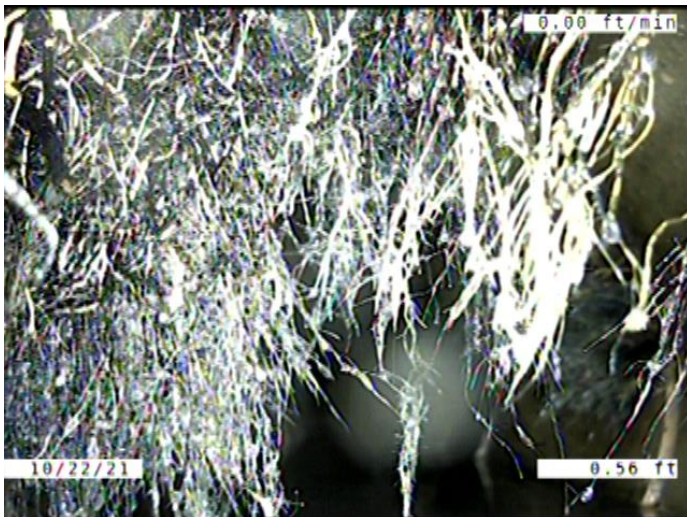
Code: **RMJ**
Description: **Roots Medium Joint**

Distance (ft): **.6**
Structural Grade: **0**
O&M Grade: **3**
Clock Start/From: **8**
Clock To: **4**
1st Value:
2nd Value:
Value Percent: **50.000**
Continuous Index:
Within 8" of Joint: **YES**
Remarks:

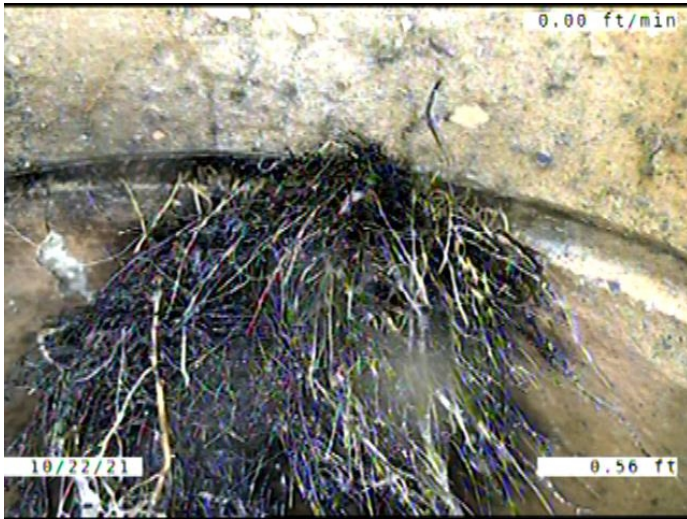
Code: **RMJ**
 Description: **Roots Medium Joint**

Distance (ft): **.6**
 Structural Grade: **0**
 O&M Grade: **3**
 Clock Start/From: **8**
 Clock To: **4**
 1st Value:
 2nd Value:
 Value Percent: **20.000**
 Continuous Index: **S01**
 Within 8" of Joint: **YES**
 Remarks:

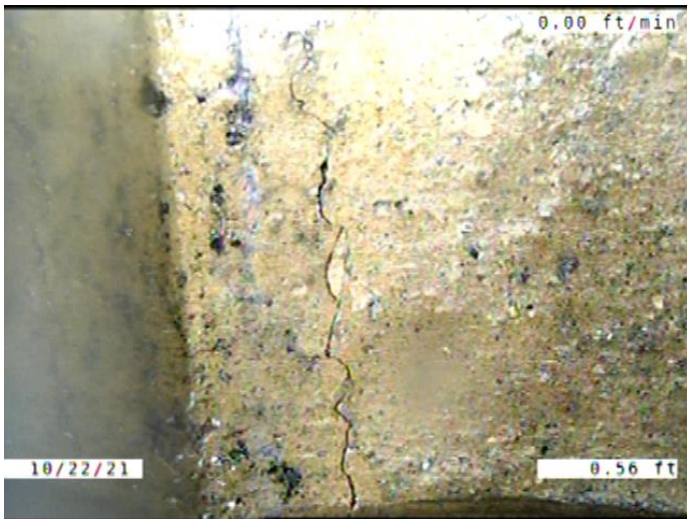
Code: **CL**
 Description: **Crack Longitudinal**

Distance (ft): **.6**
 Structural Grade: **2**
 O&M Grade: **0**
 Clock Start/From: **9**
 Clock To:
 1st Value:
 2nd Value:
 Value Percent:
 Continuous Index:
 Within 8" of Joint: **YES**
 Remarks:

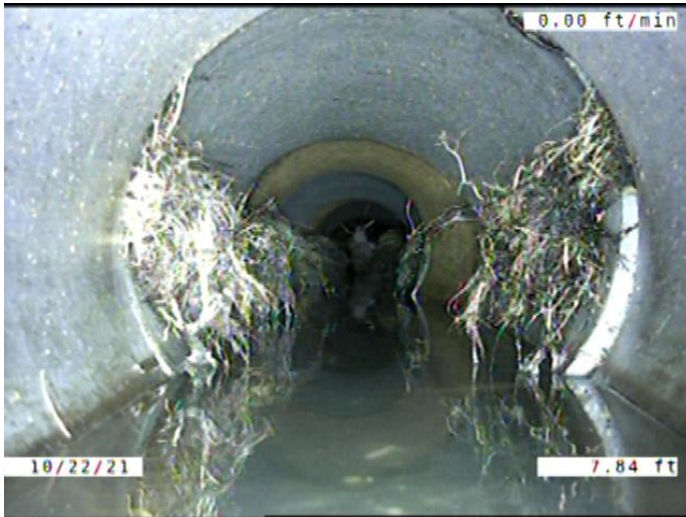
Code: **RMJ**
 Description: **Roots Medium Joint**

Distance (ft): **7.8**
 Structural Grade: **0**
 O&M Grade: **3**
 Clock Start/From: **8**
 Clock To: **4**
 1st Value:
 2nd Value:
 Value Percent: **20.000**
 Continuous Index: **F01**
 Within 8" of Joint: **YES**
 Remarks:

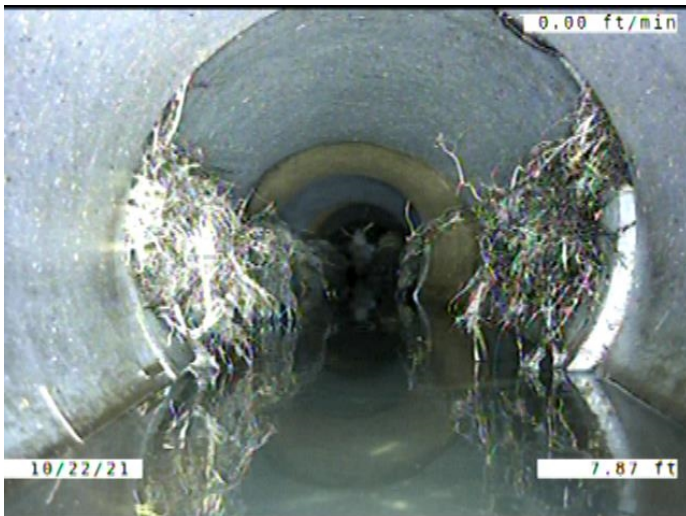
Code: **MSA**
 Description: **Miscellaneous Survey Abandoned**

Distance (ft): **7.9**
 Structural Grade: **0**
 O&M Grade: **0**
 Clock Start/From:
 Clock To:
 1st Value:
 2nd Value:
 Value Percent:
 Continuous Index:
 Within 8" of Joint: **NO**
 Remarks: **CAMERA CANT MAKE IT PAST ROOTS.**
