Profile/Photo Observation Report

Profile/Prioto Observation Report									
Date:	10/22/2021	Weather:		Coding:	PACP 7.0				
Pipe Length (ft)	: 146.9	Owner:	City of Hobart	Pre Clean:	Heavy Cleaning				
P.O.#:	YES502259	Surveyor:	S. Bucklin	PSR:	P-503-005-004				
Customer:	City of Hobart	Clean Date:	10/21/2021	Shape:	С				
Street:	West 40th Place		Flow Control:	Not Controlle	d				
City:	Hobart, IN		Year Renewed:						
Location:	Alley		Tape/Media #:						
Purpose:	Routine Assessmen	nt	Dia/Height:	12"					
Use:	Sanitary Sewage Pi	pe	Material:	VCP					
Drain Area:			Lining:	None					
Category:	NA								
Comment:									
Location Details	s:		Direction of Surve	ey: Upstream					
US MH:	M-503-004	DS MH:	M-503-005	Total Length Surveyed (f	t): 146.9				
O&M Index:	1.73	O&M Quick:	3423	O&M Rating:	26.00				
Structural Index:	2.29	Structural Qu	ick: 4133		39.00				
Overall Index:	2.03	Overall Quick	442		65.00				
			·

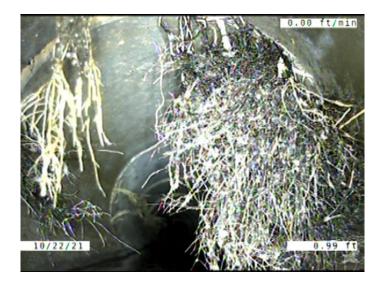
Code: RMJ

Description: Roots Medium Joint

Distance (ft): 1.0
Structural Grade: 0
O&M Grade: 3
Clock Start/From: 8
Clock To: 4

Value Percent: 45.000

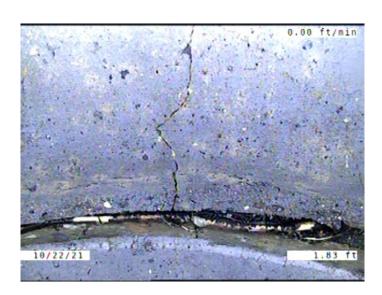
Code: CL

Description: Crack Longitudinal

Distance (ft): 1.8
Structural Grade: 2
O&M Grade: 0
Clock Start/From: 12

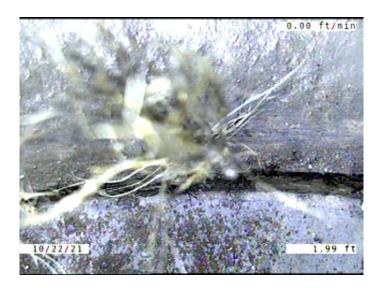
Code: RFJ

Description: Roots Fine Joint

Distance (ft): 2.0
Structural Grade: 0
O&M Grade: 1
Clock Start/From: 8
Clock To: 4

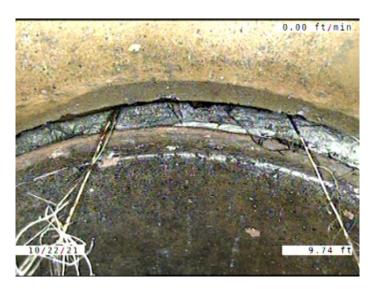
Code: **JOM**

Description: Joint Offset Medium

Distance (ft): 9.7
Structural Grade: 3
O&M Grade: 0

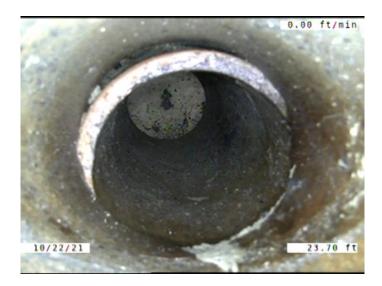
Code: **TFD**

Description: Tap Factory Defective

Distance (ft): 23.7
Structural Grade: 0

O&M Grade: 3

Remarks: CAPPED. LARGE OFFSET FIRST JOINT

BACK. SOIL VISIIBLE

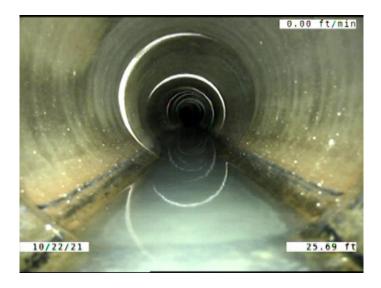
Code: RFJ

Description: Roots Fine Joint

Distance (ft): 25.7
Structural Grade: 0
O&M Grade: 1
Clock Start/From: 8
Clock To: 4

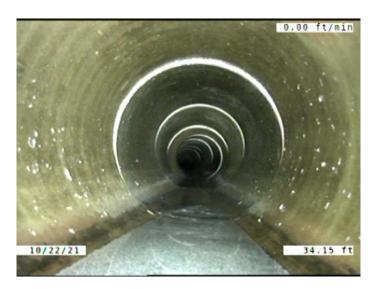
Code: MWLS

Description: Miscellaneous Water Level Sag

Distance (ft): 34.2
Structural Grade: 2
O&M Grade: 0

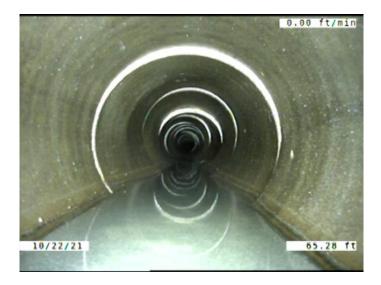
Code: MWLS

Description: Miscellaneous Water Level Sag

Distance (ft): 65.3
Structural Grade: 2
O&M Grade: 0

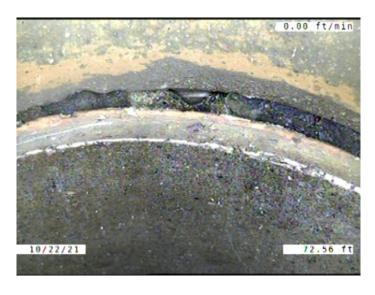
Code: **JOM**

Description: Joint Offset Medium

Distance (ft): 72.6
Structural Grade: 3
O&M Grade: 0

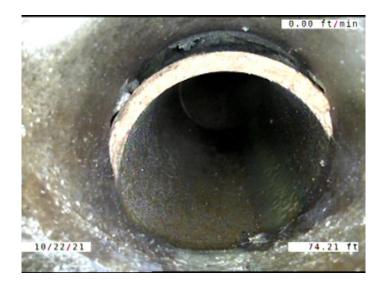
Code: **TFD**

Description: Tap Factory Defective

Distance (ft): 74.2
Structural Grade: 0
O&M Grade: 3
Clock Start/From: 1

Remarks: LARGE OFFSET FIRST JOINT BACK.

SOIL VISIIBLE

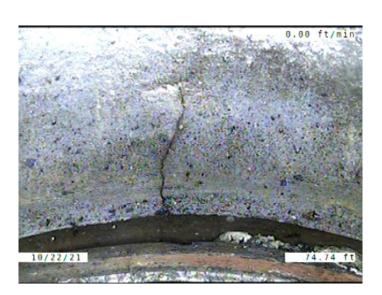
Code: CL

Description: Crack Longitudinal

Distance (ft): 74.7
Structural Grade: 2
O&M Grade: 0
Clock Start/From: 12

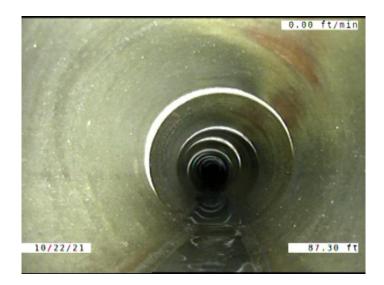
Code: **MWLS**

Description: **Miscellaneous Water Level Sag**

Distance (ft): 87.3 Structural Grade: 2 0 O&M Grade:

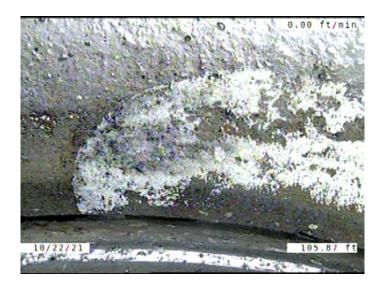
Code: DAE

Description: **Deposits Attached Encrustation**

Distance (ft): 105.9 Structural Grade: 0 2 O&M Grade: Clock Start/From: 3 Clock To: 5

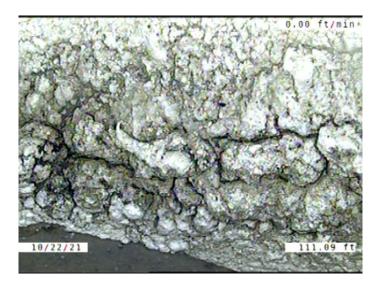
Code: DAE

Description: **Deposits Attached Encrustation**

Distance (ft): 111.1 Structural Grade: 0 O&M Grade: 2 Clock Start/From: 8 Clock To: 1st Value:

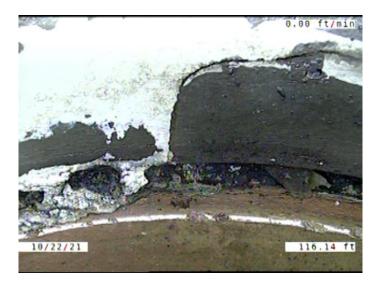
Code: Description: Broken

Distance (ft): 116.1 Structural Grade: 4 0 O&M Grade: Clock Start/From: 11 Clock To: 1 1st Value: 2nd Value: Value Percent: Continuous Index: Within 8" of Joint: YES

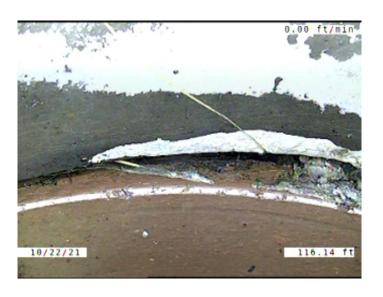
Code: DAE

Description: **Deposits Attached Encrustation**

Distance (ft): 116.1 Structural Grade: 0 O&M Grade: 2 Clock Start/From: 8 Clock To: 4 1st Value: 2nd Value:

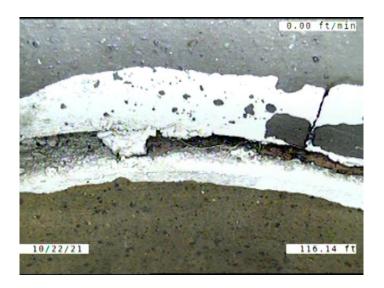
Code: RFJ

Description: **Roots Fine Joint**

Distance (ft): 116.1 Structural Grade: 0 O&M Grade: 1 Clock Start/From: 9 Clock To: 3

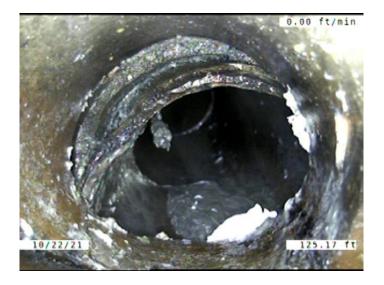
Code: **TFD**

Description: Tap Factory Defective

Distance (ft): 125.2
Structural Grade: 0
O&M Grade: 3
Clock Start/From: 1

Remarks: LARGE OFFSET FIRST JOINT BACK.

SOIL VISIIBLE

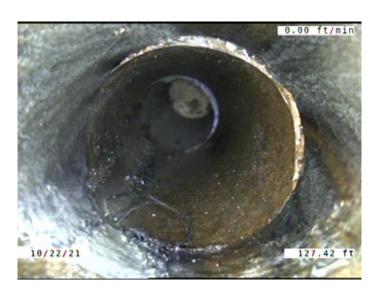
Code: TFC

Description: Tap Factory Capped

Remarks: ROOTS IN THE JOINTS

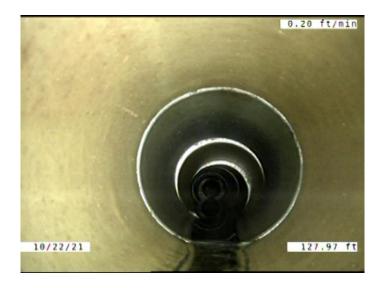
Code: **MWLS**

Description: **Miscellaneous Water Level Sag**

128.0 Distance (ft): Structural Grade: 2 0 O&M Grade:

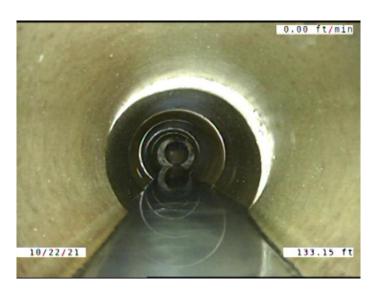
Code: **MWLS**

Description: **Miscellaneous Water Level Sag**

Distance (ft): 133.1 Structural Grade: 2 O&M Grade: 0

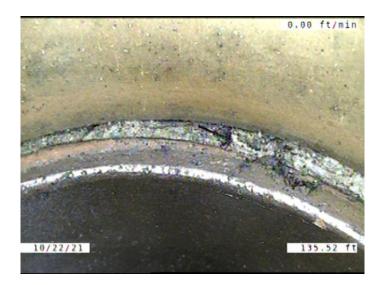
Code: **JOMD**

Description: **Joint Offset Medium Defective**

Distance (ft): 135.5 Structural Grade: 3 0 O&M Grade:

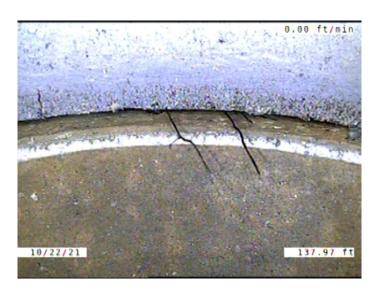
RFJ Code:

Description: **Roots Fine Joint**

Distance (ft): 138.0 Structural Grade: 0 O&M Grade: 1 Clock Start/From: 1

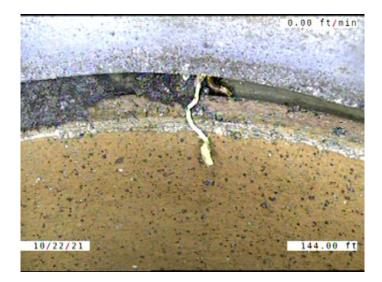
Code: RFJ

Description: **Roots Fine Joint**

Distance (ft): 144.0 Structural Grade: 0 O&M Grade: 1 2

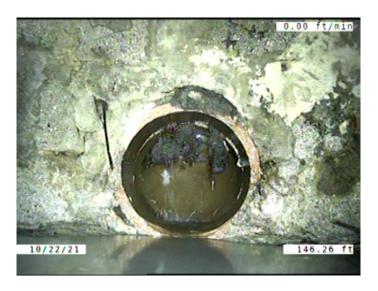
Code: **MWLS**

Description: **Miscellaneous Water Level Sag**

Distance (ft): 146.3 Structural Grade: 2 O&M Grade: 0
