Profile/Photo Observation Report

Date:	04/12/2018	Weather:		Coding:	PACP 6.0
Pipe Length (ft):	219.9	Owner:	NA	Pre Clean:	Not Known
P.O.#:		Surveyor:	Jen Costello	PSR:	P-503-008-004
Customer:		Clean Date:	01/01/1900	Shape:	C

Street:	W 40TH AVE	Flow Control:	Not Controlled
City:	Hobart, IN	Year Renewed:	
Location:	Other	Tape/Media #:	
Purpose:	Not Known	Dia/Height:	12"
Use:	Sanitary	Material:	VCP
Drain Area:	NA	Lining:	
Category:	NA		
Comment:

Location Details:		Direction of Survey:	Downstream
US MH:	M-503-004	DS MH:	M-503-008
		Total Length Surveyed (ft):	204.0

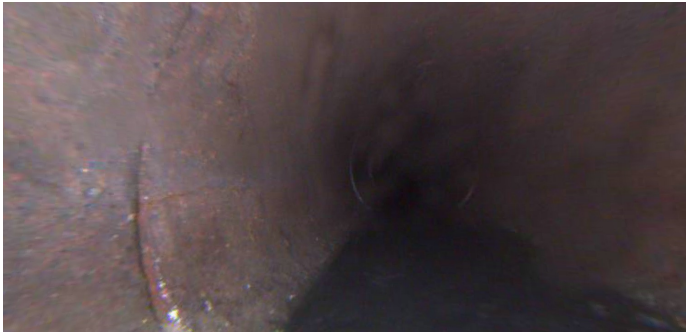
Code: **FL**
Description: **Fracture Longitudinal**

Distance (ft): **3.0**
Structural Grade: **3**
O&M Grade: **0**
Clock Start/From: **9**
Clock To:
1st Value:
2nd Value:
Value Percent:
Continuous Index:
Within 8" of Joint: **YES**
Remarks:

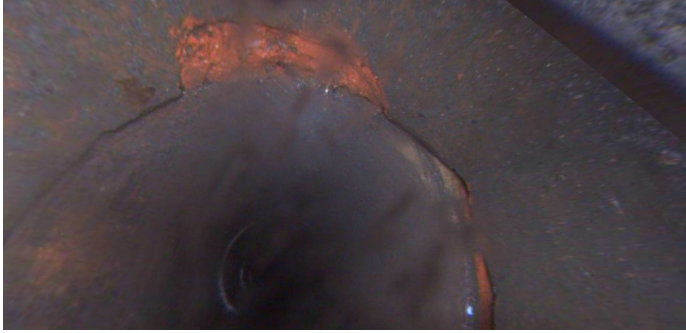
Code: **SSS**
Description: **Surface Spalling**

Distance (ft): **12.0**
Structural Grade: **2**
O&M Grade: **0**
Clock Start/From: **11**
Clock To: **1**
1st Value:
2nd Value:
Value Percent:
Continuous Index:
Within 8" of Joint: **YES**
Remarks:

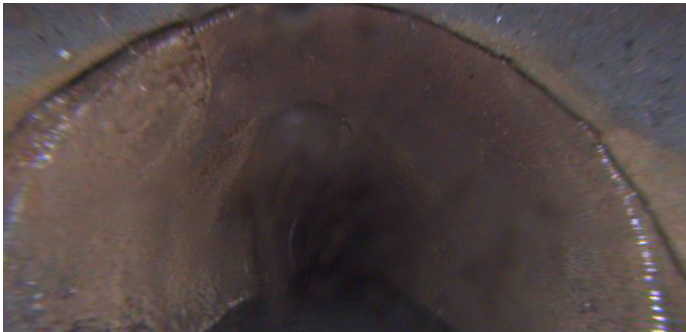
Code: **FL**
Description: **Fracture Longitudinal**

Distance (ft): **93.9**
Structural Grade: **3**
O&M Grade: **0**
Clock Start/From: **11**
Clock To:
1st Value:
2nd Value:
Value Percent:
Continuous Index:
Within 8" of Joint: **YES**
Remarks:

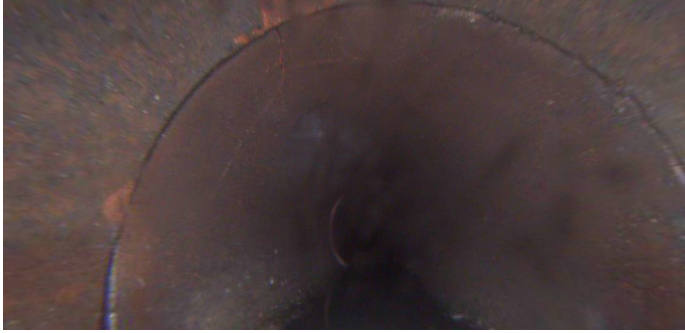
Code: **FM**
Description: **Fracture Multiple**

Distance (ft): **126.4**
Structural Grade: **4**
O&M Grade: **0**
Clock Start/From: **8**
Clock To: **12**
1st Value:
2nd Value:
Value Percent:
Continuous Index:
Within 8" of Joint: **YES**
Remarks:

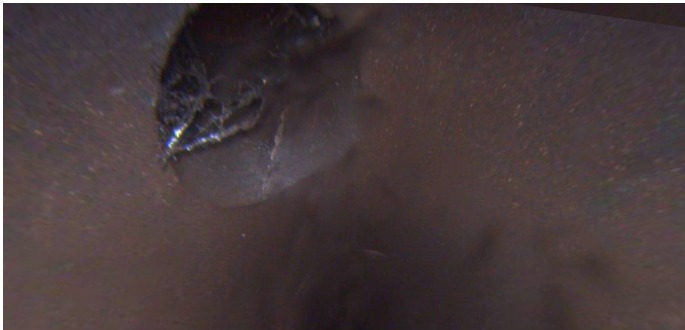
Code: **TFD**
Description: **Tap Factory Defective**

Distance (ft): **127.1**
Structural Grade: **0**
O&M Grade: **2**
Clock Start/From: **11**
Clock To:
1st Value: **4.000**
2nd Value:
Value Percent:
Continuous Index:
Within 8" of Joint:
Remarks: **roots**

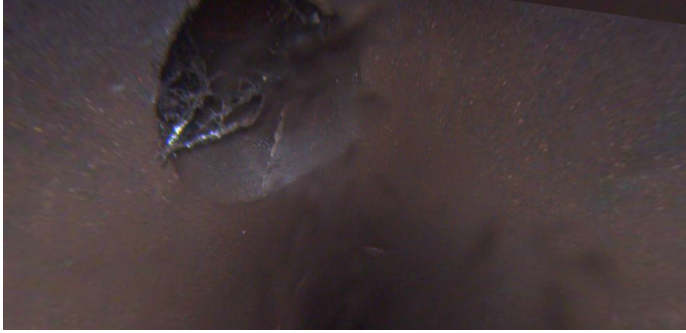
Code: **RFL**
Description: **Roots Fine Lateral**

Distance (ft): **127.1**
Structural Grade: **0**
O&M Grade: **1**
Clock Start/From: **11**
Clock To:
1st Value:
2nd Value:
Value Percent:
Continuous Index:
Within 8" of Joint: **NO**
Remarks:

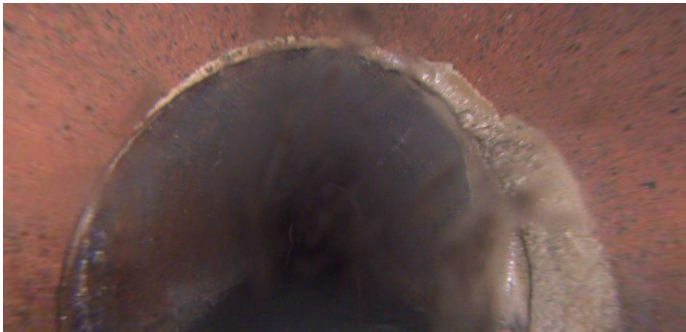
Code: **DAE**
Description: **Deposits Attached Encrustation**

Distance (ft): **138.5**
Structural Grade: **0**
O&M Grade: **2**
Clock Start/From: **8**
Clock To: **4**
1st Value:
2nd Value:
Value Percent: **5.000**
Continuous Index:
Within 8" of Joint: **YES**
Remarks:

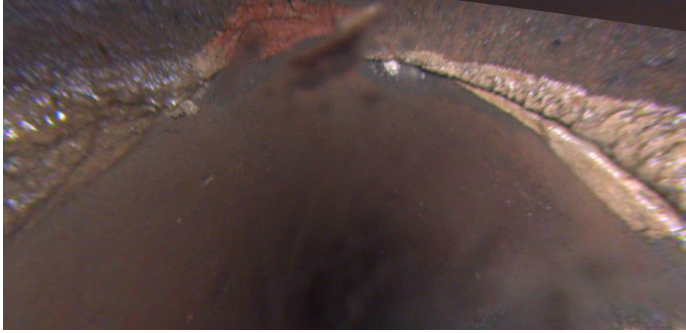
Code: **SSS**
Description: **Surface Spalling**

Distance (ft): **145.0**
Structural Grade: **2**
O&M Grade: **0**
Clock Start/From: **12**
Clock To:
1st Value:
2nd Value:
Value Percent:
Continuous Index:
Within 8" of Joint: **YES**
Remarks:

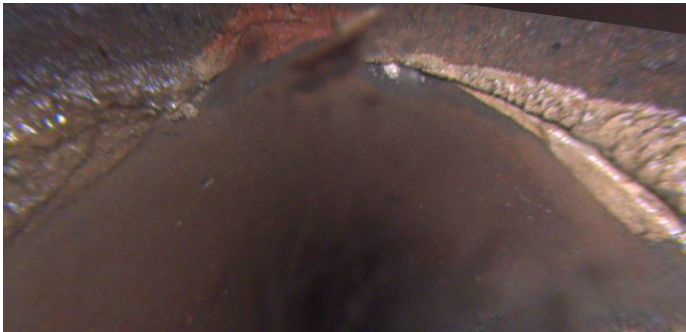
Code: **DAE**
Description: **Deposits Attached Encrustation**

Distance (ft): **145.0**
Structural Grade: **0**
O&M Grade: **2**
Clock Start/From: **8**
Clock To: **4**
1st Value:
2nd Value:
Value Percent: **5.000**
Continuous Index:
Within 8" of Joint: **YES**
Remarks:

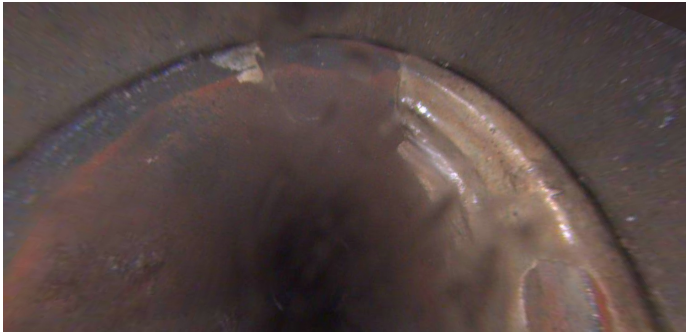
Code: **FM**
Description: **Fracture Multiple**

Distance (ft): **152.6**
Structural Grade: **4**
O&M Grade: **0**
Clock Start/From: **11**
Clock To: **1**
1st Value:
2nd Value:
Value Percent:
Continuous Index:
Within 8" of Joint: **YES**
Remarks:

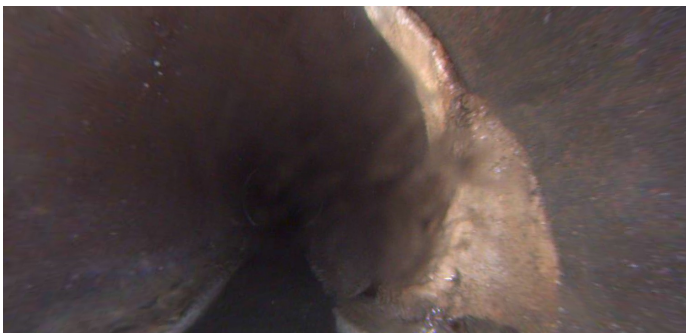
Code: **DAE**
Description: **Deposits Attached Encrustation**

Distance (ft): **155.1**
Structural Grade: **0**
O&M Grade: **2**
Clock Start/From: **1**
Clock To: **4**
1st Value:
2nd Value:
Value Percent: **5.000**
Continuous Index:
Within 8" of Joint: **YES**
Remarks:

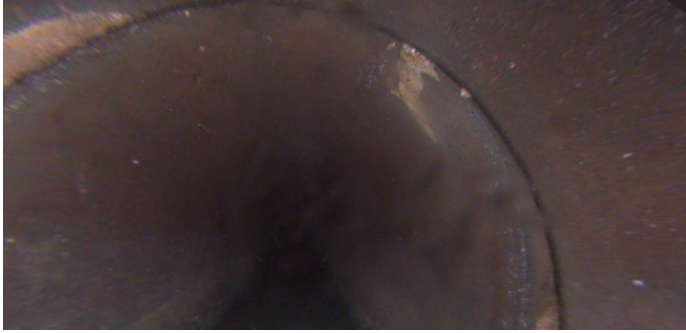
Code: **FM**
Description: **Fracture Multiple**

Distance (ft): **157.7**
Structural Grade: **4**
O&M Grade: **0**
Clock Start/From: **1**
Clock To: **4**
1st Value:
2nd Value:
Value Percent:
Continuous Index:
Within 8" of Joint: **YES**
Remarks:

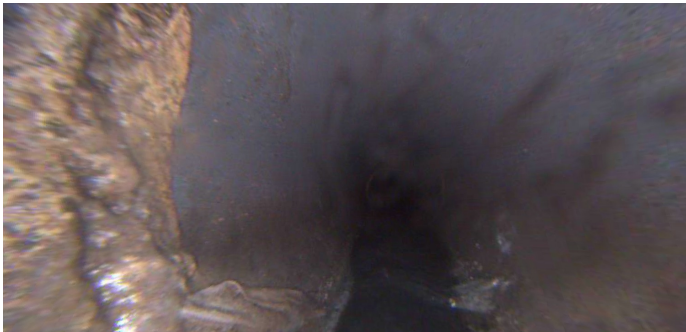
Code: **DAE**
Description: **Deposits Attached Encrustation**

Distance (ft): **165.4**
Structural Grade: **0**
O&M Grade: **2**
Clock Start/From: **7**
Clock To: **11**
1st Value:
2nd Value:
Value Percent: **5.000**
Continuous Index:
Within 8" of Joint: **YES**
Remarks:

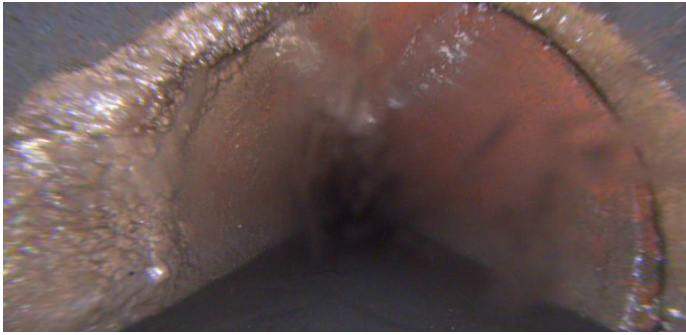
Code: **DAE**
Description: **Deposits Attached Encrustation**

Distance (ft): **169.4**
Structural Grade: **0**
O&M Grade: **2**
Clock Start/From: **8**
Clock To: **4**
1st Value:
2nd Value:
Value Percent: **5.000**
Continuous Index:
Within 8" of Joint: **YES**
Remarks:

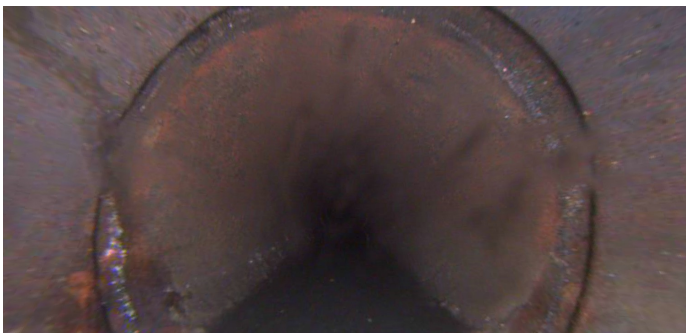
Code: **IW**
Description: **Infil Weeper**

Distance (ft): **181.6**
Structural Grade: **0**
O&M Grade: **2**
Clock Start/From: **7**
Clock To: **9**
1st Value:
2nd Value:
Value Percent:
Continuous Index:
Within 8" of Joint: **YES**
Remarks:

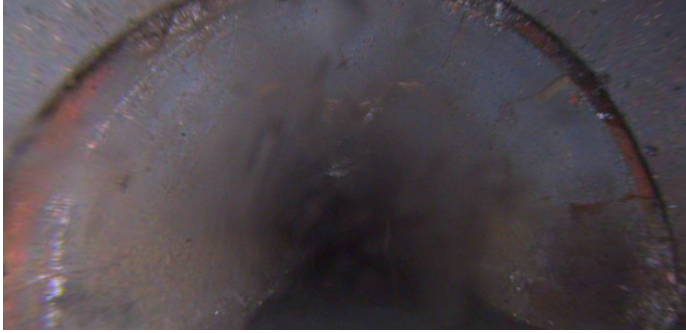
Code: **FM**
Description: **Fracture Multiple**

Distance (ft): **188.0**
Structural Grade: **4**
O&M Grade: **0**
Clock Start/From: **11**
Clock To: **4**
1st Value:
2nd Value:
Value Percent:
Continuous Index:
Within 8" of Joint: **YES**
Remarks:

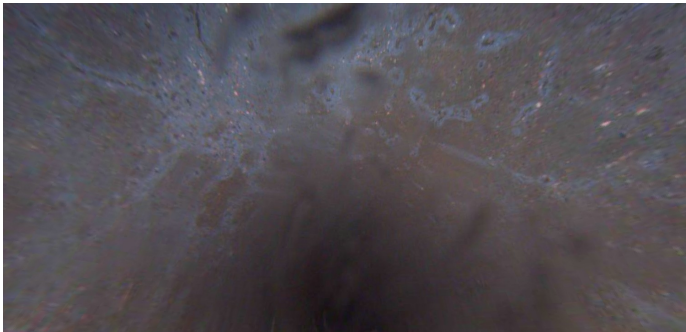
Code: **FM**
Description: **Fracture Multiple**

Distance (ft): **196.8**
Structural Grade: **4**
O&M Grade: **0**
Clock Start/From: **8**
Clock To: **4**
1st Value:
2nd Value:
Value Percent:
Continuous Index:
Within 8" of Joint: **YES**
Remarks:

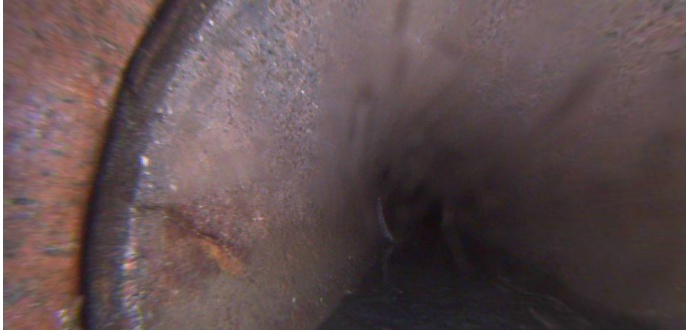
Code: **CL**
Description: **Crack Longitudinal**

Distance (ft): **200.5**
Structural Grade: **2**
O&M Grade: **0**
Clock Start/From: **9**
Clock To:
1st Value:
2nd Value:
Value Percent:
Continuous Index:
Within 8" of Joint: **YES**
Remarks:
