Profile/Photo Observation Report

Date:	04/12/2018	Weather:		Coding:	PACP 6.0
Pipe Length (ft):	219.9	Owner:	NA	Pre Clean:	Not Known
P.O.#:		Surveyor:	Jen Costello	PSR:	P-503-008-004
Customer:		Clean Date:	01/01/1900	Shape:	C

Street:	W 40th ave	Flow Control:	Not Controlled
City:	Hobart, IN	Year Renewed:	
Location:	Other	Tape/Media #:	
Purpose:	Not Known	Dia/Height:	12"
Use:	Sanitary	Material:	VCP
Drain Area:	NA	Lining:	
Category:	NA		
Comment:

Location Details:		Direction of Survey:	Downstream
US MH:	M-503-004	DS MH:	M-503-008
		Total Length Surveyed (ft):	204.0

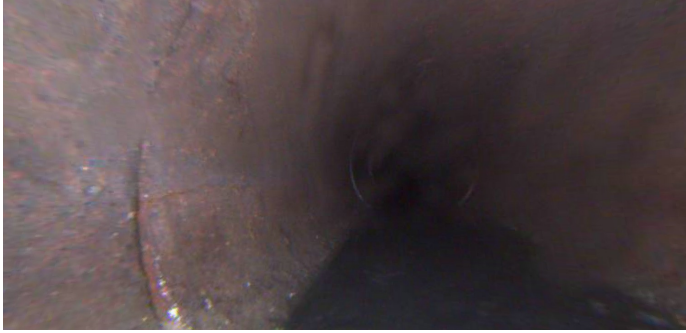
Code: **FL**
Description: **Fracture Longitudinal**

Distance (ft): **3.0**
Structural Grade: **3**
O&M Grade: **0**
Clock Start/From: **9**
Clock To:
1st Value:
2nd Value:
Value Percent:
Continuous Index:
Within 8" of Joint: **YES**
Remarks:

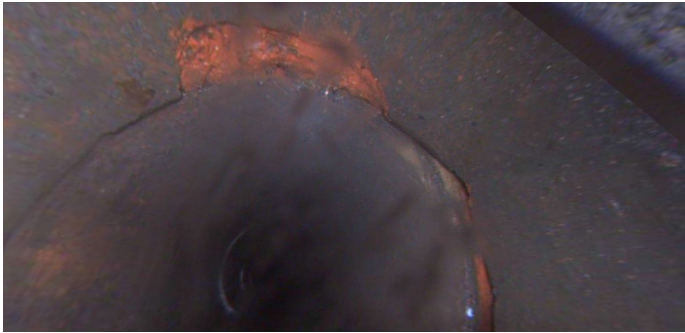
Code: **SSS**
Description: **Surface Spalling**

Distance (ft): **12.0**
Structural Grade: **2**
O&M Grade: **0**
Clock Start/From: **11**
Clock To: **1**
1st Value:
2nd Value:
Value Percent:
Continuous Index:
Within 8" of Joint: **YES**
Remarks:

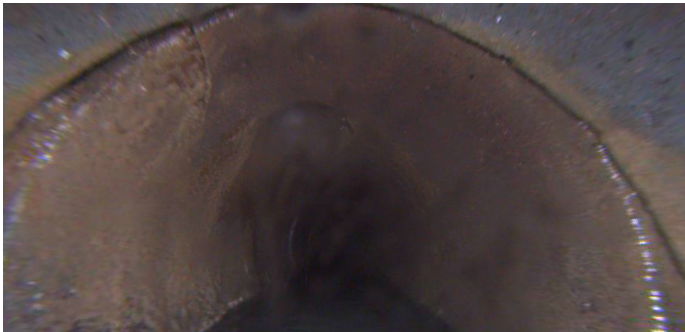
Code: **FL**
Description: **Fracture Longitudinal**

Distance (ft): **93.9**
Structural Grade: **3**
O&M Grade: **0**
Clock Start/From: **11**
Clock To:
1st Value:
2nd Value:
Value Percent:
Continuous Index:
Within 8" of Joint: **YES**
Remarks:

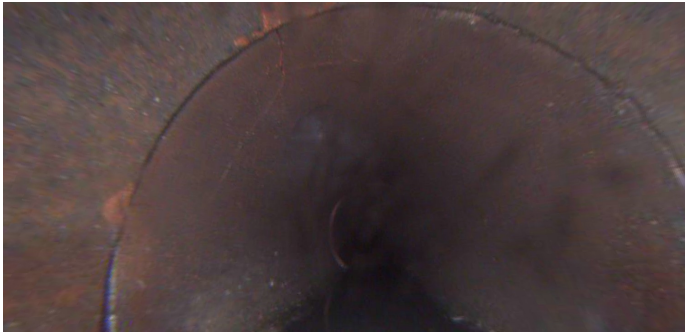
Code: **FM**
Description: **Fracture Multiple**

Distance (ft): **126.4**
Structural Grade: **4**
O&M Grade: **0**
Clock Start/From: **8**
Clock To: **12**
1st Value:
2nd Value:
Value Percent:
Continuous Index:
Within 8" of Joint: **YES**
Remarks:

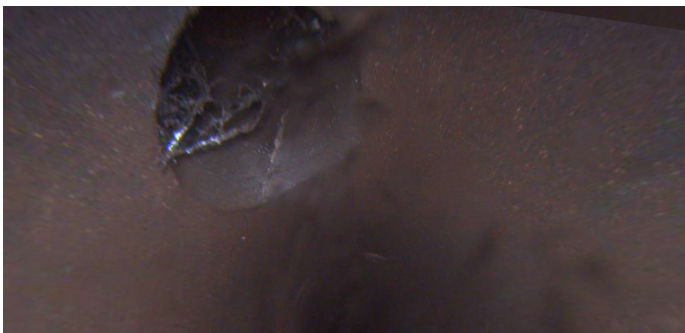
Code: **TFD**
Description: **Tap Factory Defective**

Distance (ft): **127.1**
Structural Grade: **0**
O&M Grade: **2**
Clock Start/From: **11**
Clock To:
1st Value: **4.000**
2nd Value:
Value Percent:
Continuous Index:
Within 8" of Joint:
Remarks: **roots**

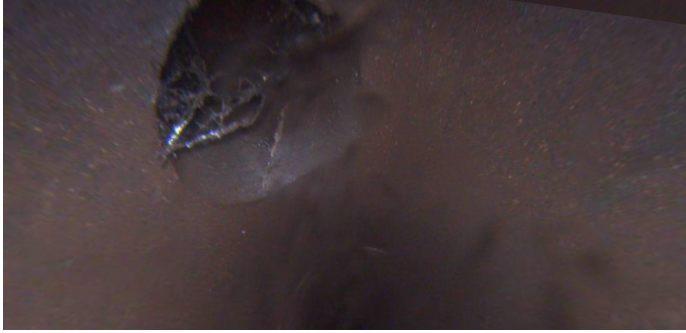
Code: **RFL**
Description: **Roots Fine Lateral**

Distance (ft): **127.1**
Structural Grade: **0**
O&M Grade: **1**
Clock Start/From: **11**
Clock To:
1st Value:
2nd Value:
Value Percent:
Continuous Index:
Within 8" of Joint: **NO**
Remarks:

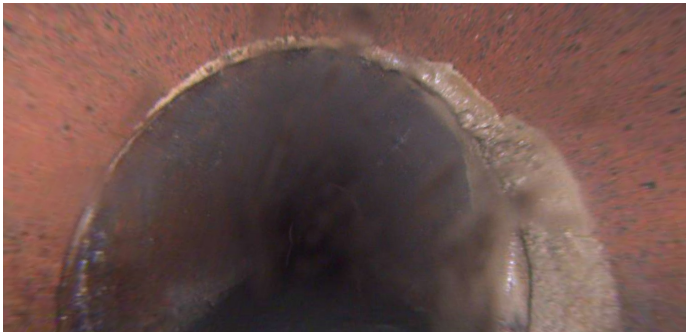
Code: **DAE**
Description: **Deposits Attached Encrustation**

Distance (ft): **138.5**
Structural Grade: **0**
O&M Grade: **2**
Clock Start/From: **8**
Clock To: **4**
1st Value:
2nd Value:
Value Percent: **5.000**
Continuous Index:
Within 8" of Joint: **YES**
Remarks:

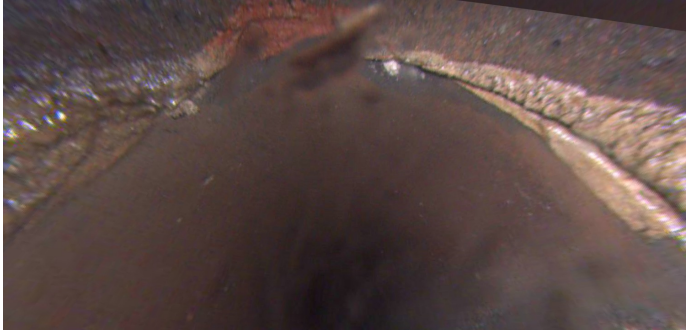
Code: **SSS**
Description: **Surface Spalling**

Distance (ft): **145.0**
Structural Grade: **2**
O&M Grade: **0**
Clock Start/From: **12**
Clock To:
1st Value:
2nd Value:
Value Percent:
Continuous Index:
Within 8" of Joint: **YES**
Remarks:

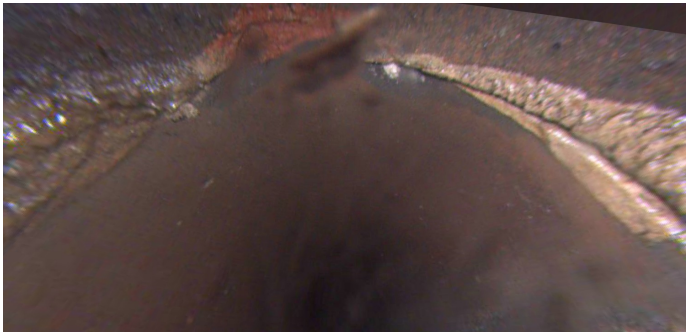
Code: **DAE**
Description: **Deposits Attached Encrustation**

Distance (ft): **145.0**
Structural Grade: **0**
O&M Grade: **2**
Clock Start/From: **8**
Clock To: **4**
1st Value:
2nd Value:
Value Percent: **5.000**
Continuous Index:
Within 8" of Joint: **YES**
Remarks:

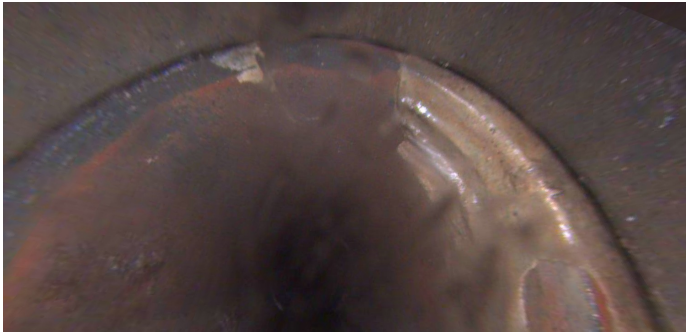
Code: **FM**
Description: **Fracture Multiple**

Distance (ft): **152.6**
Structural Grade: **4**
O&M Grade: **0**
Clock Start/From: **11**
Clock To: **1**
1st Value:
2nd Value:
Value Percent:
Continuous Index:
Within 8" of Joint: **YES**
Remarks:

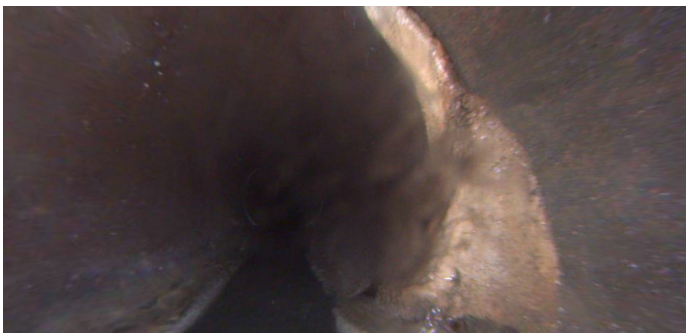
Code: **DAE**
Description: **Deposits Attached Encrustation**

Distance (ft): **155.1**
Structural Grade: **0**
O&M Grade: **2**
Clock Start/From: **1**
Clock To: **4**
1st Value:
2nd Value:
Value Percent: **5.000**
Continuous Index:
Within 8" of Joint: **YES**
Remarks:

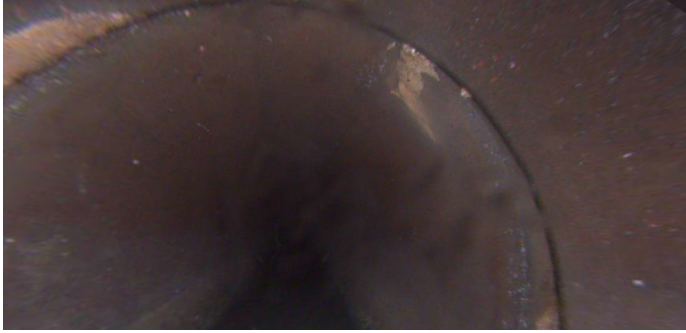
Code: **FM**
Description: **Fracture Multiple**

Distance (ft): **157.7**
Structural Grade: **4**
O&M Grade: **0**
Clock Start/From: **1**
Clock To: **4**
1st Value:
2nd Value:
Value Percent:
Continuous Index:
Within 8" of Joint: **YES**
Remarks:

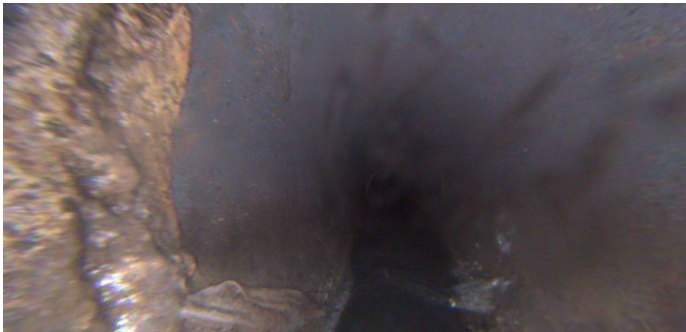
Code: **DAE**
Description: **Deposits Attached Encrustation**

Distance (ft): **165.4**
Structural Grade: **0**
O&M Grade: **2**
Clock Start/From: **7**
Clock To: **11**
1st Value:
2nd Value:
Value Percent: **5.000**
Continuous Index:
Within 8" of Joint: **YES**
Remarks:

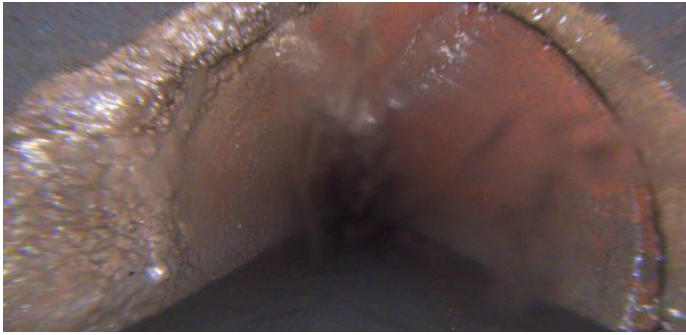
Code: **DAE**
Description: **Deposits Attached Encrustation**

Distance (ft): **169.4**
Structural Grade: **0**
O&M Grade: **2**
Clock Start/From: **8**
Clock To: **4**
1st Value:
2nd Value:
Value Percent: **5.000**
Continuous Index:
Within 8" of Joint: **YES**
Remarks:

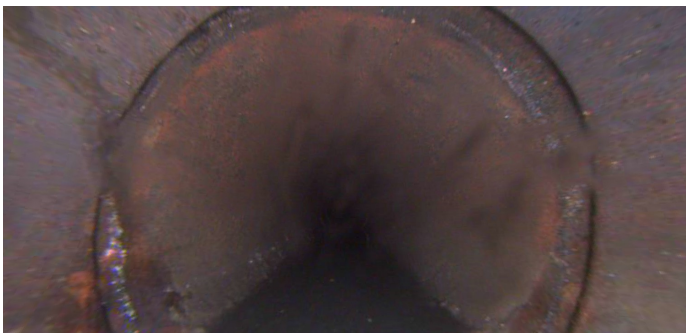
Code: **IW**
Description: **Infil Weeper**

Distance (ft): **181.6**
Structural Grade: **0**
O&M Grade: **2**
Clock Start/From: **7**
Clock To: **9**
1st Value:
2nd Value:
Value Percent:
Continuous Index:
Within 8" of Joint: **YES**
Remarks:

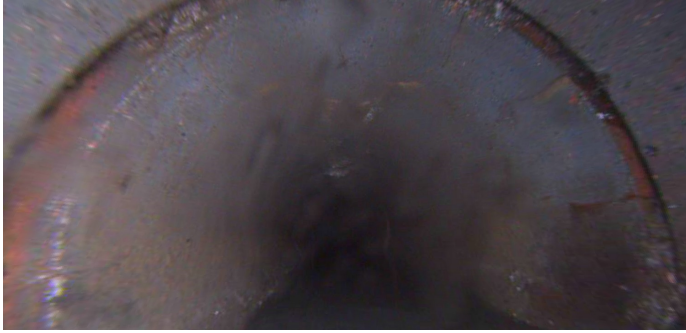
Code: **FM**
Description: **Fracture Multiple**

Distance (ft): **188.0**
Structural Grade: **4**
O&M Grade: **0**
Clock Start/From: **11**
Clock To: **4**
1st Value:
2nd Value:
Value Percent:
Continuous Index:
Within 8" of Joint: **YES**
Remarks:

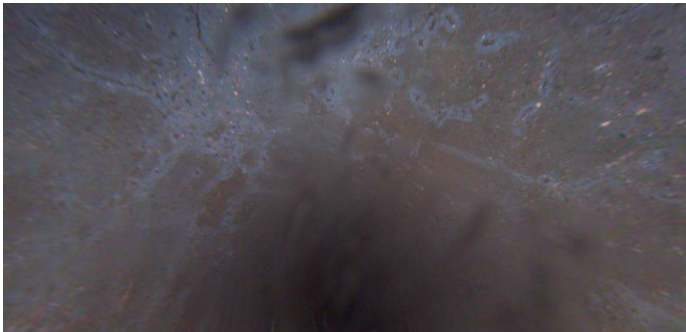
Code: **FM**
Description: **Fracture Multiple**

Distance (ft): **196.8**
Structural Grade: **4**
O&M Grade: **0**
Clock Start/From: **8**
Clock To: **4**
1st Value:
2nd Value:
Value Percent:
Continuous Index:
Within 8" of Joint: **YES**
Remarks:

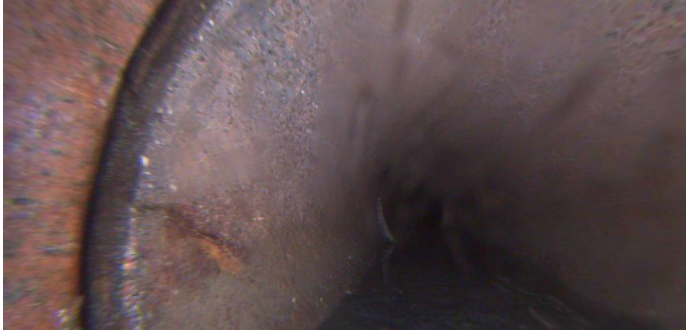
Code: **CL**
Description: **Crack Longitudinal**

Distance (ft): **200.5**
Structural Grade: **2**
O&M Grade: **0**
Clock Start/From: **9**
Clock To:
1st Value:
2nd Value:
Value Percent:
Continuous Index:
Within 8" of Joint: **YES**
Remarks:
