Profile/Photo Observation Report

Date:	10/21/2021	Weather:		Coding:	PACP 7.0
Pipe Length (ft):	221.0	Owner:	City of Hobart	Pre Clean:	Light Cleaning
P.O.#:	YES502259	Surveyor:	S. Bucklin	PSR:	P-503-007-006
Customer:	City of Hobart	Clean Date:	10/21/2021	Shape:	C

Street:	West 40th Avenue	Flow Control:	Not Controlled
City:	Hobart, IN	Year Renewed:	
Location:	Yard	Tape/Media #:	
Purpose:	Routine Assessment	Dia/Height:	10"
Use:	Sanitary Sewage Pipe	Material:	VCP
Drain Area:		Lining:	None
Category:	NA		
Comment:

Location Details:		Direction of Survey:	Downstream
US MH:	M-503-006	DS MH:	M-503-007
		Total Length Surveyed (ft):	24.3

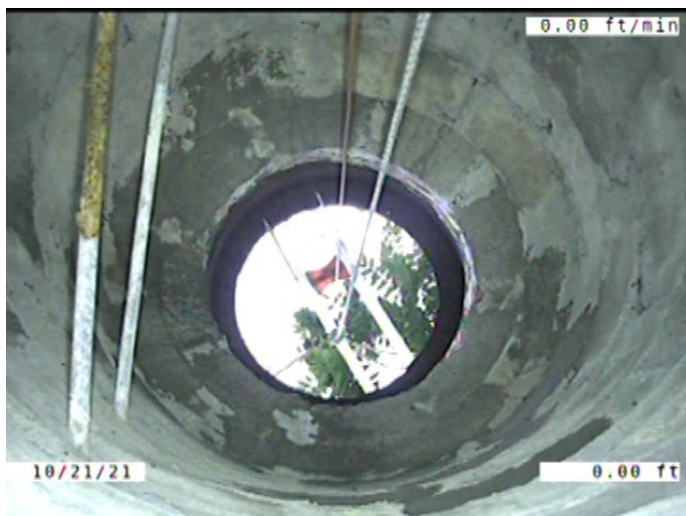
Code: **AMH**
 Description: **Manhole**

Distance (ft): **.0**
 Structural Grade: **0**
 O&M Grade: **0**
 Clock Start/From:
 Clock To:
 1st Value:
 2nd Value:
 Value Percent:
 Continuous Index:
 Within 8" of Joint: **NO**
 Remarks: **M-503-006**

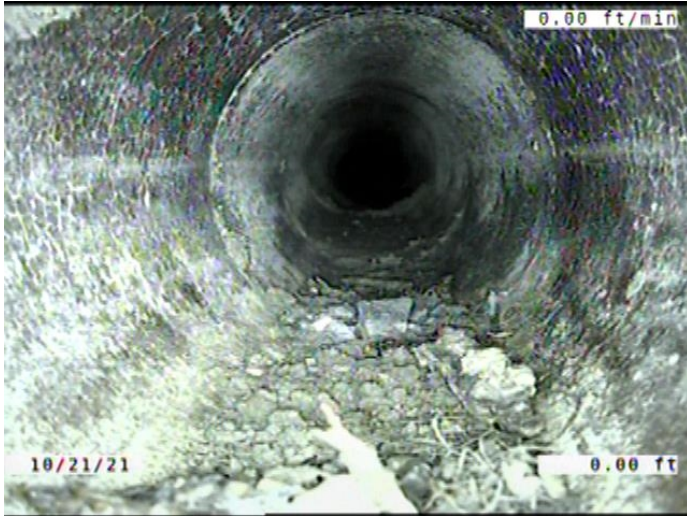
Code: **MWL**
Description: **Miscellaneous Water Level**

Distance (ft): **.0**
Structural Grade: **0**
O&M Grade: **0**
Clock Start/From:
Clock To:
1st Value:
2nd Value:
Value Percent: **0.000**
Continuous Index:
Within 8" of Joint: **NO**
Remarks:

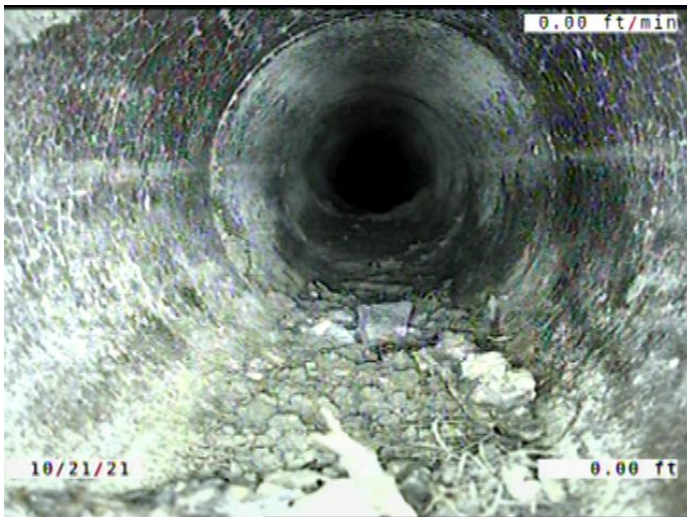
Code: **DSF**
Description: **Deposits Settled Fine**

Distance (ft): **.0**
Structural Grade: **0**
O&M Grade: **2**
Clock Start/From: **5**
Clock To: **7**
1st Value:
2nd Value:
Value Percent: **5.000**
Continuous Index: **S01**
Within 8" of Joint: **YES**
Remarks:

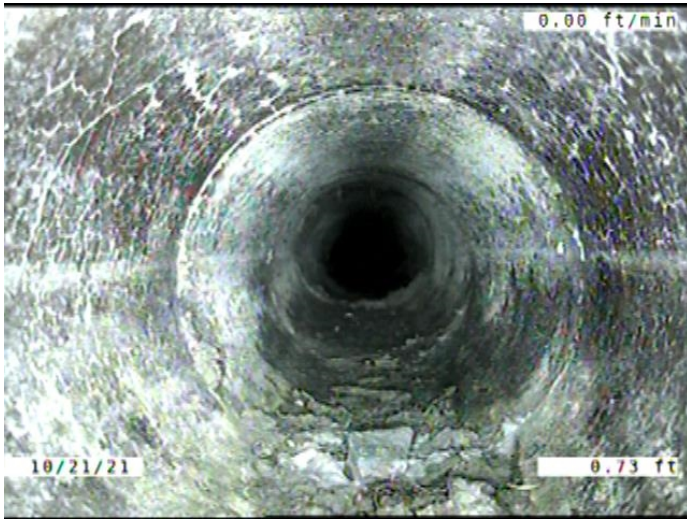
Code: **CM**
Description: **Crack Multiple**

Distance (ft): **.7**
Structural Grade: **3**
O&M Grade: **0**
Clock Start/From: **12**
Clock To: **12**
1st Value:
2nd Value:
Value Percent:
Continuous Index: **S02**
Within 8" of Joint: **YES**
Remarks:

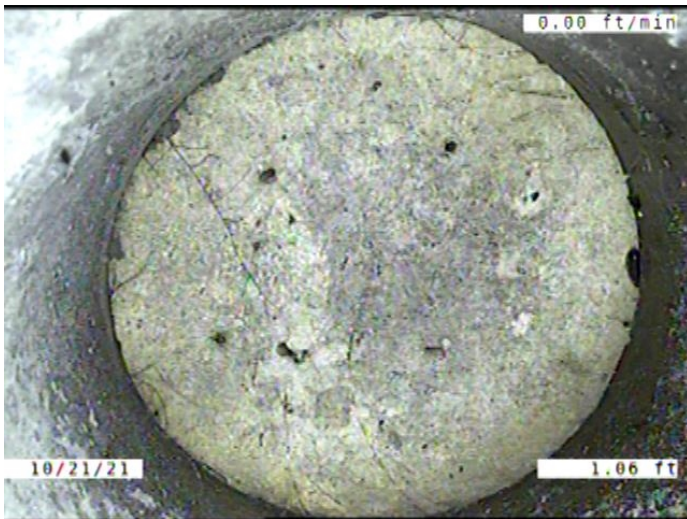
Code: **TFC**
Description: **Tap Factory Capped**

Distance (ft): **1.1**
Structural Grade: **0**
O&M Grade: **0**
Clock Start/From: **11**
Clock To:
1st Value: **4.000**
2nd Value:
Value Percent:
Continuous Index:
Within 8" of Joint: **YES**
Remarks:

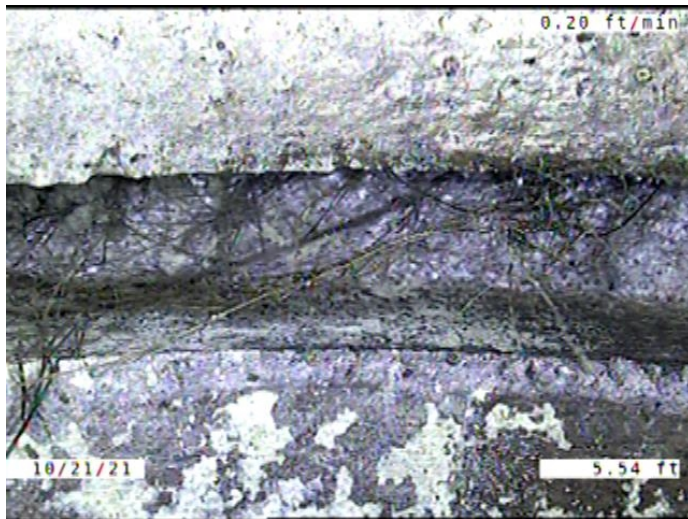
Code: **RFJ**
 Description: **Roots Fine Joint**

Distance (ft): **5.5**
 Structural Grade: **0**
 O&M Grade: **1**
 Clock Start/From: **12**
 Clock To: **12**
 1st Value:
 2nd Value:
 Value Percent:
 Continuous Index: **S04**
 Within 8" of Joint: **YES**
 Remarks:

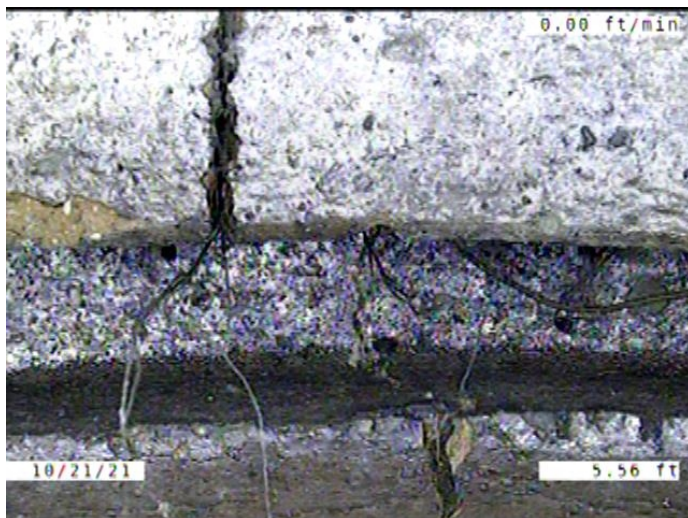
Code: **FM**
 Description: **Fracture Multiple**

Distance (ft): **5.6**
 Structural Grade: **4**
 O&M Grade: **0**
 Clock Start/From: **11**
 Clock To: **1**
 1st Value:
 2nd Value:
 Value Percent:
 Continuous Index: **S03**
 Within 8" of Joint: **YES**
 Remarks:

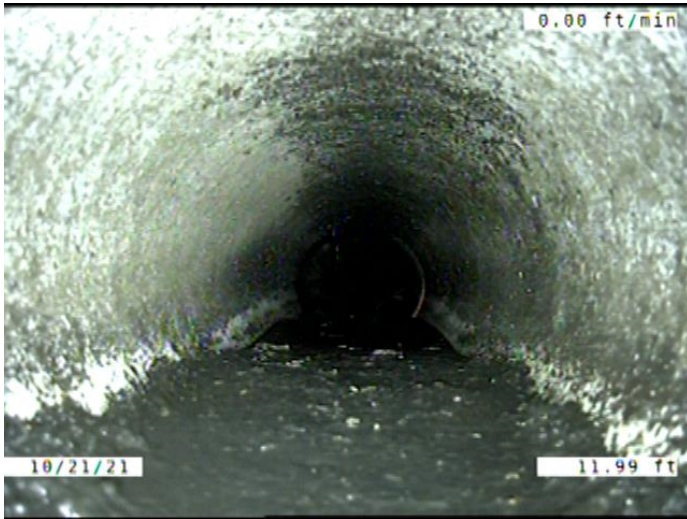
Code: **FM**
Description: **Fracture Multiple**

Distance (ft): **12.0**
Structural Grade: **4**
O&M Grade: **0**
Clock Start/From: **11**
Clock To: **1**
1st Value:
2nd Value:
Value Percent:
Continuous Index: **F03**
Within 8" of Joint: **YES**
Remarks:

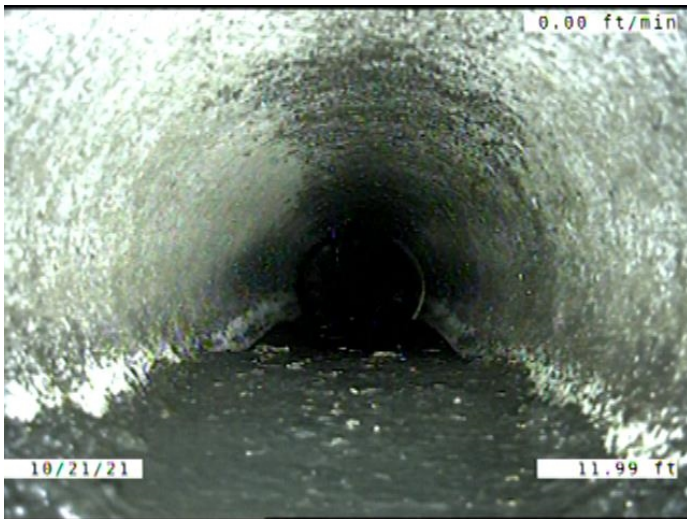
Code: **CM**
Description: **Crack Multiple**

Distance (ft): **12.0**
Structural Grade: **3**
O&M Grade: **0**
Clock Start/From: **12**
Clock To: **12**
1st Value:
2nd Value:
Value Percent:
Continuous Index: **F02**
Within 8" of Joint: **YES**
Remarks:

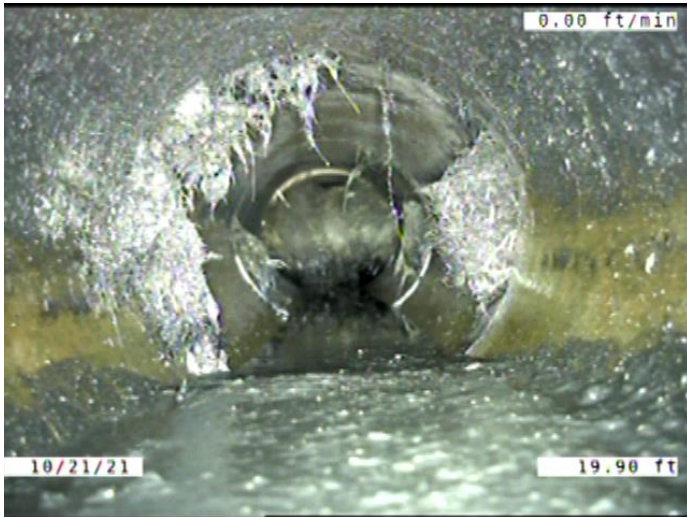
Code: **RMJ**
Description: **Roots Medium Joint**

Distance (ft): **19.9**
Structural Grade: **0**
O&M Grade: **3**
Clock Start/From: **7**
Clock To: **3**
1st Value:
2nd Value:
Value Percent: **15.000**
Continuous Index: **S05**
Within 8" of Joint: **YES**
Remarks:

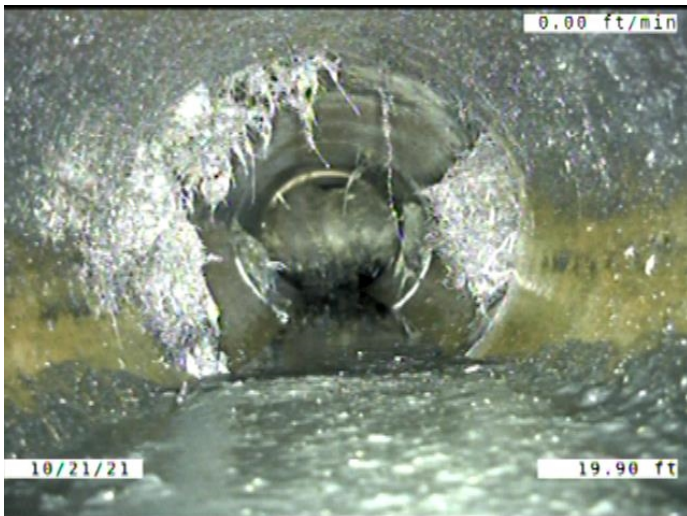
Code: **RFJ**
Description: **Roots Fine Joint**

Distance (ft): **19.9**
Structural Grade: **0**
O&M Grade: **1**
Clock Start/From: **12**
Clock To: **12**
1st Value:
2nd Value:
Value Percent:
Continuous Index: **F04**
Within 8" of Joint: **YES**
Remarks:

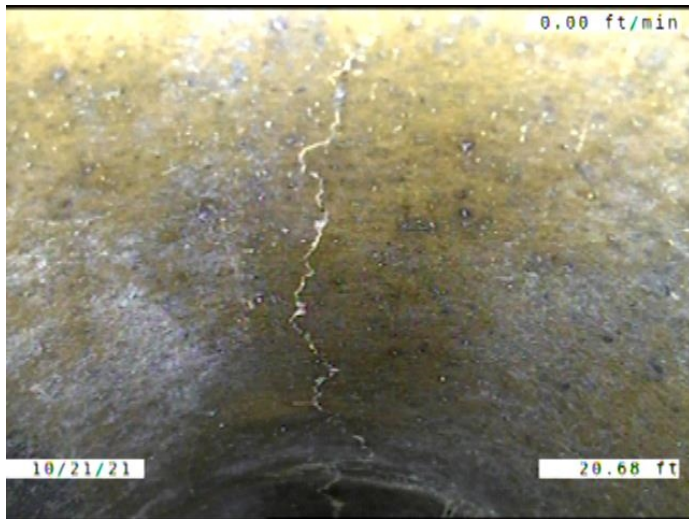
Code: **CM**
 Description: **Crack Multiple**

Distance (ft): **20.7**
 Structural Grade: **3**
 O&M Grade: **0**
 Clock Start/From: **11**
 Clock To: **1**
 1st Value:
 2nd Value:
 Value Percent:
 Continuous Index:
 Within 8" of Joint: **YES**
 Remarks:

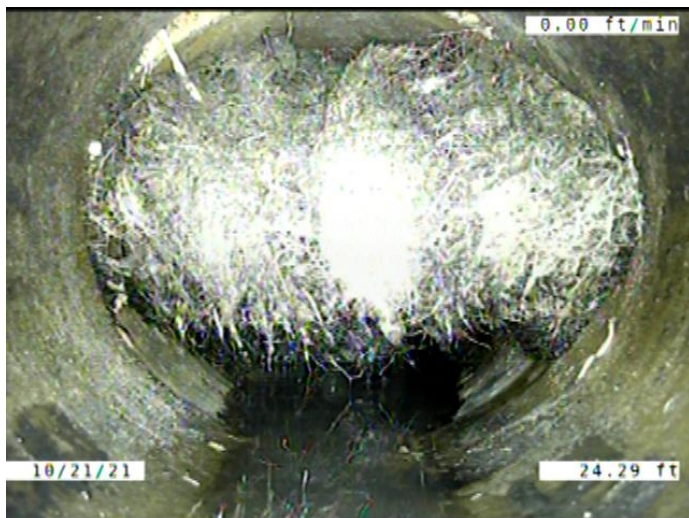
Code: **RBJ**
 Description: **Roots Ball Joint**

Distance (ft): **24.3**
 Structural Grade: **0**
 O&M Grade: **4**
 Clock Start/From: **8**
 Clock To: **4**
 1st Value:
 2nd Value:
 Value Percent: **80.000**
 Continuous Index:
 Within 8" of Joint: **YES**
 Remarks:

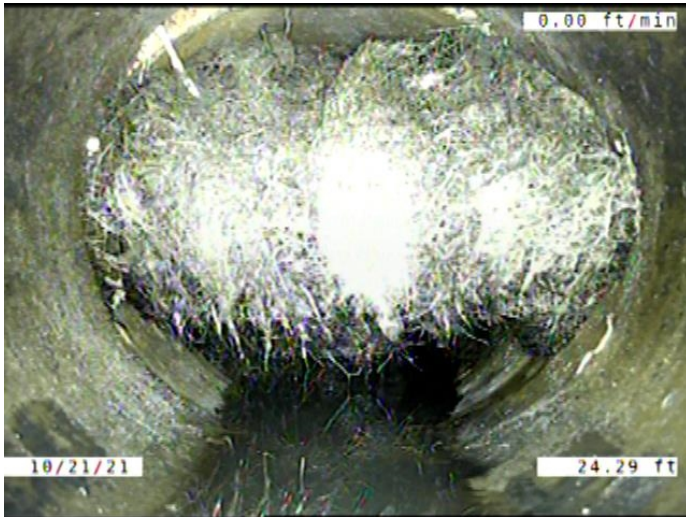
Code: **DSF**
Description: **Deposits Settled Fine**

Distance (ft): **24.3**
Structural Grade: **0**
O&M Grade: **2**
Clock Start/From: **5**
Clock To: **7**
1st Value:
2nd Value:
Value Percent: **5.000**
Continuous Index: **F01**
Within 8" of Joint: **YES**
Remarks:

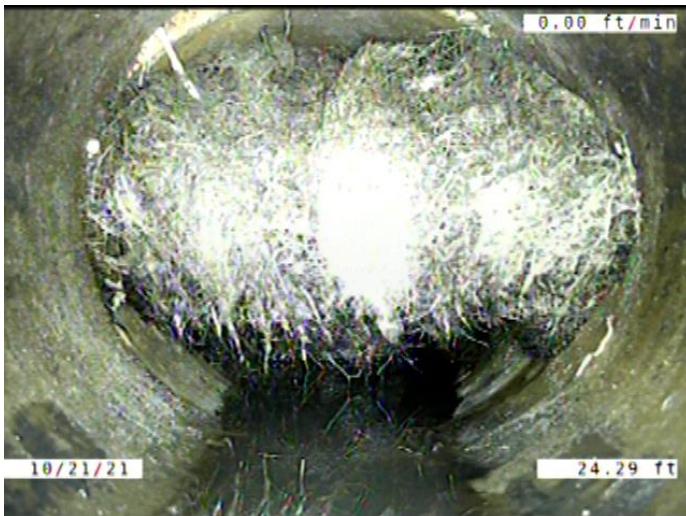
Code: **RMJ**
Description: **Roots Medium Joint**

Distance (ft): **24.3**
Structural Grade: **0**
O&M Grade: **3**
Clock Start/From: **7**
Clock To: **3**
1st Value:
2nd Value:
Value Percent: **15.000**
Continuous Index: **F05**
Within 8" of Joint: **YES**
Remarks:

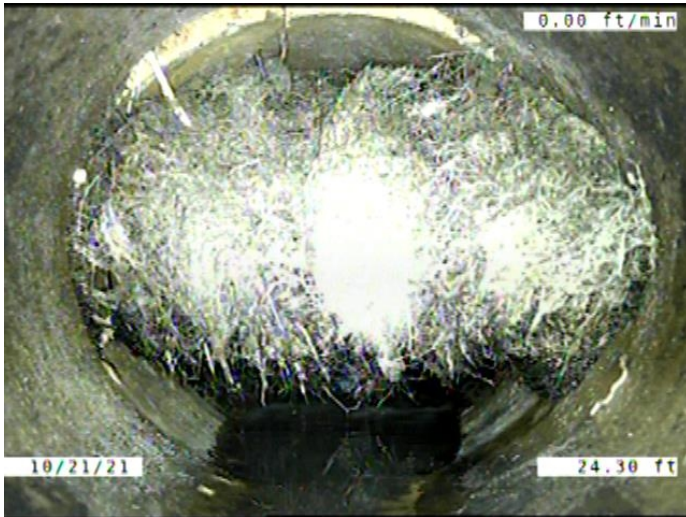
MSA

Miscellaneous Survey Abandoned

**CAMERA CANT MAKE IT PAST
ROOTS.**
