## Profile/Photo Observation Report

Street:	<b>West 40th Avenue</b>	Flow Control:	<b>Not Controlled</b>
City:	<b>Hobart, IN</b>	Year Renewed:	
Location:	<b>Yard</b>	Tape/Media #:	
Purpose:	<b>Routine Assessment</b>	Dia/Height:	<b>10"</b>
Use:	<b>Sanitary Sewage Pipe</b>	Material:	<b>VCP</b>
Drain Area:		Lining:	<b>None</b>
Category:	<b>NA</b>		
Comment:

Location Details:		Direction of Survey:	<b>Downstream</b>
US MH:	<b>M-503-006</b>	DS MH:	<b>M-503-007</b>
		Total Length Surveyed (ft):	<b>24.3</b>

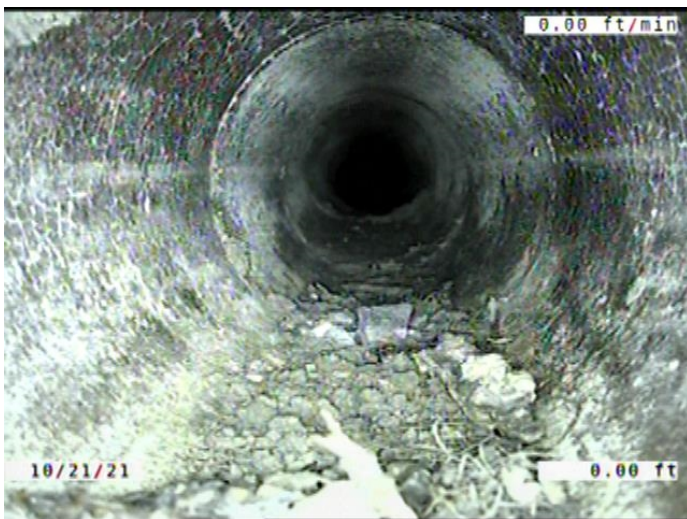
Code: **DSF**  
Description: **Deposits Settled Fine**

Distance (ft): **.0**  
Structural Grade: **0**  
O&M Grade: **2**  
Clock Start/From: **5**  
Clock To: **7**  
1st Value:  
2nd Value:  
Value Percent: **5.000**  
Continuous Index: **S01**  
Within 8" of Joint: **YES**  
Remarks:

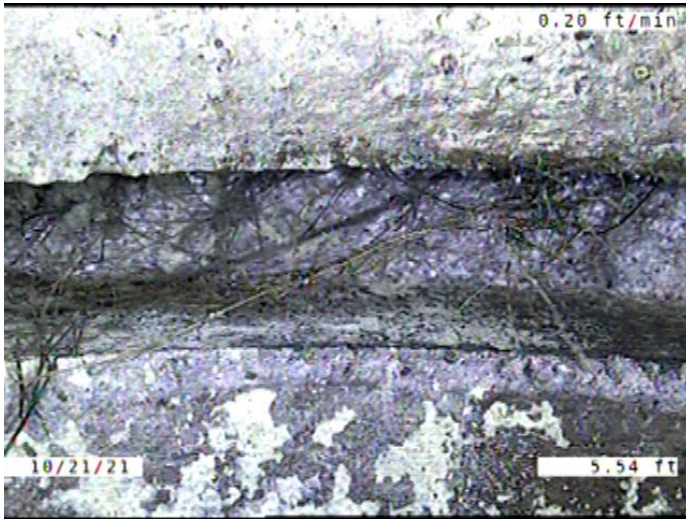
Code: **RFJ**  
 Description: **Roots Fine Joint**

Distance (ft): **5.5**  
 Structural Grade: **0**  
 O&M Grade: **1**  
 Clock Start/From: **12**  
 Clock To: **12**  
 1st Value:  
 2nd Value:  
 Value Percent:  
 Continuous Index: **S04**  
 Within 8" of Joint: **YES**  
 Remarks:

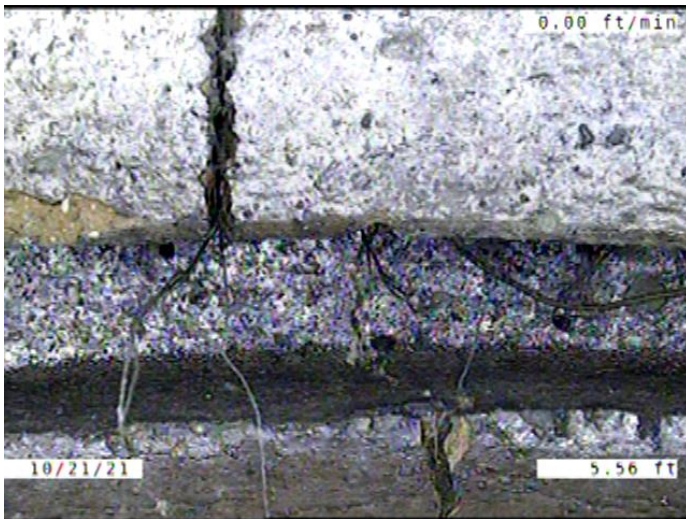
Code: **FM**  
 Description: **Fracture Multiple**

Distance (ft): **5.6**  
 Structural Grade: **4**  
 O&M Grade: **0**  
 Clock Start/From: **11**  
 Clock To: **1**  
 1st Value:  
 2nd Value:  
 Value Percent:  
 Continuous Index: **S03**  
 Within 8" of Joint: **YES**  
 Remarks:

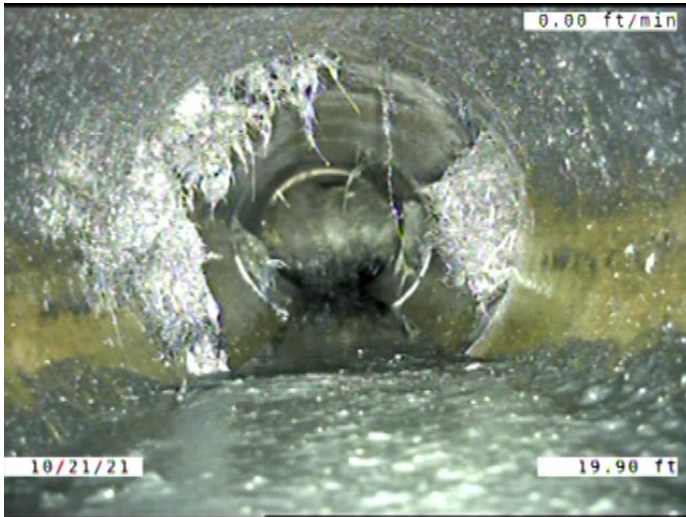
Code: **RMJ**  
 Description: **Roots Medium Joint**

Distance (ft): **19.9**  
 Structural Grade: **0**  
 O&M Grade: **3**  
 Clock Start/From: **7**  
 Clock To: **3**  
 1st Value:  
 2nd Value:  
 Value Percent: **15.000**  
 Continuous Index: **S05**  
 Within 8" of Joint: **YES**  
 Remarks:

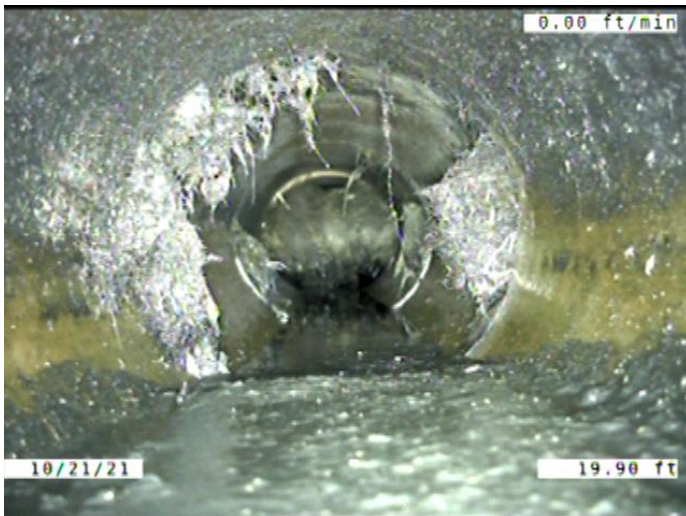
Code: **RFJ**  
 Description: **Roots Fine Joint**

Distance (ft): **19.9**  
 Structural Grade: **0**  
 O&M Grade: **1**  
 Clock Start/From: **12**  
 Clock To: **12**  
 1st Value:  
 2nd Value:  
 Value Percent:  
 Continuous Index: **F04**  
 Within 8" of Joint: **YES**  
 Remarks:

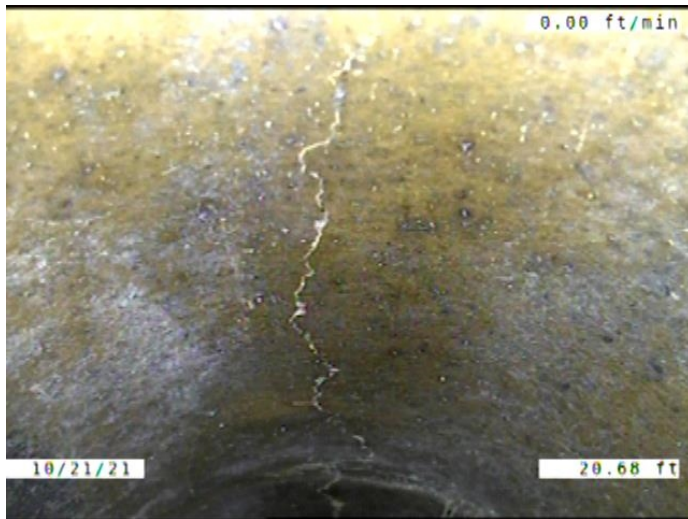
Code: **CM**  
 Description: **Crack Multiple**

Distance (ft): **20.7**  
 Structural Grade: **3**  
 O&M Grade: **0**  
 Clock Start/From: **11**  
 Clock To: **1**  
 1st Value:  
 2nd Value:  
 Value Percent:  
 Continuous Index:  
 Within 8" of Joint: **YES**  
 Remarks:

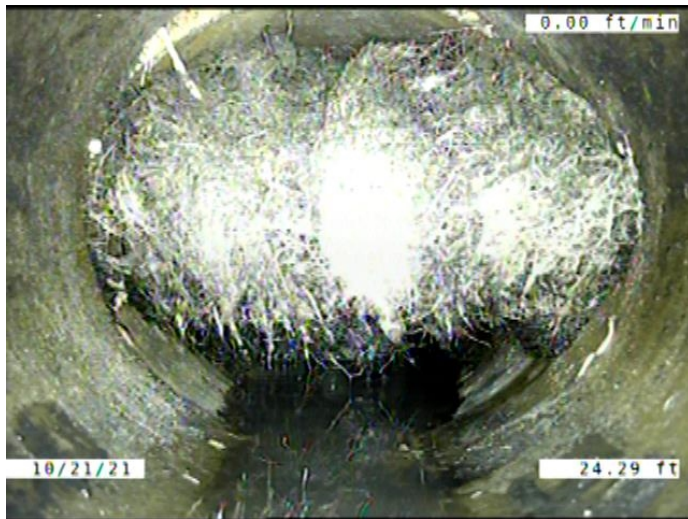
Code: **RBJ**  
 Description: **Roots Ball Joint**

Distance (ft): **24.3**  
 Structural Grade: **0**  
 O&M Grade: **4**  
 Clock Start/From: **8**  
 Clock To: **4**  
 1st Value:  
 2nd Value:  
 Value Percent: **80.000**  
 Continuous Index:  
 Within 8" of Joint: **YES**  
 Remarks:
