Profile/Photo Observation Report

Street:	ALLEY BETWEEN W 40TH AVE & W 3	Flow Control:	Not Controlled		
City:	Hobart, IN	Year Renewed:			
Location:	Other	Tape/Media #:			
Purpose:	Not Known	Dia/Height:	10"		
Use:	Sanitary	Material:	VCP		
Drain Area:	NA	Lining:			
Category:	NA				
Comment:					
Location Details:		Direction of Survey:	Downstream		
US MH:	M-503-009	DS MH:	M-503-010	Total Length Surveyed (ft):	5.8

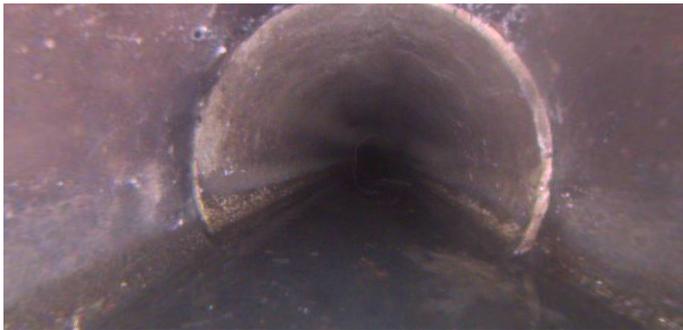
Code: **AMH**
Description: **Manhole**

Distance (ft): **.0**
Structural Grade: **0**
O&M Grade: **0**
Clock Start/From:
Clock To:
1st Value:
2nd Value:
Value Percent:
Continuous Index:
Within 8" of Joint: **NO**
Remarks: **M-503-009**

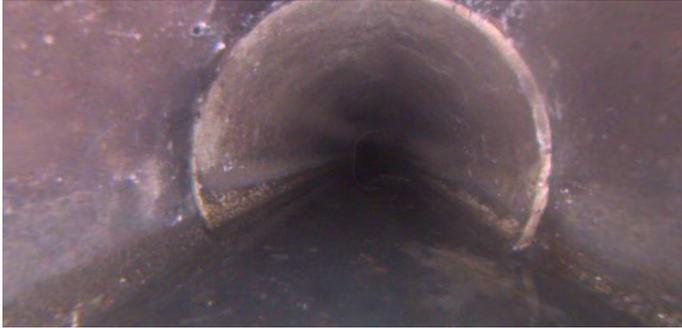
Code: **MWL**
Description: **Water Level**

Distance (ft): **.0**
Structural Grade: **0**
O&M Grade: **0**
Clock Start/From:
Clock To:
1st Value:
2nd Value:
Value Percent: **20.000**
Continuous Index:
Within 8" of Joint: **NO**
Remarks:

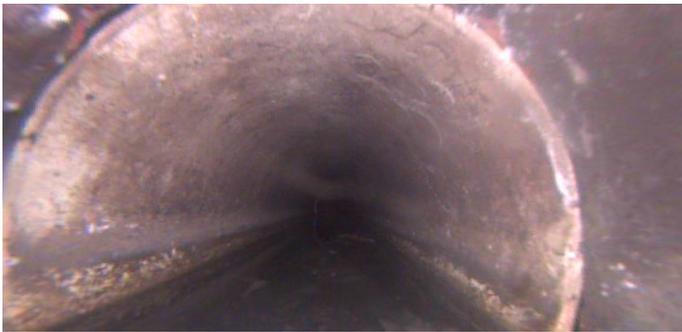
Code: **MMC**
Description: **Material Change**

Distance (ft): **1.0**
Structural Grade: **0**
O&M Grade: **0**
Clock Start/From:
Clock To:
1st Value:
2nd Value:
Value Percent:
Continuous Index:
Within 8" of Joint: **NO**
Remarks: **pvc**

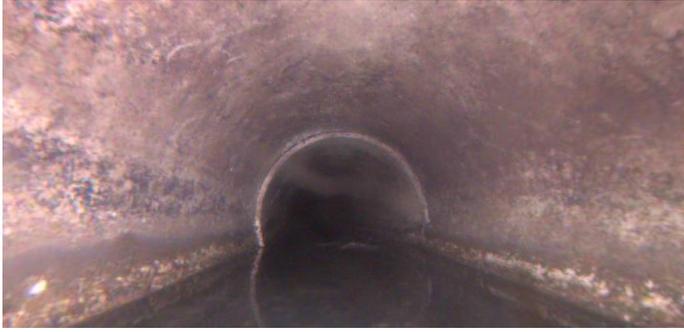
Code: **MSA**
Description: **Abandoned Survey**

Distance (ft): **5.8**
Structural Grade: **0**
O&M Grade: **0**
Clock Start/From:
Clock To:
1st Value:
2nd Value:
Value Percent:
Continuous Index:
Within 8" of Joint: **NO**
Remarks: **debris under water**
