# Profile/Photo Observation Report

Date:	09/19/2021	Weather:		Coding:	PACP 7.0
Pipe Length (ft):	185.8	Owner:	City of Hobart	Pre Clean:	Light Cleaning
P.O.#:	YES502259	Surveyor:	S. Bucklin	PSR:	P-503-010-009
Customer:	City of Hobart	Clean Date:	09/06/2021	Shape:	C

Street:	West 39th Place	Flow Control:	Not Controlled
City:	Hobart, IN	Year Renewed:	
Location:	Alley	Tape/Media #:	
Purpose:	Routine Assessment	Dia/Height:	10"
Use:	Sanitary Sewage Pipe	Material:	VCP
Drain Area:		Lining:	None
Category:	NA		
Comment:			
Location Details:		Direction of Survey:	Downstream
US MH:	M-503-009	DS MH:	M-503-010
		Total Length Surveyed (ft):	185.8

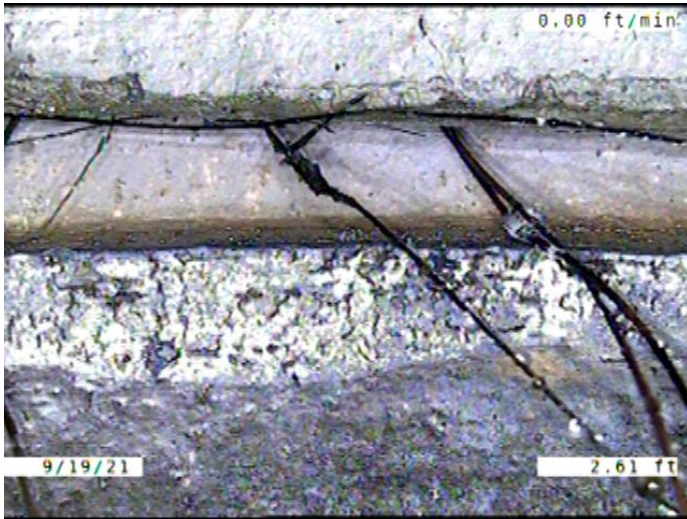
Code: **RFJ**  
Description: **Roots Fine Joint**

Distance (ft): **2.6**  
Structural Grade: **0**  
O&M Grade: **1**  
Clock Start/From: **10**  
Clock To: **4**  
1st Value:  
2nd Value:  
Value Percent:  
Continuous Index:  
Within 8" of Joint: **YES**  
Remarks:

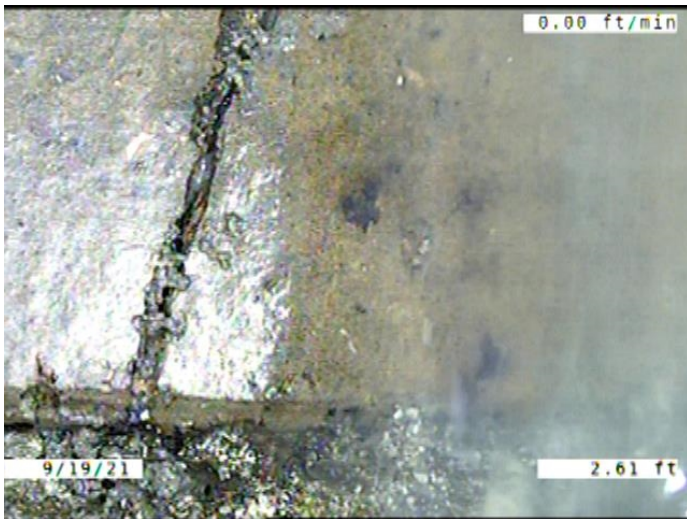
Code: **FM**  
Description: **Fracture Multiple**

Distance (ft): **2.6**  
Structural Grade: **4**  
O&M Grade: **0**  
Clock Start/From: **4**  
Clock To: **8**  
1st Value:  
2nd Value:  
Value Percent:  
Continuous Index:  
Within 8" of Joint: **YES**  
Remarks:

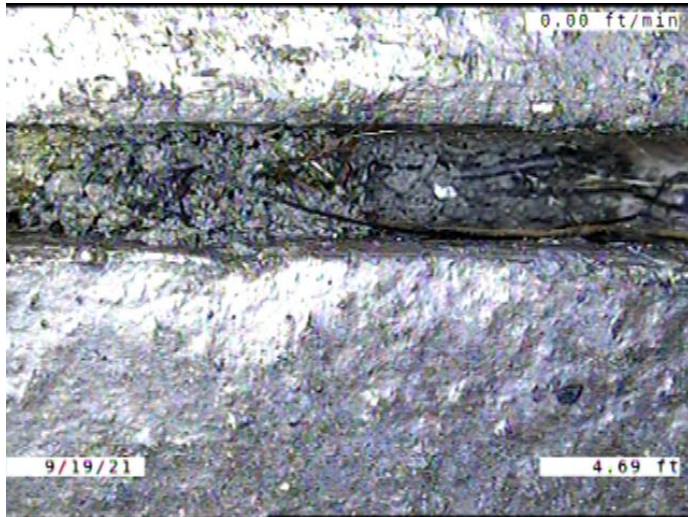
Code: **RFJ**  
 Description: **Roots Fine Joint**

Distance (ft): **4.7**  
 Structural Grade: **0**  
 O&M Grade: **1**  
 Clock Start/From: **8**  
 Clock To: **4**  
 1st Value:  
 2nd Value:  
 Value Percent:  
 Continuous Index:  
 Within 8" of Joint: **YES**  
 Remarks:

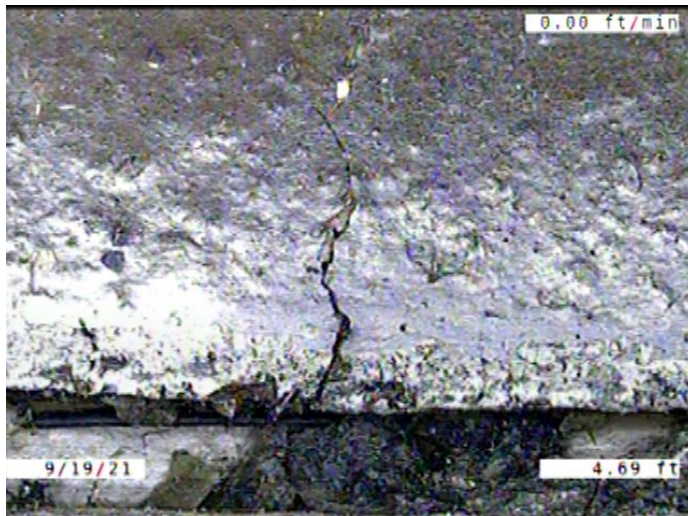
Code: **FM**  
 Description: **Fracture Multiple**

Distance (ft): **4.7**  
 Structural Grade: **4**  
 O&M Grade: **0**  
 Clock Start/From: **12**  
 Clock To: **12**  
 1st Value:  
 2nd Value:  
 Value Percent:  
 Continuous Index: **S01**  
 Within 8" of Joint: **YES**  
 Remarks:

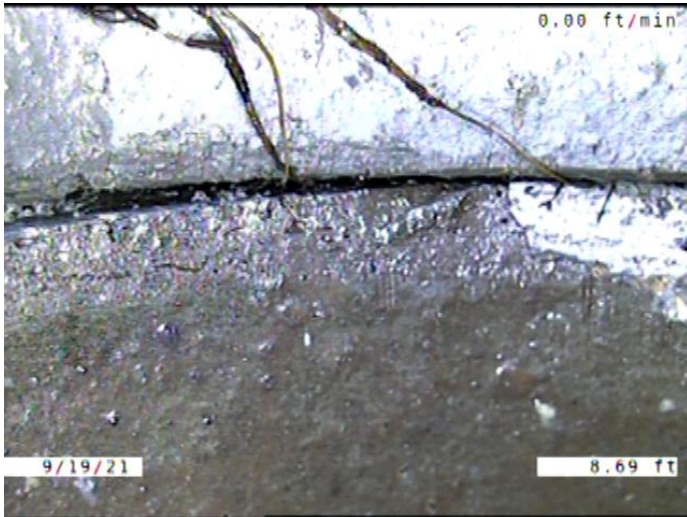
Code: **RFJ**  
 Description: **Roots Fine Joint**

Distance (ft): **8.7**  
 Structural Grade: **0**  
 O&M Grade: **1**  
 Clock Start/From: **9**  
 Clock To: **4**  
 1st Value:  
 2nd Value:  
 Value Percent:  
 Continuous Index: **S02**  
 Within 8" of Joint: **YES**  
 Remarks:

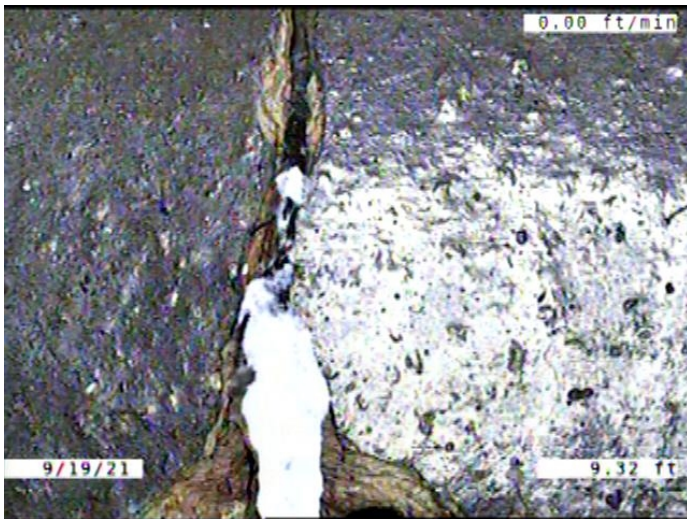
Code: **RFB**  
 Description: **Roots Fine Barrel**

Distance (ft): **9.3**  
 Structural Grade: **0**  
 O&M Grade: **2**  
 Clock Start/From: **12**  
 Clock To: **1**  
 1st Value:  
 2nd Value:  
 Value Percent:  
 Continuous Index:  
 Within 8" of Joint: **NO**  
 Remarks:

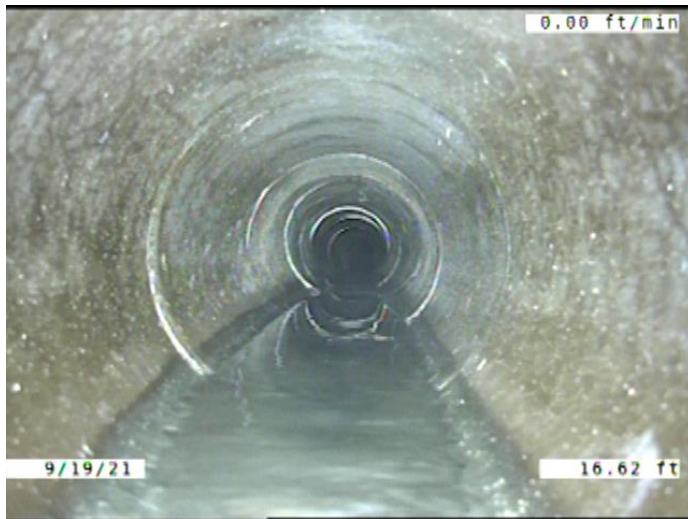
Code: **RFJ**  
 Description: **Roots Fine Joint**

Distance (ft): **16.6**  
 Structural Grade: **0**  
 O&M Grade: **1**  
 Clock Start/From: **9**  
 Clock To: **4**  
 1st Value:  
 2nd Value:  
 Value Percent:  
 Continuous Index: **F02**  
 Within 8" of Joint: **YES**  
 Remarks:

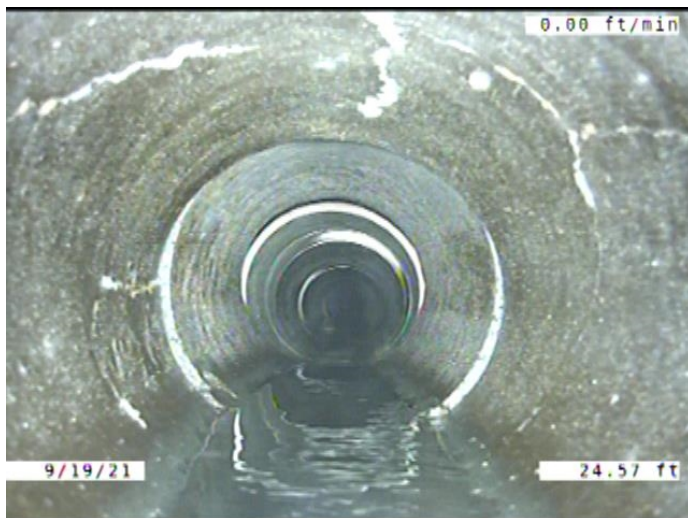
Code: **MWLS**  
 Description: **Miscellaneous Water Level Sag**

Distance (ft): **24.6**  
 Structural Grade: **2**  
 O&M Grade: **0**  
 Clock Start/From:  
 Clock To:  
 1st Value:  
 2nd Value:  
 Value Percent: **5.000**  
 Continuous Index: **F03**  
 Within 8" of Joint: **NO**  
 Remarks:

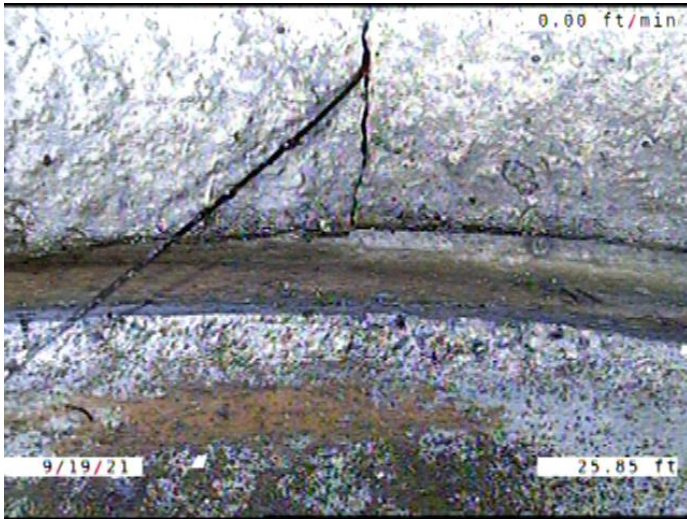
Code: **RFB**  
Description: **Roots Fine Barrel**

Distance (ft): **25.9**  
Structural Grade: **0**  
O&M Grade: **2**  
Clock Start/From: **10**  
Clock To: **4**  
1st Value:  
2nd Value:  
Value Percent:  
Continuous Index:  
Within 8" of Joint: **NO**  
Remarks:

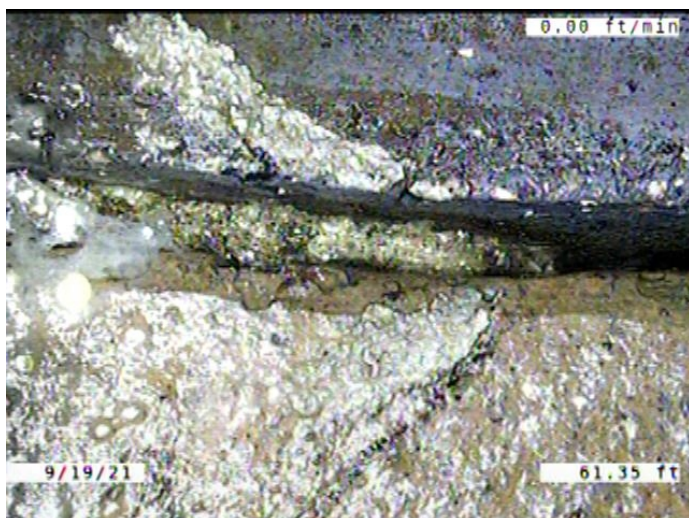
Code: **DAE**  
 Description: **Deposits Attached Encrustation**

Distance (ft): **61.3**  
 Structural Grade: **0**  
 O&M Grade: **2**  
 Clock Start/From: **4**  
 Clock To:  
 1st Value:  
 2nd Value:  
 Value Percent: **5.000**  
 Continuous Index:  
 Within 8" of Joint: **YES**  
 Remarks:

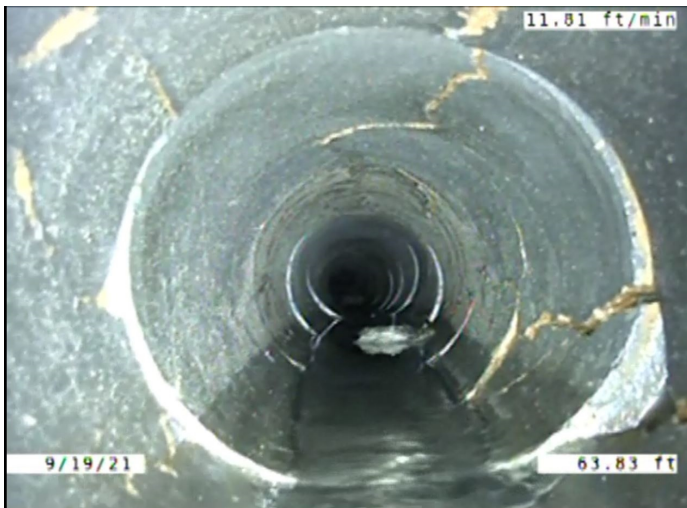
Code: **FM**  
 Description: **Fracture Multiple**

Distance (ft): **63.8**  
 Structural Grade: **4**  
 O&M Grade: **0**  
 Clock Start/From: **8**  
 Clock To: **4**  
 1st Value:  
 2nd Value:  
 Value Percent:  
 Continuous Index: **S09**  
 Within 8" of Joint: **NO**  
 Remarks:

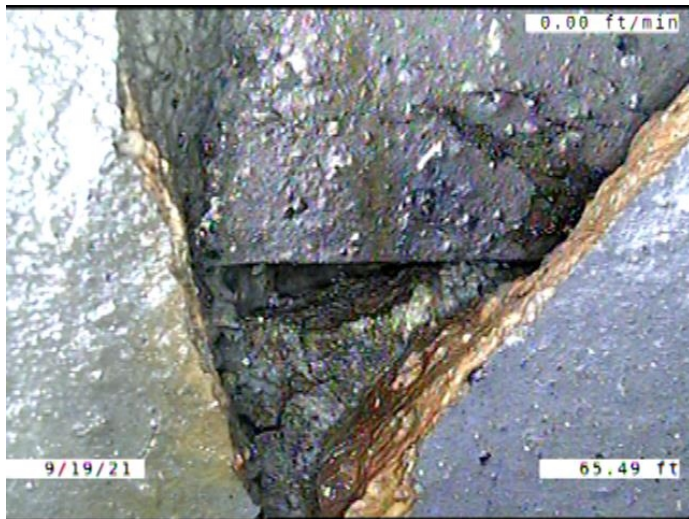
Code:	<b>SMW</b>
Description:	<b>Surface Damage Missing Wall</b>
Distance (ft):	<b>65.5</b>
Structural Grade:	<b>5</b>
O&M Grade:	<b>0</b>
Clock Start/From:	<b>2</b>
Clock To:	<b>4</b>
1st Value:	
2nd Value:	
Value Percent:	
Continuous Index:	
Within 8" of Joint:	<b>YES</b>
Remarks:

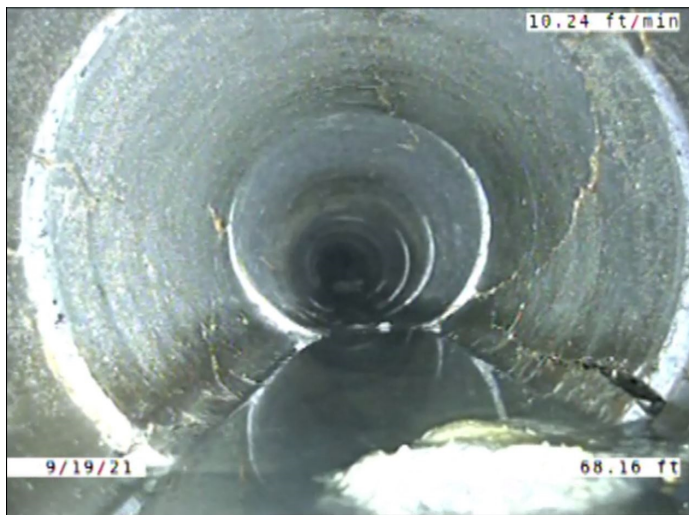
Code: **BVV**  
 Description: **Broken Void Visible**

Distance (ft): **68.2**  
 Structural Grade: **5**  
 O&M Grade: **0**  
 Clock Start/From: **3**  
 Clock To: **5**  
 1st Value:  
 2nd Value:  
 Value Percent:  
 Continuous Index: **F05**  
 Within 8" of Joint: **YES**  
 Remarks: **SOIL VISIBLE TOO**

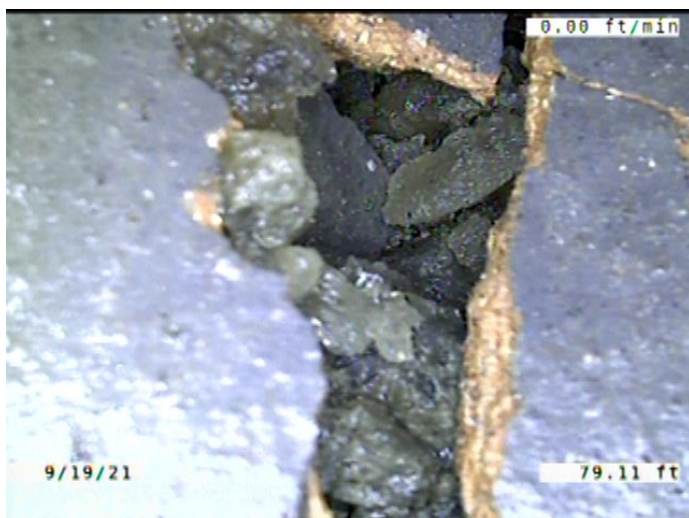
Code: **HSV**  
 Description: **Hole Soil Visible**

Distance (ft): **79.1**  
 Structural Grade: **5**  
 O&M Grade: **0**  
 Clock Start/From: **3**  
 Clock To: **4**  
 1st Value:  
 2nd Value:  
 Value Percent:  
 Continuous Index:  
 Within 8" of Joint: **NO**  
 Remarks:

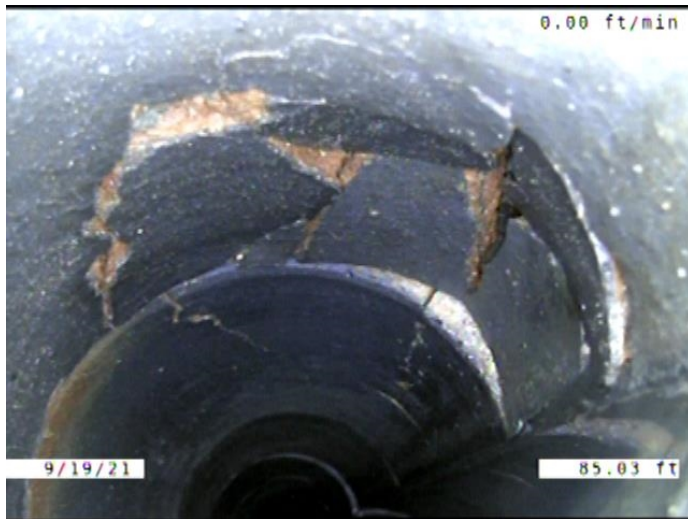
Code: **BVV**  
Description: **Broken Void Visible**

Distance (ft): **85.0**  
Structural Grade: **5**  
O&M Grade: **0**  
Clock Start/From: **2**  
Clock To: **4**  
1st Value:  
2nd Value:  
Value Percent:  
Continuous Index:  
Within 8" of Joint: **NO**  
Remarks:

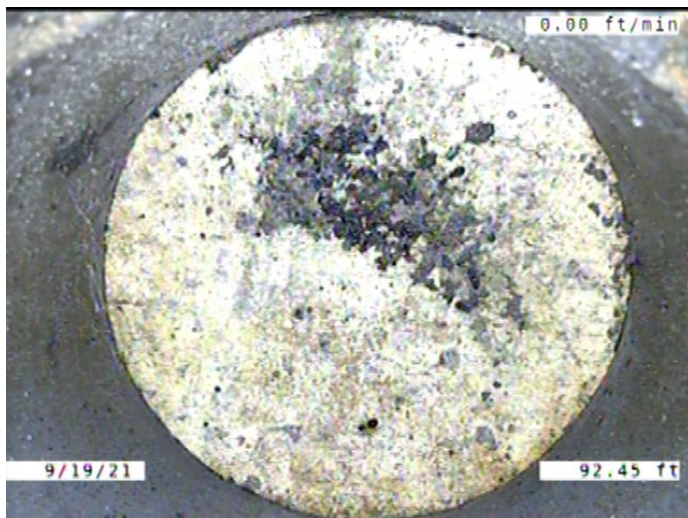
Code: **TFD**  
Description: **Tap Factory Defective**

Distance (ft): **92.5**  
Structural Grade: **0**  
O&M Grade: **3**  
Clock Start/From: **1**  
Clock To:  
1st Value: **4.000**  
2nd Value:  
Value Percent:  
Continuous Index:  
Within 8" of Joint: **YES**  
Remarks: **CAPPED**

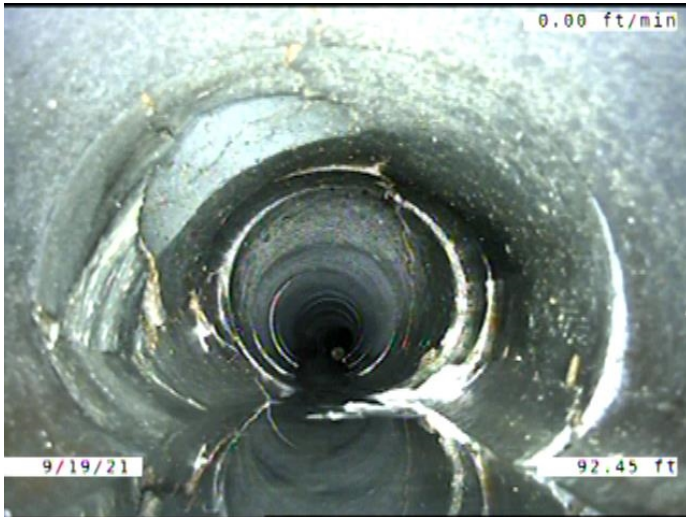
Code: **DR**  
 Description: **Deformed Rigid**

Distance (ft): **92.5**  
 Structural Grade: **4**  
 O&M Grade: **0**  
 Clock Start/From:  
 Clock To:  
 1st Value:  
 2nd Value:  
 Value Percent: **5.000**  
 Continuous Index:  
 Within 8" of Joint: **NO**  
 Remarks:

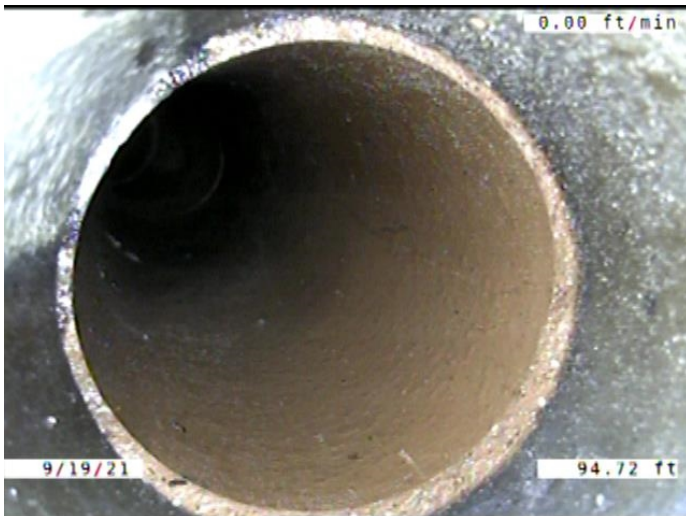
Code: **TFD**  
 Description: **Tap Factory Defective**

Distance (ft): **94.7**  
 Structural Grade: **0**  
 O&M Grade: **3**  
 Clock Start/From: **11**  
 Clock To:  
 1st Value: **4.000**  
 2nd Value:  
 Value Percent:  
 Continuous Index:  
 Within 8" of Joint: **YES**  
 Remarks: **Defective**

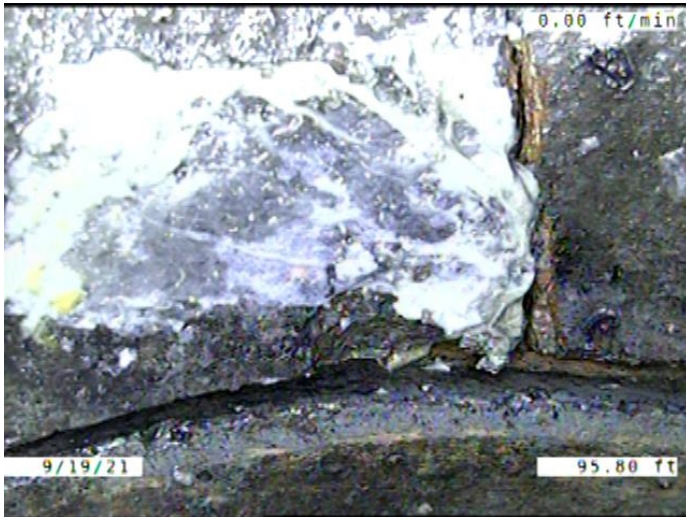
Code: **DAE**  
 Description: **Deposits Attached Encrustation**

Distance (ft): **95.8**  
 Structural Grade: **0**  
 O&M Grade: **2**  
 Clock Start/From: **9**  
 Clock To: **10**  
 1st Value:  
 2nd Value:  
 Value Percent: **5.000**  
 Continuous Index:  
 Within 8" of Joint: **YES**  
 Remarks:

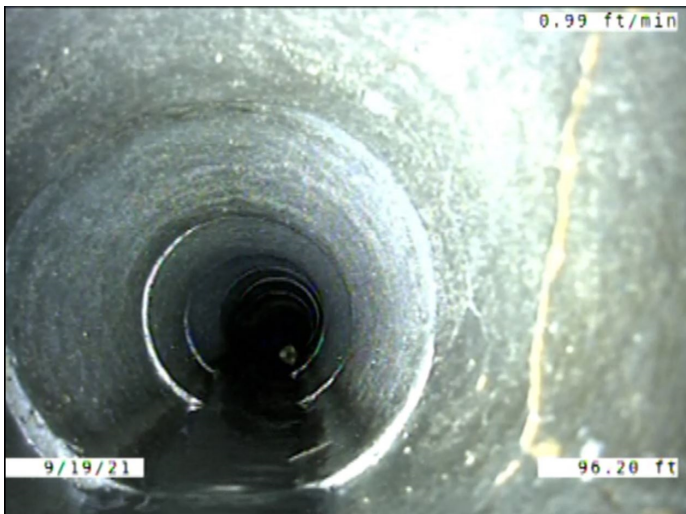
Code: **FM**  
 Description: **Fracture Multiple**

Distance (ft): **96.2**  
 Structural Grade: **4**  
 O&M Grade: **0**  
 Clock Start/From: **8**  
 Clock To: **4**  
 1st Value:  
 2nd Value:  
 Value Percent:  
 Continuous Index: **F09**  
 Within 8" of Joint: **NO**  
 Remarks:

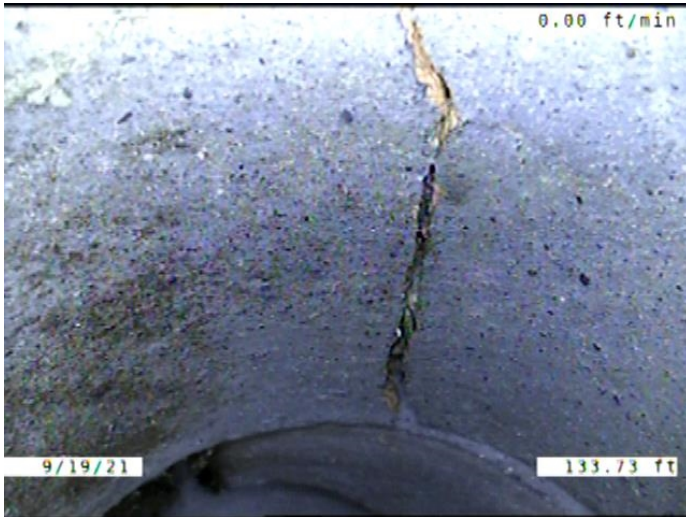
Code: **BSV**  
Description: **Broken Soil Visible**

Distance (ft): **133.7**  
Structural Grade: **5**  
O&M Grade: **0**  
Clock Start/From: **5**  
Clock To: **1**  
1st Value:  
2nd Value:  
Value Percent:  
Continuous Index: **S08**  
Within 8" of Joint: **YES**  
Remarks:

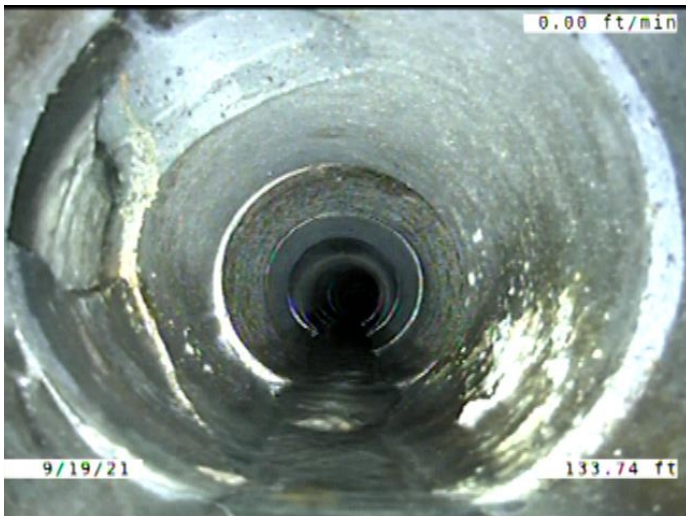
Code: **MWLS**  
Description: **Miscellaneous Water Level Sag**

Distance (ft): **133.7**  
Structural Grade: **2**  
O&M Grade: **0**  
Clock Start/From:  
Clock To:  
1st Value:  
2nd Value:  
Value Percent: **10.000**  
Continuous Index: **F06**  
Within 8" of Joint: **NO**  
Remarks:

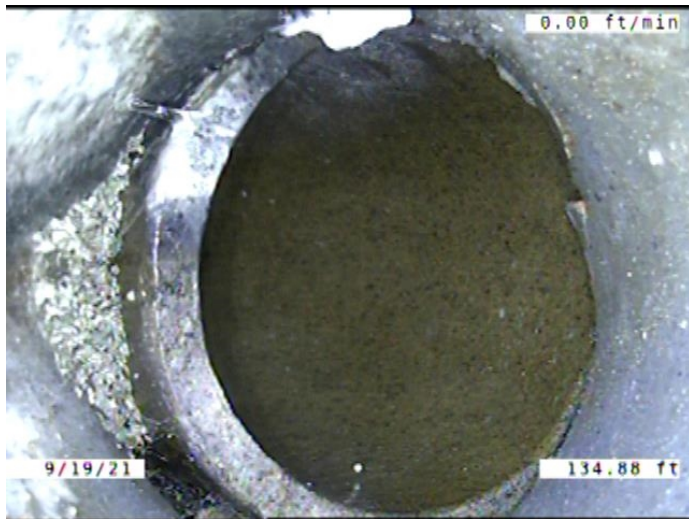
Code: **TFD**  
 Description: **Tap Factory Defective**

Distance (ft): **134.9**  
 Structural Grade: **0**  
 O&M Grade: **3**  
 Clock Start/From: **11**  
 Clock To:  
 1st Value: **4.000**  
 2nd Value:  
 Value Percent:  
 Continuous Index:  
 Within 8" of Joint: **YES**  
 Remarks: **Defective**

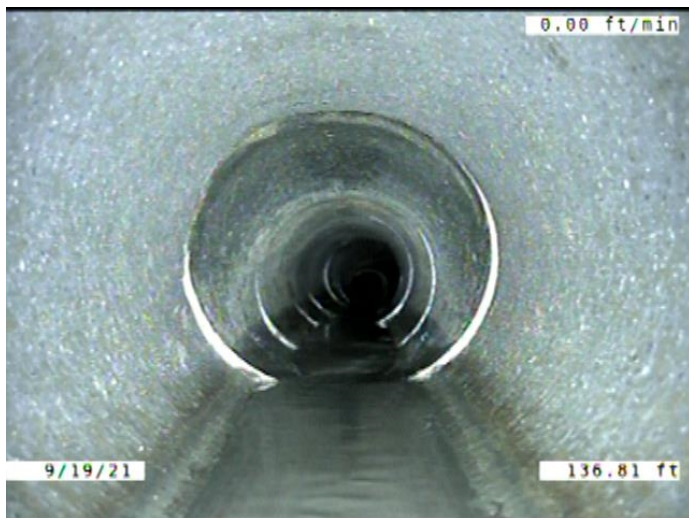
Code: **BSV**  
 Description: **Broken Soil Visible**

Distance (ft): **136.8**  
 Structural Grade: **5**  
 O&M Grade: **0**  
 Clock Start/From: **5**  
 Clock To: **1**  
 1st Value:  
 2nd Value:  
 Value Percent:  
 Continuous Index: **F08**  
 Within 8" of Joint: **YES**  
 Remarks:

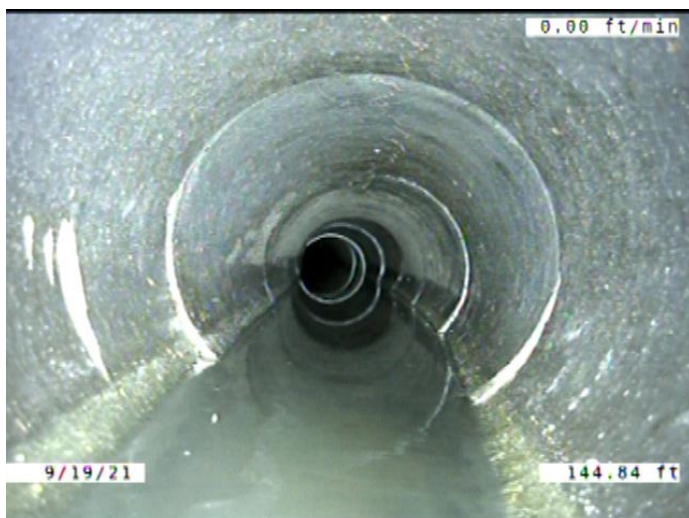
Code: **MWLS**  
 Description: **Miscellaneous Water Level Sag**

Distance (ft): **144.8**  
 Structural Grade: **2**  
 O&M Grade: **0**  
 Clock Start/From:  
 Clock To:  
 1st Value:  
 2nd Value:  
 Value Percent: **20.000**  
 Continuous Index: **S09**  
 Within 8" of Joint: **NO**  
 Remarks:

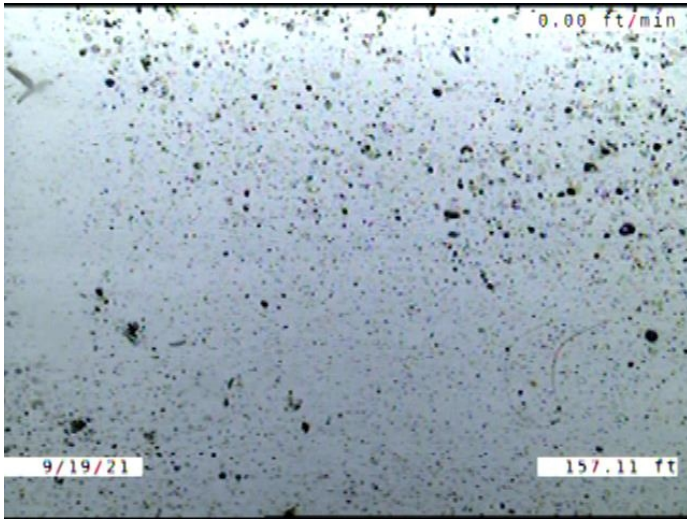
Code: **FM**  
Description: **Fracture Multiple**

Distance (ft): **157.1**  
Structural Grade: **4**  
O&M Grade: **0**  
Clock Start/From: **11**  
Clock To: **1**  
1st Value:  
2nd Value:  
Value Percent:  
Continuous Index: **F07**  
Within 8" of Joint: **YES**  
Remarks:

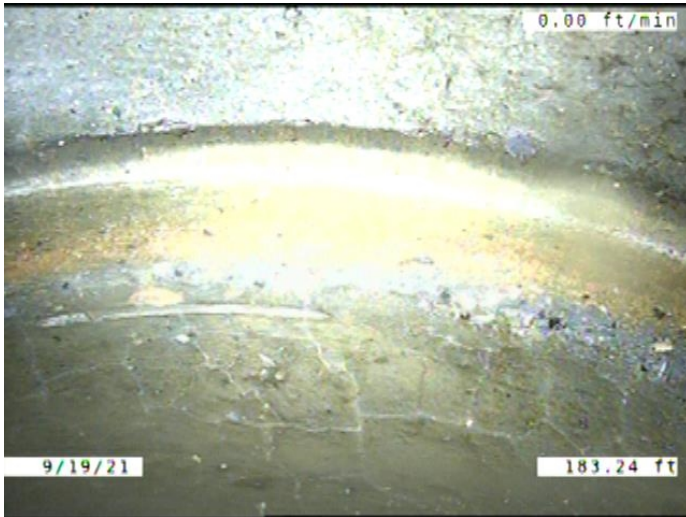
Code: **JOM**  
Description: **Joint Offset Medium**

Distance (ft): **183.2**  
Structural Grade: **3**  
O&M Grade: **0**  
Clock Start/From:  
Clock To:  
1st Value:  
2nd Value:  
Value Percent:  
Continuous Index:  
Within 8" of Joint: **NO**  
Remarks:

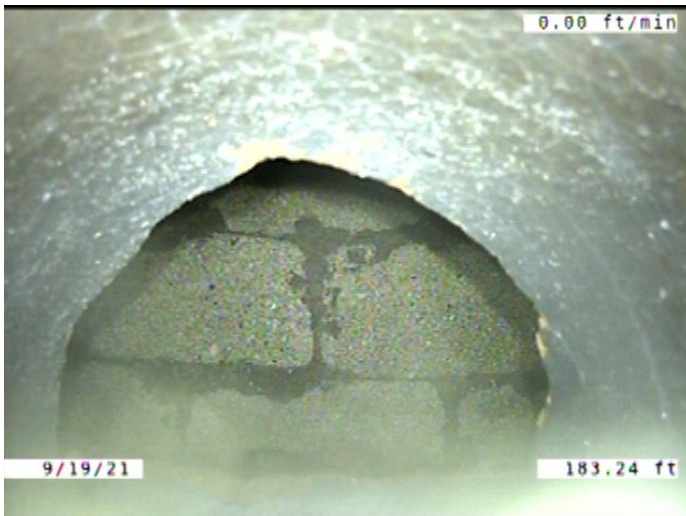
Code: **MWLS**  
Description: **Miscellaneous Water Level Sag**

Distance (ft): **183.2**  
Structural Grade: **2**  
O&M Grade: **0**  
Clock Start/From:  
Clock To:  
1st Value:  
2nd Value:  
Value Percent: **20.000**  
Continuous Index: **F09**  
Within 8" of Joint: **NO**  
Remarks:
