Profile/Photo Observation Report

Date:	09/19/2021	Weather:		Coding:	PACP 7.0
Pipe Length (ft):	185.8	Owner:	City of Hobart	Pre Clean:	Light Cleaning
P.O.#:	YES502259	Surveyor:	S. Bucklin	PSR:	P-503-010-009
Customer:	City of Hobart	Clean Date:	09/06/2021	Shape:	C

Street:	West 39th Place	Flow Control:	Not Controlled
City:	Hobart, IN	Year Renewed:	
Location:	Alley	Tape/Media #:	
Purpose:	Routine Assessment	Dia/Height:	10"
Use:	Sanitary Sewage Pipe	Material:	VCP
Drain Area:		Lining:	None
Category:	NA		
Comment:			
Location Details:		Direction of Survey:	Downstream
US MH:	M-503-009	DS MH:	M-503-010
		Total Length Surveyed (ft):	185.8

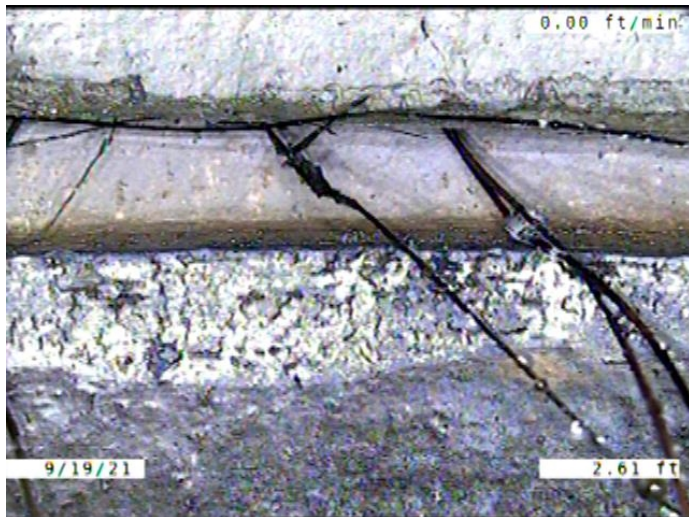
Code: **RFJ**
 Description: **Roots Fine Joint**

Distance (ft): **2.6**
 Structural Grade: **0**
 O&M Grade: **1**
 Clock Start/From: **10**
 Clock To: **4**
 1st Value:
 2nd Value:
 Value Percent:
 Continuous Index:
 Within 8" of Joint: **YES**
 Remarks:

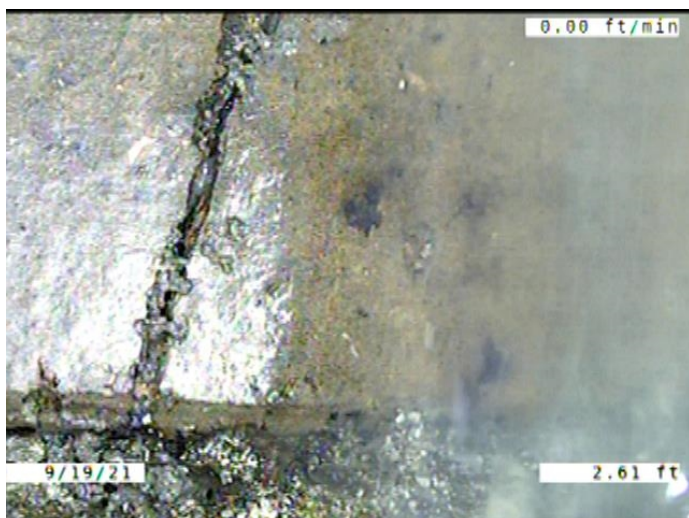
Code: **FM**
 Description: **Fracture Multiple**

Distance (ft): **2.6**
 Structural Grade: **4**
 O&M Grade: **0**
 Clock Start/From: **4**
 Clock To: **8**
 1st Value:
 2nd Value:
 Value Percent:
 Continuous Index:
 Within 8" of Joint: **YES**
 Remarks:

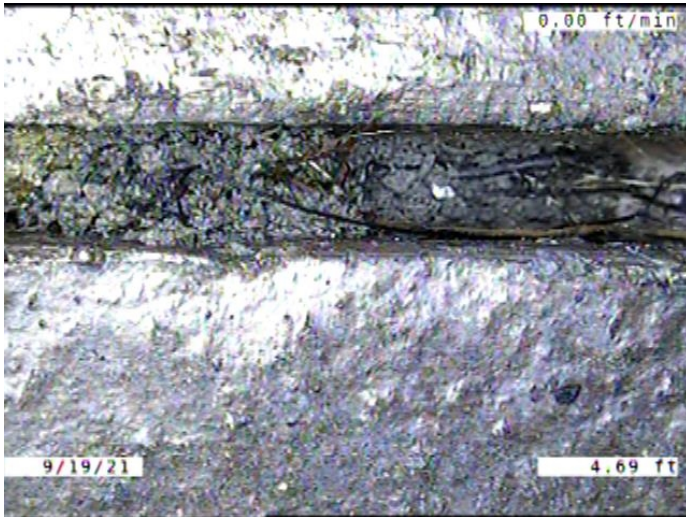
Code: **RFJ**
 Description: **Roots Fine Joint**

Distance (ft): **4.7**
 Structural Grade: **0**
 O&M Grade: **1**
 Clock Start/From: **8**
 Clock To: **4**
 1st Value:
 2nd Value:
 Value Percent:
 Continuous Index:
 Within 8" of Joint: **YES**
 Remarks:

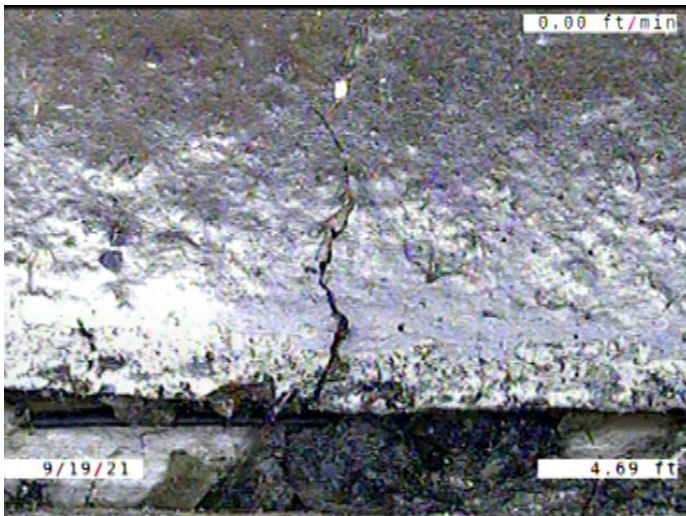
Code: **FM**
 Description: **Fracture Multiple**

Distance (ft): **4.7**
 Structural Grade: **4**
 O&M Grade: **0**
 Clock Start/From: **12**
 Clock To: **12**
 1st Value:
 2nd Value:
 Value Percent:
 Continuous Index: **S01**
 Within 8" of Joint: **YES**
 Remarks:

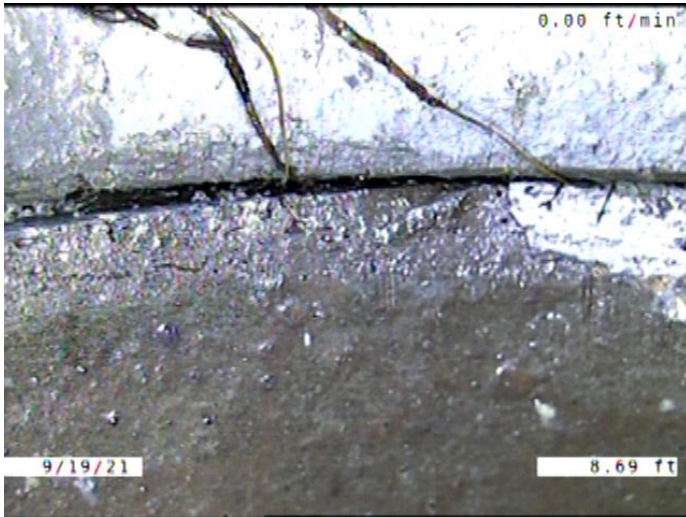
Code: **RFJ**
 Description: **Roots Fine Joint**

Distance (ft): **8.7**
 Structural Grade: **0**
 O&M Grade: **1**
 Clock Start/From: **9**
 Clock To: **4**
 1st Value:
 2nd Value:
 Value Percent:
 Continuous Index: **S02**
 Within 8" of Joint: **YES**
 Remarks:

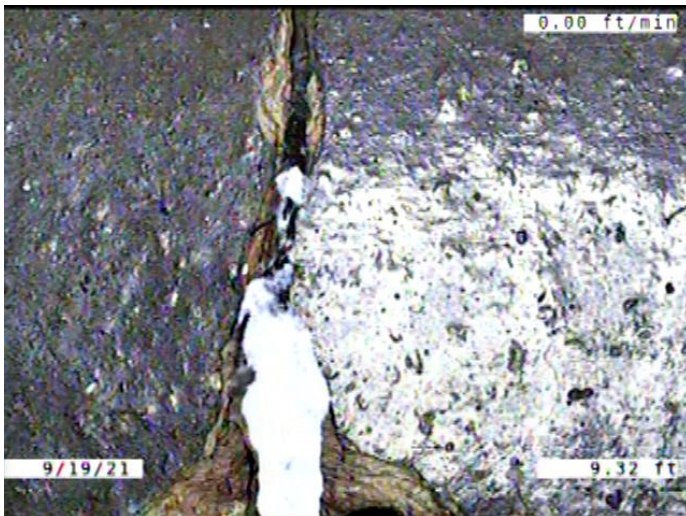
Code: **RFB**
 Description: **Roots Fine Barrel**

Distance (ft): **9.3**
 Structural Grade: **0**
 O&M Grade: **2**
 Clock Start/From: **12**
 Clock To: **1**
 1st Value:
 2nd Value:
 Value Percent:
 Continuous Index:
 Within 8" of Joint: **NO**
 Remarks:

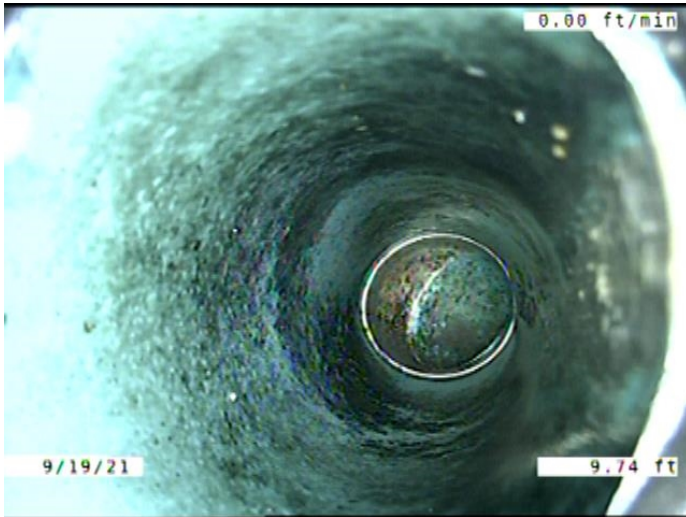
Code: **TBD**
 Description: **Tap Break-in/Hammer Defective**

Distance (ft): **9.7**
 Structural Grade: **0**
 O&M Grade: **3**
 Clock Start/From: **1**
 Clock To:
 1st Value: **4.000**
 2nd Value:
 Value Percent:
 Continuous Index:
 Within 8" of Joint: **YES**
 Remarks: **Defective**

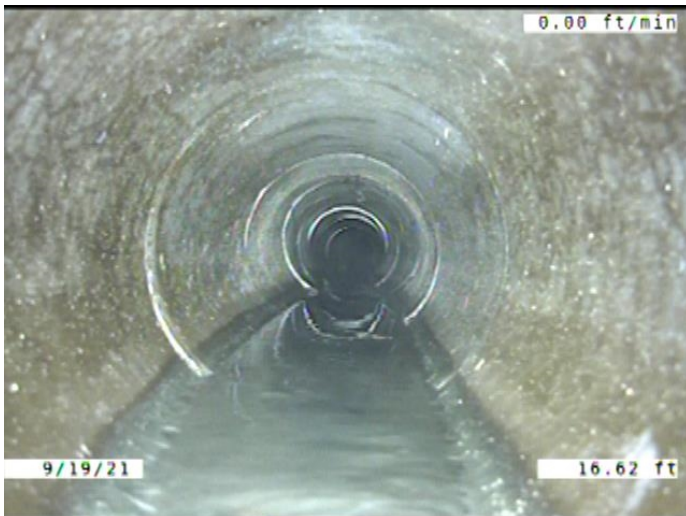
Code: **MWLS**
 Description: **Miscellaneous Water Level Sag**

Distance (ft): **16.6**
 Structural Grade: **2**
 O&M Grade: **0**
 Clock Start/From:
 Clock To:
 1st Value:
 2nd Value:
 Value Percent: **5.000**
 Continuous Index: **S03**
 Within 8" of Joint: **NO**
 Remarks:

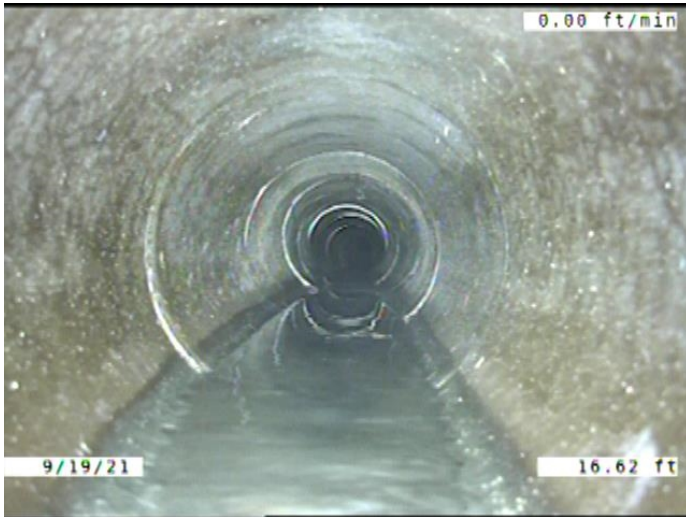
Code: **RFJ**
 Description: **Roots Fine Joint**

Distance (ft): **16.6**
 Structural Grade: **0**
 O&M Grade: **1**
 Clock Start/From: **9**
 Clock To: **4**
 1st Value:
 2nd Value:
 Value Percent:
 Continuous Index: **F02**
 Within 8" of Joint: **YES**
 Remarks:

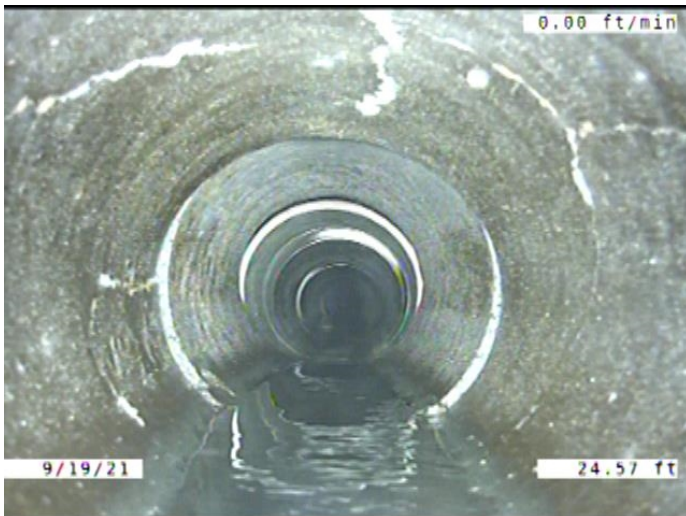
Code: **MWLS**
 Description: **Miscellaneous Water Level Sag**

Distance (ft): **24.6**
 Structural Grade: **2**
 O&M Grade: **0**
 Clock Start/From:
 Clock To:
 1st Value:
 2nd Value:
 Value Percent: **5.000**
 Continuous Index: **F03**
 Within 8" of Joint: **NO**
 Remarks:

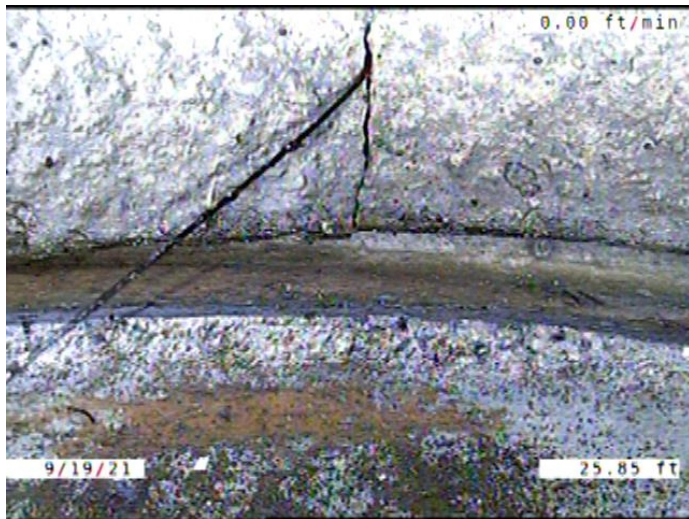
Code: **RFB**
 Description: **Roots Fine Barrel**

Distance (ft): **25.9**
 Structural Grade: **0**
 O&M Grade: **2**
 Clock Start/From: **10**
 Clock To: **4**
 1st Value:
 2nd Value:
 Value Percent:
 Continuous Index:
 Within 8" of Joint: **NO**
 Remarks:

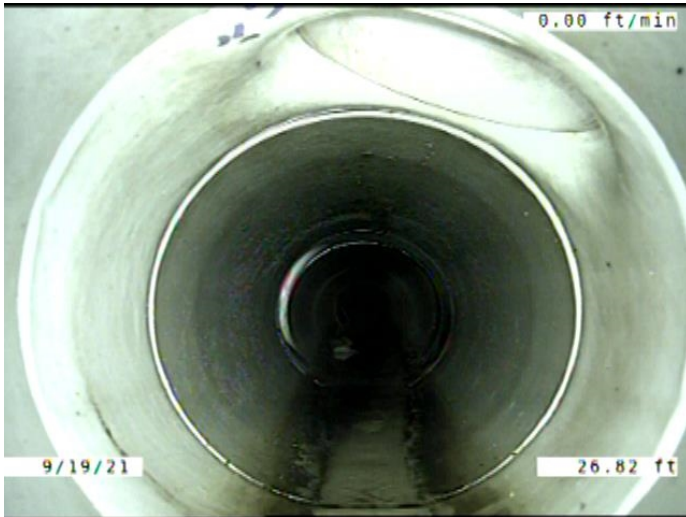
Code: **FM**
 Description: **Fracture Multiple**

Distance (ft): **26.8**
 Structural Grade: **4**
 O&M Grade: **0**
 Clock Start/From: **12**
 Clock To: **12**
 1st Value:
 2nd Value:
 Value Percent:
 Continuous Index: **F01**
 Within 8" of Joint: **YES**
 Remarks:

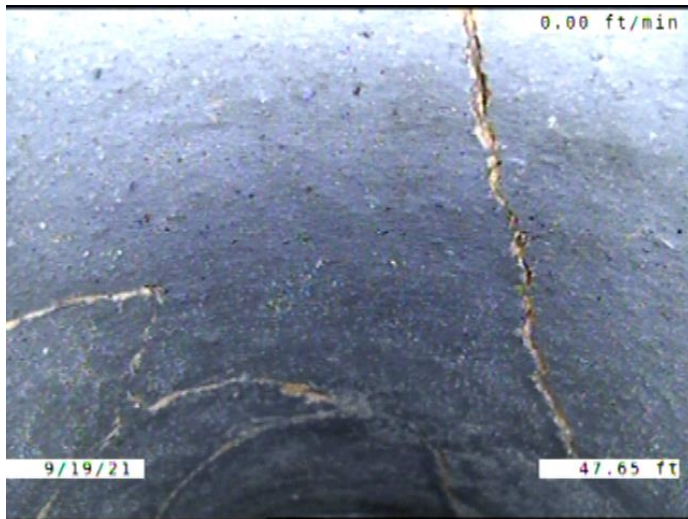
Code: **FM**
 Description: **Fracture Multiple**

Distance (ft): **47.7**
 Structural Grade: **4**
 O&M Grade: **0**
 Clock Start/From: **7**
 Clock To: **5**
 1st Value:
 2nd Value:
 Value Percent:
 Continuous Index: **S04**
 Within 8" of Joint: **YES**
 Remarks:

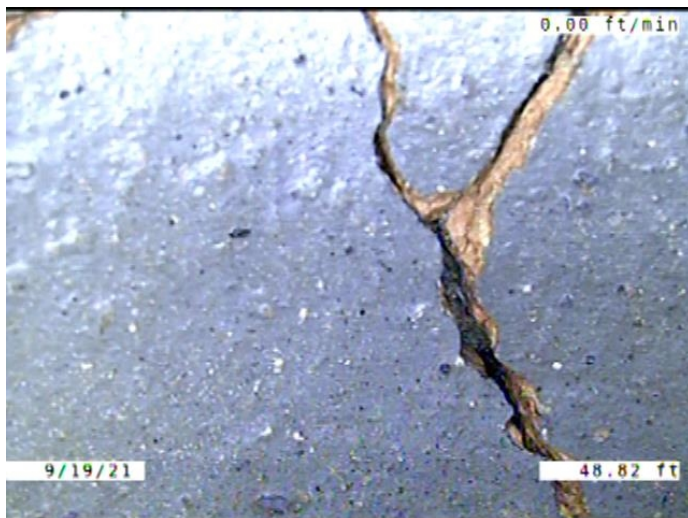
Code: **BSV**
 Description: **Broken Soil Visible**

Distance (ft): **48.8**
 Structural Grade: **5**
 O&M Grade: **0**
 Clock Start/From: **12**
 Clock To:
 1st Value:
 2nd Value:
 Value Percent:
 Continuous Index:
 Within 8" of Joint: **YES**
 Remarks:

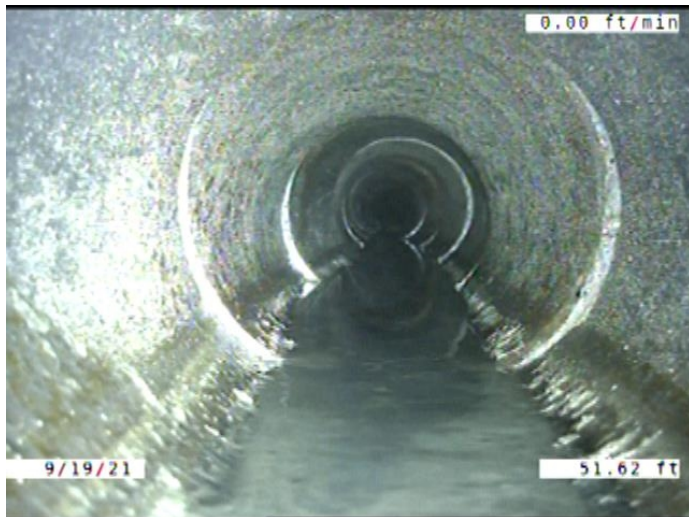
Code: **FM**
 Description: **Fracture Multiple**

Distance (ft): **51.6**
 Structural Grade: **4**
 O&M Grade: **0**
 Clock Start/From: **7**
 Clock To: **5**
 1st Value:
 2nd Value:
 Value Percent:
 Continuous Index: **F04**
 Within 8" of Joint: **YES**
 Remarks:

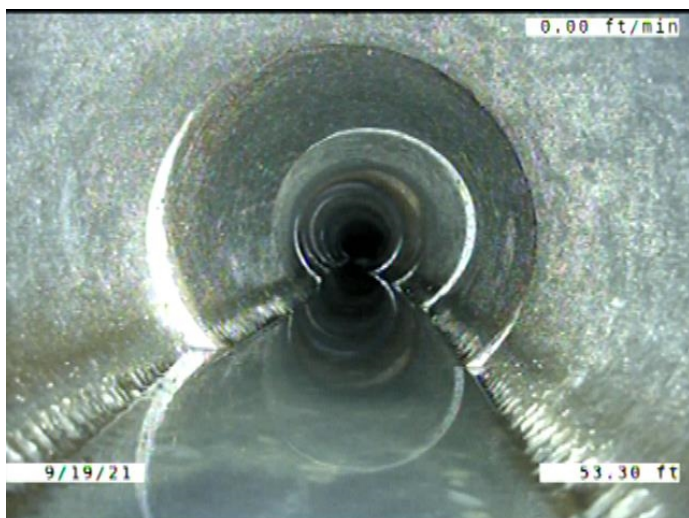
Code: **MWLS**
 Description: **Miscellaneous Water Level Sag**

Distance (ft): **53.3**
 Structural Grade: **2**
 O&M Grade: **0**
 Clock Start/From:
 Clock To:
 1st Value:
 2nd Value:
 Value Percent: **5.000**
 Continuous Index:
 Within 8" of Joint: **NO**
 Remarks:

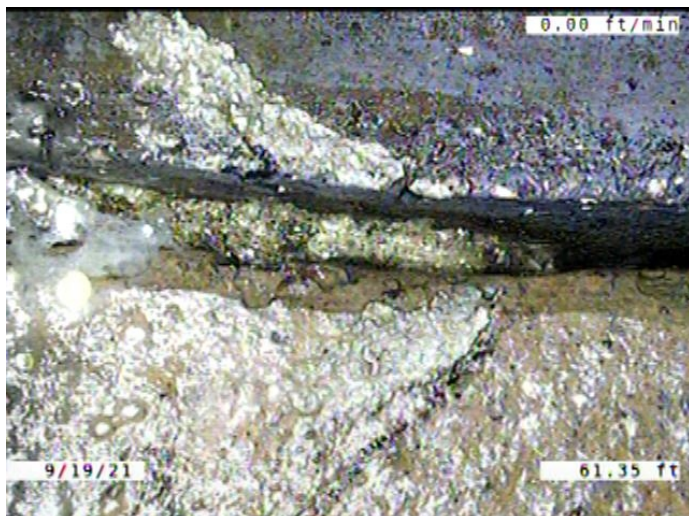
Code: **DAE**
 Description: **Deposits Attached Encrustation**

Distance (ft): **61.3**
 Structural Grade: **0**
 O&M Grade: **2**
 Clock Start/From: **4**
 Clock To:
 1st Value:
 2nd Value:
 Value Percent: **5.000**
 Continuous Index:
 Within 8" of Joint: **YES**
 Remarks:

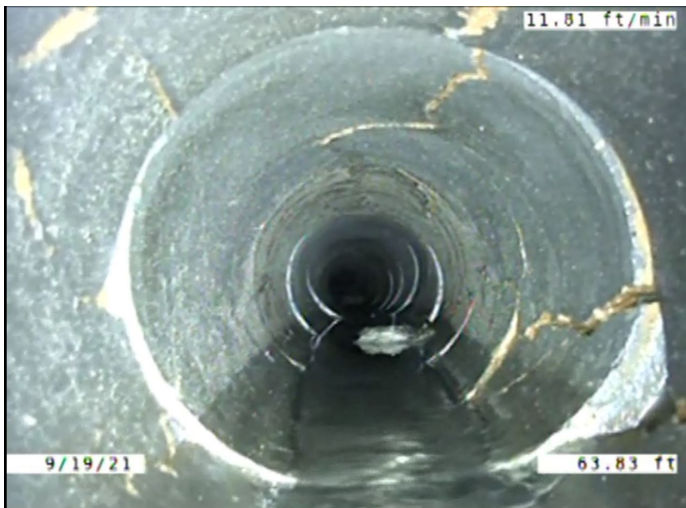
Code: **FM**
 Description: **Fracture Multiple**

Distance (ft): **63.8**
 Structural Grade: **4**
 O&M Grade: **0**
 Clock Start/From: **8**
 Clock To: **4**
 1st Value:
 2nd Value:
 Value Percent:
 Continuous Index: **S09**
 Within 8" of Joint: **NO**
 Remarks:

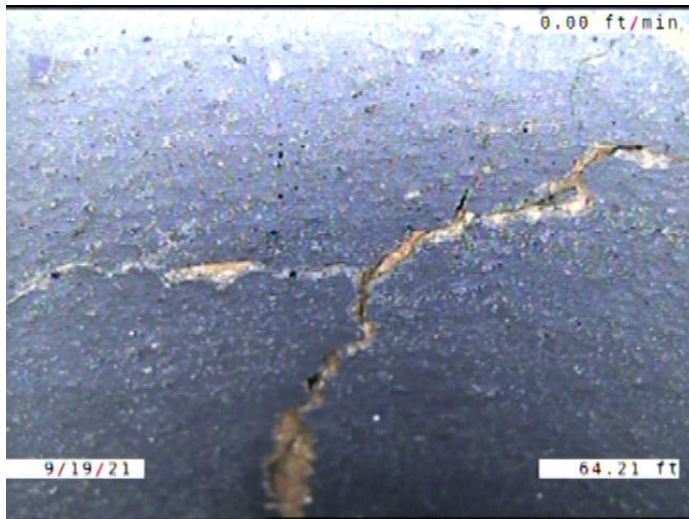
Code: **BVV**
 Description: **Broken Void Visible**

Distance (ft): **64.2**
 Structural Grade: **5**
 O&M Grade: **0**
 Clock Start/From: **3**
 Clock To: **5**
 1st Value:
 2nd Value:
 Value Percent:
 Continuous Index: **S05**
 Within 8" of Joint: **YES**
 Remarks: **SOIL VISIBLE TOO**

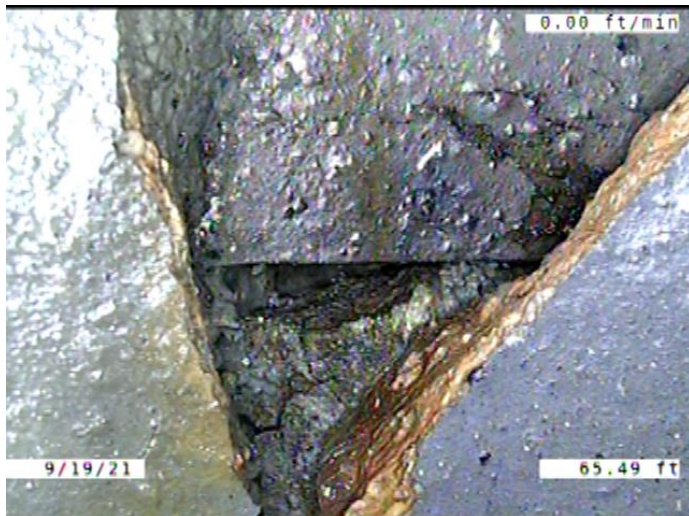
Code: **SMW**
 Description: **Surface Damage Missing Wall**

Distance (ft): **65.5**
 Structural Grade: **5**
 O&M Grade: **0**
 Clock Start/From: **2**
 Clock To: **4**
 1st Value:
 2nd Value:
 Value Percent:
 Continuous Index:
 Within 8" of Joint: **YES**
 Remarks:

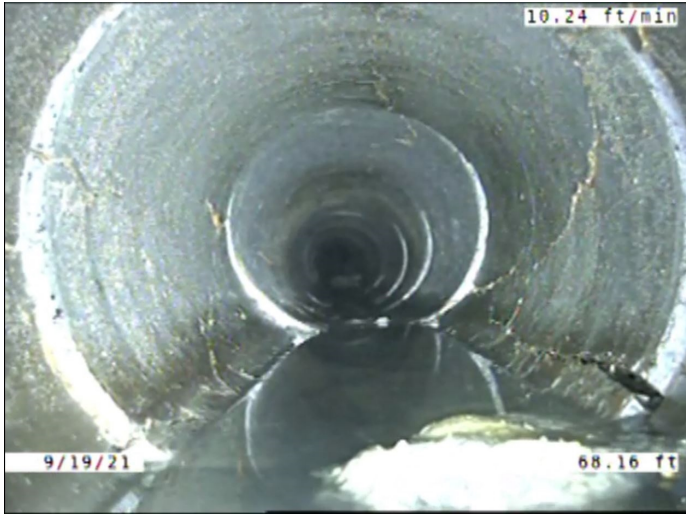
Code: **BVV**
Description: **Broken Void Visible**

Distance (ft): **68.2**
Structural Grade: **5**
O&M Grade: **0**
Clock Start/From: **3**
Clock To: **5**
1st Value:
2nd Value:
Value Percent:
Continuous Index: **F05**
Within 8" of Joint: **YES**
Remarks: **SOIL VISIBLE TOO**

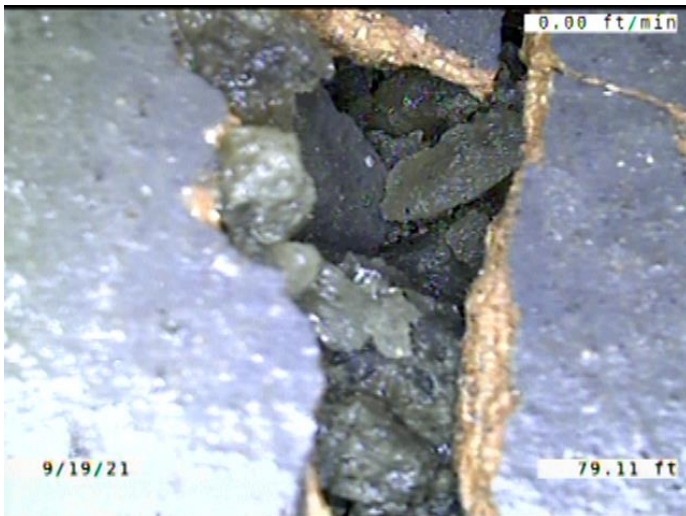
Code: **HSV**
Description: **Hole Soil Visible**

Distance (ft): **79.1**
Structural Grade: **5**
O&M Grade: **0**
Clock Start/From: **3**
Clock To: **4**
1st Value:
2nd Value:
Value Percent:
Continuous Index:
Within 8" of Joint: **NO**
Remarks:

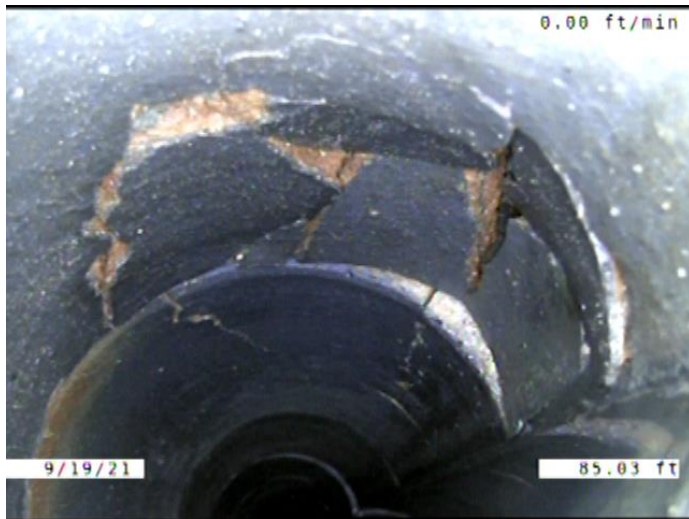
Code: **BVV**
Description: **Broken Void Visible**

Distance (ft): **85.0**
Structural Grade: **5**
O&M Grade: **0**
Clock Start/From: **2**
Clock To: **4**
1st Value:
2nd Value:
Value Percent:
Continuous Index:
Within 8" of Joint: **NO**
Remarks:

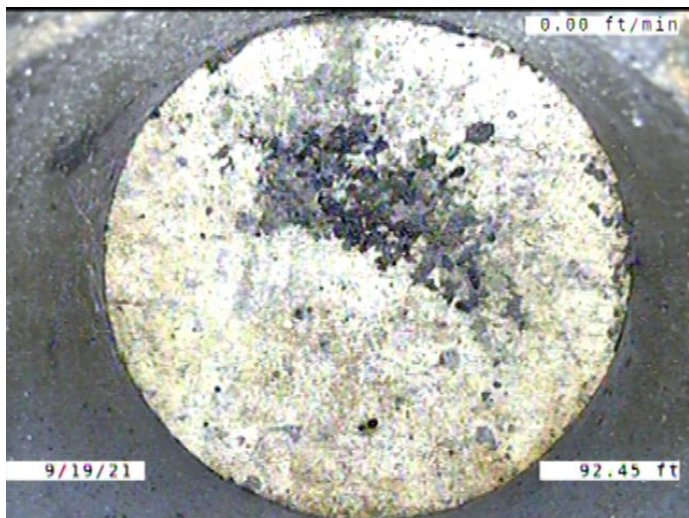
Code: **TFD**
Description: **Tap Factory Defective**

Distance (ft): **92.5**
Structural Grade: **0**
O&M Grade: **3**
Clock Start/From: **1**
Clock To:
1st Value: **4.000**
2nd Value:
Value Percent:
Continuous Index:
Within 8" of Joint: **YES**
Remarks: **CAPPED**

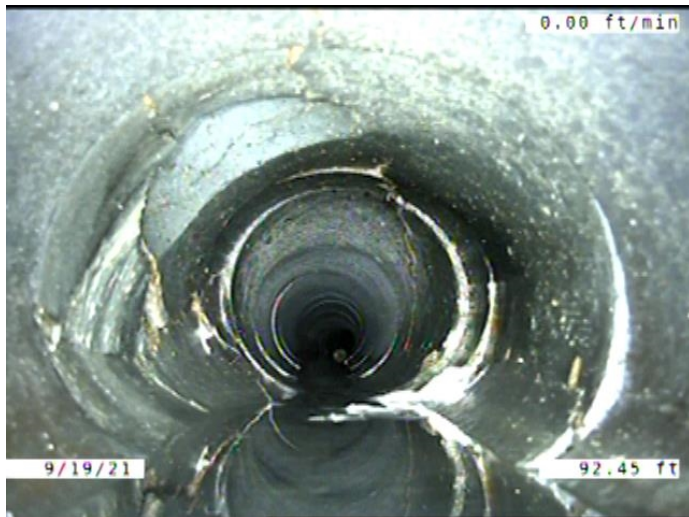
Code: **DR**
 Description: **Deformed Rigid**

Distance (ft): **92.5**
 Structural Grade: **4**
 O&M Grade: **0**
 Clock Start/From:
 Clock To:
 1st Value:
 2nd Value:
 Value Percent: **5.000**
 Continuous Index:
 Within 8" of Joint: **NO**
 Remarks:

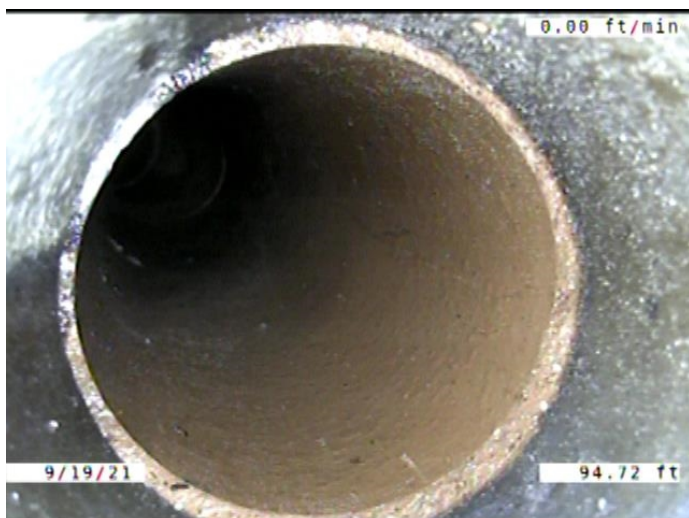
Code: **TFD**
 Description: **Tap Factory Defective**

Distance (ft): **94.7**
 Structural Grade: **0**
 O&M Grade: **3**
 Clock Start/From: **11**
 Clock To:
 1st Value: **4.000**
 2nd Value:
 Value Percent:
 Continuous Index:
 Within 8" of Joint: **YES**
 Remarks: **Defective**

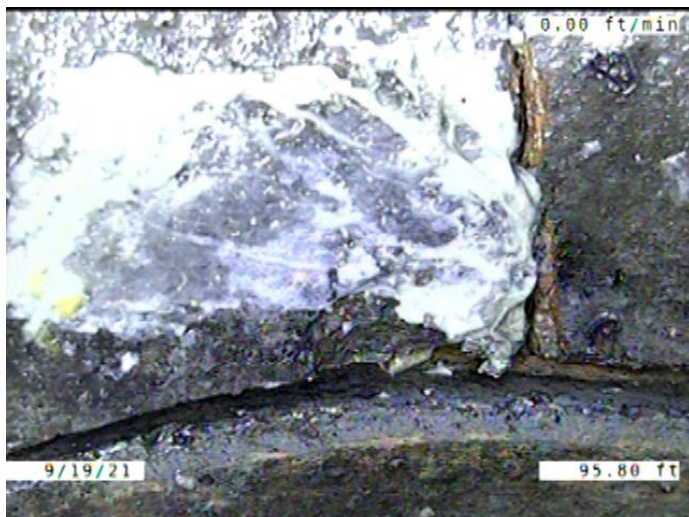
Code: **DAE**
 Description: **Deposits Attached Encrustation**

Distance (ft): **95.8**
 Structural Grade: **0**
 O&M Grade: **2**
 Clock Start/From: **9**
 Clock To: **10**
 1st Value:
 2nd Value:
 Value Percent: **5.000**
 Continuous Index:
 Within 8" of Joint: **YES**
 Remarks:

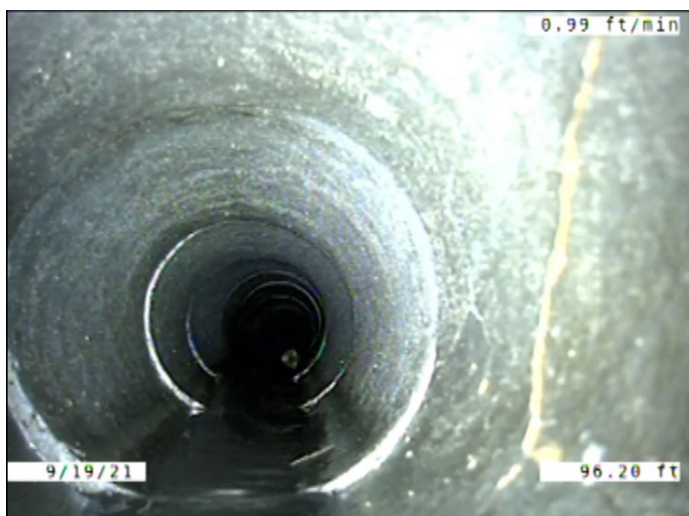
Code: **FM**
 Description: **Fracture Multiple**

Distance (ft): **96.2**
 Structural Grade: **4**
 O&M Grade: **0**
 Clock Start/From: **8**
 Clock To: **4**
 1st Value:
 2nd Value:
 Value Percent:
 Continuous Index: **F09**
 Within 8" of Joint: **NO**
 Remarks:

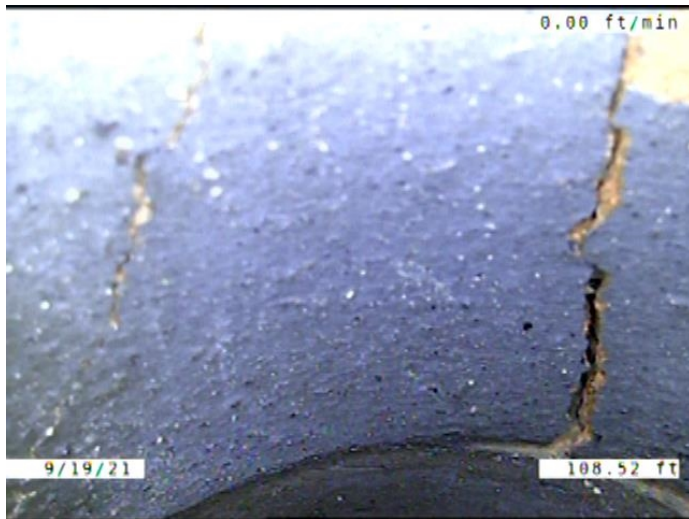
Code: **B**
 Description: **Broken**

Distance (ft): **108.5**
 Structural Grade: **4**
 O&M Grade: **0**
 Clock Start/From: **7**
 Clock To: **12**
 1st Value:
 2nd Value:
 Value Percent:
 Continuous Index:
 Within 8" of Joint: **YES**
 Remarks:

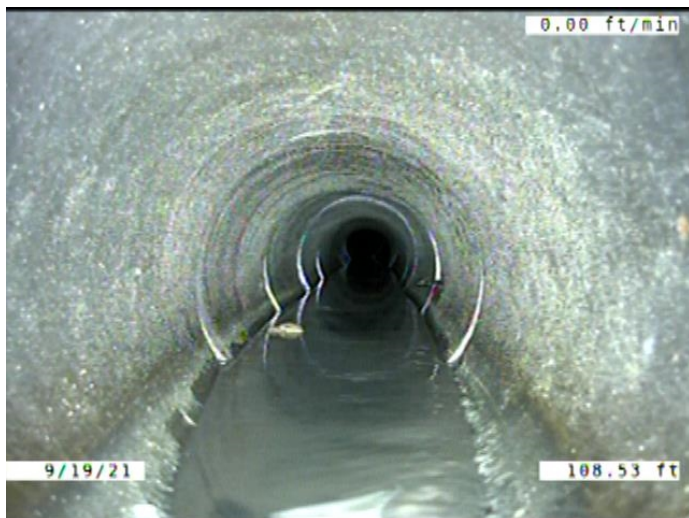
Code: **MWLS**
 Description: **Miscellaneous Water Level Sag**

Distance (ft): **108.5**
 Structural Grade: **2**
 O&M Grade: **0**
 Clock Start/From:
 Clock To:
 1st Value:
 2nd Value:
 Value Percent: **10.000**
 Continuous Index: **S06**
 Within 8" of Joint: **NO**
 Remarks:

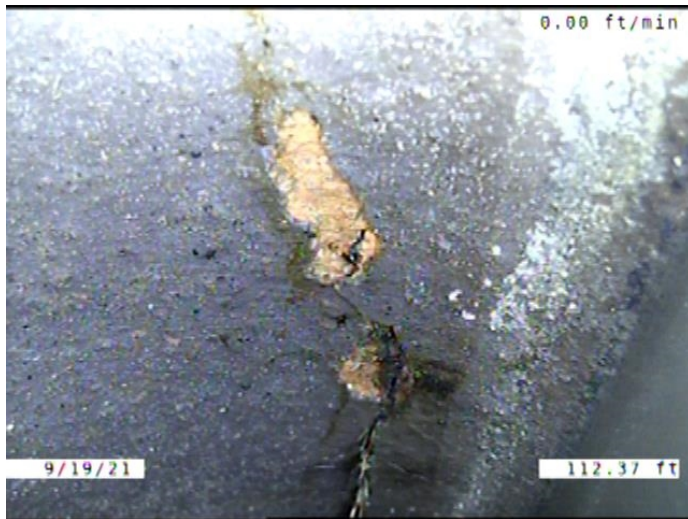
Code: **B**
Description: **Broken**

Distance (ft): **112.4**
Structural Grade: **4**
O&M Grade: **0**
Clock Start/From: **12**
Clock To: **3**
1st Value:
2nd Value:
Value Percent:
Continuous Index:
Within 8" of Joint: **YES**
Remarks:

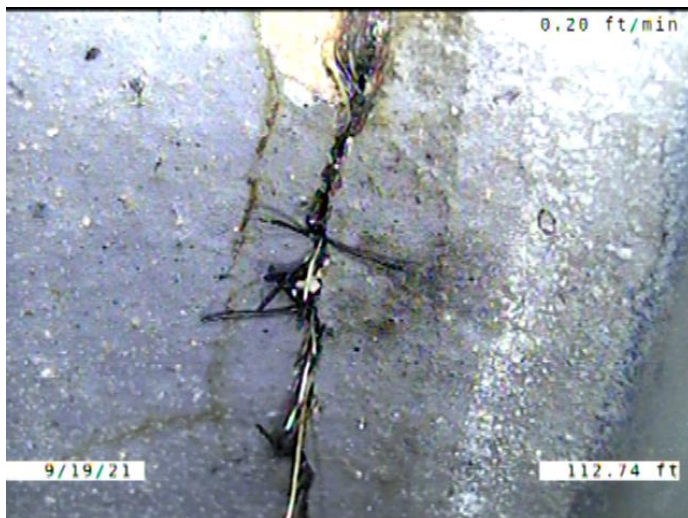
Code: **RFB**
Description: **Roots Fine Barrel**

Distance (ft): **112.7**
Structural Grade: **0**
O&M Grade: **2**
Clock Start/From: **3**
Clock To:
1st Value:
2nd Value:
Value Percent:
Continuous Index:
Within 8" of Joint: **NO**
Remarks:

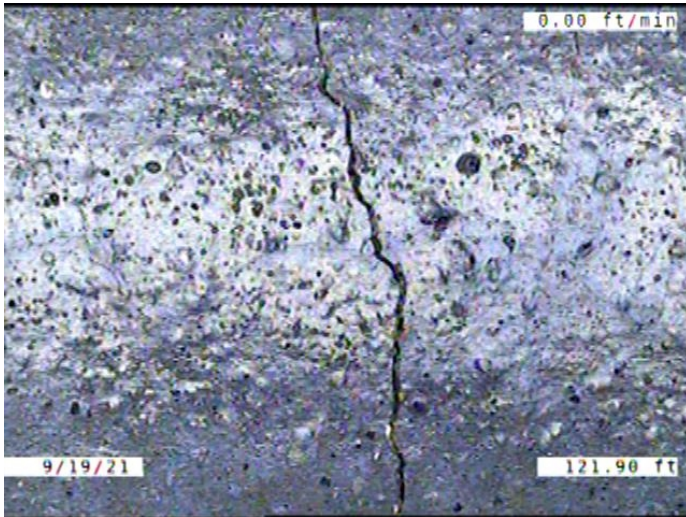
Code: **FM**
 Description: **Fracture Multiple**

Distance (ft): **121.9**
 Structural Grade: **4**
 O&M Grade: **0**
 Clock Start/From: **11**
 Clock To: **1**
 1st Value:
 2nd Value:
 Value Percent:
 Continuous Index: **S07**
 Within 8" of Joint: **YES**
 Remarks:

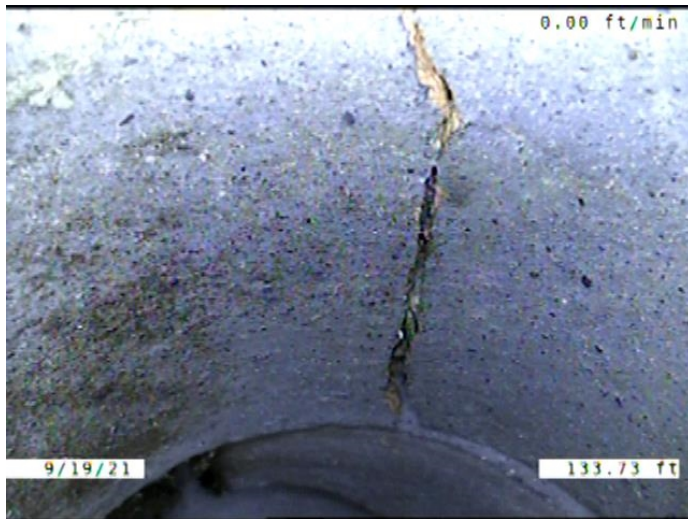
Code: **BSV**
 Description: **Broken Soil Visible**

Distance (ft): **133.7**
 Structural Grade: **5**
 O&M Grade: **0**
 Clock Start/From: **5**
 Clock To: **1**
 1st Value:
 2nd Value:
 Value Percent:
 Continuous Index: **S08**
 Within 8" of Joint: **YES**
 Remarks:

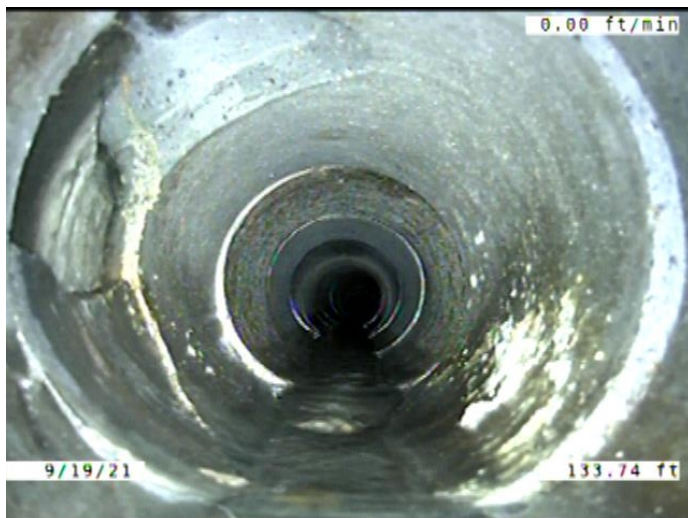
Code: **MWLS**
 Description: **Miscellaneous Water Level Sag**

Distance (ft): **133.7**
 Structural Grade: **2**
 O&M Grade: **0**
 Clock Start/From:
 Clock To:
 1st Value:
 2nd Value:
 Value Percent: **10.000**
 Continuous Index: **F06**
 Within 8" of Joint: **NO**
 Remarks:

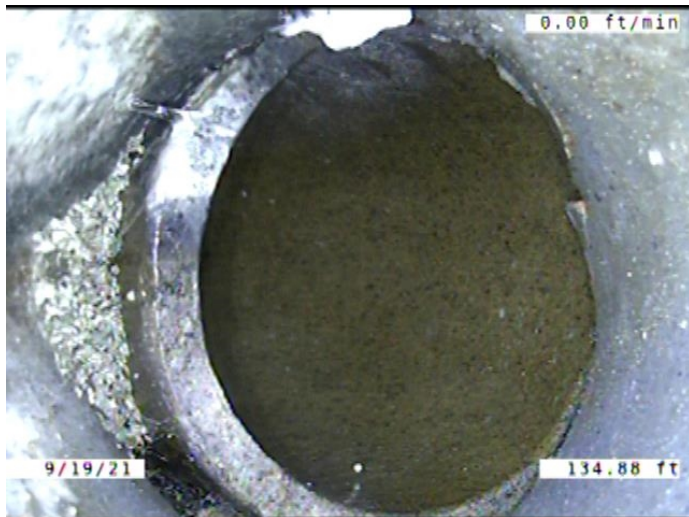
Code: **TFD**
 Description: **Tap Factory Defective**

Distance (ft): **134.9**
 Structural Grade: **0**
 O&M Grade: **3**
 Clock Start/From: **11**
 Clock To:
 1st Value: **4.000**
 2nd Value:
 Value Percent:
 Continuous Index:
 Within 8" of Joint: **YES**
 Remarks: **Defective**

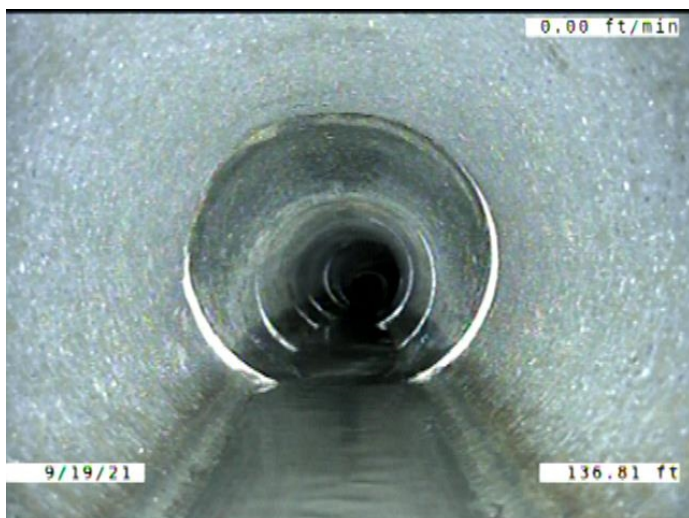
Code: **BSV**
 Description: **Broken Soil Visible**

Distance (ft): **136.8**
 Structural Grade: **5**
 O&M Grade: **0**
 Clock Start/From: **5**
 Clock To: **1**
 1st Value:
 2nd Value:
 Value Percent:
 Continuous Index: **F08**
 Within 8" of Joint: **YES**
 Remarks:

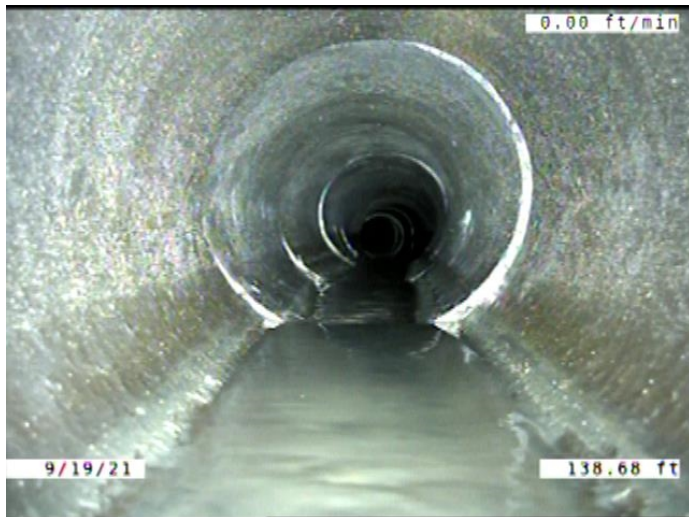
Code: **MWLS**
 Description: **Miscellaneous Water Level Sag**

Distance (ft): **138.7**
 Structural Grade: **2**
 O&M Grade: **0**
 Clock Start/From:
 Clock To:
 1st Value:
 2nd Value:
 Value Percent: **5.000**
 Continuous Index:
 Within 8" of Joint: **NO**
 Remarks:

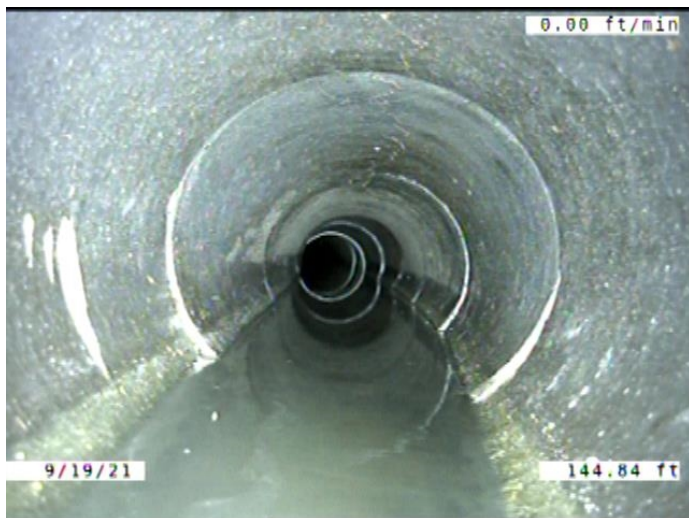
Code: **MWLS**
 Description: **Miscellaneous Water Level Sag**

Distance (ft): **144.8**
 Structural Grade: **2**
 O&M Grade: **0**
 Clock Start/From:
 Clock To:
 1st Value:
 2nd Value:
 Value Percent: **20.000**
 Continuous Index: **S09**
 Within 8" of Joint: **NO**
 Remarks:

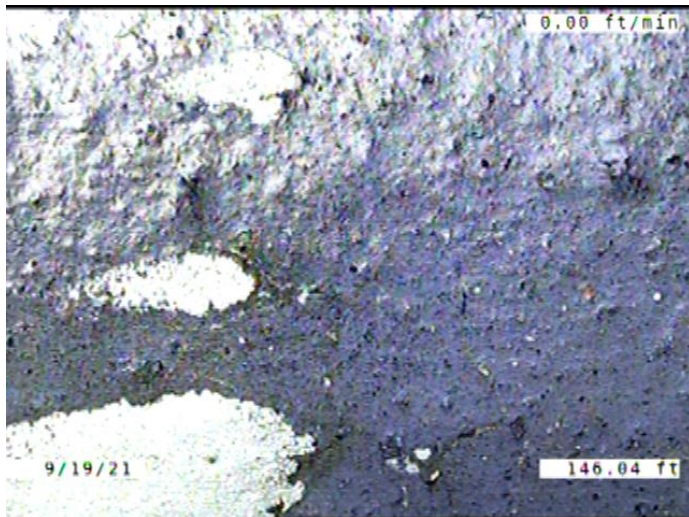
Code: **DAE**
 Description: **Deposits Attached Encrustation**

Distance (ft): **146.0**
 Structural Grade: **0**
 O&M Grade: **2**
 Clock Start/From: **8**
 Clock To: **9**
 1st Value:
 2nd Value:
 Value Percent: **5.000**
 Continuous Index:
 Within 8" of Joint: **NO**
 Remarks:

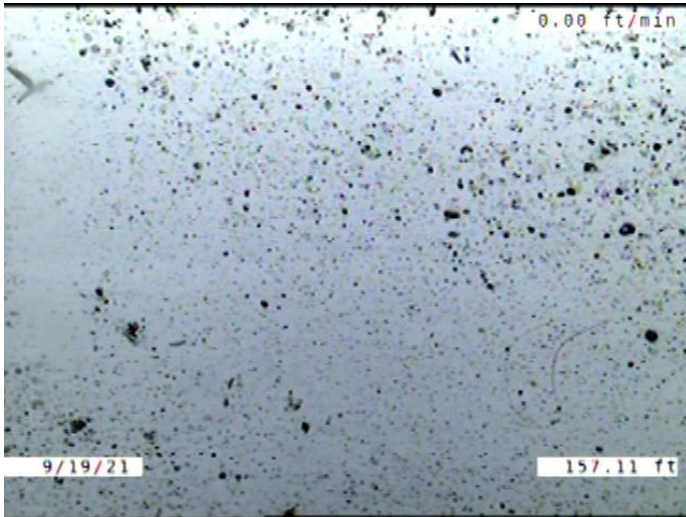
Code: **FM**
Description: **Fracture Multiple**

Distance (ft): **157.1**
Structural Grade: **4**
O&M Grade: **0**
Clock Start/From: **11**
Clock To: **1**
1st Value:
2nd Value:
Value Percent:
Continuous Index: **F07**
Within 8" of Joint: **YES**
Remarks:

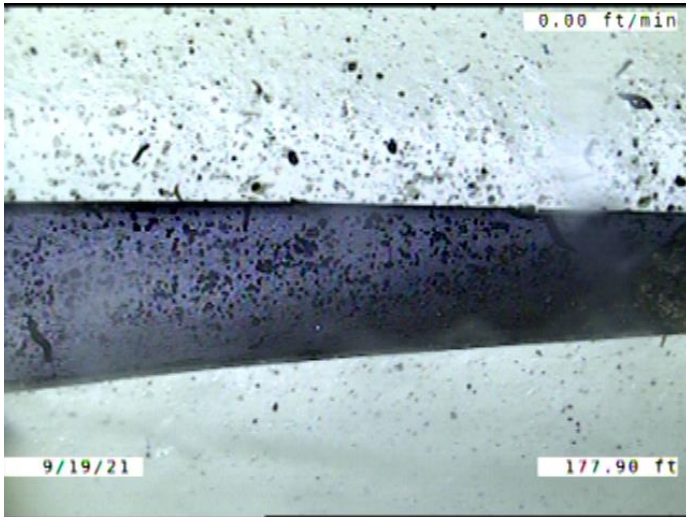
Code: **JAL**
Description: **Joint Angular Large**

Distance (ft): **177.9**
Structural Grade: **4**
O&M Grade: **0**
Clock Start/From:
Clock To:
1st Value:
2nd Value:
Value Percent:
Continuous Index:
Within 8" of Joint: **NO**
Remarks:

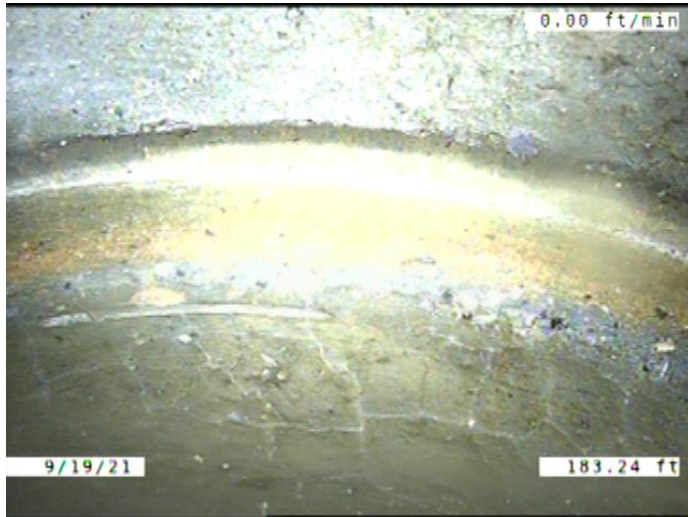
Code: **JOM**
Description: **Joint Offset Medium**

Distance (ft): **183.2**
Structural Grade: **3**
O&M Grade: **0**
Clock Start/From:
Clock To:
1st Value:
2nd Value:
Value Percent:
Continuous Index:
Within 8" of Joint: **NO**
Remarks:

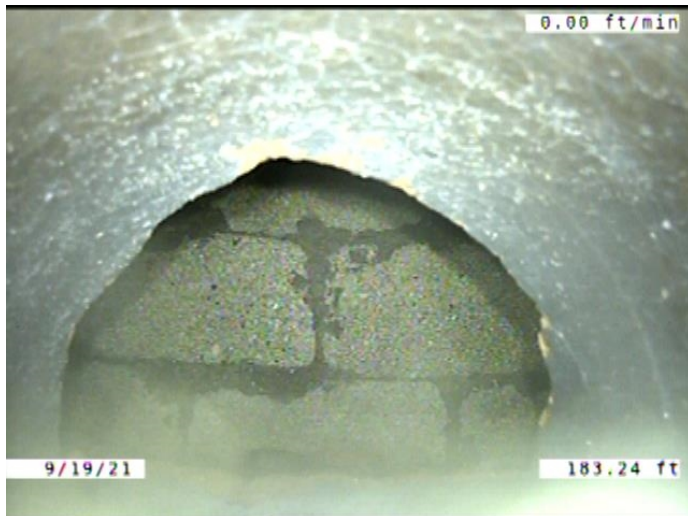
Code: **MWLS**
Description: **Miscellaneous Water Level Sag**

Distance (ft): **183.2**
Structural Grade: **2**
O&M Grade: **0**
Clock Start/From:
Clock To:
1st Value:
2nd Value:
Value Percent: **20.000**
Continuous Index: **F09**
Within 8" of Joint: **NO**
Remarks:

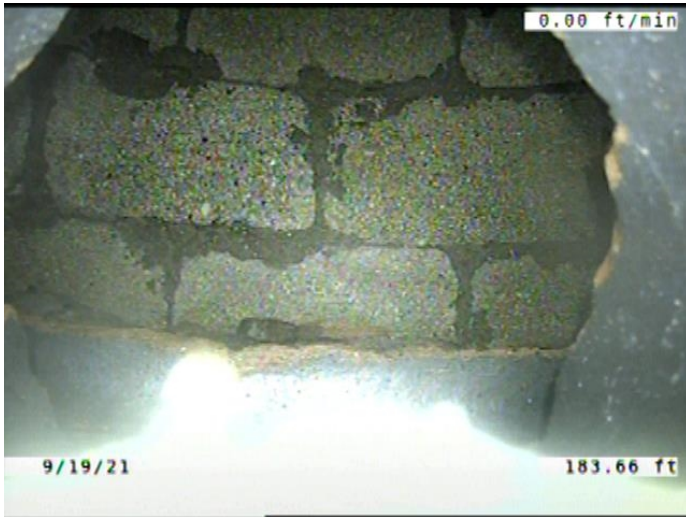
Code: **OBZ**
 Description: **Obstruction Other**

Distance (ft): **183.7**
 Structural Grade: **0**
 O&M Grade: **3**
 Clock Start/From: **4**
 Clock To: **8**
 1st Value:
 2nd Value:
 Value Percent: **15.000**
 Continuous Index:
 Within 8" of Joint: **YES**
 Remarks: **TP, RAGS, SEWER DEBRIS**
