## Profile/Photo Observation Report

Street:	<b>W 39TH PL</b>	Flow Control:	<b>Not Controlled</b>
City:	<b>Hobart, IN</b>	Year Renewed:	
Location:	<b>Other</b>	Tape/Media #:	
Purpose:	<b>Not Known</b>	Dia/Height:	<b>12"</b>
Use:	<b>Sanitary</b>	Material:	<b>PVC</b>
Drain Area:	<b>NA</b>	Lining:	
Category:	<b>NA</b>		
Comment:

Location Details:		Direction of Survey:	<b>Downstream</b>
US MH:	<b>M-503-009</b>	DS MH:	<b>M-503-016</b>
		Total Length Surveyed (ft):	<b>11.0</b>

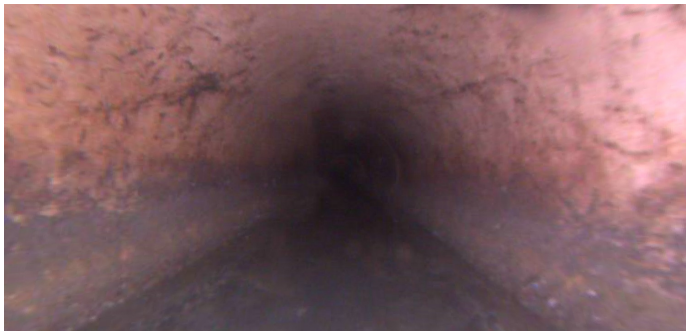
Code: **AMH**  
Description: **Manhole**

Distance (ft): **.0**  
Structural Grade: **0**  
O&M Grade: **0**  
Clock Start/From:  
Clock To:  
1st Value:  
2nd Value:  
Value Percent:  
Continuous Index:  
Within 8" of Joint: **NO**  
Remarks: **M-503-009**

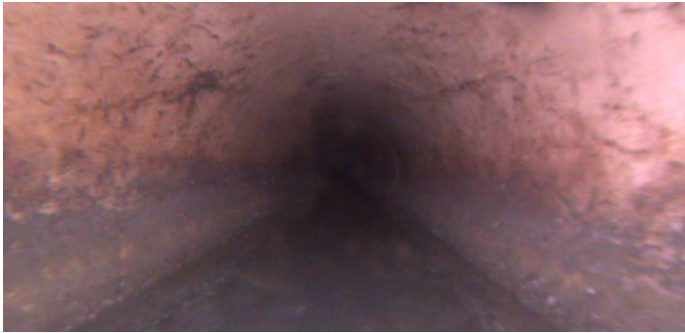
Code:	<b>MWL</b>
Description:	<b>Water Level</b>

Distance (ft):	<b>.0</b>
Structural Grade:	<b>0</b>
O&M Grade:	<b>0</b>
Clock Start/From:	
Clock To:	
1st Value:	
2nd Value:	
Value Percent:	<b>20.000</b>
Continuous Index:	
Within 8" of Joint:	<b>NO</b>
Remarks:

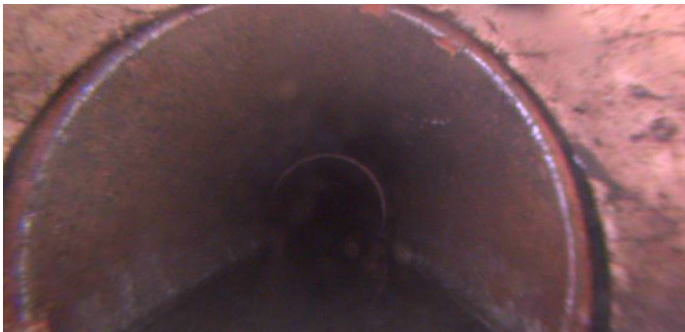
Code:	<b>MMC</b>
Description:	<b>Material Change</b>

Distance (ft):	<b>6.7</b>
Structural Grade:	<b>0</b>
O&M Grade:	<b>0</b>
Clock Start/From:	
Clock To:	
1st Value:	
2nd Value:	
Value Percent:	
Continuous Index:	
Within 8" of Joint:	<b>NO</b>
Remarks:	<b>VCP</b>

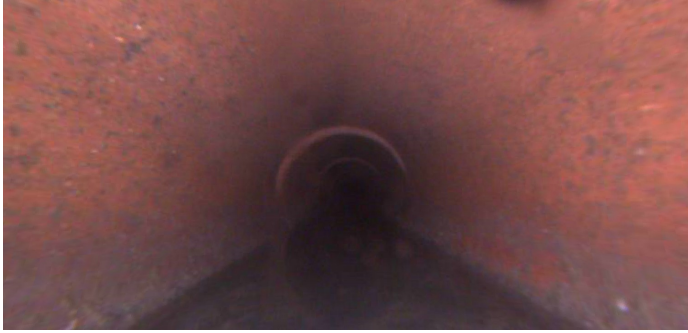
Code:	<b>MSA</b>
Description:	<b>Abandoned Survey</b>
Distance (ft):	<b>11.0</b>
Structural Grade:	<b>0</b>
O&M Grade:	<b>0</b>
Clock Start/From:	
Clock To:	
1st Value:	
2nd Value:	
Value Percent:	
Continuous Index:	
Within 8" of Joint:	<b>NO</b>
Remarks:	<b>DEBRIS UNDER WATER</b>
