Profile/Photo Observation Report

Date:	04/12/2018	Weather:		Coding:	PACP 6.0
Pipe Length (ft):	167.4	Owner:	NA	Pre Clean:	Not Known
P.O.#:		Surveyor:	Jen Costello	PSR:	P-503-016-009
Customer:		Clean Date:	01/01/1900	Shape:	C

Location Details:		Direction of Survey:	Downstream
US MH:	M-503-009	DS MH:	M-503-016
		Total Length Surveyed (ft):	11.0

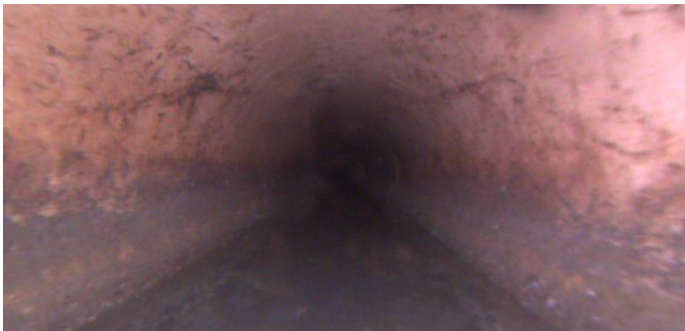
Code: **AMH**
Description: **Manhole**

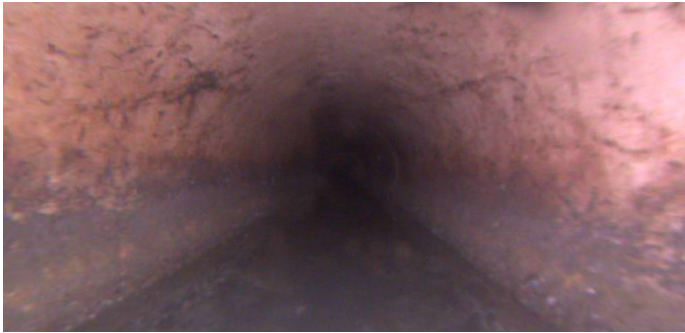
Code:	MWL
Description:	Water Level

Distance (ft):	.0
Structural Grade:	0
O&M Grade:	0
Clock Start/From:	
Clock To:	
1st Value:	
2nd Value:	
Value Percent:	20.000
Continuous Index:	
Within 8" of Joint:	NO
Remarks:

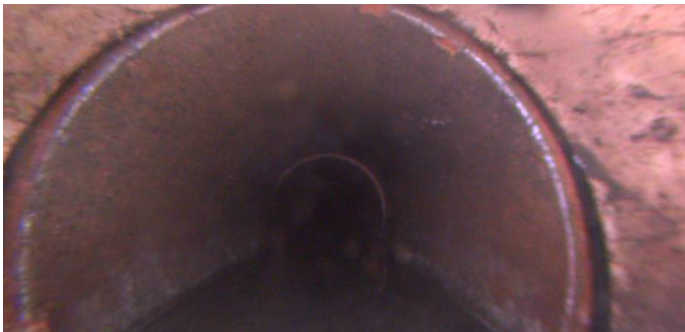
Code:	MMC
Description:	Material Change

Distance (ft):	6.7
Structural Grade:	0
O&M Grade:	0
Clock Start/From:	
Clock To:	
1st Value:	
2nd Value:	
Value Percent:	
Continuous Index:	
Within 8" of Joint:	NO
Remarks:	VCP

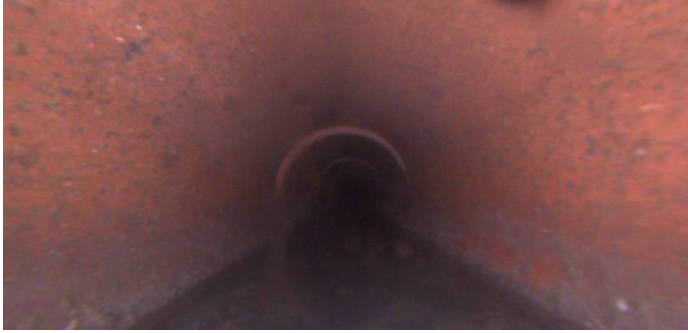
Code:	MSA
Description:	Abandoned Survey
Distance (ft):	11.0
Structural Grade:	0
O&M Grade:	0
Clock Start/From:	
Clock To:	
1st Value:	
2nd Value:	
Value Percent:	
Continuous Index:	
Within 8" of Joint:	NO
Remarks:	DEBRIS UNDER WATER
