Profile/Photo Observation Report

Street:	W 39TH PL	Flow Control:	Not Controlled
City:	Hobart, IN	Year Renewed:	
Location:	Other	Tape/Media #:	
Purpose:	Not Known	Dia/Height:	12"
Use:	Sanitary	Material:	VCP
Drain Area:	NA	Lining:	
Category:	NA		
Comment:

Location Details:		Direction of Survey:	Upstream
US MH:	M-503-009	DS MH:	M-503-016
		Total Length Surveyed (ft):	124.7

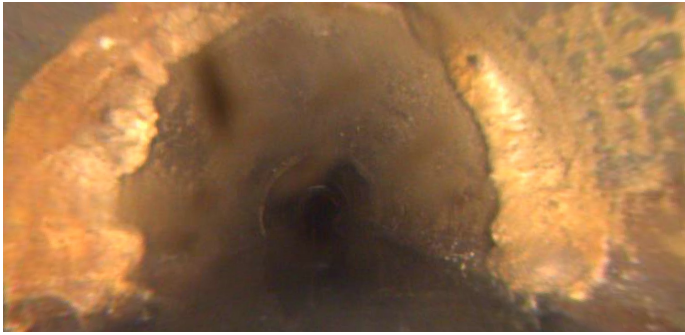
Code: **DAE**
Description: **Deposits Attached Encrustation**

Distance (ft): **5.5**
Structural Grade: **0**
O&M Grade: **2**
Clock Start/From: **8**
Clock To: **4**
1st Value:
2nd Value:
Value Percent: **10.000**
Continuous Index:
Within 8" of Joint: **YES**
Remarks:

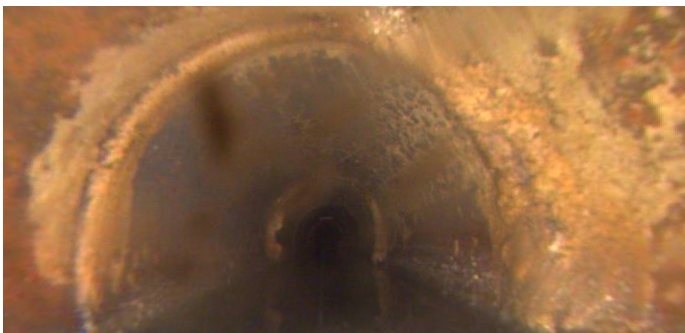
Code: **DAE**
Description: **Deposits Attached Encrustation**

Distance (ft): **7.5**
Structural Grade: **0**
O&M Grade: **2**
Clock Start/From: **8**
Clock To: **4**
1st Value:
2nd Value:
Value Percent: **5.000**
Continuous Index:
Within 8" of Joint: **YES**
Remarks:

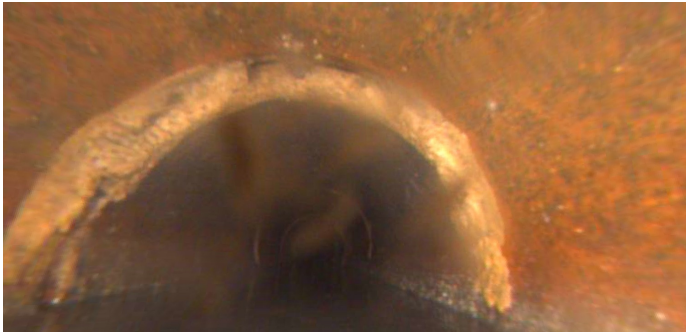
Code: **DAE**
Description: **Deposits Attached Encrustation**

Distance (ft): **11.6**
Structural Grade: **0**
O&M Grade: **2**
Clock Start/From: **8**
Clock To: **4**
1st Value:
2nd Value:
Value Percent: **5.000**
Continuous Index:
Within 8" of Joint: **YES**
Remarks:

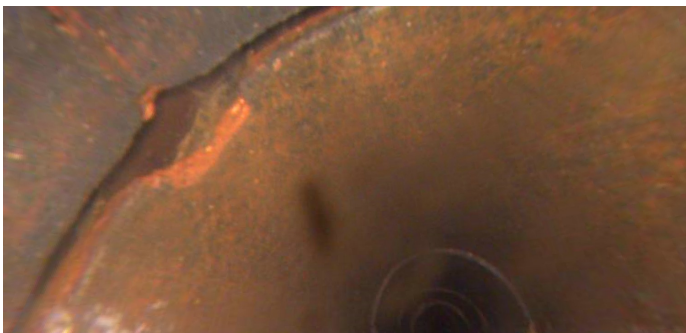
Code: **SSS**
Description: **Surface Spalling**

Distance (ft): **17.0**
Structural Grade: **2**
O&M Grade: **0**
Clock Start/From: **1**
Clock To: **2**
1st Value:
2nd Value:
Value Percent:
Continuous Index:
Within 8" of Joint: **YES**
Remarks:

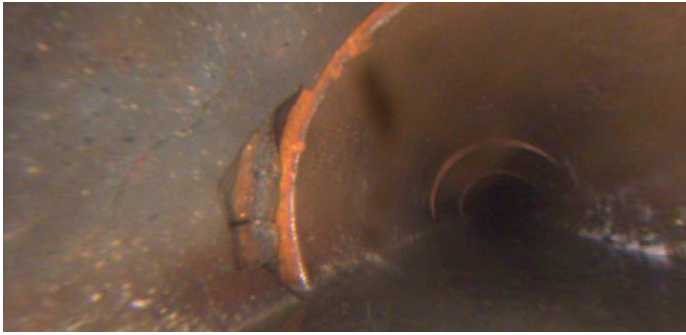
Code: **BVV**
Description: **Broken Void Visible**

Distance (ft): **45.7**
Structural Grade: **5**
O&M Grade: **0**
Clock Start/From: **2**
Clock To: **4**
1st Value:
2nd Value:
Value Percent:
Continuous Index:
Within 8" of Joint: **YES**
Remarks:

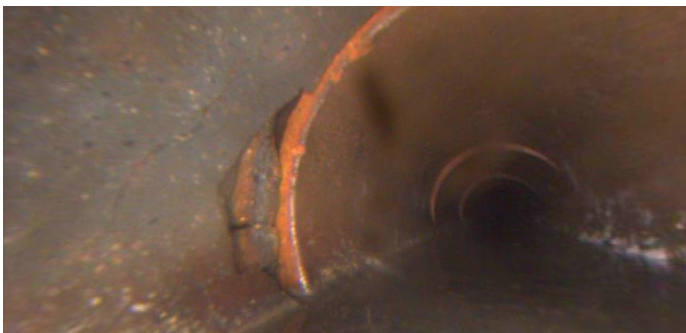
Code: **SSS**
Description: **Surface Spalling**

Distance (ft): **45.7**
Structural Grade: **2**
O&M Grade: **0**
Clock Start/From: **2**
Clock To: **4**
1st Value:
2nd Value:
Value Percent:
Continuous Index:
Within 8" of Joint: **YES**
Remarks:

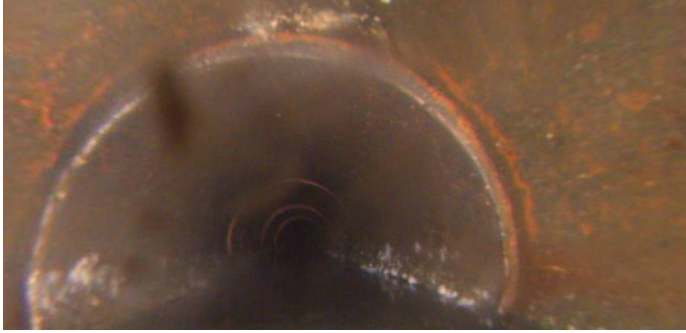
Code: **CM**
Description: **Crack Multiple**

Distance (ft): **47.8**
Structural Grade: **3**
O&M Grade: **0**
Clock Start/From: **8**
Clock To: **4**
1st Value:
2nd Value:
Value Percent:
Continuous Index:
Within 8" of Joint: **YES**
Remarks:

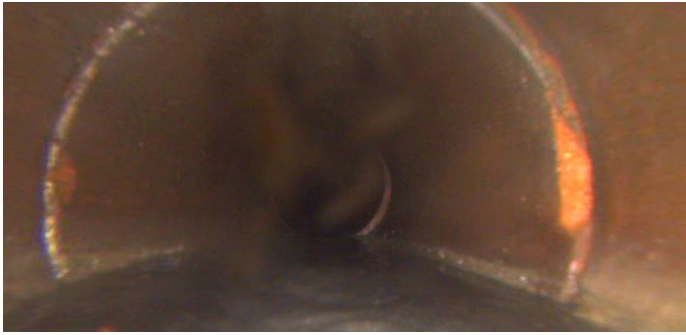
Code: **SSS**
Description: **Surface Spalling**

Distance (ft): **73.9**
Structural Grade: **2**
O&M Grade: **0**
Clock Start/From: **8**
Clock To: **4**
1st Value:
2nd Value:
Value Percent:
Continuous Index:
Within 8" of Joint: **YES**
Remarks:

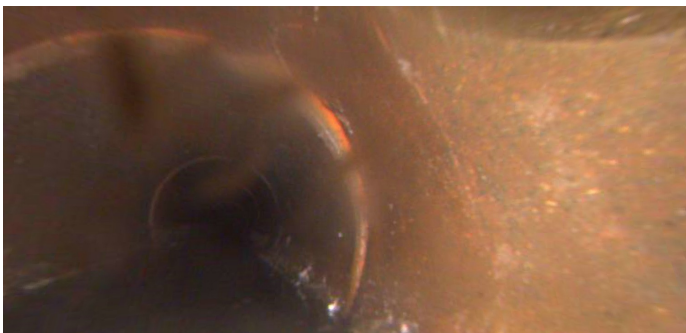
Code: **FM**
Description: **Fracture Multiple**

Distance (ft): **84.2**
Structural Grade: **4**
O&M Grade: **0**
Clock Start/From: **8**
Clock To: **12**
1st Value:
2nd Value:
Value Percent:
Continuous Index:
Within 8" of Joint: **YES**
Remarks:

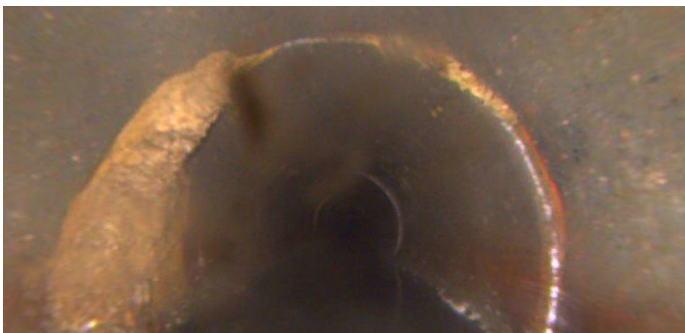
Code: **DAE**
Description: **Deposits Attached Encrustation**

Distance (ft): **114.2**
Structural Grade: **0**
O&M Grade: **2**
Clock Start/From: **1**
Clock To: **4**
1st Value:
2nd Value:
Value Percent: **5.000**
Continuous Index:
Within 8" of Joint: **YES**
Remarks:

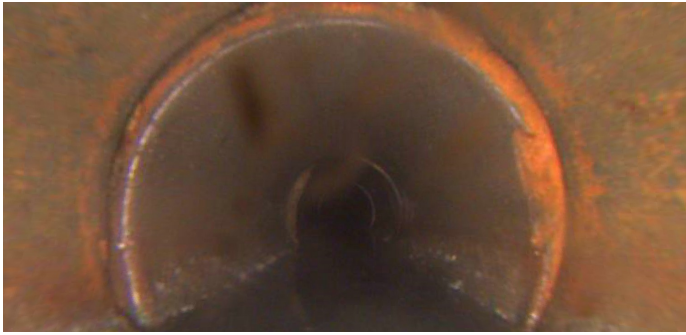
Code: **SSS**
Description: **Surface Spalling**

Distance (ft): **116.2**
Structural Grade: **2**
O&M Grade: **0**
Clock Start/From: **9**
Clock To:
1st Value:
2nd Value:
Value Percent:
Continuous Index:
Within 8" of Joint: **YES**
Remarks:

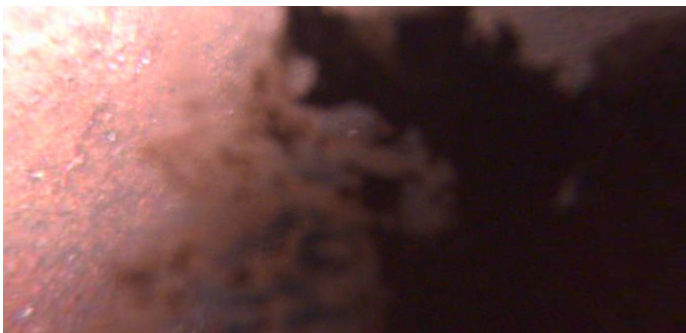
Code: **MSA**
Description: **Abandoned Survey**

Distance (ft): **124.7**
Structural Grade: **0**
O&M Grade: **0**
Clock Start/From:
Clock To:
1st Value:
2nd Value:
Value Percent:
Continuous Index:
Within 8" of Joint: **NO**
Remarks: **debris under water**
