## Profile/Photo Observation Report

Date:	<b>04/12/2018</b>	Weather:		Coding:	<b>PACP 6.0</b>
Pipe Length (ft):	<b>167.4</b>	Owner:	<b>NA</b>	Pre Clean:	<b>Not Known</b>
P.O.#:		Surveyor:	<b>Jen Costello</b>	PSR:	<b>P-503-016-009</b>
Customer:		Clean Date:	<b>01/01/1900</b>	Shape:	<b>C</b>

Street:	<b>W 40th ave</b>	Flow Control:	<b>Not Controlled</b>
City:	<b>Hobart, IN</b>	Year Renewed:	
Location:	<b>Other</b>	Tape/Media #:	
Purpose:	<b>Not Known</b>	Dia/Height:	<b>12"</b>
Use:	<b>Sanitary</b>	Material:	<b>VCP</b>
Drain Area:	<b>NA</b>	Lining:	
Category:	<b>NA</b>		
Comment:

Location Details:		Direction of Survey:	<b>Upstream</b>
US MH:	<b>M-503-009</b>	DS MH:	<b>M-503-016</b>
		Total Length Surveyed (ft):	<b>124.7</b>

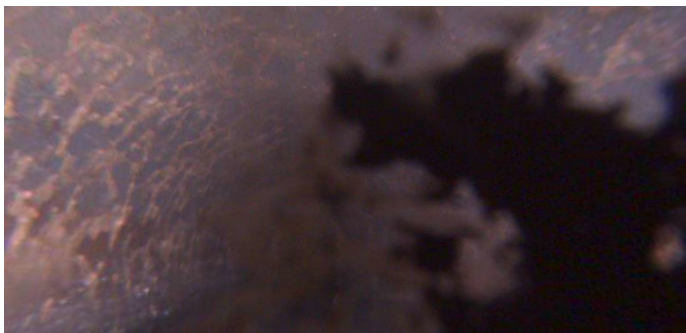
Code: **AMH**  
Description: **Manhole**

Distance (ft): **.0**  
Structural Grade: **0**  
O&M Grade: **0**  
Clock Start/From:  
Clock To:  
1st Value:  
2nd Value:  
Value Percent:  
Continuous Index:  
Within 8" of Joint: **NO**  
Remarks: **M-503-009**

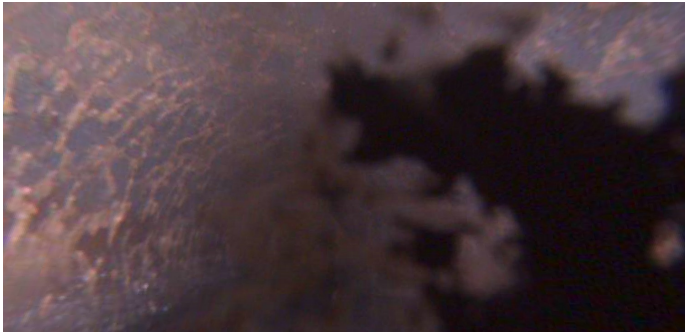
Code:	<b>MWL</b>
Description:	<b>Water Level</b>

Distance (ft):	<b>.0</b>
Structural Grade:	<b>0</b>
O&M Grade:	<b>0</b>
Clock Start/From:	
Clock To:	
1st Value:	
2nd Value:	
Value Percent:	<b>20.000</b>
Continuous Index:	
Within 8" of Joint:	<b>NO</b>
Remarks:

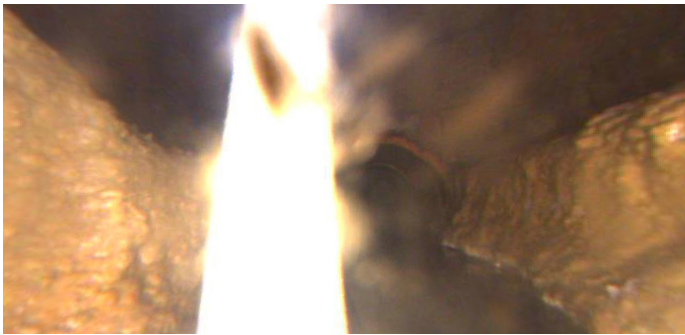
Code:	<b>MGO</b>
Description:	<b>General Observation</b>

Distance (ft):	<b>.0</b>
Structural Grade:	<b>0</b>
O&M Grade:	<b>0</b>
Clock Start/From:	
Clock To:	
1st Value:	
2nd Value:	
Value Percent:	
Continuous Index:	
Within 8" of Joint:	<b>NO</b>
Remarks:	<b>rear camera</b>

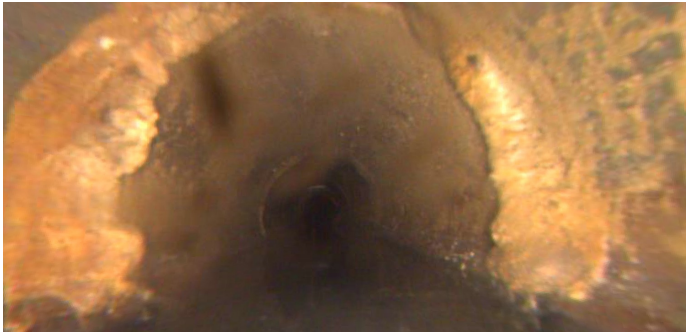
Code: **DAE**  
Description: **Deposits Attached Encrustation**

Distance (ft): **5.5**  
Structural Grade: **0**  
O&M Grade: **2**  
Clock Start/From: **8**  
Clock To: **4**  
1st Value:  
2nd Value:  
Value Percent: **10.000**  
Continuous Index:  
Within 8" of Joint: **YES**  
Remarks:

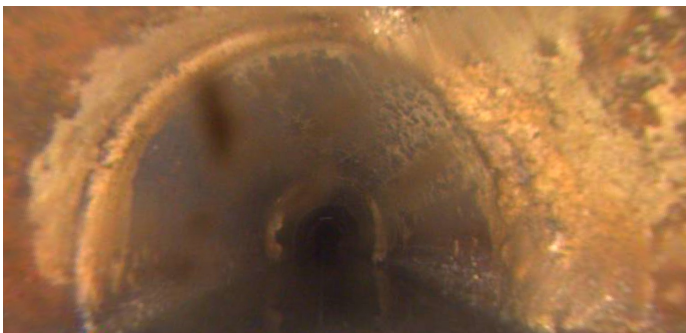
Code: **DAE**  
Description: **Deposits Attached Encrustation**

Distance (ft): **7.5**  
Structural Grade: **0**  
O&M Grade: **2**  
Clock Start/From: **8**  
Clock To: **4**  
1st Value:  
2nd Value:  
Value Percent: **5.000**  
Continuous Index:  
Within 8" of Joint: **YES**  
Remarks:

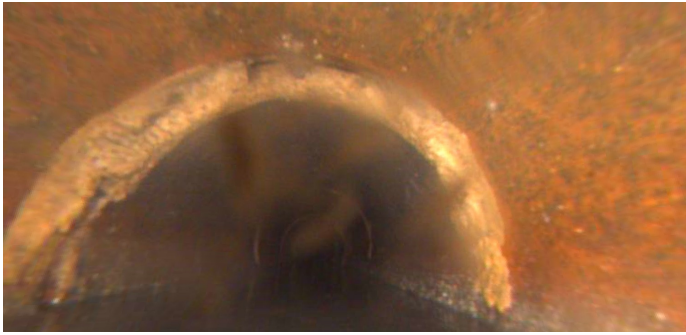
Code: **DAE**  
Description: **Deposits Attached Encrustation**

Distance (ft): **11.6**  
Structural Grade: **0**  
O&M Grade: **2**  
Clock Start/From: **8**  
Clock To: **4**  
1st Value:  
2nd Value:  
Value Percent: **5.000**  
Continuous Index:  
Within 8" of Joint: **YES**  
Remarks:

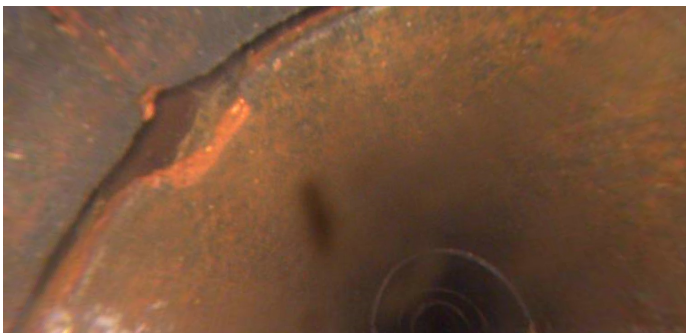
Code: **SSS**  
Description: **Surface Spalling**

Distance (ft): **17.0**  
Structural Grade: **2**  
O&M Grade: **0**  
Clock Start/From: **1**  
Clock To: **2**  
1st Value:  
2nd Value:  
Value Percent:  
Continuous Index:  
Within 8" of Joint: **YES**  
Remarks:

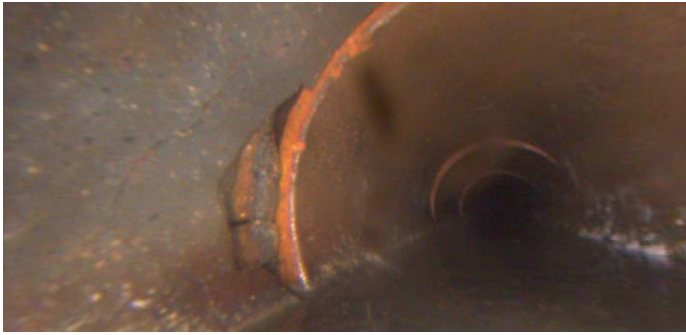
Code: **BVV**  
Description: **Broken Void Visible**

Distance (ft): **45.7**  
Structural Grade: **5**  
O&M Grade: **0**  
Clock Start/From: **2**  
Clock To: **4**  
1st Value:  
2nd Value:  
Value Percent:  
Continuous Index:  
Within 8" of Joint: **YES**  
Remarks:

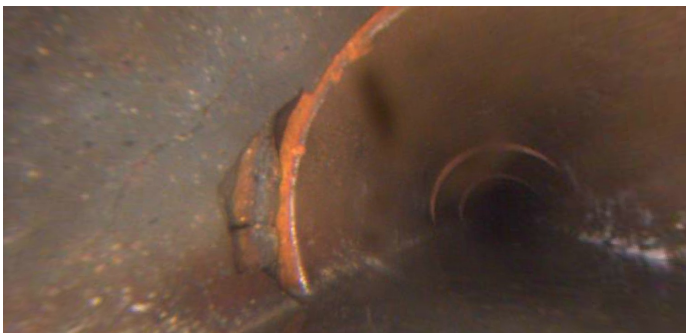
Code: **SSS**  
Description: **Surface Spalling**

Distance (ft): **45.7**  
Structural Grade: **2**  
O&M Grade: **0**  
Clock Start/From: **2**  
Clock To: **4**  
1st Value:  
2nd Value:  
Value Percent:  
Continuous Index:  
Within 8" of Joint: **YES**  
Remarks:

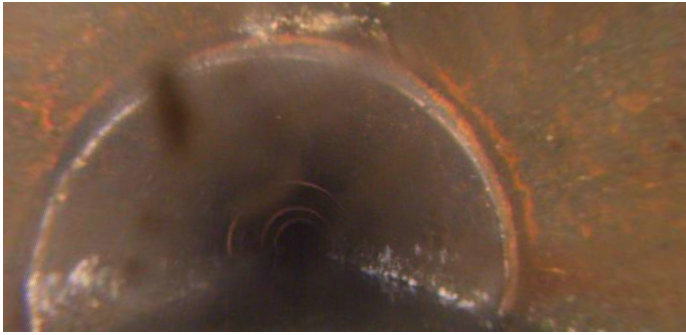
Code: **CM**  
Description: **Crack Multiple**

Distance (ft): **47.8**  
Structural Grade: **3**  
O&M Grade: **0**  
Clock Start/From: **8**  
Clock To: **4**  
1st Value:  
2nd Value:  
Value Percent:  
Continuous Index:  
Within 8" of Joint: **YES**  
Remarks:

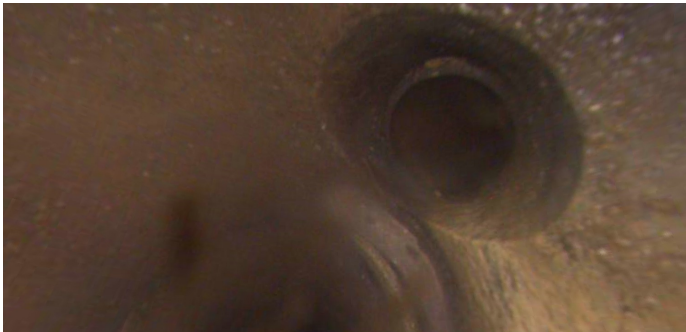
Code: **TF**  
Description: **Tap Factory**

Distance (ft): **62.6**  
Structural Grade: **0**  
O&M Grade: **0**  
Clock Start/From: **10**  
Clock To:  
1st Value: **4.000**  
2nd Value:  
Value Percent:  
Continuous Index:  
Within 8" of Joint:  
Remarks:

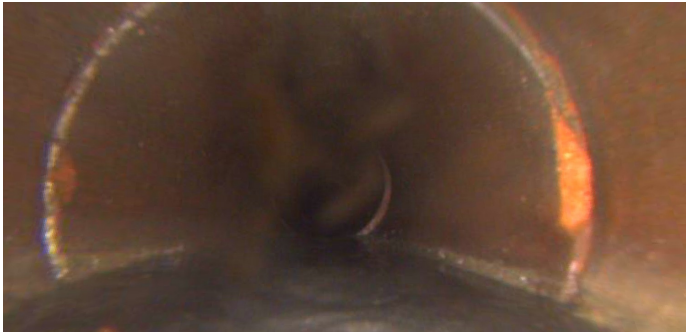
Code: **SSS**  
Description: **Surface Spalling**

Distance (ft): **73.9**  
Structural Grade: **2**  
O&M Grade: **0**  
Clock Start/From: **8**  
Clock To: **4**  
1st Value:  
2nd Value:  
Value Percent:  
Continuous Index:  
Within 8" of Joint: **YES**  
Remarks:

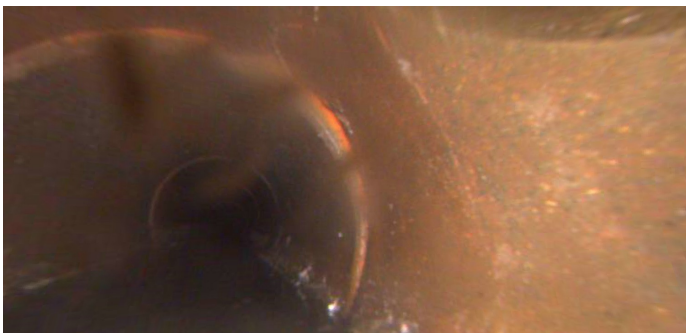
Code: **FM**  
Description: **Fracture Multiple**

Distance (ft): **84.2**  
Structural Grade: **4**  
O&M Grade: **0**  
Clock Start/From: **8**  
Clock To: **12**  
1st Value:  
2nd Value:  
Value Percent:  
Continuous Index:  
Within 8" of Joint: **YES**  
Remarks:

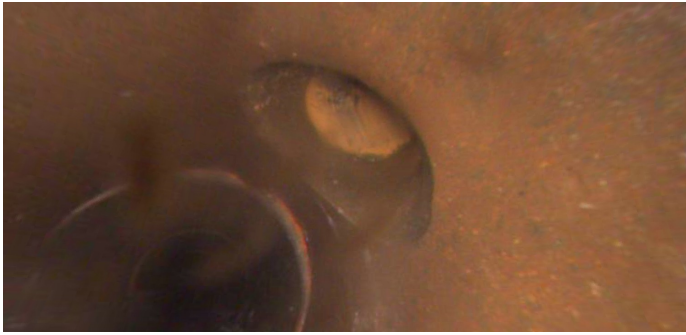
Code: **TFC**  
Description: **Tap Factory Capped**

Distance (ft): **84.9**  
Structural Grade: **0**  
O&M Grade: **0**  
Clock Start/From: **10**  
Clock To:  
1st Value: **4.000**  
2nd Value:  
Value Percent:  
Continuous Index:  
Within 8" of Joint:  
Remarks:

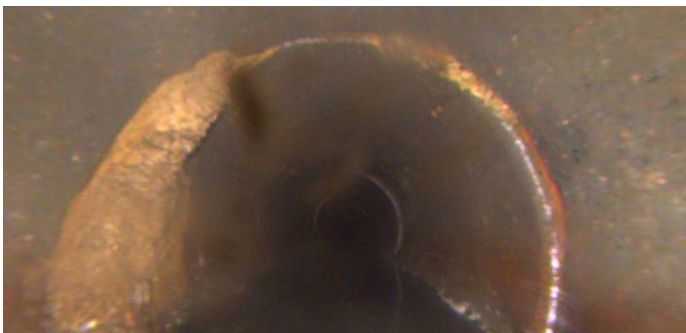
Code: **DAE**  
Description: **Deposits Attached Encrustation**

Distance (ft): **114.2**  
Structural Grade: **0**  
O&M Grade: **2**  
Clock Start/From: **1**  
Clock To: **4**  
1st Value:  
2nd Value:  
Value Percent: **5.000**  
Continuous Index:  
Within 8" of Joint: **YES**  
Remarks:

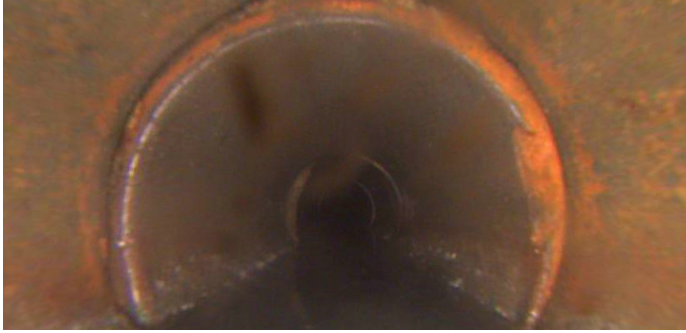
Code: **SSS**  
Description: **Surface Spalling**

Distance (ft): **116.2**  
Structural Grade: **2**  
O&M Grade: **0**  
Clock Start/From: **9**  
Clock To:  
1st Value:  
2nd Value:  
Value Percent:  
Continuous Index:  
Within 8" of Joint: **YES**  
Remarks:

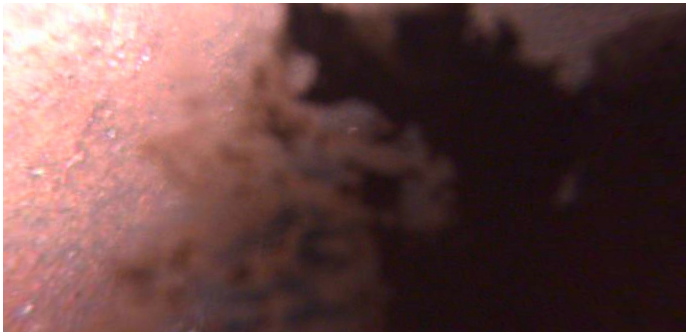
Code: **MSA**  
Description: **Abandoned Survey**

Distance (ft): **124.7**  
Structural Grade: **0**  
O&M Grade: **0**  
Clock Start/From:  
Clock To:  
1st Value:  
2nd Value:  
Value Percent:  
Continuous Index:  
Within 8" of Joint: **NO**  
Remarks: **debris under water**
