Profile/Photo Observation Report

Date:	10/19/2021	Weather:		Coding:	PACP 7.0
Pipe Length (ft):	167.1	Owner:	City of Hobart	Pre Clean:	Heavy Cleaning
P.O.#:	YES502259	Surveyor:	S. Bucklin	PSR:	P-503-016-009
Customer:	City of Hobart	Clean Date:	09/06/2021	Shape:	C

Street:	West 39th Place	Flow Control:	Not Controlled
City:	Hobart, IN	Year Renewed:	
Location:	Alley	Tape/Media #:	
Purpose:	Routine Assessment	Dia/Height:	12"
Use:	Sanitary Sewage Pipe	Material:	VCP
Drain Area:		Lining:	
Category:	NA		
Comment:			
Location Details:		Direction of Survey:	Downstream
US MH:	M-503-009	DS MH:	M-503-016
		Total Length Surveyed (ft):	167.1

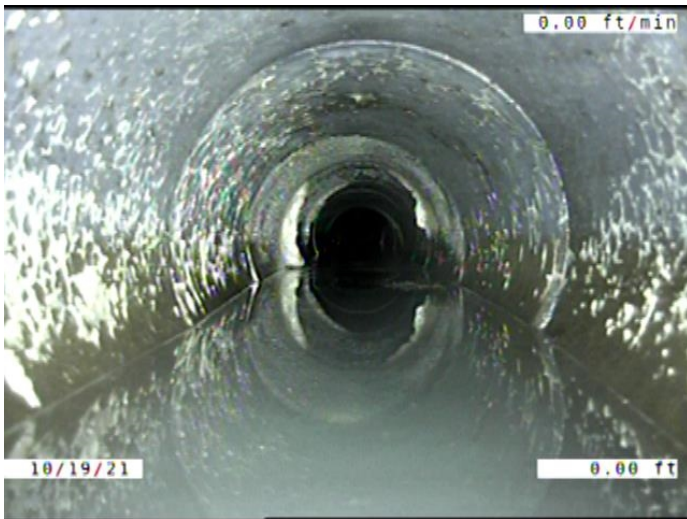
Code: **DSF**
Description: **Deposits Settled Fine**

Distance (ft): **.0**
Structural Grade: **0**
O&M Grade: **2**
Clock Start/From: **5**
Clock To: **7**
1st Value:
2nd Value:
Value Percent: **5.000**
Continuous Index: **S01**
Within 8" of Joint: **YES**
Remarks:

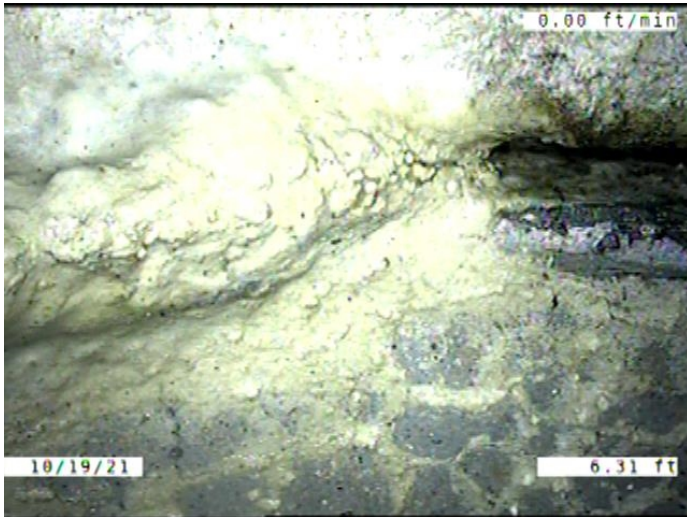
Code:	DAE
Description:	Deposits Attached Encrustation
Distance (ft):	6.3
Structural Grade:	0
O&M Grade:	2
Clock Start/From:	8
Clock To:	4
1st Value:	
2nd Value:	
Value Percent:	5.000
Continuous Index:	S02
Within 8" of Joint:	YES
Remarks:

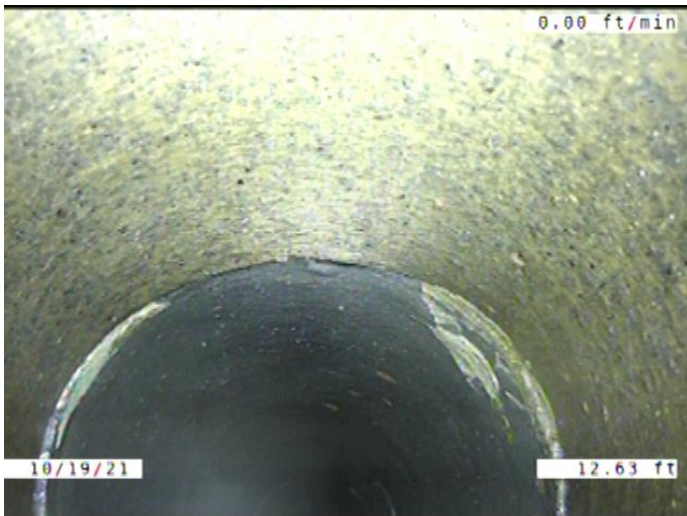
Code:	MWLS
Description:	Miscellaneous Water Level Sag
Distance (ft):	12.6
Structural Grade:	2
O&M Grade:	0
Clock Start/From:	
Clock To:	
1st Value:	
2nd Value:	
Value Percent:	15.000
Continuous Index:	
Within 8" of Joint:	NO
Remarks:

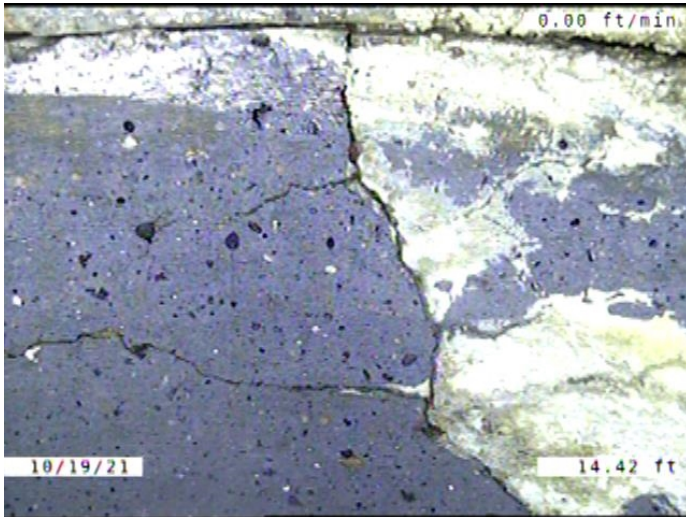
Code: **FM**
 Description: **Fracture Multiple**

Distance (ft): **14.4**
 Structural Grade: **4**
 O&M Grade: **0**
 Clock Start/From: **10**
 Clock To: **2**
 1st Value:
 2nd Value:
 Value Percent:
 Continuous Index:
 Within 8" of Joint: **YES**
 Remarks:

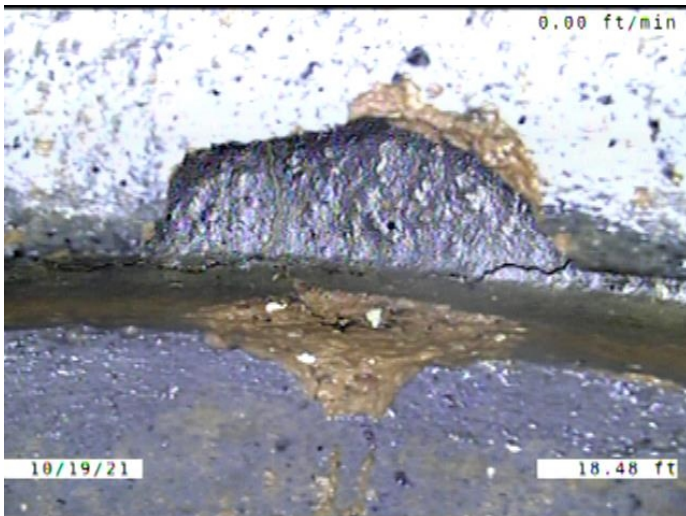
Code: **SZ**
 Description: **Surface Damage Other**

Distance (ft): **18.5**
 Structural Grade: **0**
 O&M Grade: **0**
 Clock Start/From: **1**
 Clock To:
 1st Value:
 2nd Value:
 Value Percent:
 Continuous Index:
 Within 8" of Joint: **YES**
 Remarks: **A PIECE CHIPPED AWAY FROM THE JOINT**

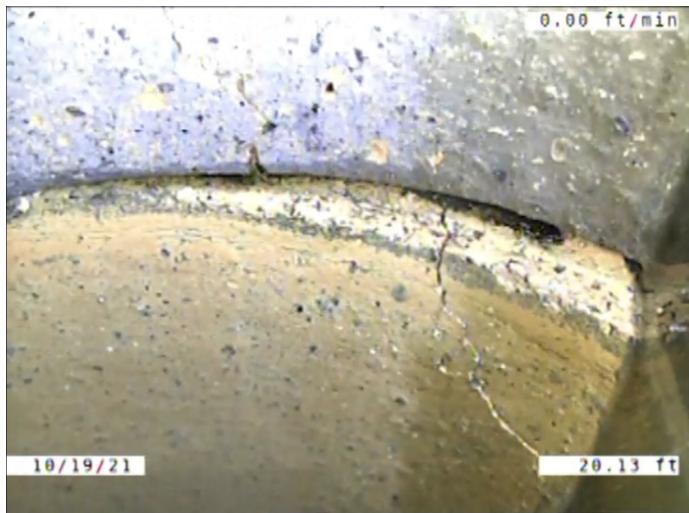
Code: **FM**
 Description: **Fracture Multiple**

Distance (ft): **20.1**
 Structural Grade: **4**
 O&M Grade: **0**
 Clock Start/From: **12**
 Clock To: **5**
 1st Value:
 2nd Value:
 Value Percent:
 Continuous Index:
 Within 8" of Joint: **YES**
 Remarks:

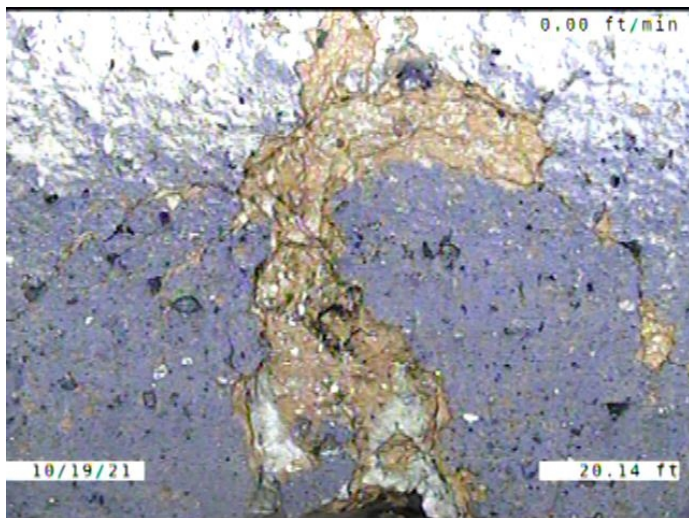
Code: **B**
 Description: **Broken**

Distance (ft): **20.1**
 Structural Grade: **4**
 O&M Grade: **0**
 Clock Start/From: **2**
 Clock To:
 1st Value:
 2nd Value:
 Value Percent:
 Continuous Index:
 Within 8" of Joint: **YES**
 Remarks:

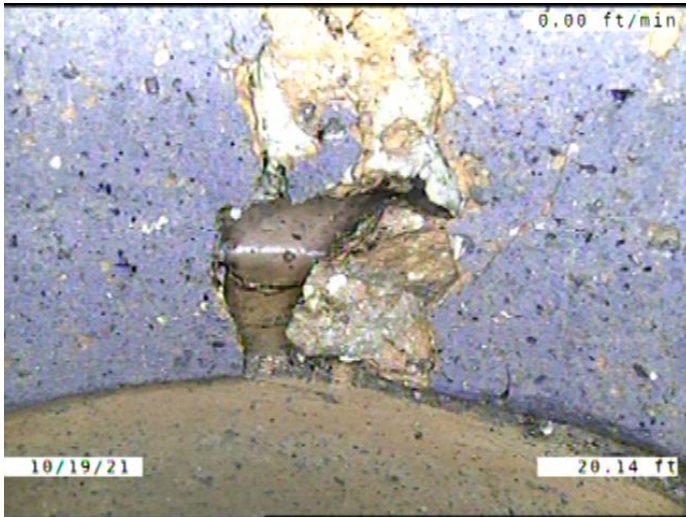
Code: **SMW**
 Description: **Surface Damage Missing Wall**

Distance (ft): **20.1**
 Structural Grade: **5**
 O&M Grade: **0**
 Clock Start/From: **1**
 Clock To:
 1st Value:
 2nd Value:
 Value Percent:
 Continuous Index:
 Within 8" of Joint: **YES**
 Remarks: **INSIDE OF THE JOINT**

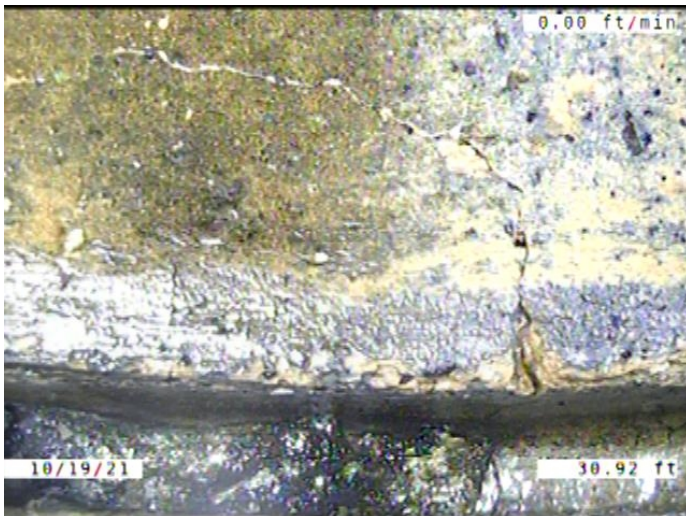
Code: **CM**
 Description: **Crack Multiple**

Distance (ft): **30.9**
 Structural Grade: **3**
 O&M Grade: **0**
 Clock Start/From: **3**
 Clock To: **6**
 1st Value:
 2nd Value:
 Value Percent:
 Continuous Index:
 Within 8" of Joint: **YES**
 Remarks:

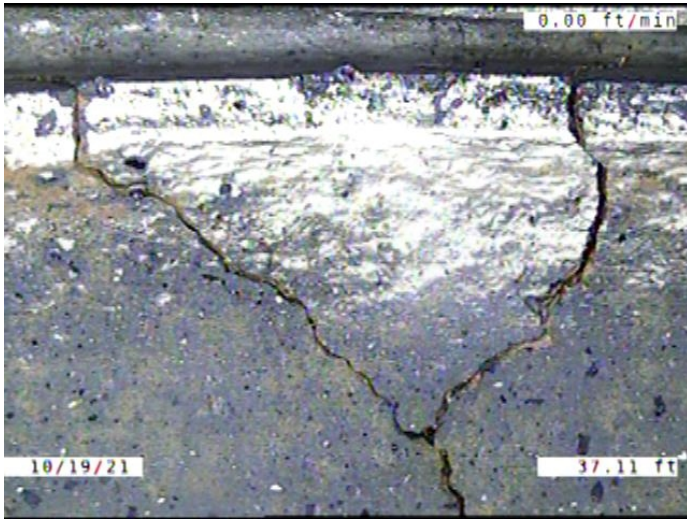
Code: **FM**
 Description: **Fracture Multiple**

Distance (ft): **37.1**
 Structural Grade: **4**
 O&M Grade: **0**
 Clock Start/From: **8**
 Clock To: **4**
 1st Value:
 2nd Value:
 Value Percent:
 Continuous Index:
 Within 8" of Joint: **YES**
 Remarks:

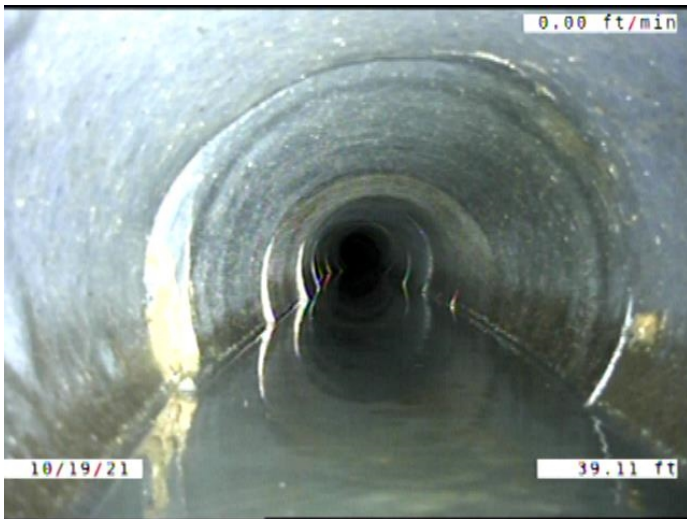
Code: **MWLS**
 Description: **Miscellaneous Water Level Sag**

Distance (ft): **39.1**
 Structural Grade: **2**
 O&M Grade: **0**
 Clock Start/From:
 Clock To:
 1st Value:
 2nd Value:
 Value Percent: **15.000**
 Continuous Index: **S04**
 Within 8" of Joint: **NO**
 Remarks:

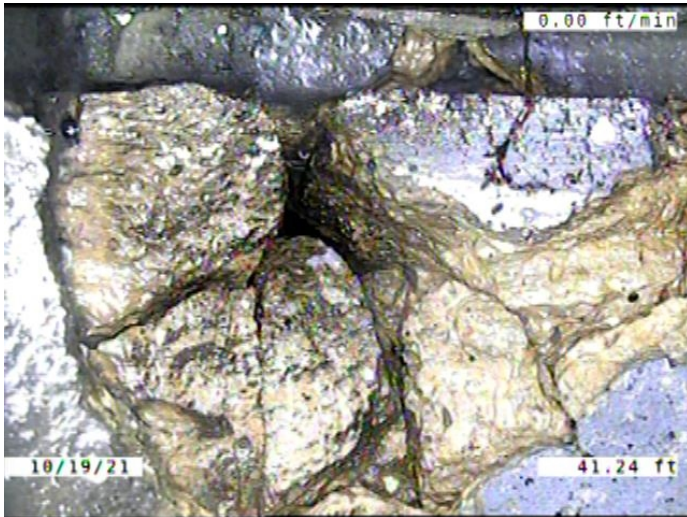
Code: **BVV**
 Description: **Broken Void Visible**

Distance (ft): **41.2**
 Structural Grade: **5**
 O&M Grade: **0**
 Clock Start/From: **8**
 Clock To: **9**
 1st Value:
 2nd Value:
 Value Percent:
 Continuous Index:
 Within 8" of Joint: **YES**
 Remarks:

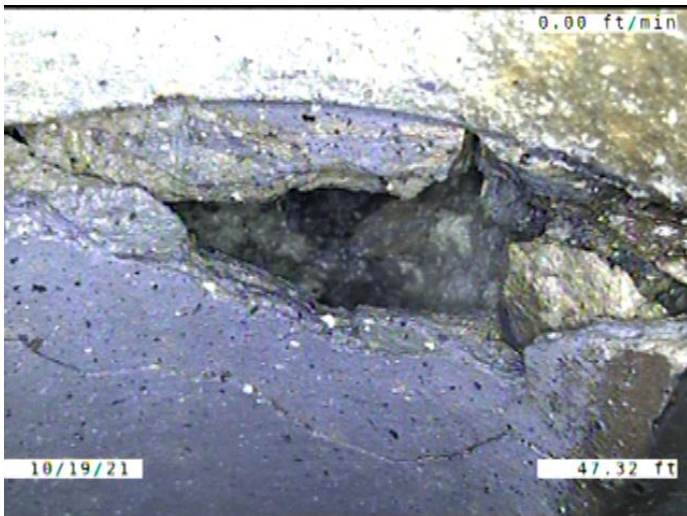
Code: **HVV**
 Description: **Hole Void Visible**

Distance (ft): **47.3**
 Structural Grade: **5**
 O&M Grade: **0**
 Clock Start/From: **1**
 Clock To: **3**
 1st Value:
 2nd Value:
 Value Percent:
 Continuous Index:
 Within 8" of Joint: **YES**
 Remarks: **SOIL AND VOID VISIBLE**

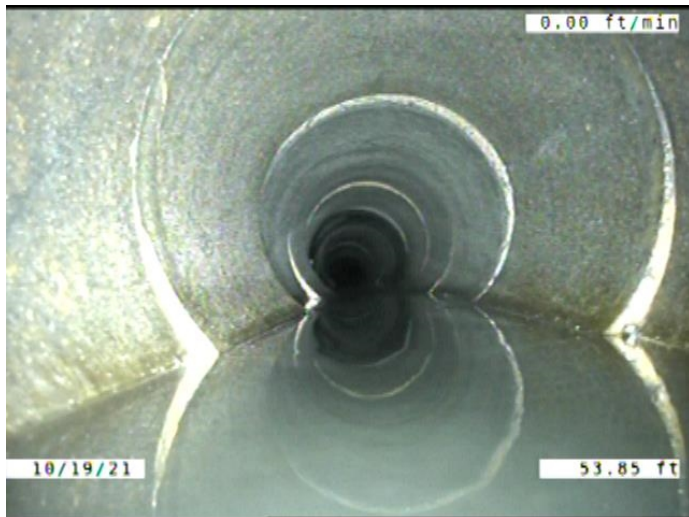
Code: **DAE**
Description: **Deposits Attached Encrustation**

Distance (ft): **53.8**
Structural Grade: **0**
O&M Grade: **2**
Clock Start/From: **8**
Clock To: **4**
1st Value:
2nd Value:
Value Percent: **5.000**
Continuous Index: **F02**
Within 8" of Joint: **YES**
Remarks:

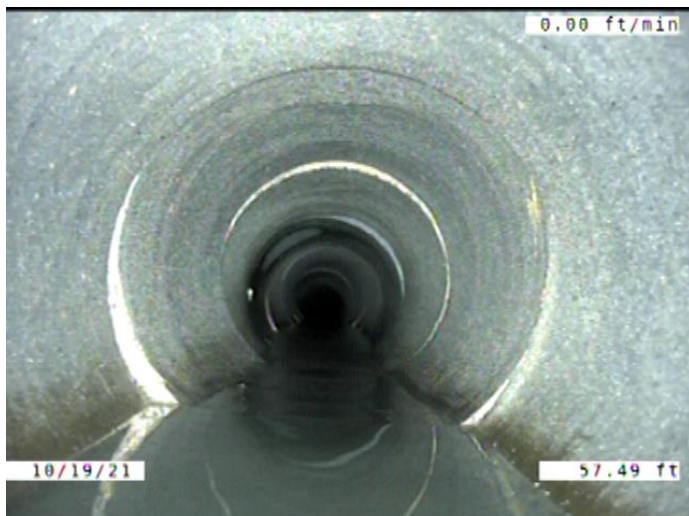
Code: **MWLS**
Description: **Miscellaneous Water Level Sag**

Distance (ft): **57.5**
Structural Grade: **2**
O&M Grade: **0**
Clock Start/From:
Clock To:
1st Value:
2nd Value:
Value Percent: **15.000**
Continuous Index: **F04**
Within 8" of Joint: **NO**
Remarks:

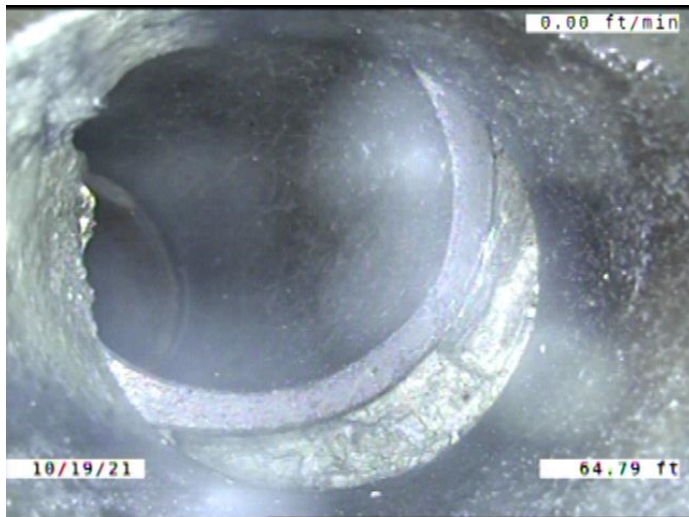
Code: **TFD**
 Description: **Tap Factory Defective**

Distance (ft): **64.8**
 Structural Grade: **0**
 O&M Grade: **3**
 Clock Start/From: **11**
 Clock To:
 1st Value: **4.000**
 2nd Value:
 Value Percent:
 Continuous Index:
 Within 8" of Joint: **YES**
 Remarks: **CONSTANTLY RUNNING WATER.
 LARGE OFFSET FIRST JOINT BACK**

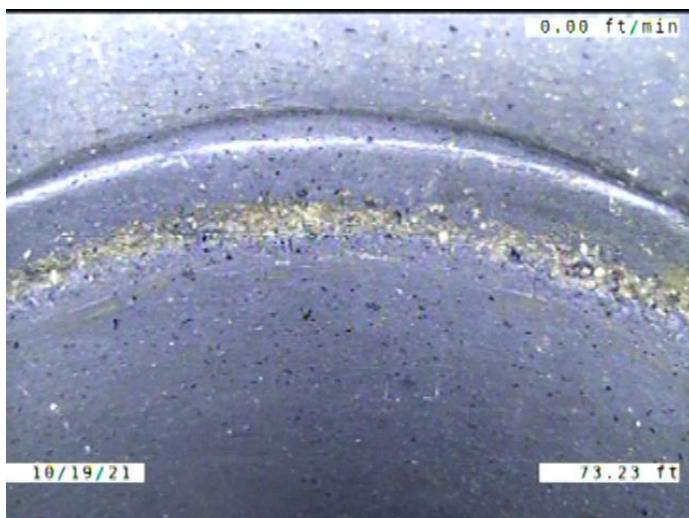
Code: **JOM**
 Description: **Joint Offset Medium**

Distance (ft): **73.2**
 Structural Grade: **3**
 O&M Grade: **0**
 Clock Start/From:
 Clock To:
 1st Value:
 2nd Value:
 Value Percent:
 Continuous Index:
 Within 8" of Joint: **NO**
 Remarks:

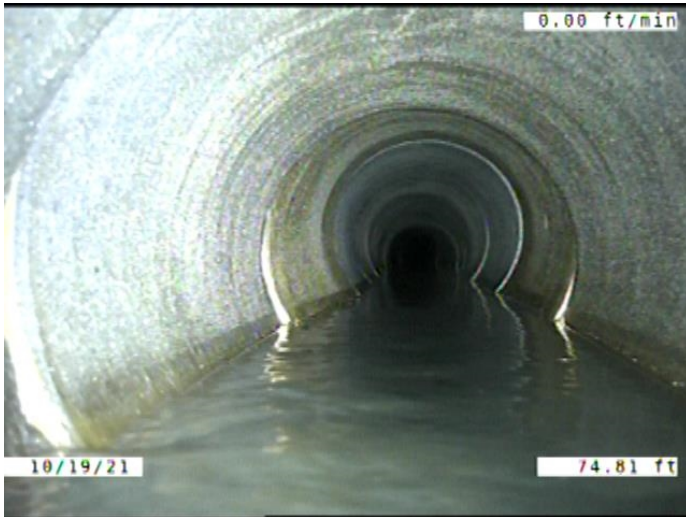
Code: **MWLS**
Description: **Miscellaneous Water Level Sag**

Distance (ft): **74.8**
Structural Grade: **2**
O&M Grade: **0**
Clock Start/From:
Clock To:
1st Value:
2nd Value:
Value Percent: **15.000**
Continuous Index: **S05**
Within 8" of Joint: **NO**
Remarks:

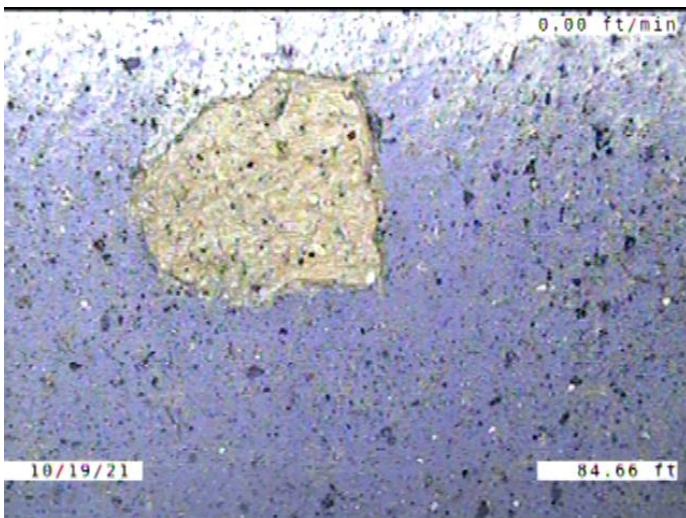
Code: **SSS**
Description: **Surface Damage Surface Spalling**

Distance (ft): **84.7**
Structural Grade: **2**
O&M Grade: **0**
Clock Start/From: **10**
Clock To:
1st Value:
2nd Value:
Value Percent:
Continuous Index:
Within 8" of Joint: **NO**
Remarks:

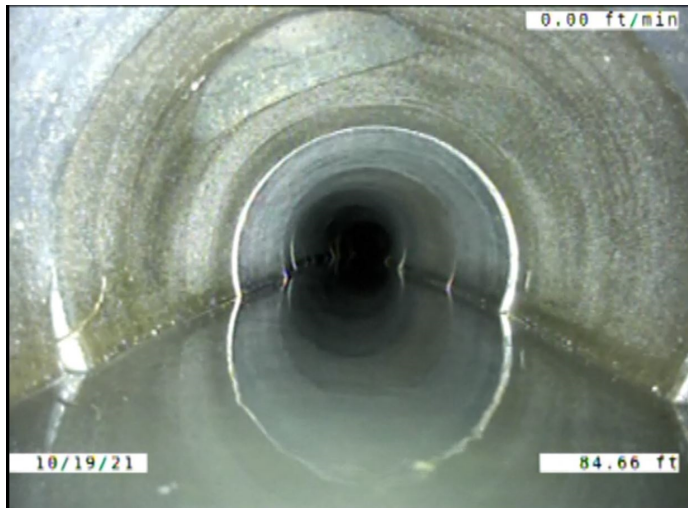
Code: **B**
Description: **Broken**

Distance (ft): **84.7**
Structural Grade: **4**
O&M Grade: **0**
Clock Start/From: **8**
Clock To: **11**
1st Value:
2nd Value:
Value Percent:
Continuous Index:
Within 8" of Joint: **YES**
Remarks:

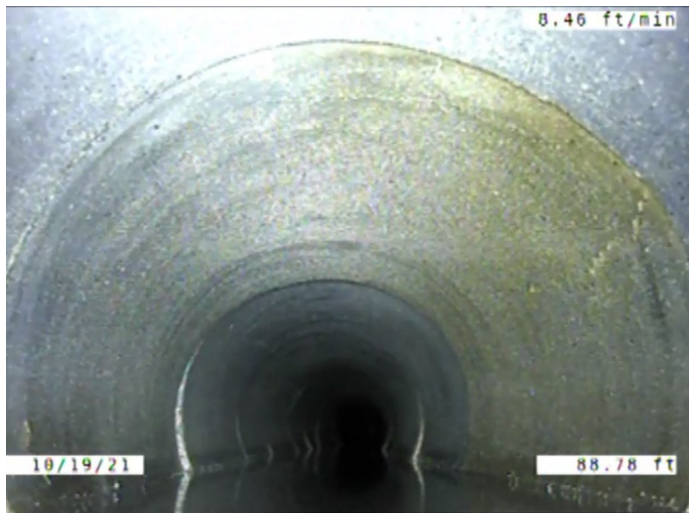
Code: **CL**
 Description: **Crack Longitudinal**

Distance (ft): **88.8**
 Structural Grade: **2**
 O&M Grade: **0**
 Clock Start/From: **2**
 Clock To:
 1st Value:
 2nd Value:
 Value Percent:
 Continuous Index:
 Within 8" of Joint: **YES**
 Remarks:

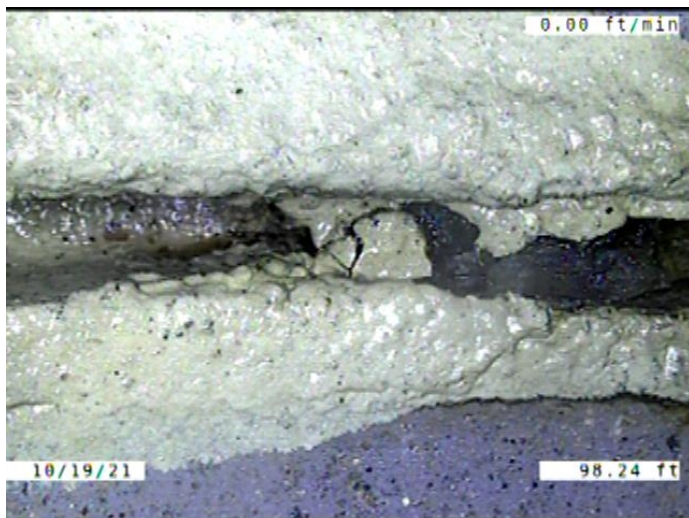
Code: **DAE**
 Description: **Deposits Attached Encrustation**

Distance (ft): **98.2**
 Structural Grade: **0**
 O&M Grade: **2**
 Clock Start/From: **9**
 Clock To: **12**
 1st Value:
 2nd Value:
 Value Percent: **5.000**
 Continuous Index:
 Within 8" of Joint: **YES**
 Remarks:

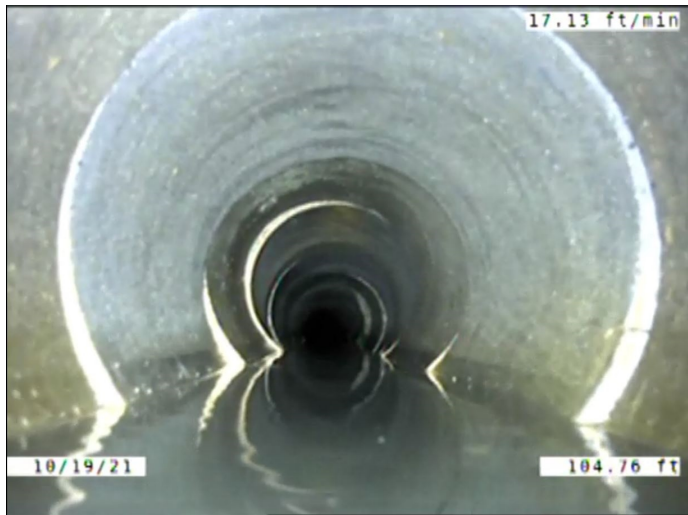
Code: **FL**
 Description: **Fracture Longitudinal**

Distance (ft): **104.8**
 Structural Grade: **3**
 O&M Grade: **0**
 Clock Start/From: **4**
 Clock To:
 1st Value:
 2nd Value:
 Value Percent:
 Continuous Index:
 Within 8" of Joint: **YES**
 Remarks:

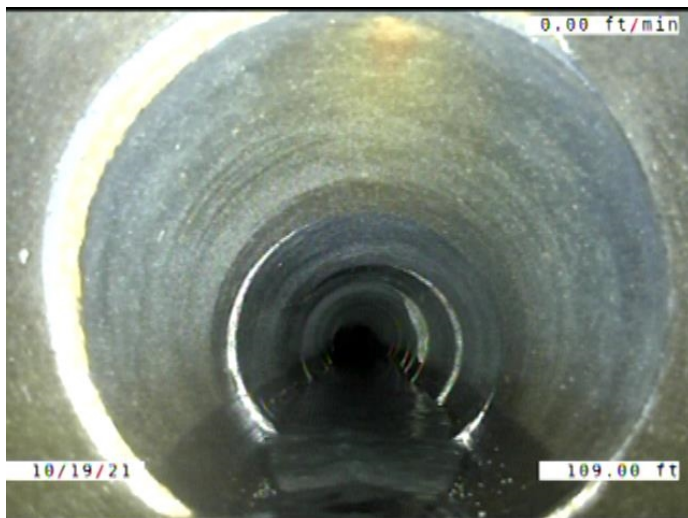
Code: **MWLS**
 Description: **Miscellaneous Water Level Sag**

Distance (ft): **109.0**
 Structural Grade: **2**
 O&M Grade: **0**
 Clock Start/From:
 Clock To:
 1st Value:
 2nd Value:
 Value Percent: **15.000**
 Continuous Index: **F05**
 Within 8" of Joint: **NO**
 Remarks:

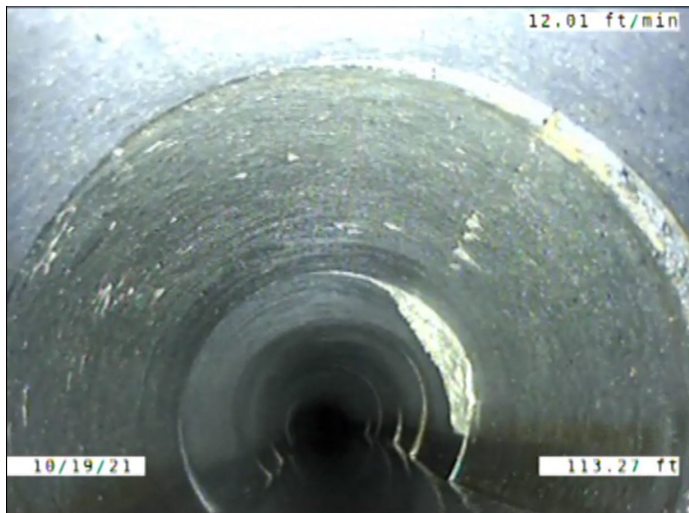
Code: **CL**
 Description: **Crack Longitudinal**

Distance (ft): **113.3**
 Structural Grade: **2**
 O&M Grade: **0**
 Clock Start/From: **2**
 Clock To:
 1st Value:
 2nd Value:
 Value Percent:
 Continuous Index:
 Within 8" of Joint: **YES**
 Remarks:

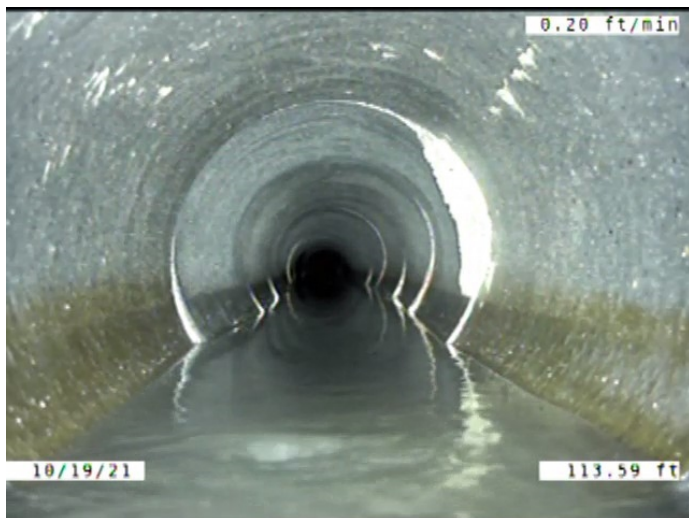
Code: **MWLS**
 Description: **Miscellaneous Water Level Sag**

Distance (ft): **113.6**
 Structural Grade: **2**
 O&M Grade: **0**
 Clock Start/From:
 Clock To:
 1st Value:
 2nd Value:
 Value Percent: **15.000**
 Continuous Index: **S06**
 Within 8" of Joint: **NO**
 Remarks:

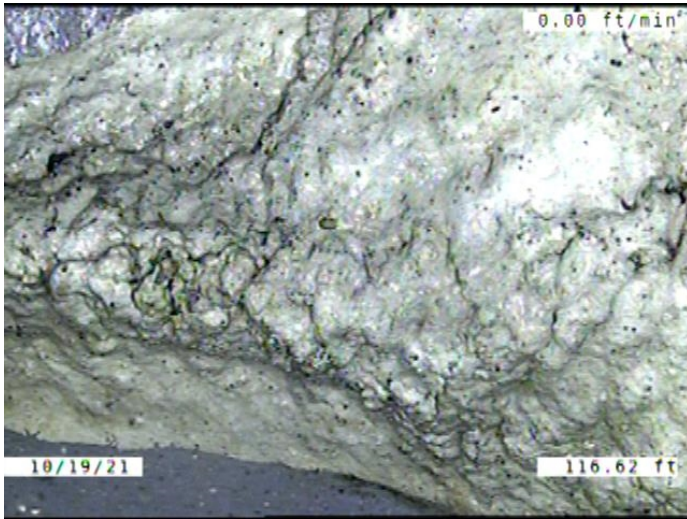
Code: **DAE**
 Description: **Deposits Attached Encrustation**

Distance (ft): **116.6**
 Structural Grade: **0**
 O&M Grade: **2**
 Clock Start/From: **10**
 Clock To: **4**
 1st Value:
 2nd Value:
 Value Percent: **5.000**
 Continuous Index:
 Within 8" of Joint: **YES**
 Remarks:

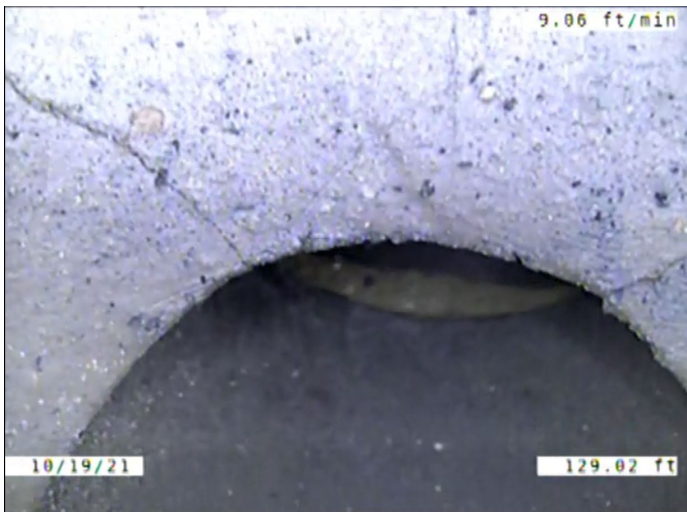
Code: **CM**
 Description: **Crack Multiple**

Distance (ft): **129.0**
 Structural Grade: **3**
 O&M Grade: **0**
 Clock Start/From: **12**
 Clock To: **1**
 1st Value:
 2nd Value:
 Value Percent:
 Continuous Index:
 Within 8" of Joint: **NO**
 Remarks:

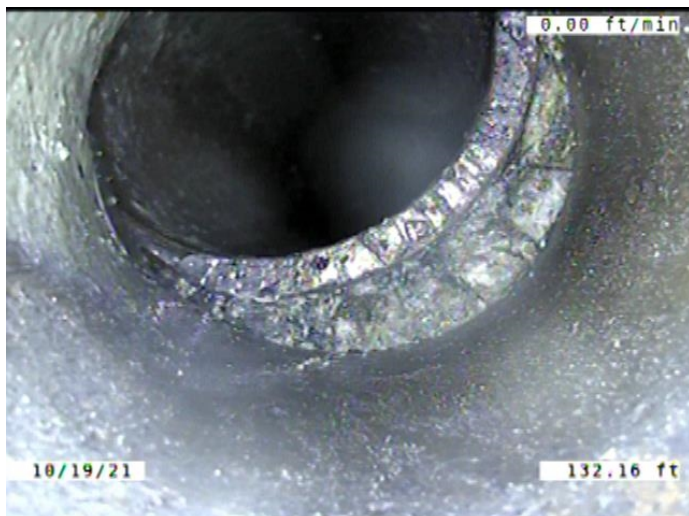
Code: **TFD**
 Description: **Tap Factory Defective**

Distance (ft): **132.2**
 Structural Grade: **0**
 O&M Grade: **3**
 Clock Start/From: **11**
 Clock To:
 1st Value: **4.000**
 2nd Value:
 Value Percent:
 Continuous Index:
 Within 8" of Joint: **YES**
 Remarks: **Defective**

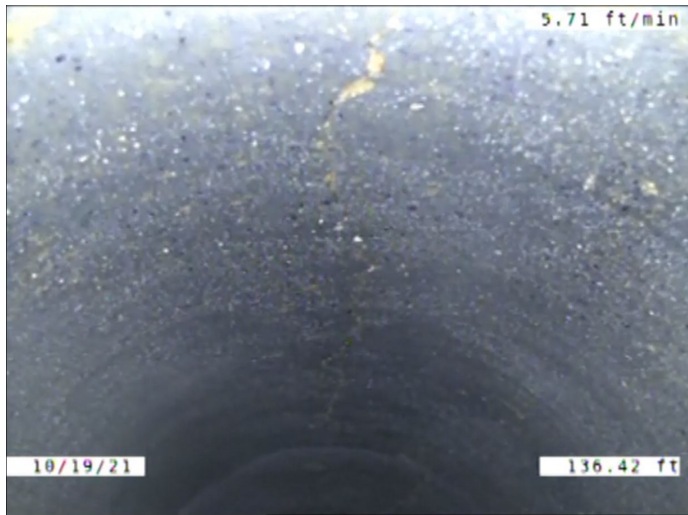
Code: **CM**
 Description: **Crack Multiple**

Distance (ft): **136.4**
 Structural Grade: **3**
 O&M Grade: **0**
 Clock Start/From: **10**
 Clock To: **1**
 1st Value:
 2nd Value:
 Value Percent:
 Continuous Index: **S07**
 Within 8" of Joint: **YES**
 Remarks: **Wandering**

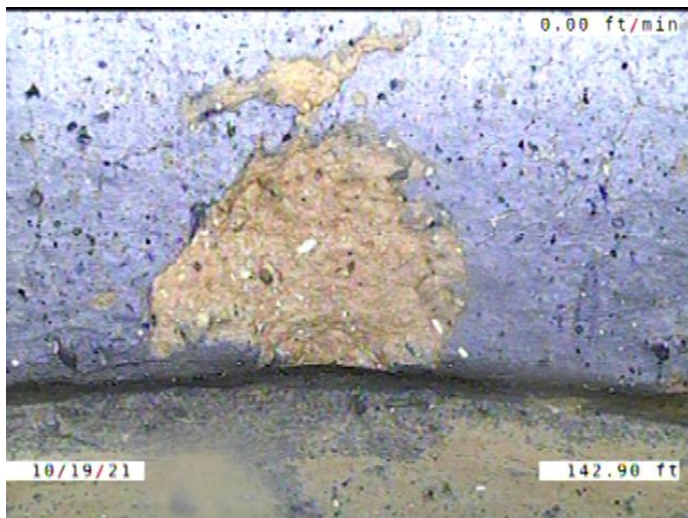
Code: **SSS**
 Description: **Surface Damage Surface Spalling**

Distance (ft): **142.9**
 Structural Grade: **2**
 O&M Grade: **0**
 Clock Start/From: **12**
 Clock To:
 1st Value:
 2nd Value:
 Value Percent:
 Continuous Index:
 Within 8" of Joint: **YES**
 Remarks:

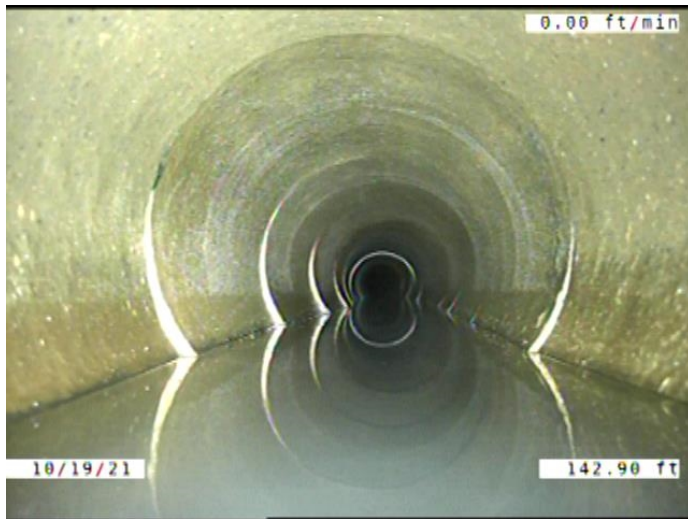
Code: **MWLS**
 Description: **Miscellaneous Water Level Sag**

Distance (ft): **142.9**
 Structural Grade: **2**
 O&M Grade: **0**
 Clock Start/From:
 Clock To:
 1st Value:
 2nd Value:
 Value Percent: **15.000**
 Continuous Index: **F06**
 Within 8" of Joint: **NO**
 Remarks:

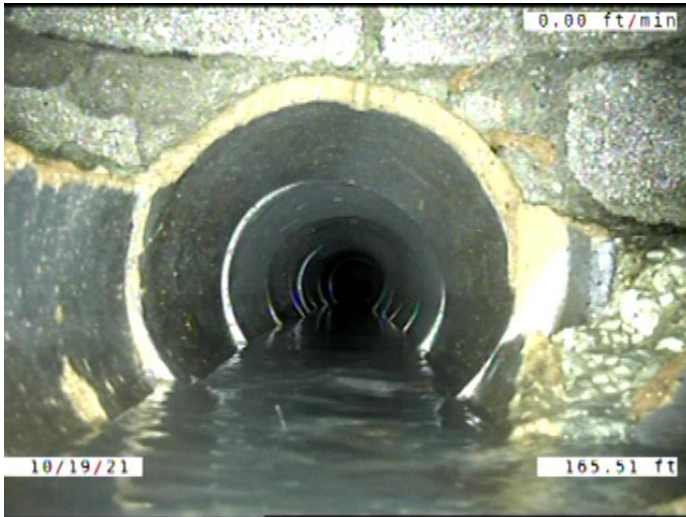
Code: **DSF**
 Description: **Deposits Settled Fine**

Distance (ft): **165.5**
 Structural Grade: **0**
 O&M Grade: **2**
 Clock Start/From: **5**
 Clock To: **7**
 1st Value:
 2nd Value:
 Value Percent: **5.000**
 Continuous Index: **F01**
 Within 8" of Joint: **YES**
 Remarks:
