Profile/Photo Observation Report

Date:	10/19/2021	Weather:		Coding:	PACP 7.0
Pipe Length (ft):	167.1	Owner:	City of Hobart	Pre Clean:	Heavy Cleaning
P.O.#:	YES502259	Surveyor:	S. Bucklin	PSR:	P-503-016-009
Customer:	City of Hobart	Clean Date:	09/06/2021	Shape:	C

Street:	West 39th Place	Flow Control:	Not Controlled
City:	Hobart, IN	Year Renewed:	
Location:	Alley	Tape/Media #:	
Purpose:	Routine Assessment	Dia/Height:	12"
Use:	Sanitary Sewage Pipe	Material:	VCP
Drain Area:		Lining:	
Category:	NA		
Comment:			
Location Details:		Direction of Survey:	Downstream
US MH:	M-503-009	DS MH:	M-503-016
		Total Length Surveyed (ft):	167.1

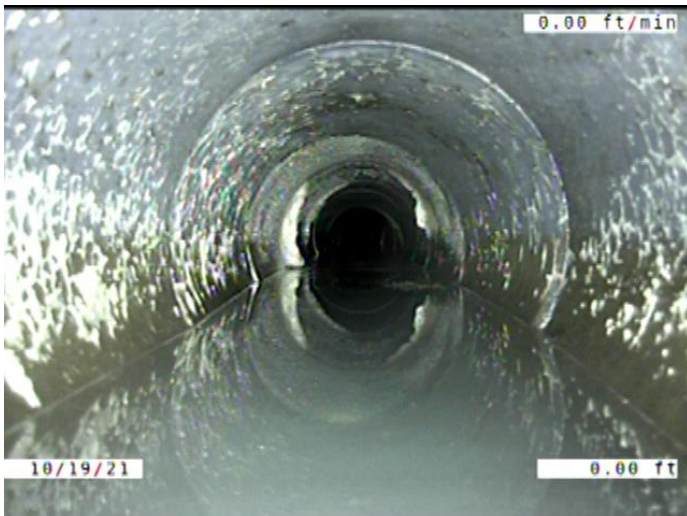
Code: **DSF**
 Description: **Deposits Settled Fine**

Distance (ft): **.0**
 Structural Grade: **0**
 O&M Grade: **2**
 Clock Start/From: **5**
 Clock To: **7**
 1st Value:
 2nd Value:
 Value Percent: **5.000**
 Continuous Index: **S01**
 Within 8" of Joint: **YES**
 Remarks:

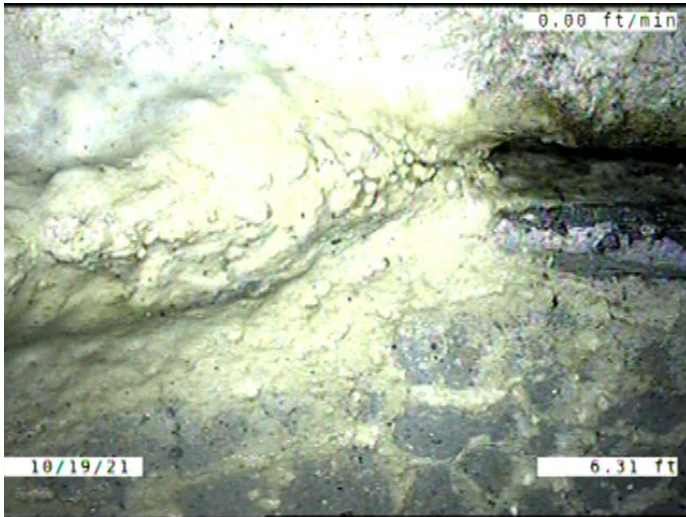
Code:	DAE
Description:	Deposits Attached Encrustation
Distance (ft):	6.3
Structural Grade:	0
O&M Grade:	2
Clock Start/From:	8
Clock To:	4
1st Value:	
2nd Value:	
Value Percent:	5.000
Continuous Index:	S02
Within 8" of Joint:	YES
Remarks:

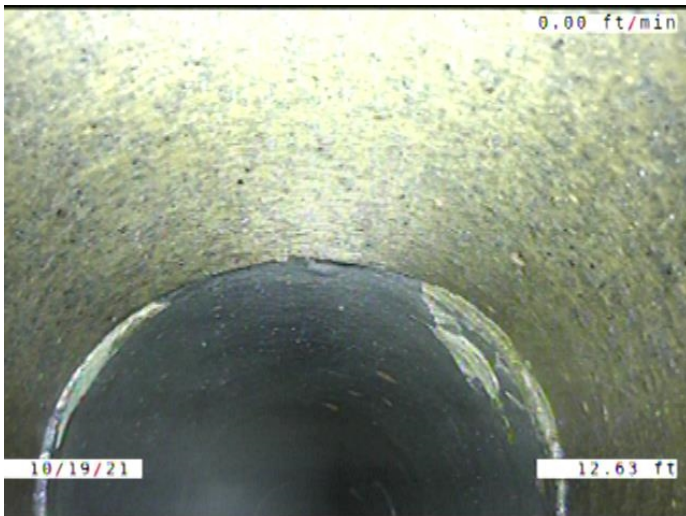
Code:	MWLS
Description:	Miscellaneous Water Level Sag
Distance (ft):	12.6
Structural Grade:	2
O&M Grade:	0
Clock Start/From:	
Clock To:	
1st Value:	
2nd Value:	
Value Percent:	15.000
Continuous Index:	
Within 8" of Joint:	NO
Remarks:

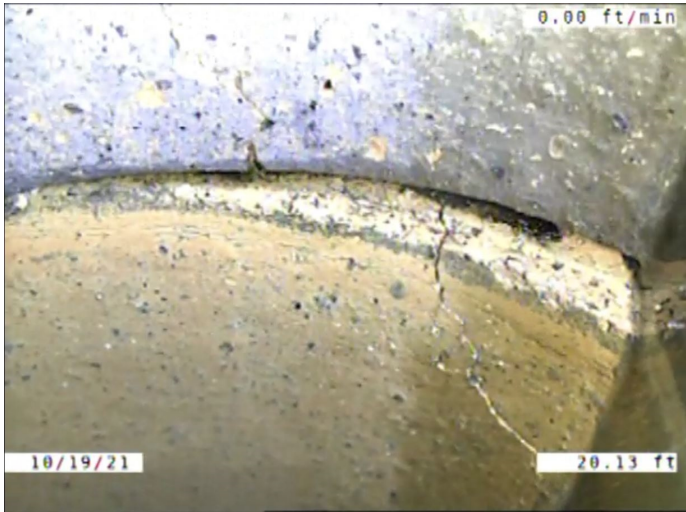
Code: **FM**
Description: **Fracture Multiple**

Distance (ft): **20.1**
Structural Grade: **4**
O&M Grade: **0**
Clock Start/From: **12**
Clock To: **5**
1st Value:
2nd Value:
Value Percent:
Continuous Index:
Within 8" of Joint: **YES**
Remarks:

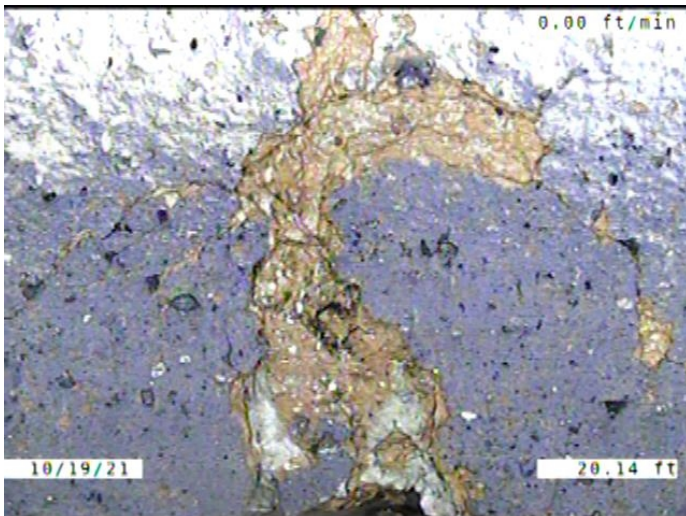
Code: **B**
Description: **Broken**

Distance (ft): **20.1**
Structural Grade: **4**
O&M Grade: **0**
Clock Start/From: **2**
Clock To:
1st Value:
2nd Value:
Value Percent:
Continuous Index:
Within 8" of Joint: **YES**
Remarks:

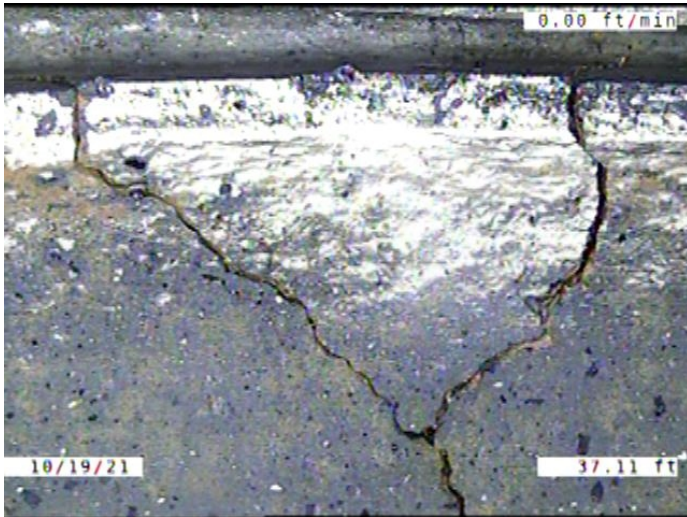
Code: **FM**
 Description: **Fracture Multiple**

Distance (ft): **37.1**
 Structural Grade: **4**
 O&M Grade: **0**
 Clock Start/From: **8**
 Clock To: **4**
 1st Value:
 2nd Value:
 Value Percent:
 Continuous Index:
 Within 8" of Joint: **YES**
 Remarks:

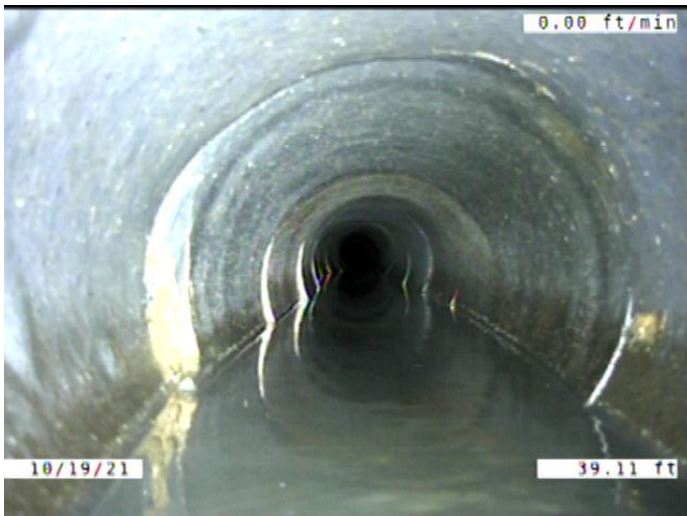
Code: **MWLS**
 Description: **Miscellaneous Water Level Sag**

Distance (ft): **39.1**
 Structural Grade: **2**
 O&M Grade: **0**
 Clock Start/From:
 Clock To:
 1st Value:
 2nd Value:
 Value Percent: **15.000**
 Continuous Index: **S04**
 Within 8" of Joint: **NO**
 Remarks:

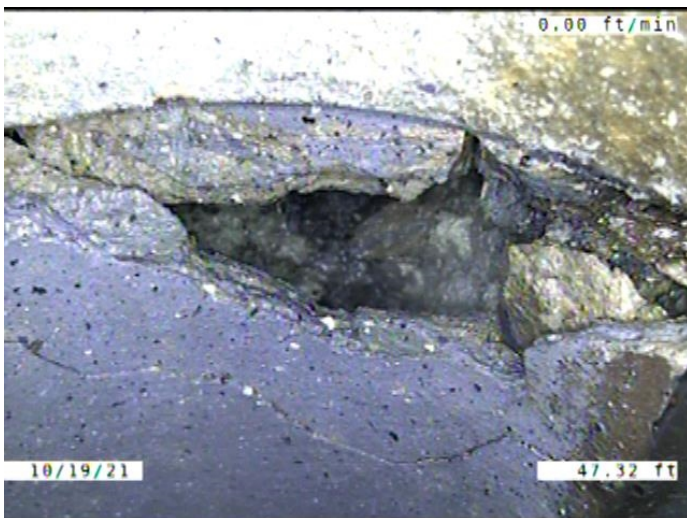
Code: **HVV**
Description: **Hole Void Visible**

Distance (ft): **47.3**
Structural Grade: **5**
O&M Grade: **0**
Clock Start/From: **1**
Clock To: **3**
1st Value:
2nd Value:
Value Percent:
Continuous Index:
Within 8" of Joint: **YES**
Remarks: **SOIL AND VOID VISIBLE**

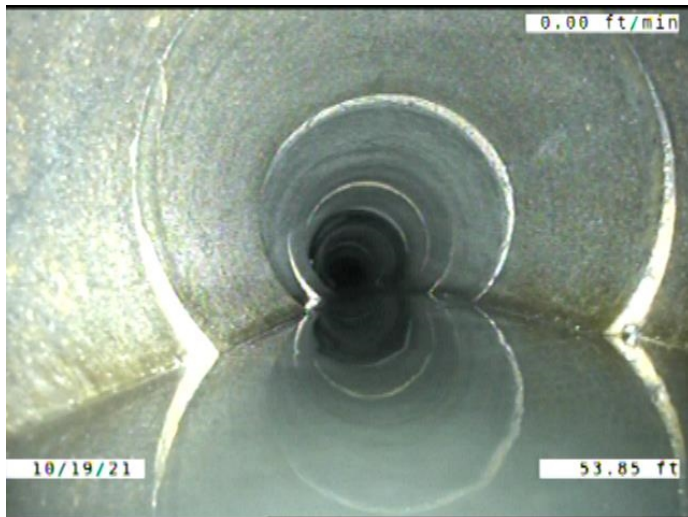
Code: **DAE**
 Description: **Deposits Attached Encrustation**

Distance (ft): **53.8**
 Structural Grade: **0**
 O&M Grade: **2**
 Clock Start/From: **8**
 Clock To: **4**
 1st Value:
 2nd Value:
 Value Percent: **5.000**
 Continuous Index: **F02**
 Within 8" of Joint: **YES**
 Remarks:

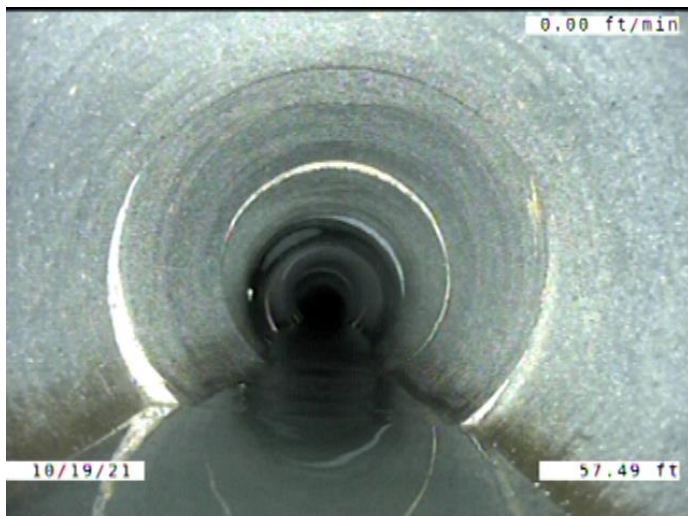
Code: **MWLS**
 Description: **Miscellaneous Water Level Sag**

Distance (ft): **57.5**
 Structural Grade: **2**
 O&M Grade: **0**
 Clock Start/From:
 Clock To:
 1st Value:
 2nd Value:
 Value Percent: **15.000**
 Continuous Index: **F04**
 Within 8" of Joint: **NO**
 Remarks:

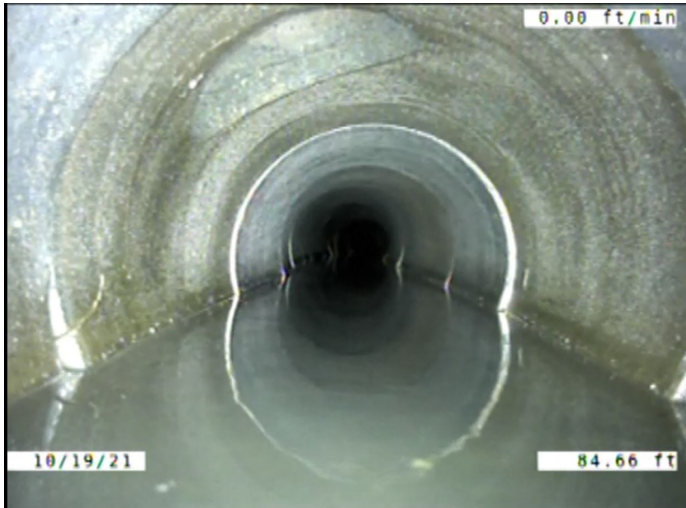
Code: **B**
Description: **Broken**

Distance (ft): **84.7**
Structural Grade: **4**
O&M Grade: **0**
Clock Start/From: **8**
Clock To: **11**
1st Value:
2nd Value:
Value Percent:
Continuous Index:
Within 8" of Joint: **YES**
Remarks:

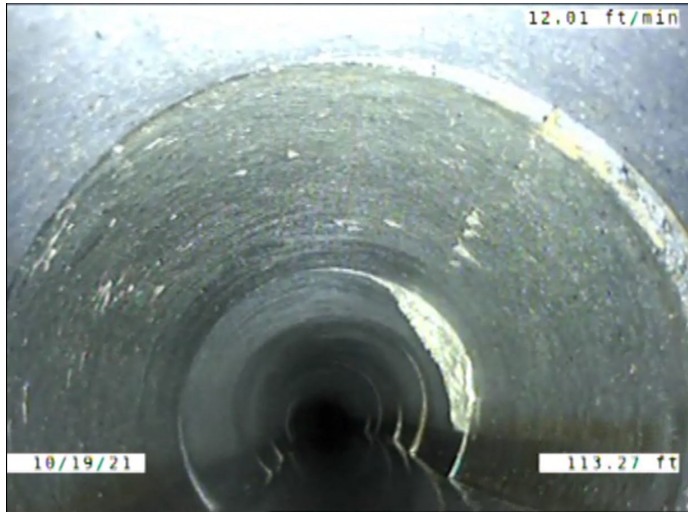
Code: **CL**
 Description: **Crack Longitudinal**

Distance (ft): **113.3**
 Structural Grade: **2**
 O&M Grade: **0**
 Clock Start/From: **2**
 Clock To:
 1st Value:
 2nd Value:
 Value Percent:
 Continuous Index:
 Within 8" of Joint: **YES**
 Remarks:

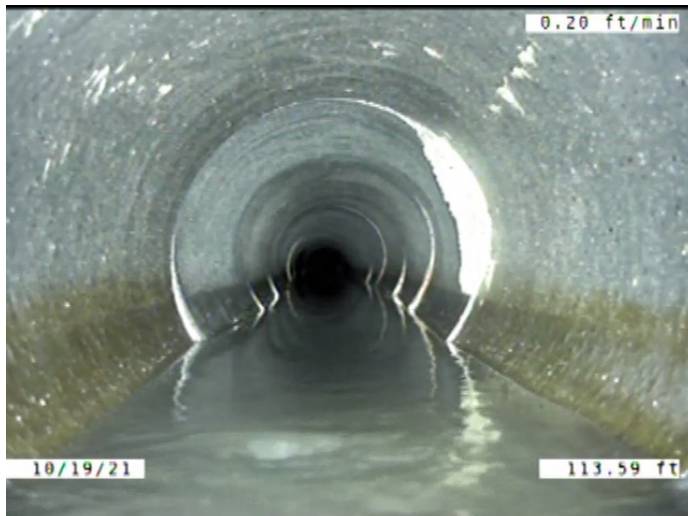
Code: **MWLS**
 Description: **Miscellaneous Water Level Sag**

Distance (ft): **113.6**
 Structural Grade: **2**
 O&M Grade: **0**
 Clock Start/From:
 Clock To:
 1st Value:
 2nd Value:
 Value Percent: **15.000**
 Continuous Index: **S06**
 Within 8" of Joint: **NO**
 Remarks:

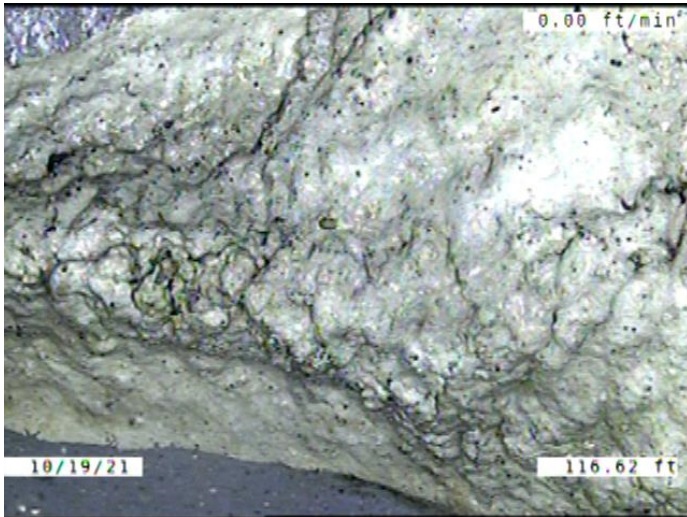
Code: **DAE**
 Description: **Deposits Attached Encrustation**

Distance (ft): **116.6**
 Structural Grade: **0**
 O&M Grade: **2**
 Clock Start/From: **10**
 Clock To: **4**
 1st Value:
 2nd Value:
 Value Percent: **5.000**
 Continuous Index:
 Within 8" of Joint: **YES**
 Remarks:

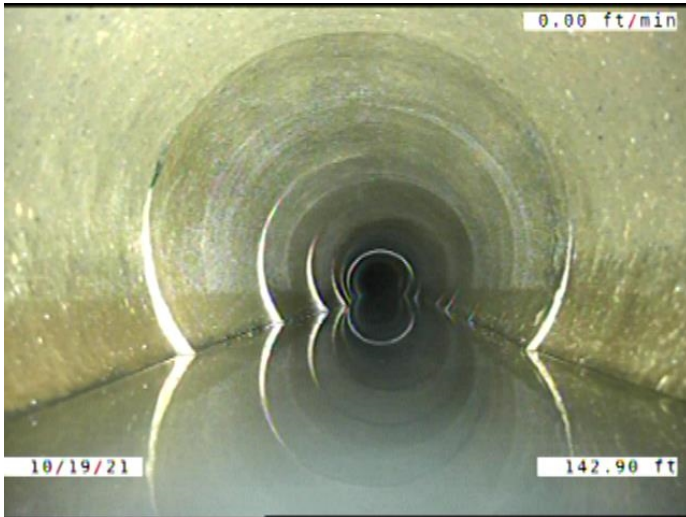
Code: **MWLS**
 Description: **Miscellaneous Water Level Sag**

Distance (ft): **142.9**
 Structural Grade: **2**
 O&M Grade: **0**
 Clock Start/From:
 Clock To:
 1st Value:
 2nd Value:
 Value Percent: **15.000**
 Continuous Index: **F06**
 Within 8" of Joint: **NO**
 Remarks:

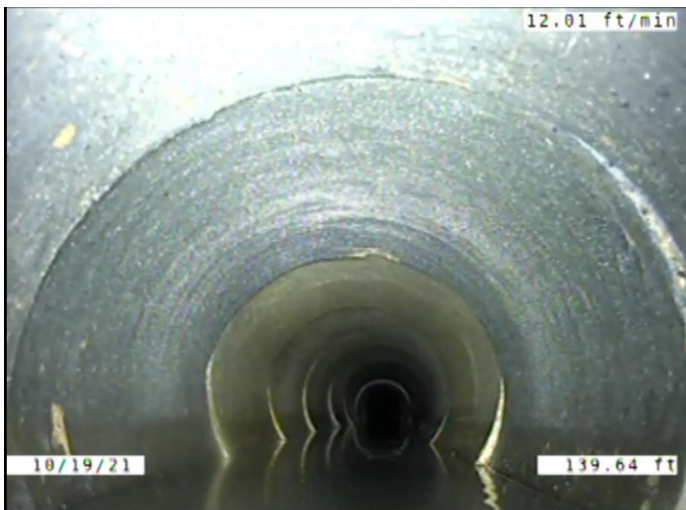
Code: **CM**
 Description: **Crack Multiple**

Distance (ft): **153.7**
 Structural Grade: **3**
 O&M Grade: **0**
 Clock Start/From: **10**
 Clock To: **1**
 1st Value:
 2nd Value:
 Value Percent:
 Continuous Index: **F07**
 Within 8" of Joint: **YES**
 Remarks: **Wandering**
