## Profile/Photo Observation Report

Street:	<b>ALLEY BETWEEN W 40TH AVE &amp; W 3</b>	Flow Control:	<b>Not Controlled</b>
City:	<b>Hobart, IN</b>	Year Renewed:	
Location:	<b>Other</b>	Tape/Media #:	
Purpose:	<b>Not Known</b>	Dia/Height:	<b>10"</b>
Use:	<b>Sanitary</b>	Material:	<b>VCP</b>
Drain Area:	<b>NA</b>	Lining:	
Category:	<b>NA</b>		
Comment:

Location Details:		Direction of Survey:	<b>Downstream</b>
US MH:	<b>M-503-010</b>	DS MH:	<b>M-503-011</b>
		Total Length Surveyed (ft):	<b>77.1</b>

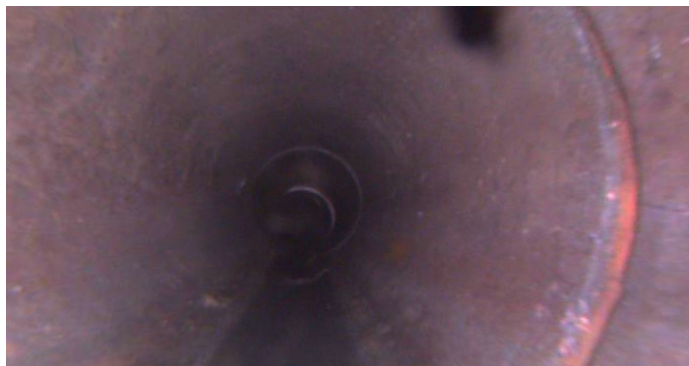
Code: **AMH**  
Description: **Manhole**

Distance (ft): **.0**  
Structural Grade: **0**  
O&M Grade: **0**  
Clock Start/From:  
Clock To:  
1st Value:  
2nd Value:  
Value Percent:  
Continuous Index:  
Within 8" of Joint: **NO**  
Remarks: **M-503-010**

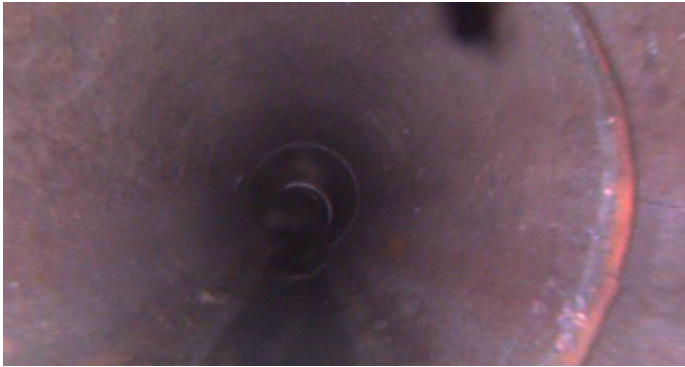
Code:	<b>MWL</b>
Description:	<b>Water Level</b>

Distance (ft):	<b>.0</b>
Structural Grade:	<b>0</b>
O&M Grade:	<b>0</b>
Clock Start/From:	
Clock To:	
1st Value:	
2nd Value:	
Value Percent:	<b>10.000</b>
Continuous Index:	
Within 8" of Joint:	<b>NO</b>
Remarks:

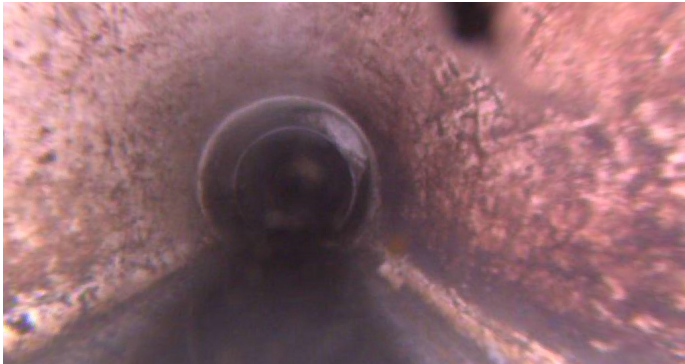
Code:	<b>MMC</b>
Description:	<b>Material Change</b>

Distance (ft):	<b>5.0</b>
Structural Grade:	<b>0</b>
O&M Grade:	<b>0</b>
Clock Start/From:	
Clock To:	
1st Value:	
2nd Value:	
Value Percent:	
Continuous Index:	
Within 8" of Joint:	<b>NO</b>
Remarks:	<b>PVC</b>

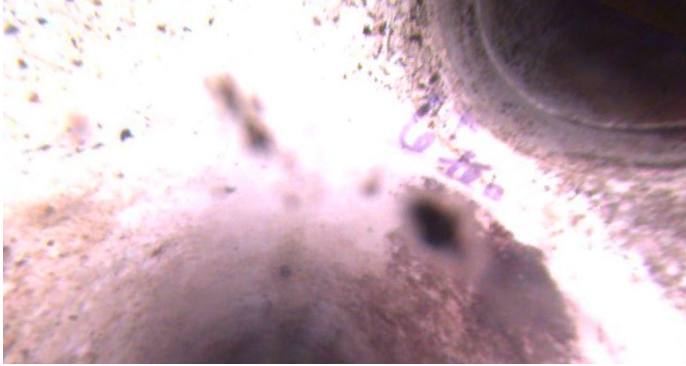
Code: **TF**  
Description: **Tap Factory**

Distance (ft): **6.9**  
Structural Grade: **0**  
O&M Grade: **0**  
Clock Start/From: **2**  
Clock To:  
1st Value: **4.000**  
2nd Value:  
Value Percent:  
Continuous Index:  
Within 8" of Joint:  
Remarks:

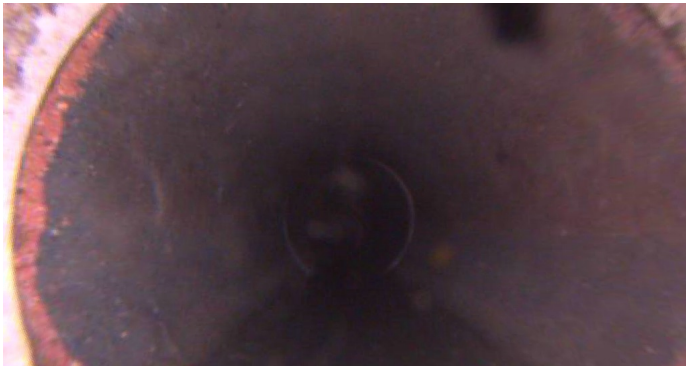
Code: **MMC**  
Description: **Material Change**

Distance (ft): **9.2**  
Structural Grade: **0**  
O&M Grade: **0**  
Clock Start/From:  
Clock To:  
1st Value:  
2nd Value:  
Value Percent:  
Continuous Index:  
Within 8" of Joint: **NO**  
Remarks: **VCP**

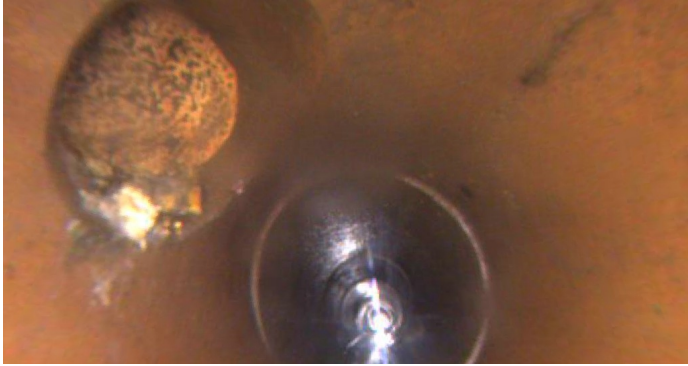
Code: **TFC**  
Description: **Tap Factory Capped**

Distance (ft): **14.4**  
Structural Grade: **0**  
O&M Grade: **0**  
Clock Start/From: **2**  
Clock To:  
1st Value: **4.000**  
2nd Value:  
Value Percent:  
Continuous Index:  
Within 8" of Joint:  
Remarks:

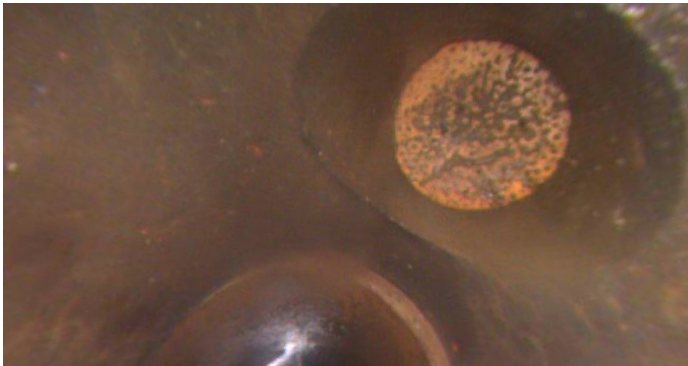
Code: **TFC**  
Description: **Tap Factory Capped**

Distance (ft): **16.3**  
Structural Grade: **0**  
O&M Grade: **0**  
Clock Start/From: **10**  
Clock To:  
1st Value: **4.000**  
2nd Value:  
Value Percent:  
Continuous Index:  
Within 8" of Joint:  
Remarks:

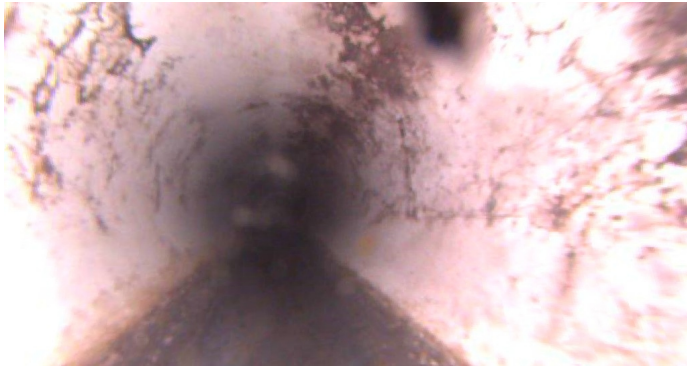
Code: **MMC**  
Description: **Material Change**

Distance (ft): **17.2**  
Structural Grade: **0**  
O&M Grade: **0**  
Clock Start/From:  
Clock To:  
1st Value:  
2nd Value:  
Value Percent:  
Continuous Index:  
Within 8" of Joint: **NO**  
Remarks: **PVC**

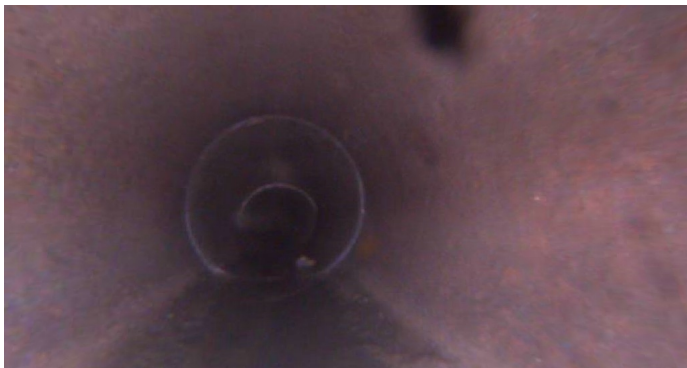
Code: **MMC**  
Description: **Material Change**

Distance (ft): **21.7**  
Structural Grade: **0**  
O&M Grade: **0**  
Clock Start/From:  
Clock To:  
1st Value:  
2nd Value:  
Value Percent:  
Continuous Index:  
Within 8" of Joint: **NO**  
Remarks: **VCP**

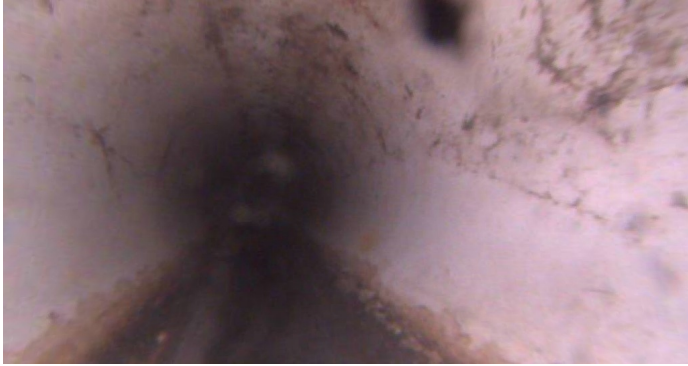
Code: **MMC**  
Description: **Material Change**

Distance (ft): **25.7**  
Structural Grade: **0**  
O&M Grade: **0**  
Clock Start/From:  
Clock To:  
1st Value:  
2nd Value:  
Value Percent:  
Continuous Index:  
Within 8" of Joint: **NO**  
Remarks: **PVC**

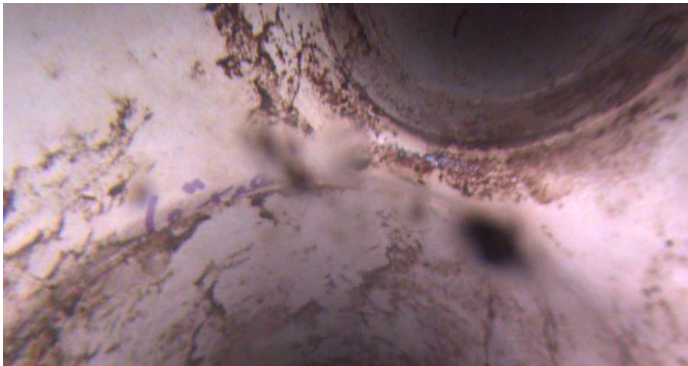
Code: **TF**  
Description: **Tap Factory**

Distance (ft): **47.6**  
Structural Grade: **0**  
O&M Grade: **0**  
Clock Start/From: **2**  
Clock To:  
1st Value: **4.000**  
2nd Value:  
Value Percent:  
Continuous Index:  
Within 8" of Joint:  
Remarks:

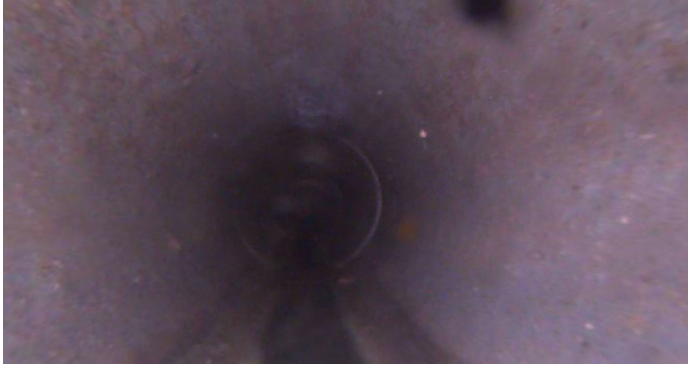
Code: **MMC**  
Description: **Material Change**

Distance (ft): **51.7**  
Structural Grade: **0**  
O&M Grade: **0**  
Clock Start/From:  
Clock To:  
1st Value:  
2nd Value:  
Value Percent:  
Continuous Index:  
Within 8" of Joint: **NO**  
Remarks: **VCP**

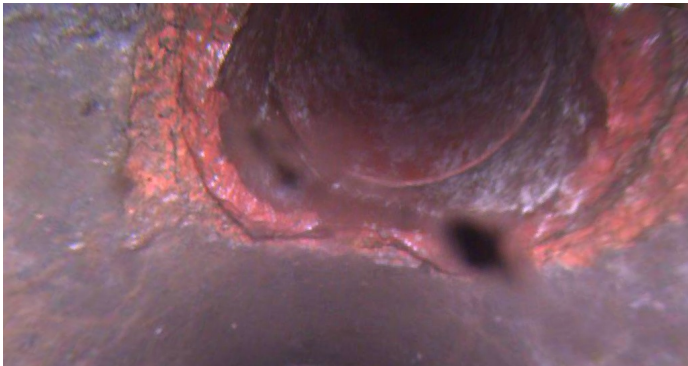
Code: **TB**  
Description: **Tap Break-in**

Distance (ft): **56.3**  
Structural Grade: **0**  
O&M Grade: **0**  
Clock Start/From: **1**  
Clock To:  
1st Value: **4.000**  
2nd Value:  
Value Percent:  
Continuous Index:  
Within 8" of Joint:  
Remarks:

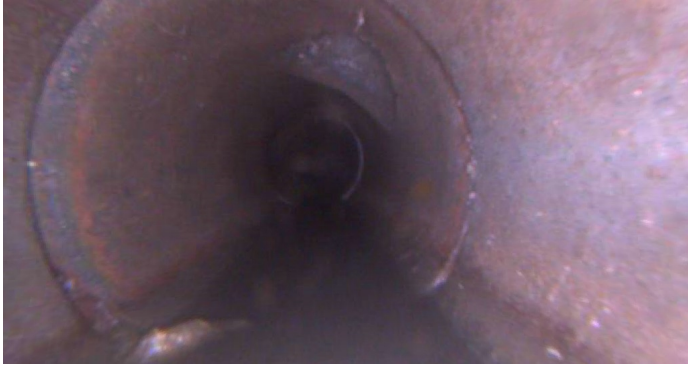
Code:	<b>MSA</b>
Description:	<b>Abandoned Survey</b>
Distance (ft):	<b>77.1</b>
Structural Grade:	<b>0</b>
O&M Grade:	<b>0</b>
Clock Start/From:	
Clock To:	
1st Value:	
2nd Value:	
Value Percent:	
Continuous Index:	
Within 8" of Joint:	<b>NO</b>
Remarks:	<b>No blockage</b>
