## Profile/Photo Observation Report

Date:	<b>04/10/2018</b>	Weather:		Coding:	<b>PACP 6.0</b>
Pipe Length (ft):	<b>193.2</b>	Owner:	<b>NA</b>	Pre Clean:	<b>Not Known</b>
P.O.#:		Surveyor:	<b>Mark Ruby</b>	PSR:	<b>P-503-011-010</b>
Customer:		Clean Date:	<b>01/01/1900</b>	Shape:	<b>C</b>

Street:	<b>W 40th ave</b>	Flow Control:	<b>Not Controlled</b>
City:	<b>Hobart, IN</b>	Year Renewed:	
Location:	<b>Other</b>	Tape/Media #:	
Purpose:	<b>Not Known</b>	Dia/Height:	<b>10"</b>
Use:	<b>Sanitary</b>	Material:	<b>VCP</b>
Drain Area:	<b>NA</b>	Lining:	
Category:	<b>NA</b>		
Comment:

Location Details:		Direction of Survey:	<b>Downstream</b>
US MH:	<b>M-503-010</b>	DS MH:	<b>M-503-011</b>
		Total Length Surveyed (ft):	<b>77.1</b>

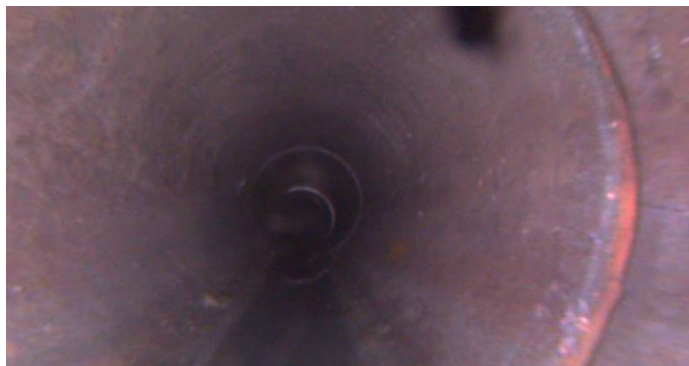
Code: **AMH**  
 Description: **Manhole**

Distance (ft): **.0**  
 Structural Grade: **0**  
 O&M Grade: **0**  
 Clock Start/From:  
 Clock To:  
 1st Value:  
 2nd Value:  
 Value Percent:  
 Continuous Index:  
 Within 8" of Joint: **NO**  
 Remarks: **M-503-010**

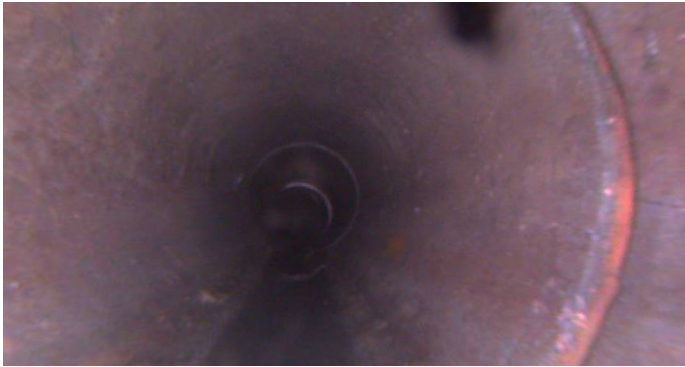
Code:	<b>MWL</b>
Description:	<b>Water Level</b>

Distance (ft):	<b>.0</b>
Structural Grade:	<b>0</b>
O&M Grade:	<b>0</b>
Clock Start/From:	
Clock To:	
1st Value:	
2nd Value:	
Value Percent:	<b>10.000</b>
Continuous Index:	
Within 8" of Joint:	<b>NO</b>
Remarks:

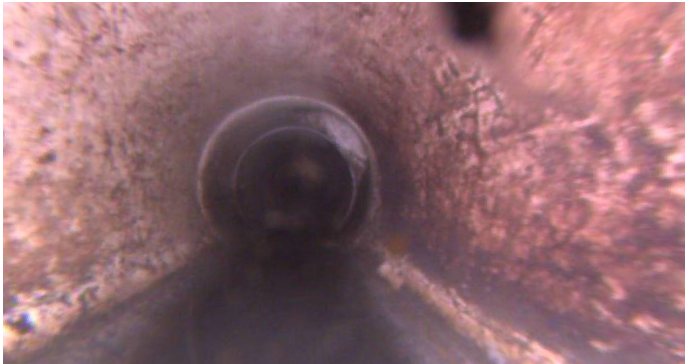
Code:	<b>MMC</b>
Description:	<b>Material Change</b>

Distance (ft):	<b>5.0</b>
Structural Grade:	<b>0</b>
O&M Grade:	<b>0</b>
Clock Start/From:	
Clock To:	
1st Value:	
2nd Value:	
Value Percent:	
Continuous Index:	
Within 8" of Joint:	<b>NO</b>
Remarks:	<b>PVC</b>

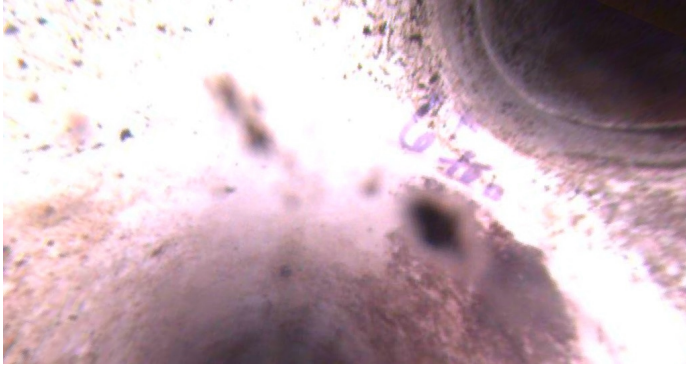
Code: **TF**  
Description: **Tap Factory**

Distance (ft): **6.9**  
Structural Grade: **0**  
O&M Grade: **0**  
Clock Start/From: **2**  
Clock To:  
1st Value: **4.000**  
2nd Value:  
Value Percent:  
Continuous Index:  
Within 8" of Joint:  
Remarks:

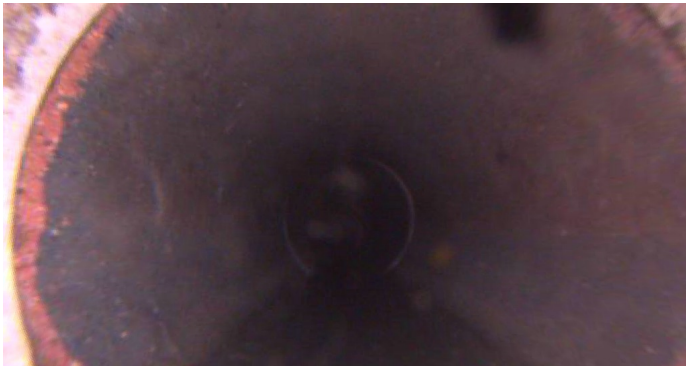
Code: **MMC**  
Description: **Material Change**

Distance (ft): **9.2**  
Structural Grade: **0**  
O&M Grade: **0**  
Clock Start/From:  
Clock To:  
1st Value:  
2nd Value:  
Value Percent:  
Continuous Index:  
Within 8" of Joint: **NO**  
Remarks: **VCP**

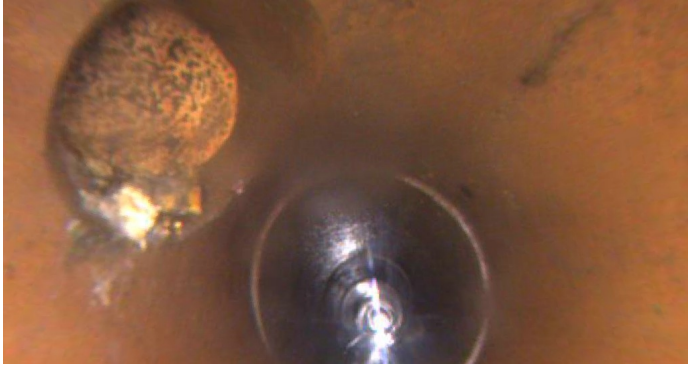
Code: **TFC**  
Description: **Tap Factory Capped**

Distance (ft): **14.4**  
Structural Grade: **0**  
O&M Grade: **0**  
Clock Start/From: **2**  
Clock To:  
1st Value: **4.000**  
2nd Value:  
Value Percent:  
Continuous Index:  
Within 8" of Joint:  
Remarks:

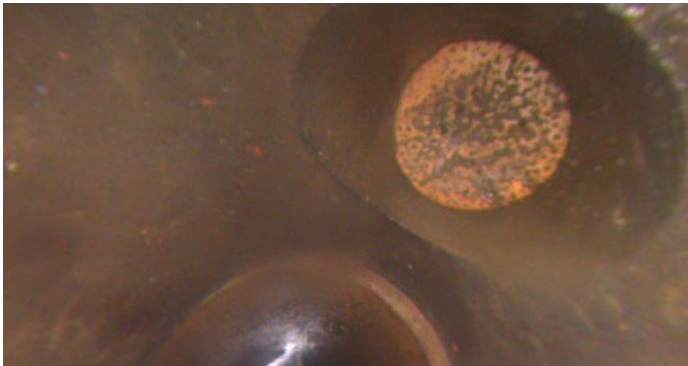
Code: **TFC**  
Description: **Tap Factory Capped**

Distance (ft): **16.3**  
Structural Grade: **0**  
O&M Grade: **0**  
Clock Start/From: **10**  
Clock To:  
1st Value: **4.000**  
2nd Value:  
Value Percent:  
Continuous Index:  
Within 8" of Joint:  
Remarks:

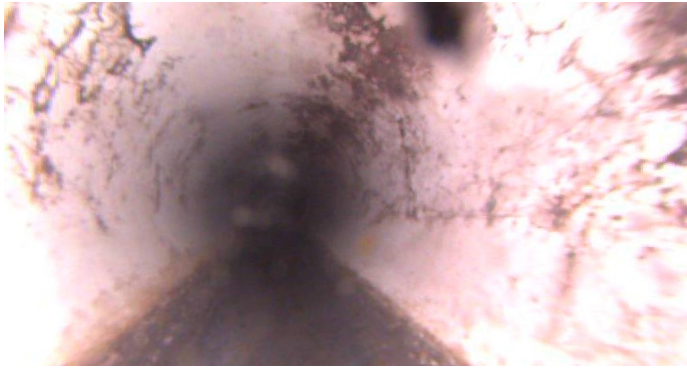
Code: **MMC**  
Description: **Material Change**

Distance (ft): **17.2**  
Structural Grade: **0**  
O&M Grade: **0**  
Clock Start/From:  
Clock To:  
1st Value:  
2nd Value:  
Value Percent:  
Continuous Index:  
Within 8" of Joint: **NO**  
Remarks: **PVC**

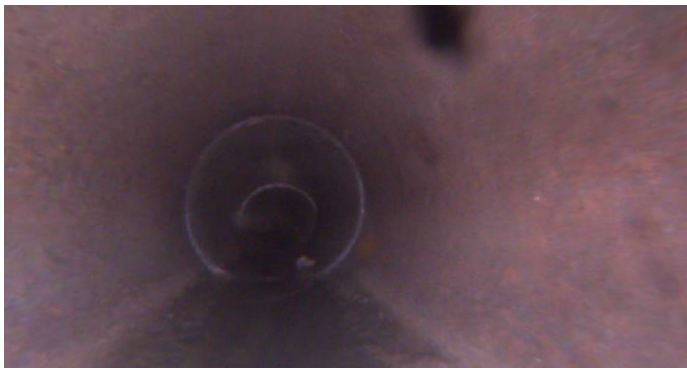
Code: **MMC**  
Description: **Material Change**

Distance (ft): **21.7**  
Structural Grade: **0**  
O&M Grade: **0**  
Clock Start/From:  
Clock To:  
1st Value:  
2nd Value:  
Value Percent:  
Continuous Index:  
Within 8" of Joint: **NO**  
Remarks: **VCP**

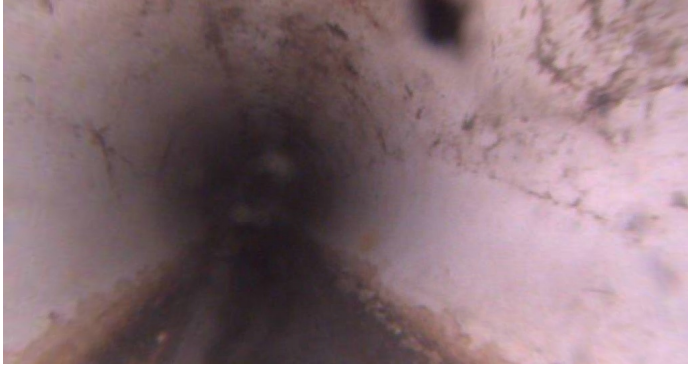
Code: **MMC**  
Description: **Material Change**

Distance (ft): **25.7**  
Structural Grade: **0**  
O&M Grade: **0**  
Clock Start/From:  
Clock To:  
1st Value:  
2nd Value:  
Value Percent:  
Continuous Index:  
Within 8" of Joint: **NO**  
Remarks: **PVC**

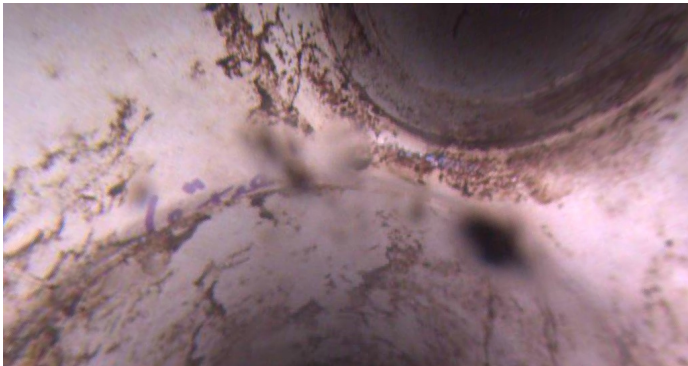
Code: **TF**  
Description: **Tap Factory**

Distance (ft): **47.6**  
Structural Grade: **0**  
O&M Grade: **0**  
Clock Start/From: **2**  
Clock To:  
1st Value: **4.000**  
2nd Value:  
Value Percent:  
Continuous Index:  
Within 8" of Joint:  
Remarks:

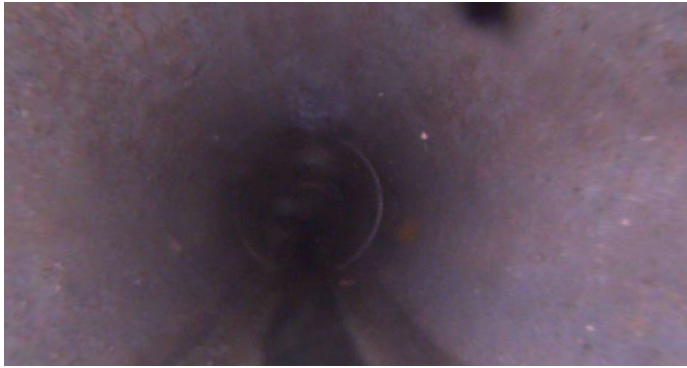
Code: **MMC**  
Description: **Material Change**

Distance (ft): **51.7**  
Structural Grade: **0**  
O&M Grade: **0**  
Clock Start/From:  
Clock To:  
1st Value:  
2nd Value:  
Value Percent:  
Continuous Index:  
Within 8" of Joint: **NO**  
Remarks: **VCP**

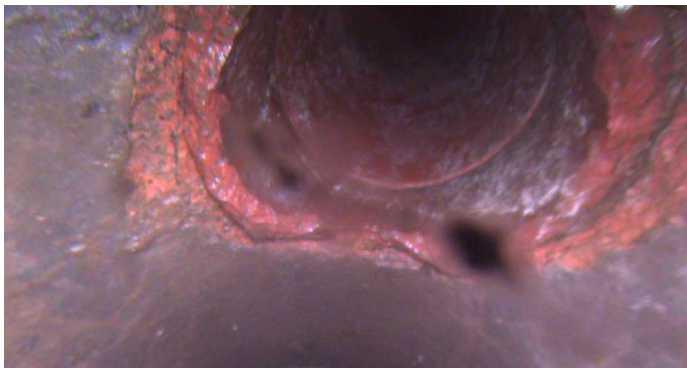
Code: **TB**  
Description: **Tap Break-in**

Distance (ft): **56.3**  
Structural Grade: **0**  
O&M Grade: **0**  
Clock Start/From: **1**  
Clock To:  
1st Value: **4.000**  
2nd Value:  
Value Percent:  
Continuous Index:  
Within 8" of Joint:  
Remarks:

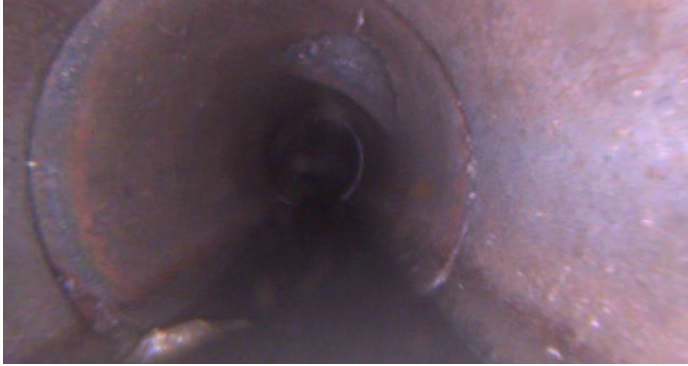
Code:	<b>MSA</b>
Description:	<b>Abandoned Survey</b>
Distance (ft):	<b>77.1</b>
Structural Grade:	<b>0</b>
O&M Grade:	<b>0</b>
Clock Start/From:	
Clock To:	
1st Value:	
2nd Value:	
Value Percent:	
Continuous Index:	
Within 8" of Joint:	<b>NO</b>
Remarks:	<b>No blockage</b>
