## Profile/Photo Observation Report

Street:	<b>ALLEY BETWEEN W 40TH AVE &amp; W 3</b>	Flow Control:	<b>Not Controlled</b>
City:	<b>Hobart, IN</b>	Year Renewed:	
Location:	<b>Other</b>	Tape/Media #:	
Purpose:	<b>Not Known</b>	Dia/Height:	<b>10"</b>
Use:	<b>Sanitary</b>	Material:	<b>VCP</b>
Drain Area:	<b>NA</b>	Lining:	
Category:	<b>NA</b>		
Comment:

Location Details:		Direction of Survey:	<b>Upstream</b>
US MH:	<b>M-503-010</b>	DS MH:	<b>M-503-011</b>
		Total Length Surveyed (ft):	<b>7.1</b>

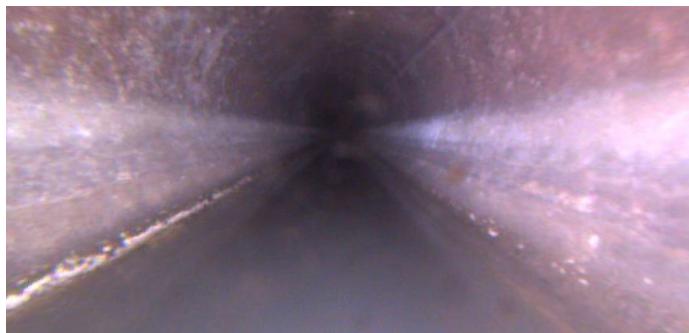
Code: **AMH**  
Description: **Manhole**

Distance (ft): **.0**  
Structural Grade: **0**  
O&M Grade: **0**  
Clock Start/From:  
Clock To:  
1st Value:  
2nd Value:  
Value Percent:  
Continuous Index:  
Within 8" of Joint: **NO**  
Remarks: **M-503-010**

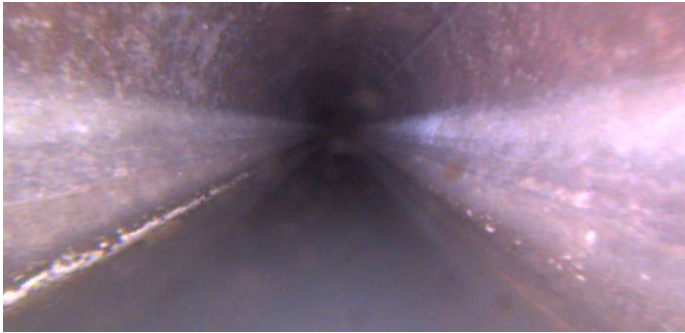
Code:	<b>MWL</b>
Description:	<b>Water Level</b>

Distance (ft):	<b>.0</b>
Structural Grade:	<b>0</b>
O&M Grade:	<b>0</b>
Clock Start/From:	
Clock To:	
1st Value:	
2nd Value:	
Value Percent:	<b>10.000</b>
Continuous Index:	
Within 8" of Joint:	<b>NO</b>
Remarks:

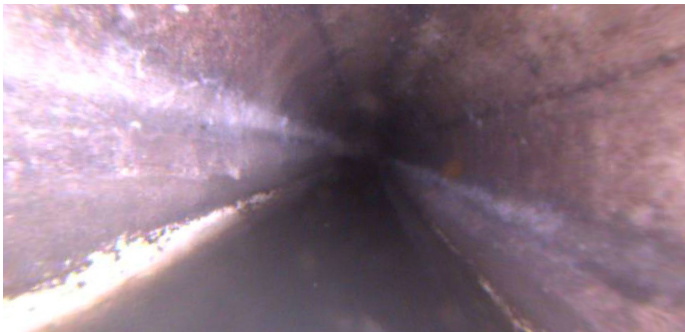
Code:	<b>MSA</b>
Description:	<b>Abandoned Survey</b>

Distance (ft):	<b>7.1</b>
Structural Grade:	<b>0</b>
O&M Grade:	<b>0</b>
Clock Start/From:	
Clock To:	
1st Value:	
2nd Value:	
Value Percent:	
Continuous Index:	
Within 8" of Joint:	<b>NO</b>
Remarks:	<b>UNKNOWN</b>
