## Profile/Photo Observation Report

Date:	<b>04/10/2018</b>	Weather:		Coding:	<b>PACP 6.0</b>
Pipe Length (ft):	<b>193.2</b>	Owner:	<b>NA</b>	Pre Clean:	<b>Not Known</b>
P.O.#:		Surveyor:	<b>Jen Costello</b>	PSR:	<b>P-503-011-010</b>
Customer:		Clean Date:	<b>01/01/1900</b>	Shape:	<b>C</b>

Street:	<b>W 40th ave</b>	Flow Control:	<b>Not Controlled</b>
City:	<b>Hobart, IN</b>	Year Renewed:	
Location:	<b>Other</b>	Tape/Media #:	
Purpose:	<b>Not Known</b>	Dia/Height:	<b>10"</b>
Use:	<b>Sanitary</b>	Material:	<b>VCP</b>
Drain Area:	<b>NA</b>	Lining:	
Category:	<b>NA</b>		
Comment:

Location Details:		Direction of Survey:	<b>Upstream</b>
US MH:	<b>M-503-010</b>	DS MH:	<b>M-503-011</b>
		Total Length Surveyed (ft):	<b>7.1</b>

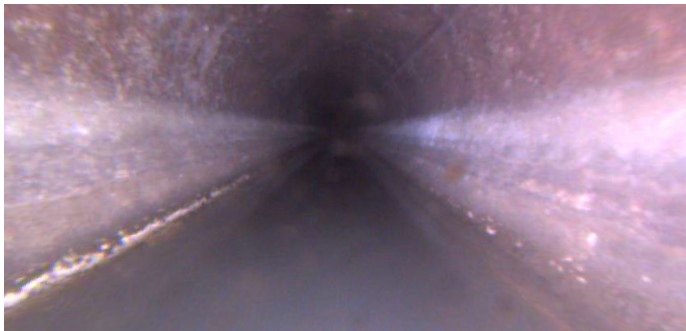
Code: **AMH**  
Description: **Manhole**

Distance (ft): **.0**  
Structural Grade: **0**  
O&M Grade: **0**  
Clock Start/From:  
Clock To:  
1st Value:  
2nd Value:  
Value Percent:  
Continuous Index:  
Within 8" of Joint: **NO**  
Remarks: **M-503-010**

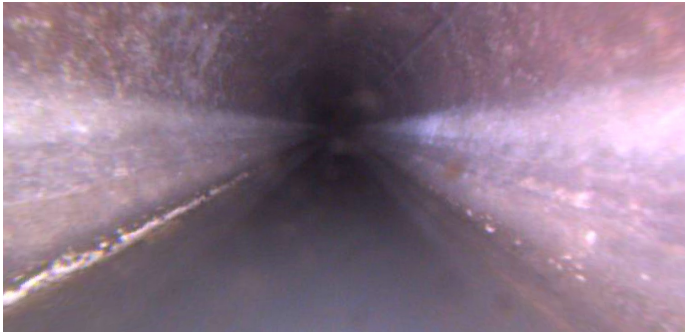
Code:	<b>MWL</b>
Description:	<b>Water Level</b>

Distance (ft):	<b>.0</b>
Structural Grade:	<b>0</b>
O&M Grade:	<b>0</b>
Clock Start/From:	
Clock To:	
1st Value:	
2nd Value:	
Value Percent:	<b>10.000</b>
Continuous Index:	
Within 8" of Joint:	<b>NO</b>
Remarks:

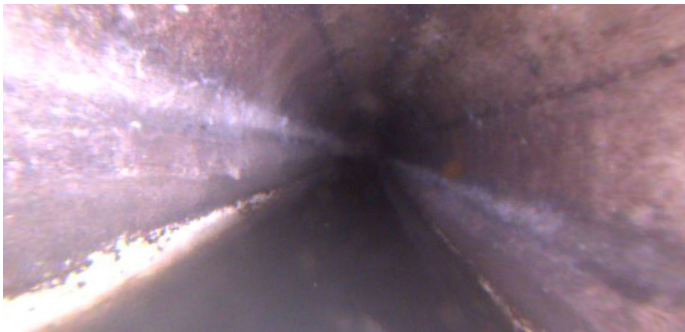
Code:	<b>MSA</b>
Description:	<b>Abandoned Survey</b>

Distance (ft):	<b>7.1</b>
Structural Grade:	<b>0</b>
O&M Grade:	<b>0</b>
Clock Start/From:	
Clock To:	
1st Value:	
2nd Value:	
Value Percent:	
Continuous Index:	
Within 8" of Joint:	<b>NO</b>
Remarks:	<b>UNKNOWN</b>
