Profile/Photo Observation Report

Date:	09/19/2021	Weather:		Coding:	PACP 7.0
Pipe Length (ft):	194.3	Owner:	City of Hobart	Pre Clean:	Light Cleaning
P.O.#:	YES502259	Surveyor:	S. Bucklin	PSR:	P-503-011-010
Customer:	City of Hobart	Clean Date:	09/06/2021	Shape:	C

Street:	West 39th Place	Flow Control:	Not Controlled
City:	Hobart, IN	Year Renewed:	
Location:	Alley	Tape/Media #:	
Purpose:	Routine Assessment	Dia/Height:	10"
Use:	Sanitary Sewage Pipe	Material:	VCP
Drain Area:		Lining:	None
Category:	NA		
Comment:			
Location Details:		Direction of Survey:	Downstream
US MH:	M-503-010	DS MH:	M-503-011
		Total Length Surveyed (ft):	194.3

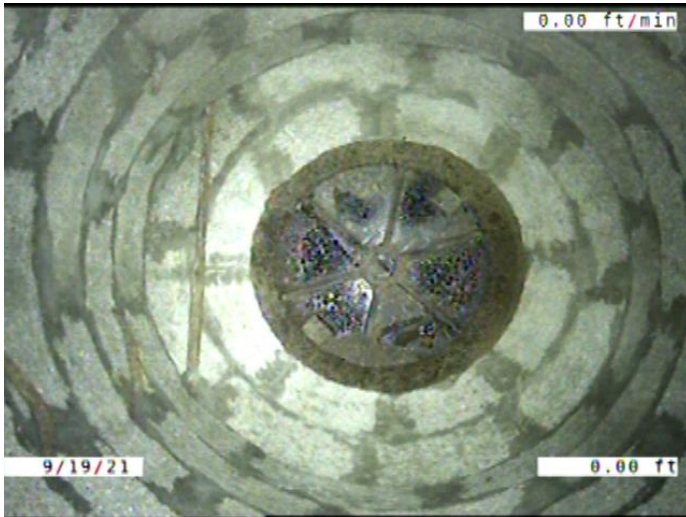
Code: **AMH**
Description: **Manhole**

Distance (ft): **.0**
Structural Grade: **0**
O&M Grade: **0**
Clock Start/From:
Clock To:
1st Value:
2nd Value:
Value Percent:
Continuous Index:
Within 8" of Joint: **NO**
Remarks: **M-503-010**

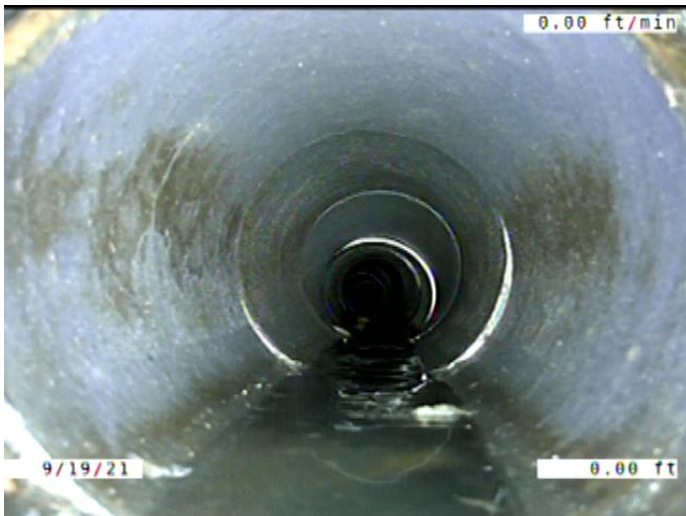
Code: **MWL**
Description: **Miscellaneous Water Level**

Distance (ft): **.0**
Structural Grade: **0**
O&M Grade: **0**
Clock Start/From:
Clock To:
1st Value:
2nd Value:
Value Percent: **5.000**
Continuous Index:
Within 8" of Joint: **NO**
Remarks:

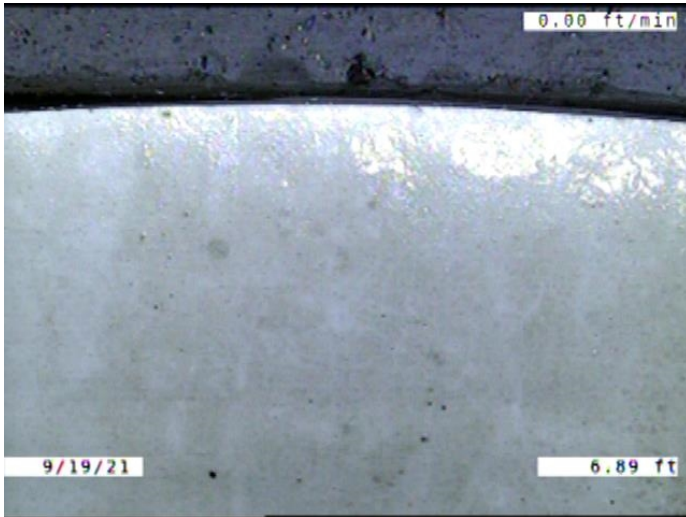
Code: **MMC**
Description: **Miscellaneous Material Change**

Distance (ft): **6.9**
Structural Grade: **0**
O&M Grade: **0**
Clock Start/From:
Clock To:
1st Value:
2nd Value:
Value Percent:
Continuous Index:
Within 8" of Joint: **NO**
Remarks: **VCP TO PVC**

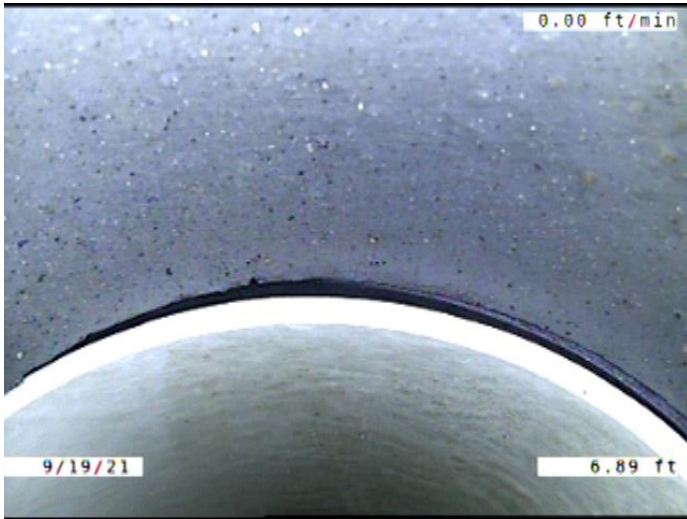
Code: **JOM**
Description: **Joint Offset Medium**

Distance (ft): **6.9**
Structural Grade: **3**
O&M Grade: **0**
Clock Start/From:
Clock To:
1st Value:
2nd Value:
Value Percent:
Continuous Index:
Within 8" of Joint: **NO**
Remarks:

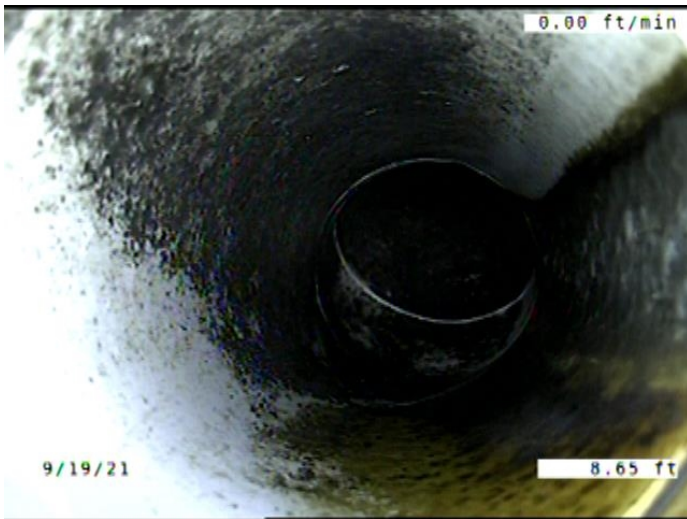
Code: **TF**
Description: **Tap Factory**

Distance (ft): **8.6**
Structural Grade: **0**
O&M Grade: **0**
Clock Start/From: **1**
Clock To:
1st Value: **4.000**
2nd Value:
Value Percent:
Continuous Index:
Within 8" of Joint: **YES**
Remarks:

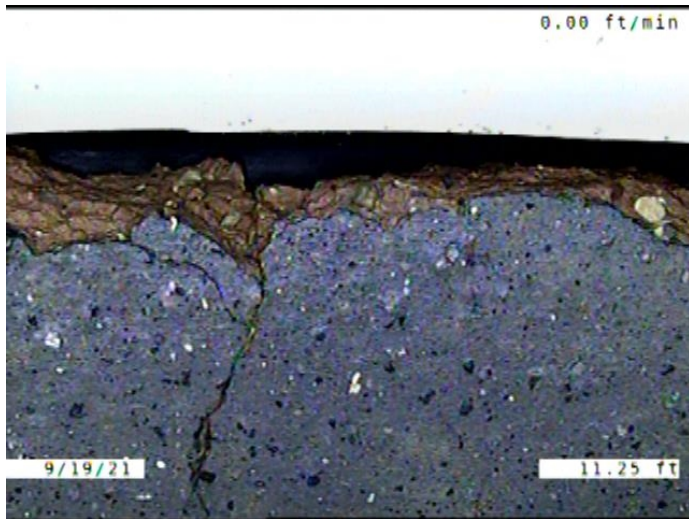
Code: **MMC**
Description: **Miscellaneous Material Change**

Distance (ft): **11.3**
Structural Grade: **0**
O&M Grade: **0**
Clock Start/From:
Clock To:
1st Value:
2nd Value:
Value Percent:
Continuous Index:
Within 8" of Joint: **NO**
Remarks: **PVC TO VCP**

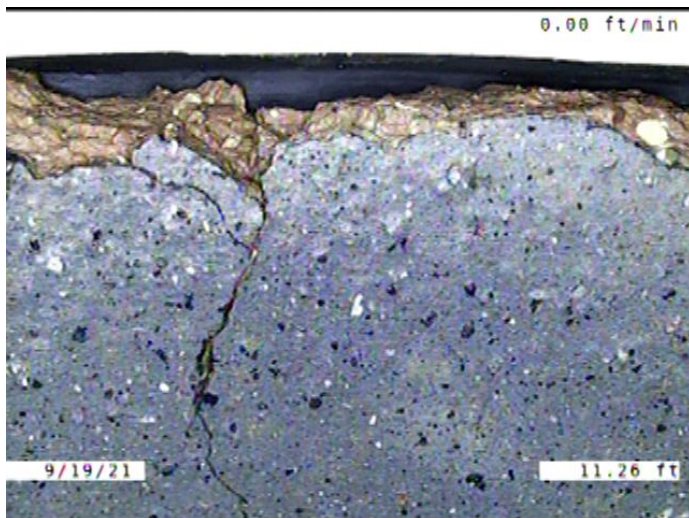
Code: **CL**
Description: **Crack Longitudinal**

Distance (ft): **11.3**
Structural Grade: **2**
O&M Grade: **0**
Clock Start/From: **12**
Clock To:
1st Value:
2nd Value:
Value Percent:
Continuous Index:
Within 8" of Joint: **YES**
Remarks:

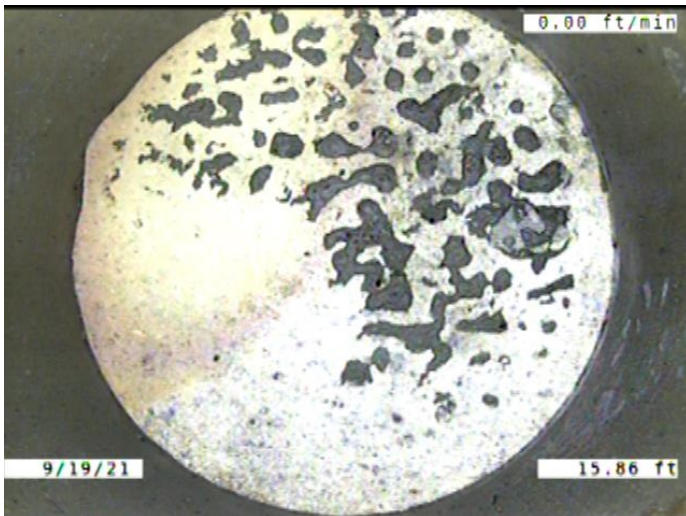
Code: **TFC**
 Description: **Tap Factory Capped**

Distance (ft): **15.9**
 Structural Grade: **0**
 O&M Grade: **0**
 Clock Start/From: **1**
 Clock To:
 1st Value: **4.000**
 2nd Value:
 Value Percent:
 Continuous Index:
 Within 8" of Joint: **YES**
 Remarks:

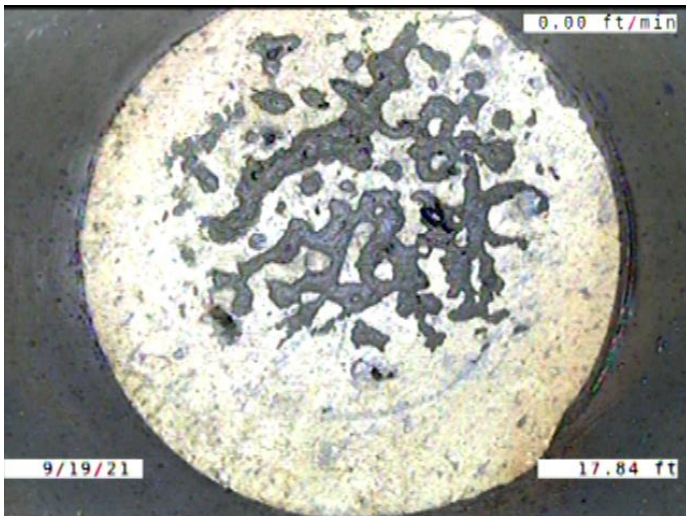
Code: **TFC**
 Description: **Tap Factory Capped**

Distance (ft): **17.8**
 Structural Grade: **0**
 O&M Grade: **0**
 Clock Start/From: **11**
 Clock To:
 1st Value: **4.000**
 2nd Value:
 Value Percent:
 Continuous Index:
 Within 8" of Joint: **YES**
 Remarks:

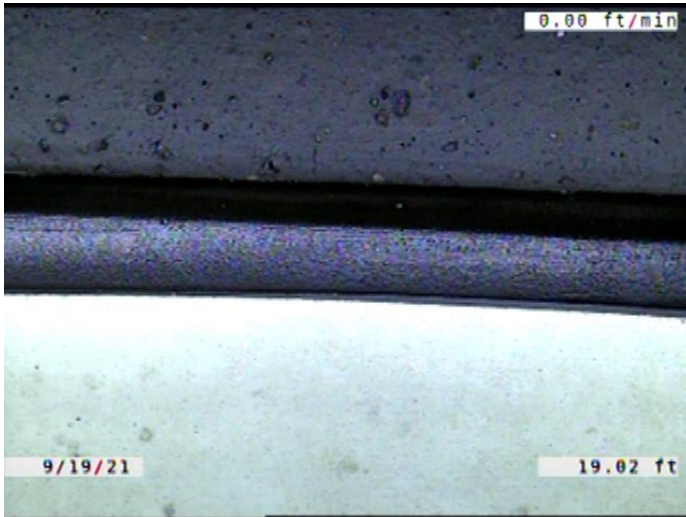
Code: **MMC**
Description: **Miscellaneous Material Change**

Distance (ft): **19.0**
Structural Grade: **0**
O&M Grade: **0**
Clock Start/From:
Clock To:
1st Value:
2nd Value:
Value Percent:
Continuous Index:
Within 8" of Joint: **NO**
Remarks: **VCP TO PVC**

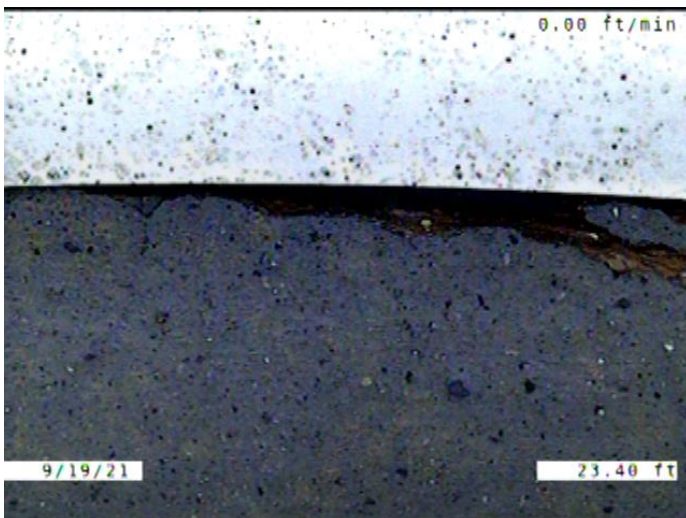
Code: **MMC**
Description: **Miscellaneous Material Change**

Distance (ft): **23.4**
Structural Grade: **0**
O&M Grade: **0**
Clock Start/From:
Clock To:
1st Value:
2nd Value:
Value Percent:
Continuous Index:
Within 8" of Joint: **NO**
Remarks: **PVC TO VCP**

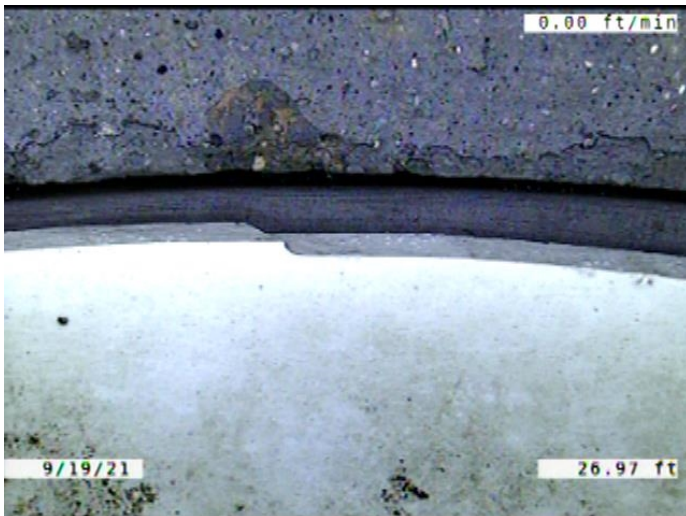
Code: **MMC**
 Description: **Miscellaneous Material Change**

Distance (ft): **27.0**
 Structural Grade: **0**
 O&M Grade: **0**
 Clock Start/From:
 Clock To:
 1st Value:
 2nd Value:
 Value Percent:
 Continuous Index:
 Within 8" of Joint: **NO**
 Remarks: **VCP TO PVC**

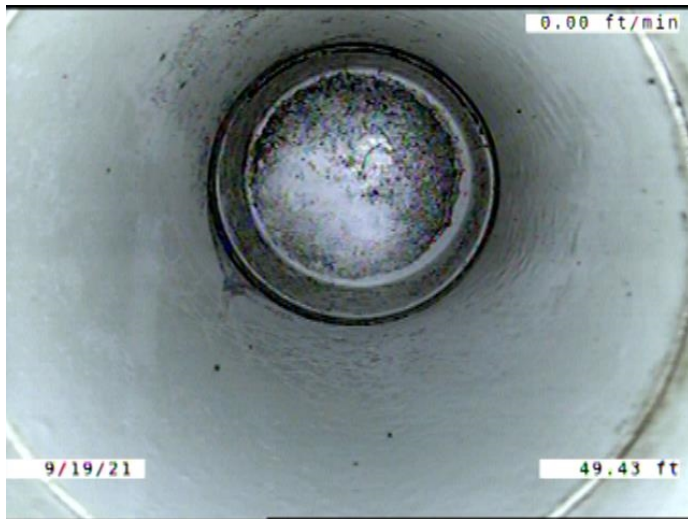
Code: **TFC**
 Description: **Tap Factory Capped**

Distance (ft): **49.4**
 Structural Grade: **0**
 O&M Grade: **0**
 Clock Start/From: **1**
 Clock To:
 1st Value: **4.000**
 2nd Value:
 Value Percent:
 Continuous Index:
 Within 8" of Joint: **YES**
 Remarks:

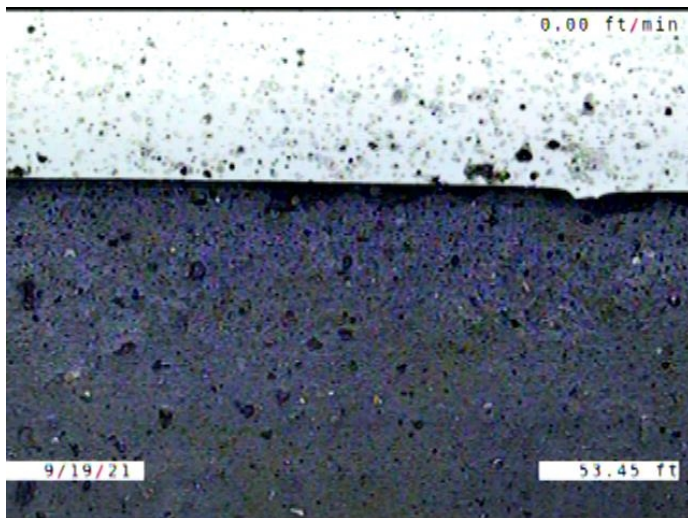
Code: **MMC**
 Description: **Miscellaneous Material Change**

Distance (ft): **53.5**
 Structural Grade: **0**
 O&M Grade: **0**
 Clock Start/From:
 Clock To:
 1st Value:
 2nd Value:
 Value Percent:
 Continuous Index:
 Within 8" of Joint: **NO**
 Remarks: **PVC TO VCP**

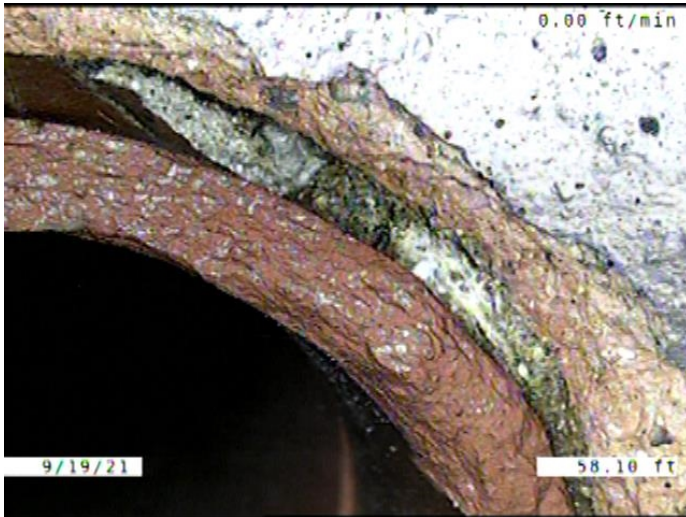
Code: **B**
Description: **Broken**

Distance (ft): **58.1**
Structural Grade: **4**
O&M Grade: **0**
Clock Start/From: **11**
Clock To: **2**
1st Value:
2nd Value:
Value Percent:
Continuous Index:
Within 8" of Joint: **YES**
Remarks:

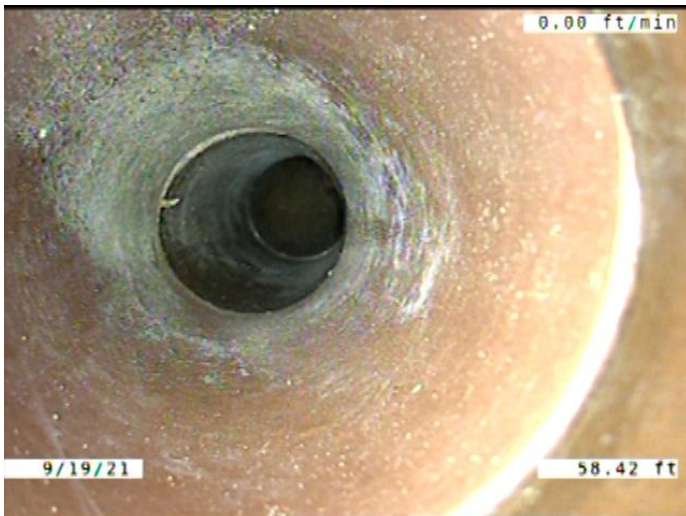
Code: **TBI**
Description: **Tap Break-in Intruding**

Distance (ft): **58.4**
Structural Grade: **0**
O&M Grade: **2**
Clock Start/From: **1**
Clock To:
1st Value: **4.000**
2nd Value: **1.000**
Value Percent:
Continuous Index:
Within 8" of Joint: **YES**
Remarks:

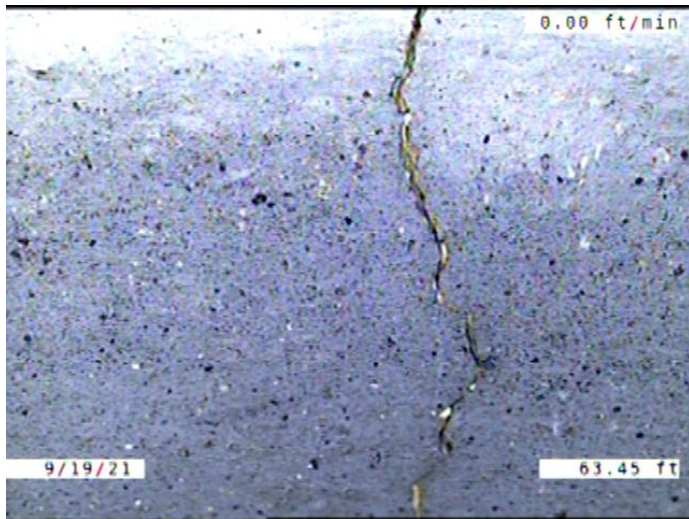
Code: **FS**
Description: **Fracture Spiral**

Distance (ft): **63.4**
Structural Grade: **3**
O&M Grade: **0**
Clock Start/From: **11**
Clock To: **12**
1st Value:
2nd Value:
Value Percent:
Continuous Index:
Within 8" of Joint: **YES**
Remarks:

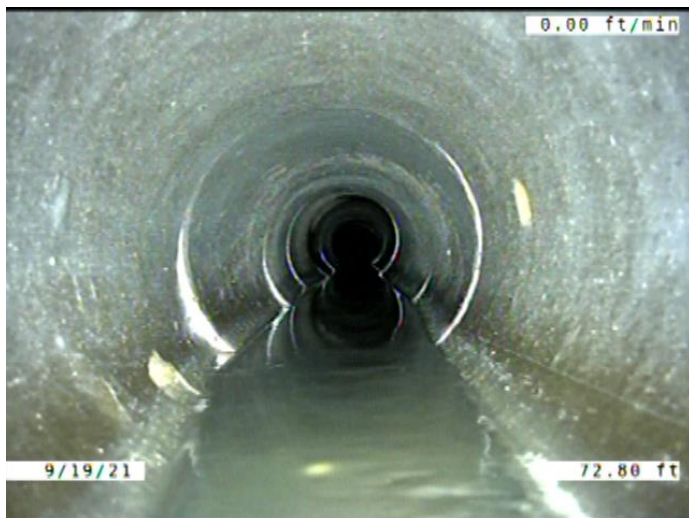
Code: **MWLS**
Description: **Miscellaneous Water Level Sag**

Distance (ft): **72.8**
Structural Grade: **2**
O&M Grade: **0**
Clock Start/From:
Clock To:
1st Value:
2nd Value:
Value Percent: **5.000**
Continuous Index: **S04**
Within 8" of Joint: **NO**
Remarks:

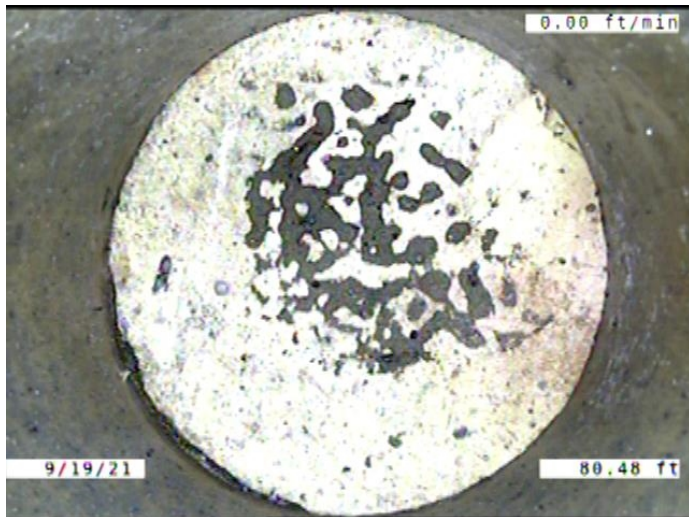
Code: **TFC**
 Description: **Tap Factory Capped**

Distance (ft): **80.5**
 Structural Grade: **0**
 O&M Grade: **0**
 Clock Start/From: **1**
 Clock To:
 1st Value: **4.000**
 2nd Value:
 Value Percent:
 Continuous Index:
 Within 8" of Joint: **YES**
 Remarks:

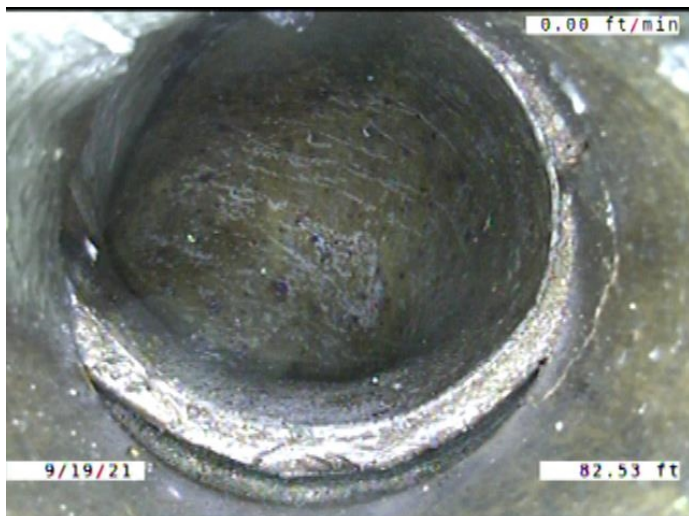
Code: **TFD**
 Description: **Tap Factory Defective**

Distance (ft): **82.5**
 Structural Grade: **0**
 O&M Grade: **3**
 Clock Start/From: **11**
 Clock To:
 1st Value: **4.000**
 2nd Value:
 Value Percent:
 Continuous Index:
 Within 8" of Joint: **YES**
 Remarks: **CONSTANTLY RUNNING WATER**

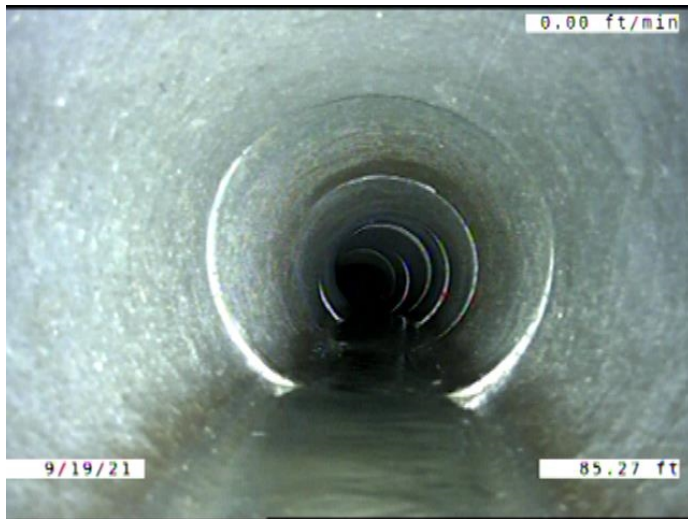
Code: **MWLS**
 Description: **Miscellaneous Water Level Sag**

Distance (ft): **85.3**
 Structural Grade: **2**
 O&M Grade: **0**
 Clock Start/From:
 Clock To:
 1st Value:
 2nd Value:
 Value Percent: **5.000**
 Continuous Index: **F04**
 Within 8" of Joint: **NO**
 Remarks:

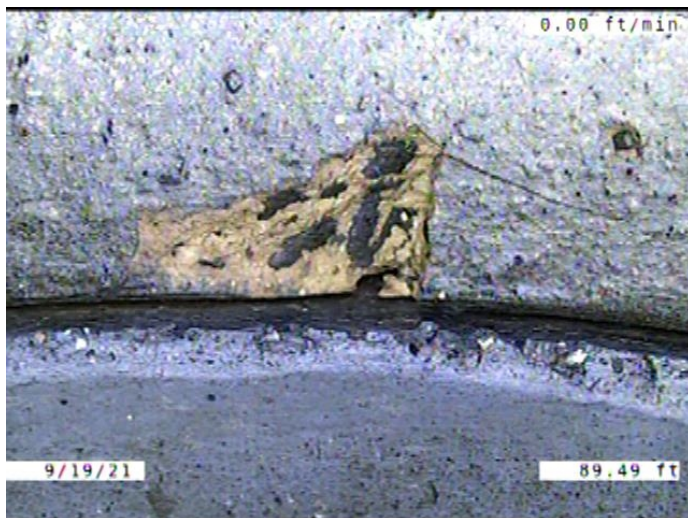
Code: **SZ**
 Description: **Surface Damage Other**

Distance (ft): **89.5**
 Structural Grade: **0**
 O&M Grade: **0**
 Clock Start/From: **12**
 Clock To: **1**
 1st Value:
 2nd Value:
 Value Percent:
 Continuous Index:
 Within 8" of Joint: **YES**
 Remarks: **A PIECE CHIPPED AWAY FROM THE JOINT**

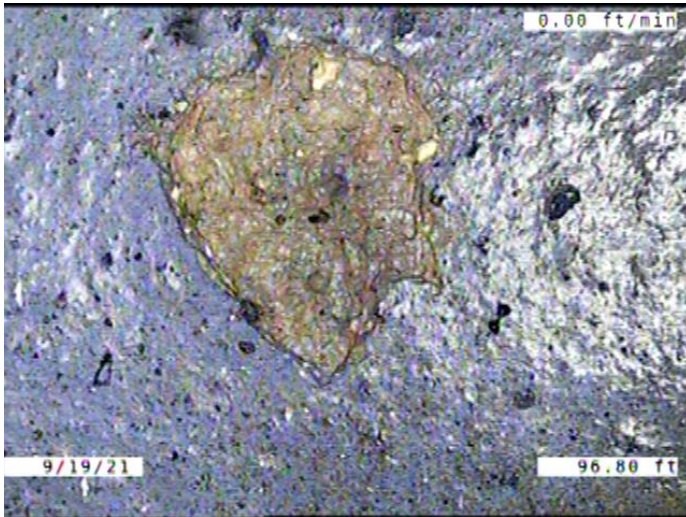
Code: **SSS**
 Description: **Surface Damage Surface Spalling**

Distance (ft): **96.8**
 Structural Grade: **2**
 O&M Grade: **0**
 Clock Start/From: **8**
 Clock To: **9**
 1st Value:
 2nd Value:
 Value Percent:
 Continuous Index:
 Within 8" of Joint: **YES**
 Remarks:

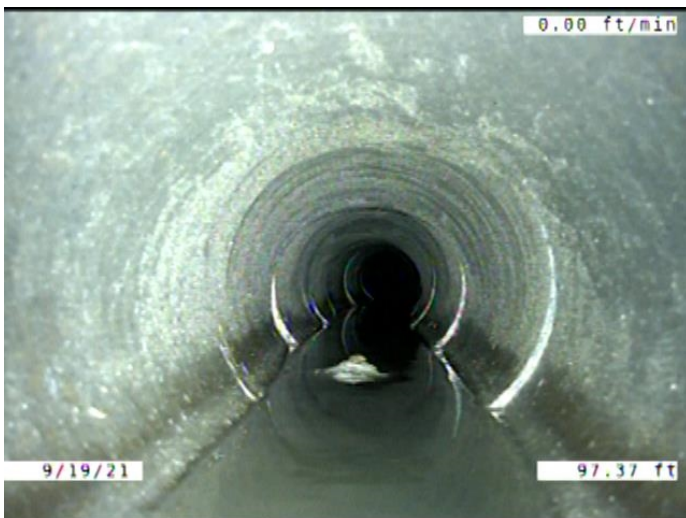
Code: **MWLS**
 Description: **Miscellaneous Water Level Sag**

Distance (ft): **97.4**
 Structural Grade: **2**
 O&M Grade: **0**
 Clock Start/From:
 Clock To:
 1st Value:
 2nd Value:
 Value Percent: **5.000**
 Continuous Index: **S05**
 Within 8" of Joint: **NO**
 Remarks:

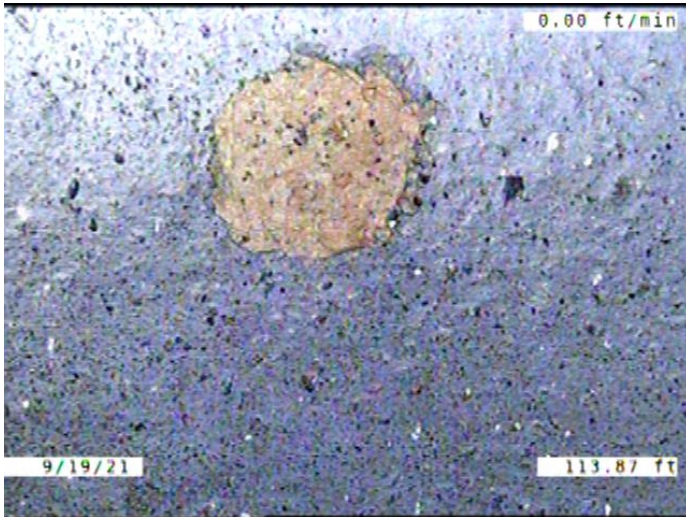
Code: **SSS**
 Description: **Surface Damage Surface Spalling**

Distance (ft): **113.9**
 Structural Grade: **2**
 O&M Grade: **0**
 Clock Start/From: **10**
 Clock To:
 1st Value:
 2nd Value:
 Value Percent:
 Continuous Index:
 Within 8" of Joint: **YES**
 Remarks:

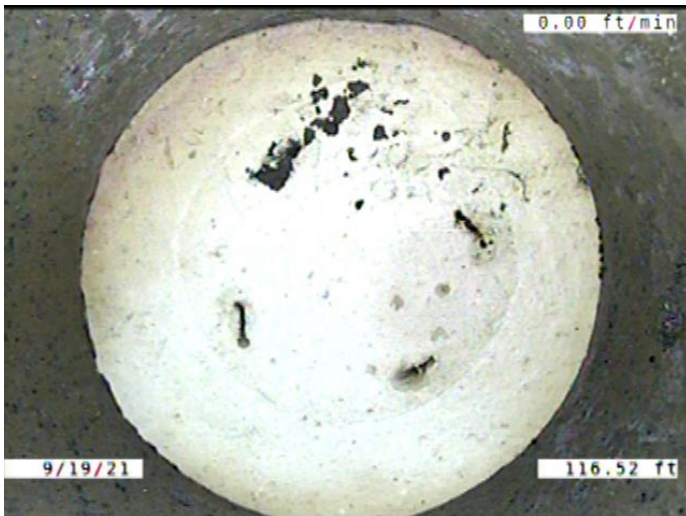
Code: **TFC**
 Description: **Tap Factory Capped**

Distance (ft): **116.5**
 Structural Grade: **0**
 O&M Grade: **0**
 Clock Start/From: **1**
 Clock To:
 1st Value: **4.000**
 2nd Value:
 Value Percent:
 Continuous Index:
 Within 8" of Joint: **YES**
 Remarks:

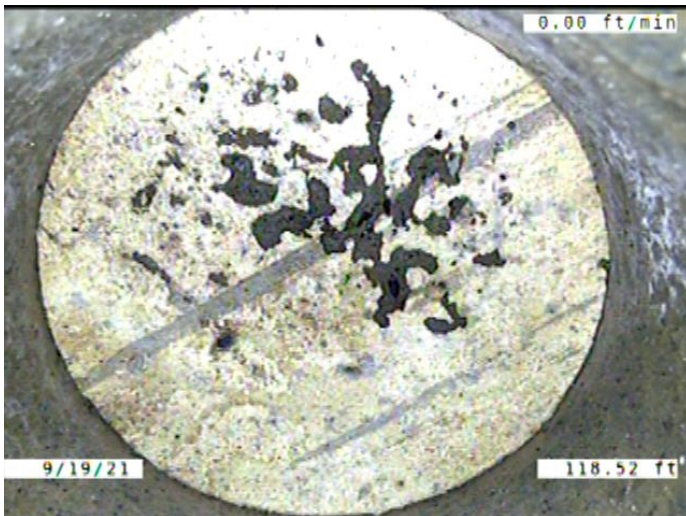
Code: **TFC**
Description: **Tap Factory Capped**

Distance (ft): **118.5**
Structural Grade: **0**
O&M Grade: **0**
Clock Start/From: **11**
Clock To:
1st Value: **4.000**
2nd Value:
Value Percent:
Continuous Index:
Within 8" of Joint: **YES**
Remarks:

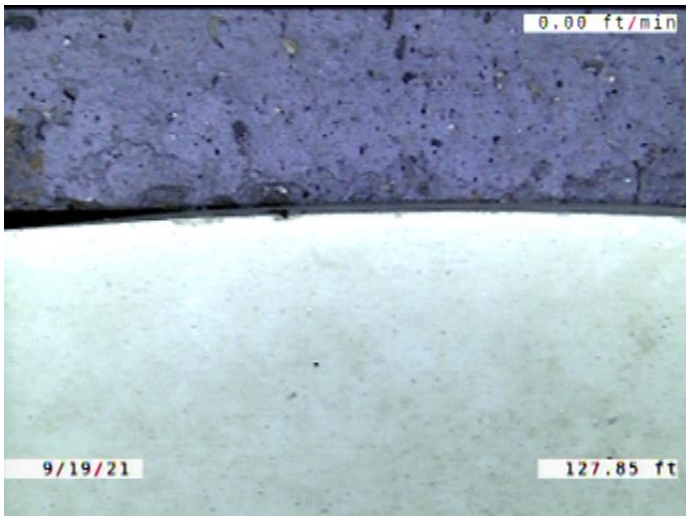
Code: **MMC**
Description: **Miscellaneous Material Change**

Distance (ft): **127.9**
Structural Grade: **0**
O&M Grade: **0**
Clock Start/From:
Clock To:
1st Value:
2nd Value:
Value Percent:
Continuous Index:
Within 8" of Joint: **NO**
Remarks: **VCP TO PVC**

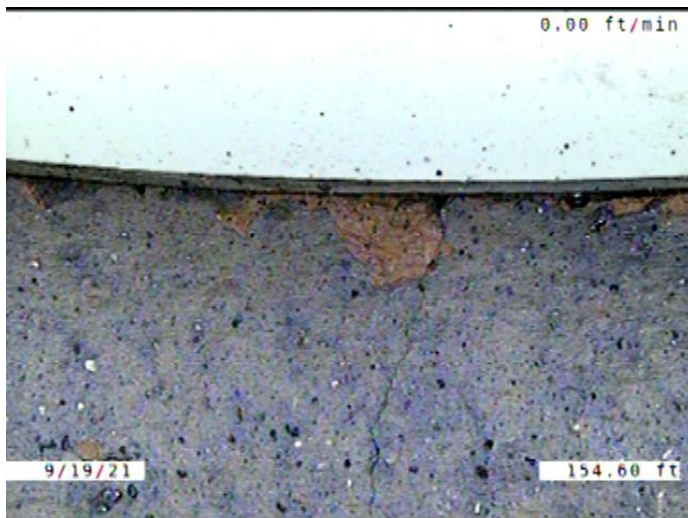
Code: **MMC**
 Description: **Miscellaneous Material Change**

Distance (ft): **154.6**
 Structural Grade: **0**
 O&M Grade: **0**
 Clock Start/From:
 Clock To:
 1st Value:
 2nd Value:
 Value Percent:
 Continuous Index:
 Within 8" of Joint: **NO**
 Remarks: **PVC TO VCP**

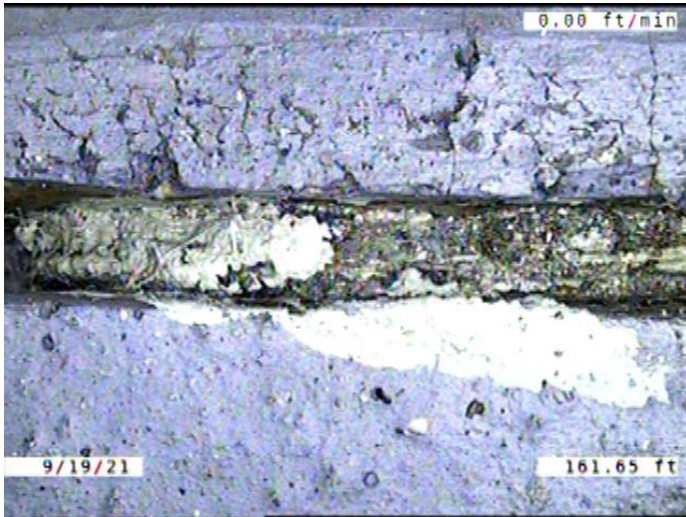
Code: **DAE**
 Description: **Deposits Attached Encrustation**

Distance (ft): **161.7**
 Structural Grade: **0**
 O&M Grade: **2**
 Clock Start/From: **3**
 Clock To: **8**
 1st Value:
 2nd Value:
 Value Percent: **5.000**
 Continuous Index:
 Within 8" of Joint: **YES**
 Remarks:

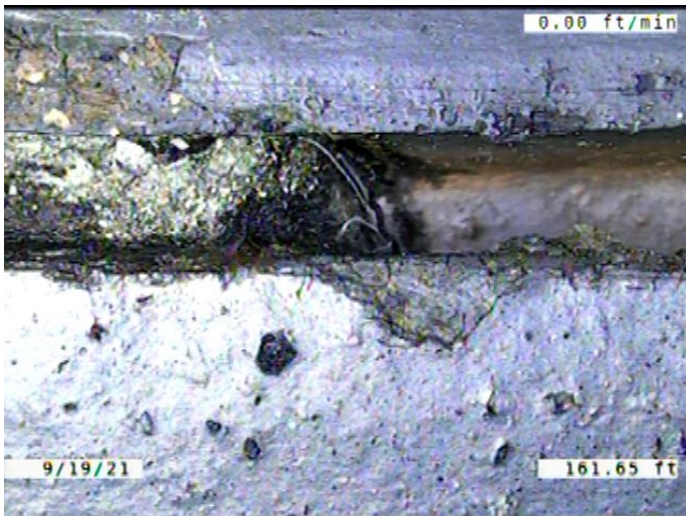
Code: **RFJ**
 Description: **Roots Fine Joint**

Distance (ft): **161.7**
 Structural Grade: **0**
 O&M Grade: **1**
 Clock Start/From: **3**
 Clock To: **8**
 1st Value:
 2nd Value:
 Value Percent:
 Continuous Index:
 Within 8" of Joint: **YES**
 Remarks:

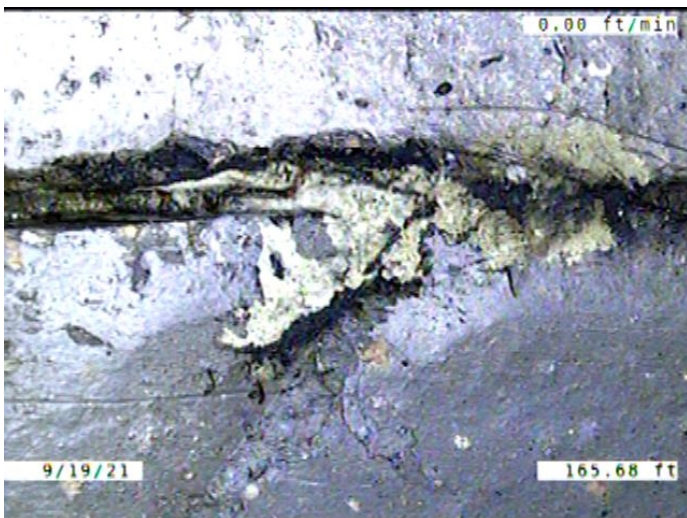
Code: **DAE**
Description: **Deposits Attached Encrustation**

Distance (ft): **165.7**
Structural Grade: **0**
O&M Grade: **2**
Clock Start/From: **7**
Clock To: **9**
1st Value:
2nd Value:
Value Percent: **5.000**
Continuous Index:
Within 8" of Joint: **YES**
Remarks:

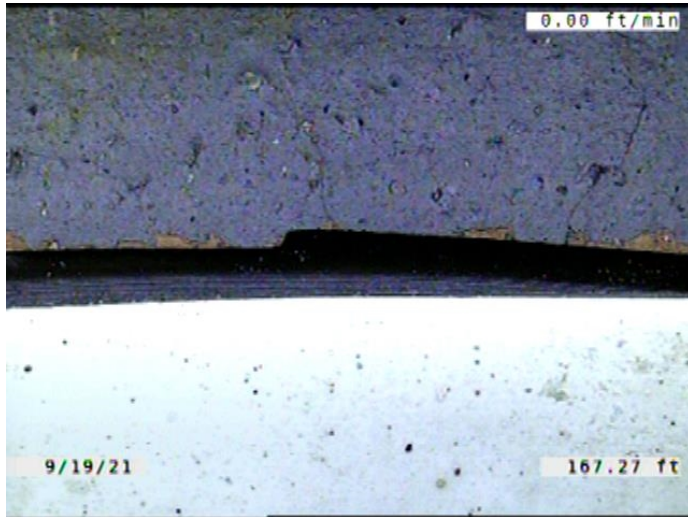
Code: **MMC**
 Description: **Miscellaneous Material Change**

Distance (ft): **167.3**
 Structural Grade: **0**
 O&M Grade: **0**
 Clock Start/From:
 Clock To:
 1st Value:
 2nd Value:
 Value Percent:
 Continuous Index:
 Within 8" of Joint: **NO**
 Remarks: **VCP TO PVC**

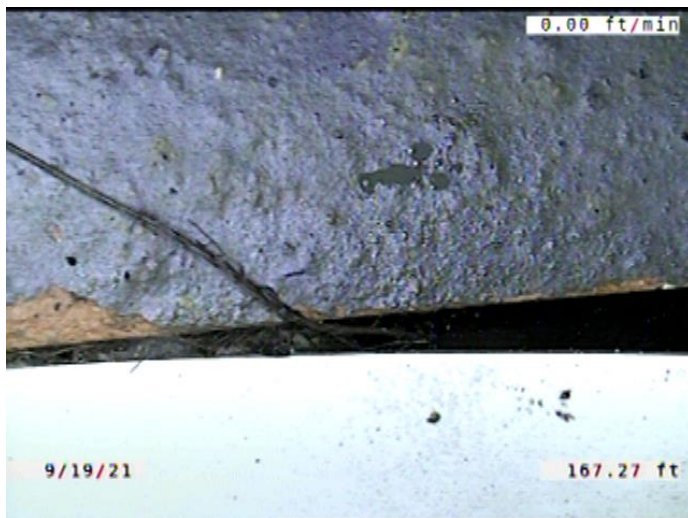
Code: **RFJ**
 Description: **Roots Fine Joint**

Distance (ft): **167.3**
 Structural Grade: **0**
 O&M Grade: **1**
 Clock Start/From: **3**
 Clock To: **9**
 1st Value:
 2nd Value:
 Value Percent:
 Continuous Index:
 Within 8" of Joint: **YES**
 Remarks:

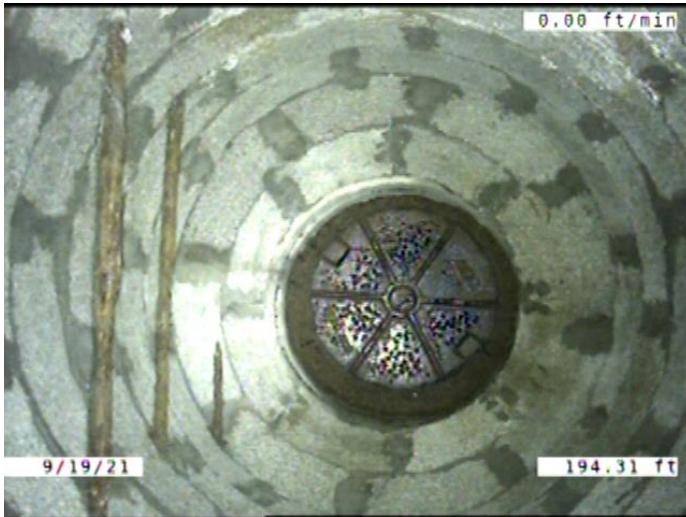
Code:	AMH
Description:	Manhole
Distance (ft):	194.3
Structural Grade:	0
O&M Grade:	0
Clock Start/From:	
Clock To:	
1st Value:	
2nd Value:	
Value Percent:	
Continuous Index:	
Within 8" of Joint:	NO
Remarks:	M-503-011
