Profile/Photo Observation Report

Date:	09/19/2021	Weather:		Coding:	PACP 7.0
Pipe Length (ft):	194.3	Owner:	City of Hobart	Pre Clean:	Light Cleaning
P.O.#:	YES502259	Surveyor:	S. Bucklin	PSR:	P-503-011-010
Customer:	City of Hobart	Clean Date:	09/06/2021	Shape:	C

Street:	West 39th Place	Flow Control:	Not Controlled
City:	Hobart, IN	Year Renewed:	
Location:	Alley	Tape/Media #:	
Purpose:	Routine Assessment	Dia/Height:	10"
Use:	Sanitary Sewage Pipe	Material:	VCP
Drain Area:		Lining:	None
Category:	NA		
Comment:			
Location Details:		Direction of Survey:	Downstream
US MH:	M-503-010	DS MH:	M-503-011
		Total Length Surveyed (ft):	194.3

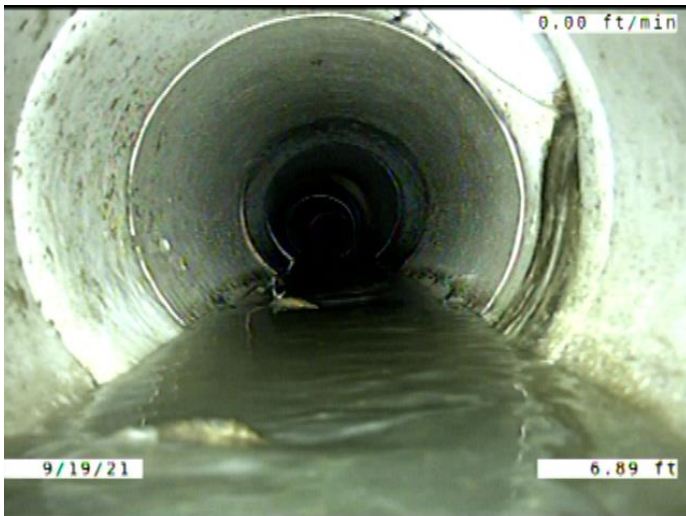
Code: **MWLS**
 Description: **Miscellaneous Water Level Sag**

Distance (ft): **6.9**
 Structural Grade: **2**
 O&M Grade: **0**
 Clock Start/From:
 Clock To:
 1st Value:
 2nd Value:
 Value Percent: **5.000**
 Continuous Index: **S01**
 Within 8" of Joint: **NO**
 Remarks:

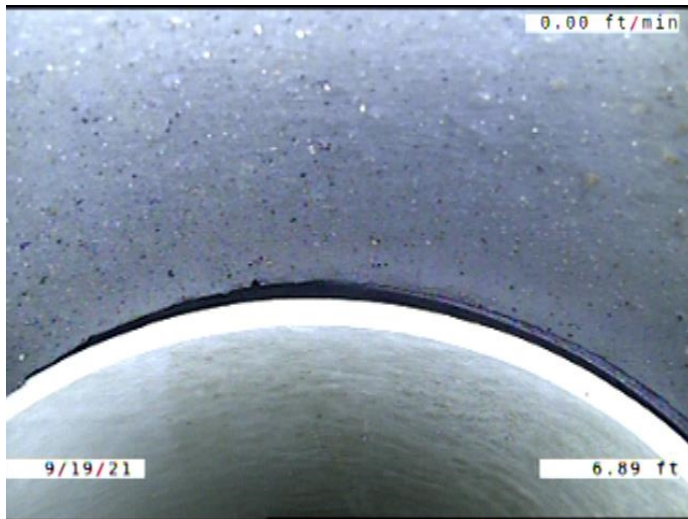
Code: **JOM**
 Description: **Joint Offset Medium**

Distance (ft): **6.9**
 Structural Grade: **3**
 O&M Grade: **0**
 Clock Start/From:
 Clock To:
 1st Value:
 2nd Value:
 Value Percent:
 Continuous Index:
 Within 8" of Joint: **NO**
 Remarks:

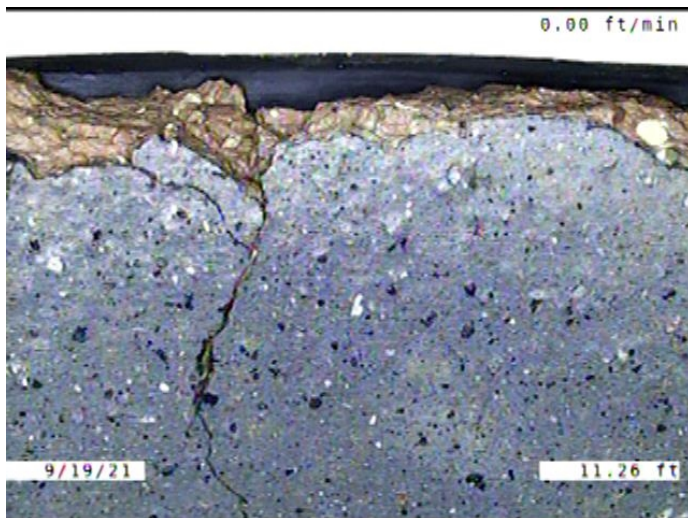
Code: **CL**
Description: **Crack Longitudinal**

Distance (ft): **11.3**
Structural Grade: **2**
O&M Grade: **0**
Clock Start/From: **12**
Clock To:
1st Value:
2nd Value:
Value Percent:
Continuous Index:
Within 8" of Joint: **YES**
Remarks:

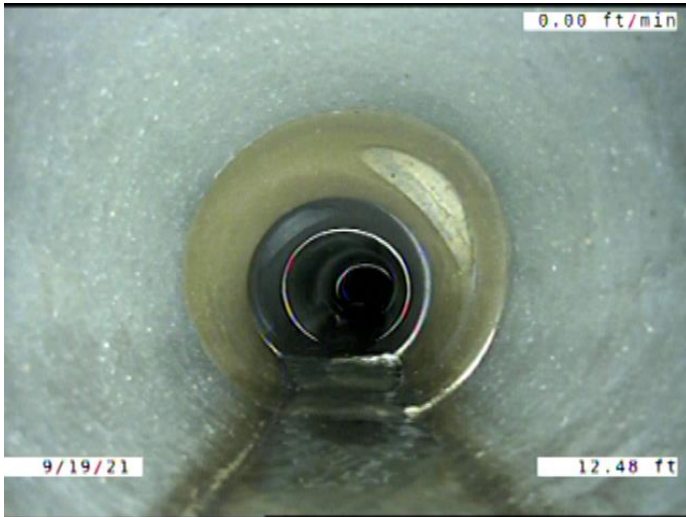
Code: **MWLS**
 Description: **Miscellaneous Water Level Sag**

Distance (ft): **12.5**
 Structural Grade: **2**
 O&M Grade: **0**
 Clock Start/From:
 Clock To:
 1st Value:
 2nd Value:
 Value Percent: **5.000**
 Continuous Index: **F01**
 Within 8" of Joint: **NO**
 Remarks:

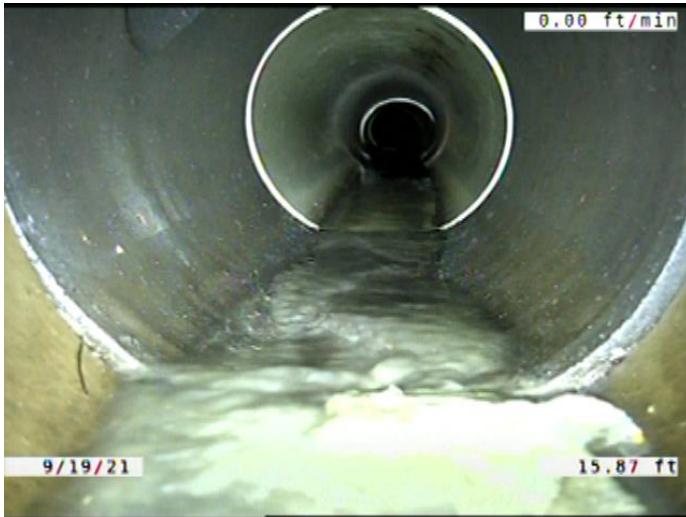
Code: **DSF**
 Description: **Deposits Settled Fine**

Distance (ft): **15.9**
 Structural Grade: **0**
 O&M Grade: **2**
 Clock Start/From: **5**
 Clock To: **7**
 1st Value:
 2nd Value:
 Value Percent: **5.000**
 Continuous Index: **S02**
 Within 8" of Joint: **YES**
 Remarks:

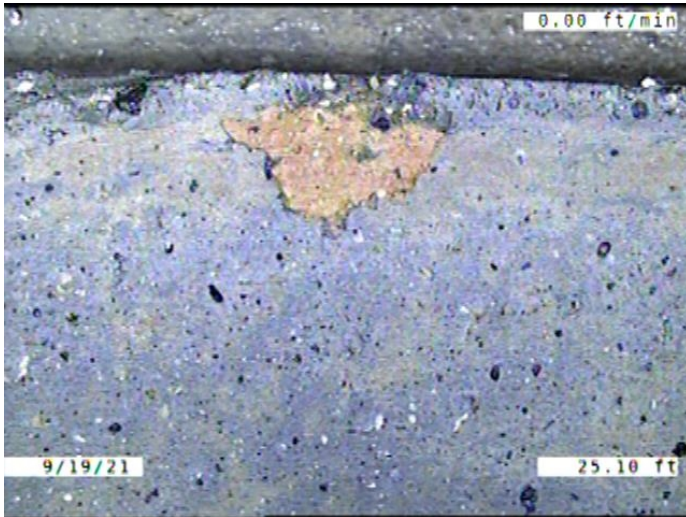
Code: **SSS**
 Description: **Surface Damage Surface Spalling**

Distance (ft): **25.1**
 Structural Grade: **2**
 O&M Grade: **0**
 Clock Start/From: **12**
 Clock To:
 1st Value:
 2nd Value:
 Value Percent:
 Continuous Index:
 Within 8" of Joint: **YES**
 Remarks:

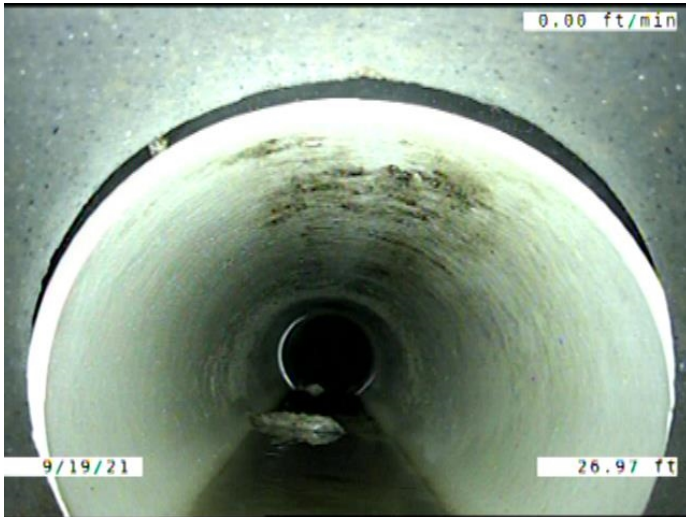
Code: **JOM**
 Description: **Joint Offset Medium**

Distance (ft): **27.0**
 Structural Grade: **3**
 O&M Grade: **0**
 Clock Start/From:
 Clock To:
 1st Value:
 2nd Value:
 Value Percent:
 Continuous Index:
 Within 8" of Joint: **NO**
 Remarks:

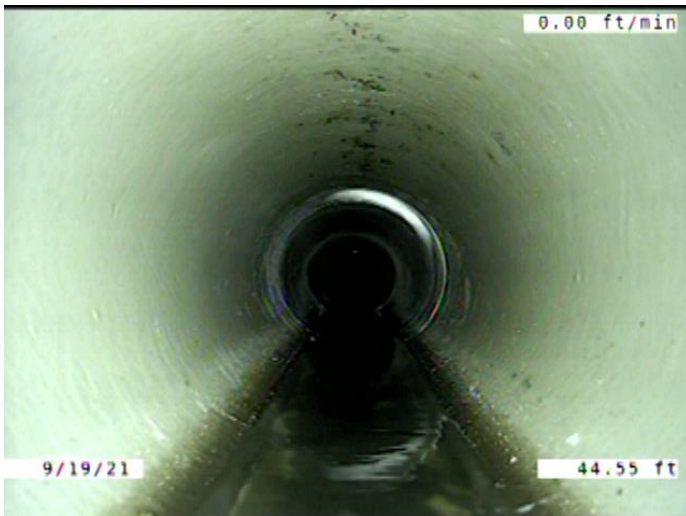
Code: **MWLS**
 Description: **Miscellaneous Water Level Sag**

Distance (ft): **44.5**
 Structural Grade: **2**
 O&M Grade: **0**
 Clock Start/From:
 Clock To:
 1st Value:
 2nd Value:
 Value Percent: **5.000**
 Continuous Index: **S03**
 Within 8" of Joint: **NO**
 Remarks:

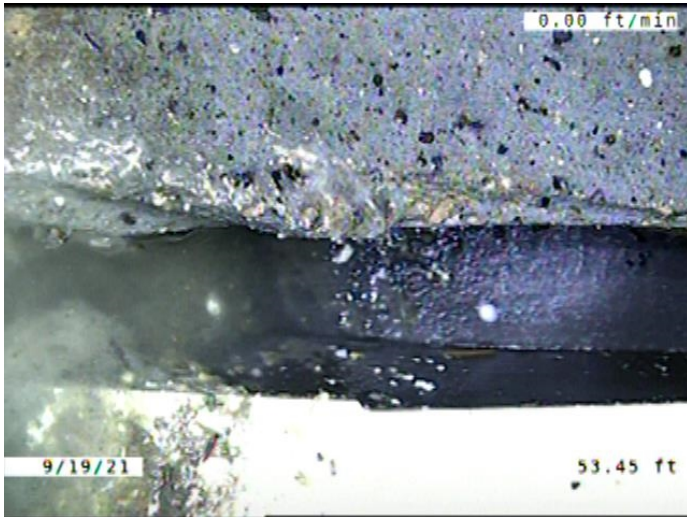
Code: **JAM**
 Description: **Joint Angular Medium**

Distance (ft): **53.5**
 Structural Grade: **3**
 O&M Grade: **0**
 Clock Start/From:
 Clock To:
 1st Value:
 2nd Value:
 Value Percent:
 Continuous Index:
 Within 8" of Joint: **NO**
 Remarks:

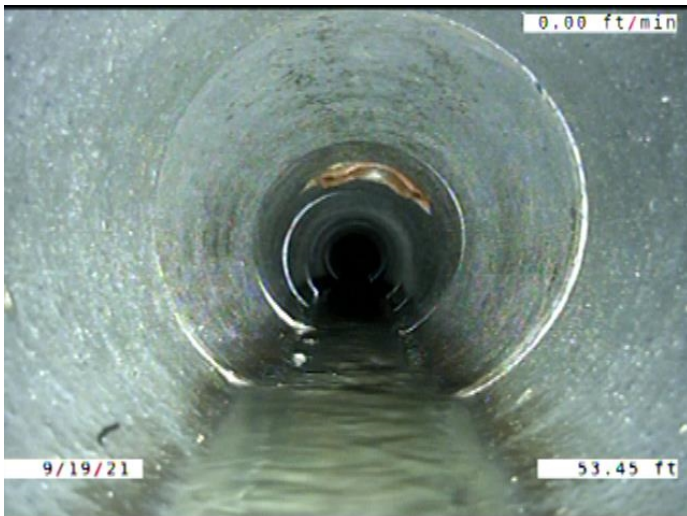
Code: **MWLS**
 Description: **Miscellaneous Water Level Sag**

Distance (ft): **53.5**
 Structural Grade: **2**
 O&M Grade: **0**
 Clock Start/From:
 Clock To:
 1st Value:
 2nd Value:
 Value Percent: **5.000**
 Continuous Index: **F03**
 Within 8" of Joint: **NO**
 Remarks:

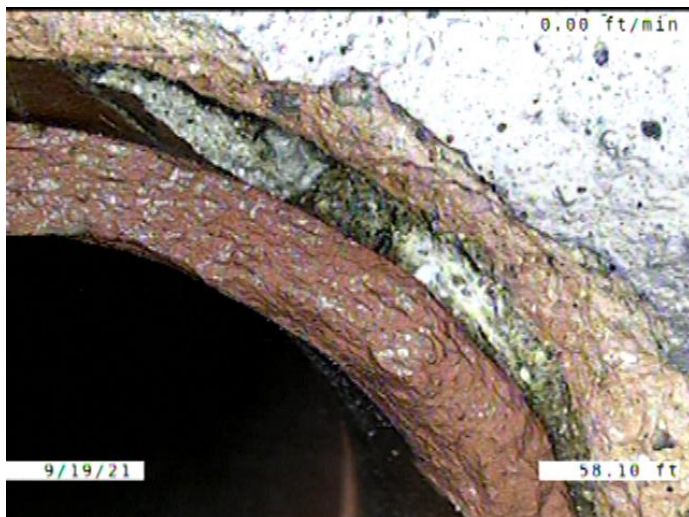
Code: **B**
 Description: **Broken**

Distance (ft): **58.1**
 Structural Grade: **4**
 O&M Grade: **0**
 Clock Start/From: **11**
 Clock To: **2**
 1st Value:
 2nd Value:
 Value Percent:
 Continuous Index:
 Within 8" of Joint: **YES**
 Remarks:

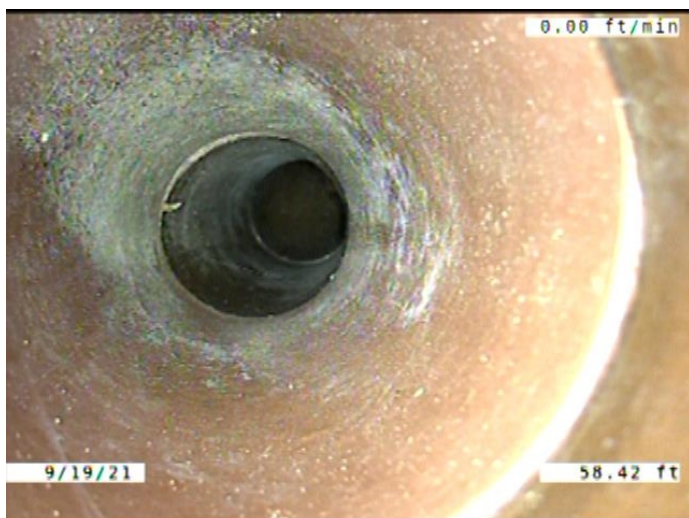
Code: **TBI**
 Description: **Tap Break-in Intruding**

Distance (ft): **58.4**
 Structural Grade: **0**
 O&M Grade: **2**
 Clock Start/From: **1**
 Clock To:
 1st Value: **4.000**
 2nd Value: **1.000**
 Value Percent:
 Continuous Index:
 Within 8" of Joint: **YES**
 Remarks:

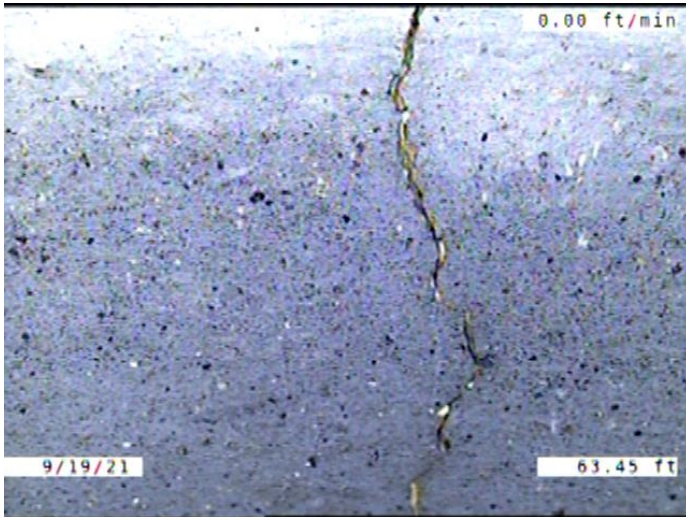
Code: **FS**
 Description: **Fracture Spiral**

Distance (ft): **63.4**
 Structural Grade: **3**
 O&M Grade: **0**
 Clock Start/From: **11**
 Clock To: **12**
 1st Value:
 2nd Value:
 Value Percent:
 Continuous Index:
 Within 8" of Joint: **YES**
 Remarks:

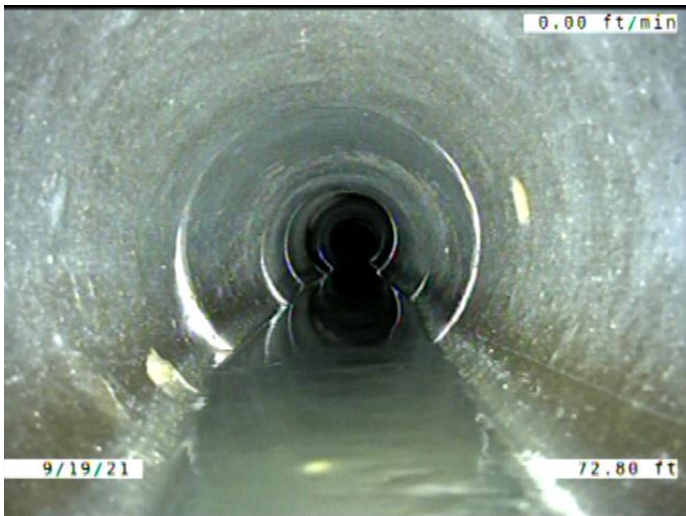
Code: **MWLS**
 Description: **Miscellaneous Water Level Sag**

Distance (ft): **72.8**
 Structural Grade: **2**
 O&M Grade: **0**
 Clock Start/From:
 Clock To:
 1st Value:
 2nd Value:
 Value Percent: **5.000**
 Continuous Index: **S04**
 Within 8" of Joint: **NO**
 Remarks:

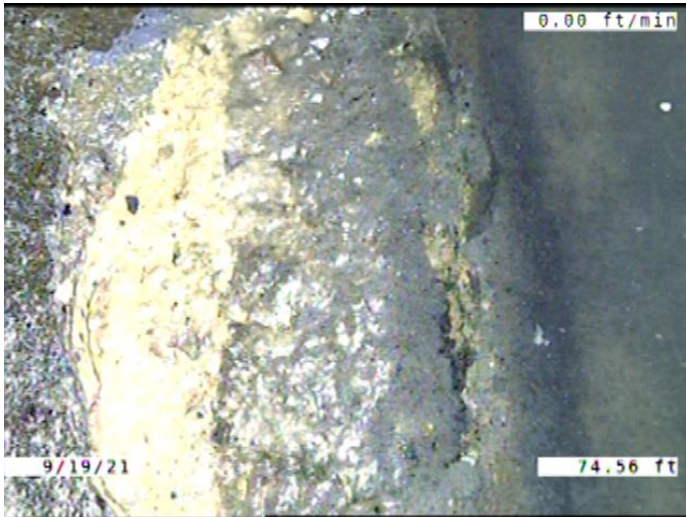
Code: **SSS**
Description: **Surface Damage Surface Spalling**

Distance (ft): **74.6**
Structural Grade: **2**
O&M Grade: **0**
Clock Start/From: **7**
Clock To: **8**
1st Value:
2nd Value:
Value Percent:
Continuous Index:
Within 8" of Joint: **YES**
Remarks:

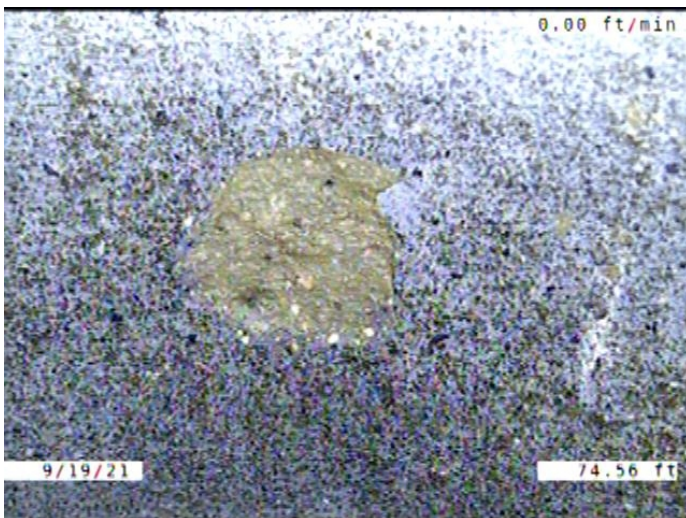
Code: **SSS**
Description: **Surface Damage Surface Spalling**

Distance (ft): **74.6**
Structural Grade: **2**
O&M Grade: **0**
Clock Start/From: **2**
Clock To:
1st Value:
2nd Value:
Value Percent:
Continuous Index:
Within 8" of Joint: **YES**
Remarks:

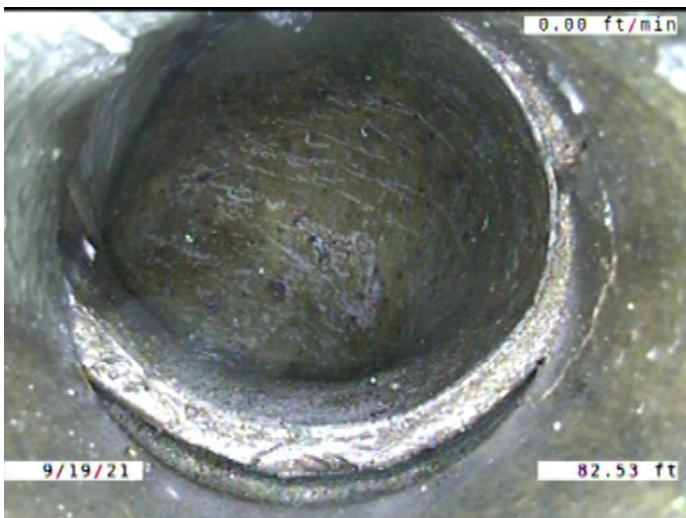
Code: **TFD**
 Description: **Tap Factory Defective**

Distance (ft): **82.5**
 Structural Grade: **0**
 O&M Grade: **3**
 Clock Start/From: **11**
 Clock To:
 1st Value: **4.000**
 2nd Value:
 Value Percent:
 Continuous Index:
 Within 8" of Joint: **YES**
 Remarks: **CONSTANTLY RUNNING WATER**

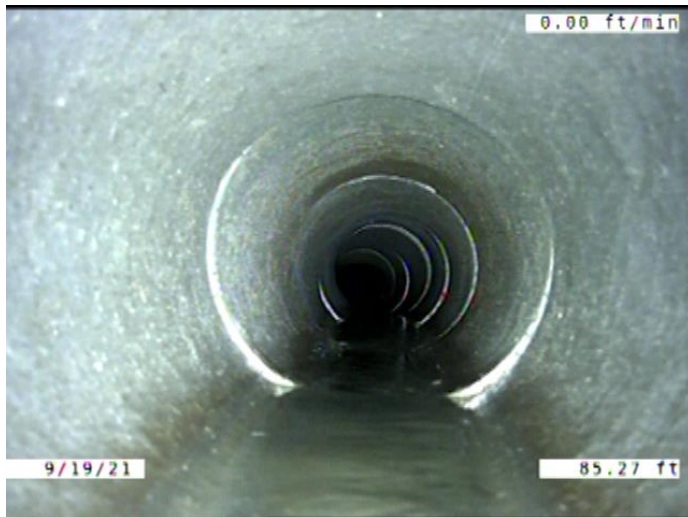
Code: **MWLS**
 Description: **Miscellaneous Water Level Sag**

Distance (ft): **85.3**
 Structural Grade: **2**
 O&M Grade: **0**
 Clock Start/From:
 Clock To:
 1st Value:
 2nd Value:
 Value Percent: **5.000**
 Continuous Index: **F04**
 Within 8" of Joint: **NO**
 Remarks:

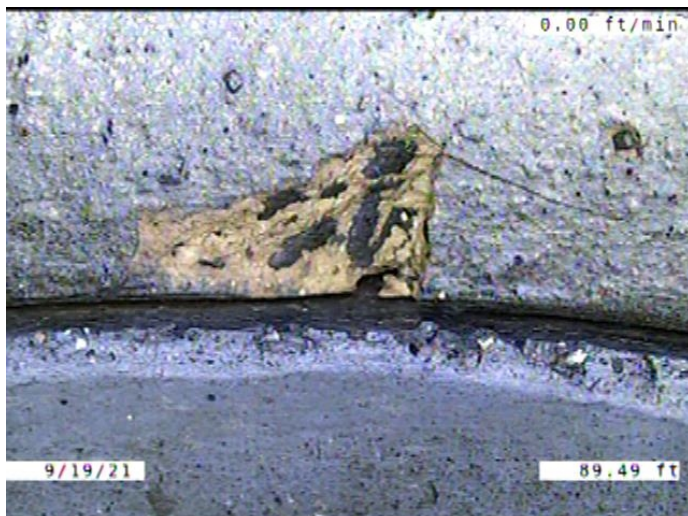
Code: **SZ**
 Description: **Surface Damage Other**

Distance (ft): **89.5**
 Structural Grade: **0**
 O&M Grade: **0**
 Clock Start/From: **12**
 Clock To: **1**
 1st Value:
 2nd Value:
 Value Percent:
 Continuous Index:
 Within 8" of Joint: **YES**
 Remarks: **A PIECE CHIPPED AWAY FROM THE JOINT**

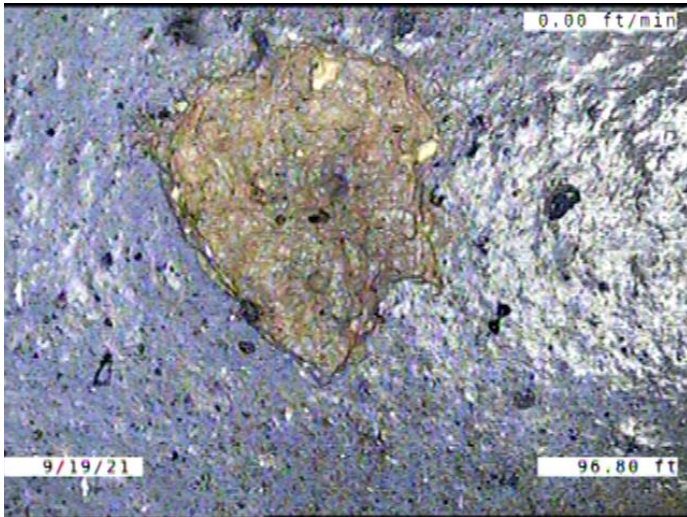
Code: **SSS**
 Description: **Surface Damage Surface Spalling**

Distance (ft): **96.8**
 Structural Grade: **2**
 O&M Grade: **0**
 Clock Start/From: **8**
 Clock To: **9**
 1st Value:
 2nd Value:
 Value Percent:
 Continuous Index:
 Within 8" of Joint: **YES**
 Remarks:

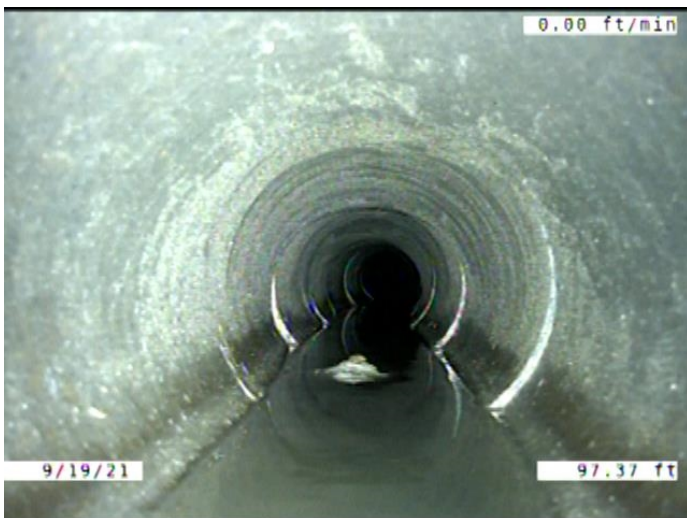
Code: **MWLS**
 Description: **Miscellaneous Water Level Sag**

Distance (ft): **97.4**
 Structural Grade: **2**
 O&M Grade: **0**
 Clock Start/From:
 Clock To:
 1st Value:
 2nd Value:
 Value Percent: **5.000**
 Continuous Index: **S05**
 Within 8" of Joint: **NO**
 Remarks:

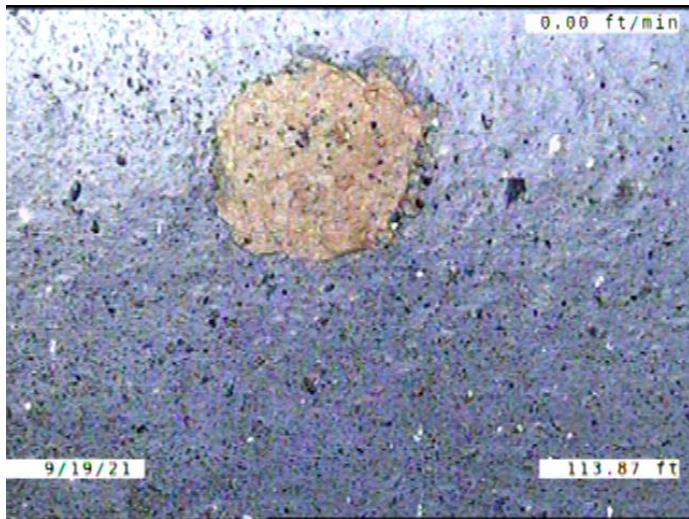
Code: **SSS**
 Description: **Surface Damage Surface Spalling**

Distance (ft): **113.9**
 Structural Grade: **2**
 O&M Grade: **0**
 Clock Start/From: **10**
 Clock To:
 1st Value:
 2nd Value:
 Value Percent:
 Continuous Index:
 Within 8" of Joint: **YES**
 Remarks:

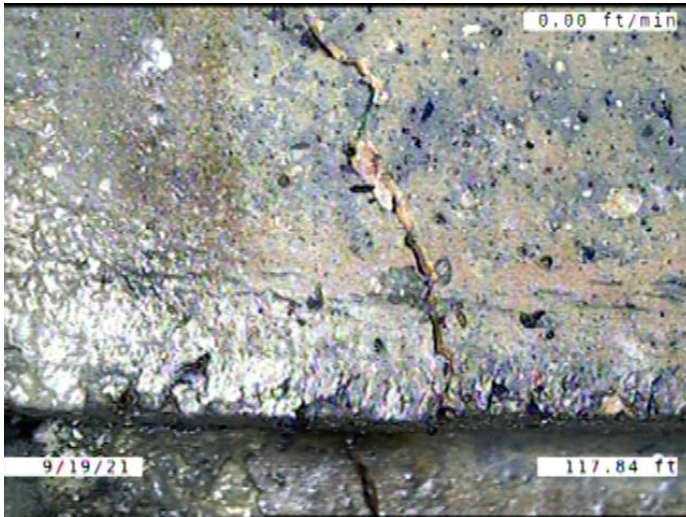
Code: **FM**
 Description: **Fracture Multiple**

Distance (ft): **117.8**
 Structural Grade: **4**
 O&M Grade: **0**
 Clock Start/From: **4**
 Clock To: **5**
 1st Value:
 2nd Value:
 Value Percent:
 Continuous Index:
 Within 8" of Joint: **YES**
 Remarks:

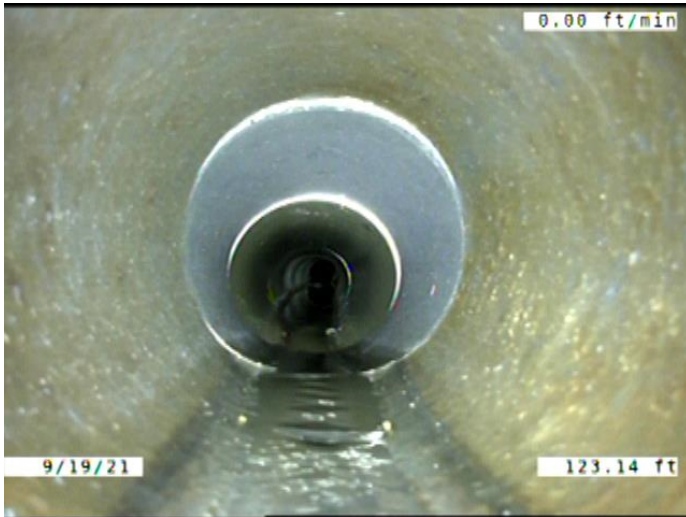
Code: **MWLS**
Description: **Miscellaneous Water Level Sag**

Distance (ft): **123.1**
Structural Grade: **2**
O&M Grade: **0**
Clock Start/From:
Clock To:
1st Value:
2nd Value:
Value Percent: **5.000**
Continuous Index: **F05**
Within 8" of Joint: **NO**
Remarks:

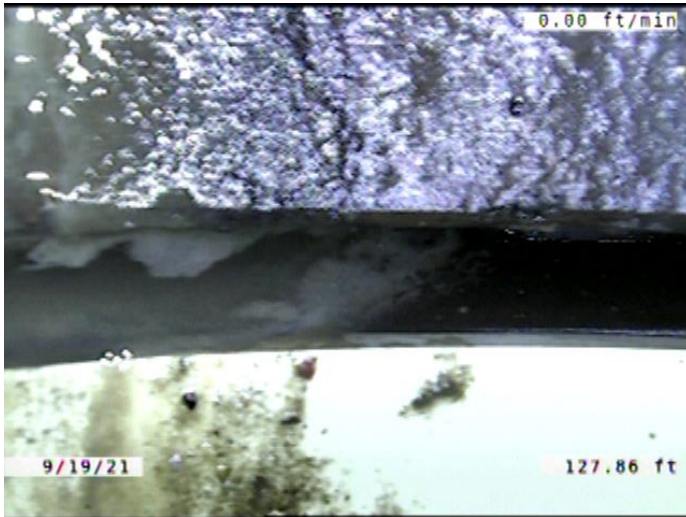
Code: **JAM**
 Description: **Joint Angular Medium**

Distance (ft): **127.9**
 Structural Grade: **3**
 O&M Grade: **0**
 Clock Start/From:
 Clock To:
 1st Value:
 2nd Value:
 Value Percent:
 Continuous Index:
 Within 8" of Joint: **NO**
 Remarks:

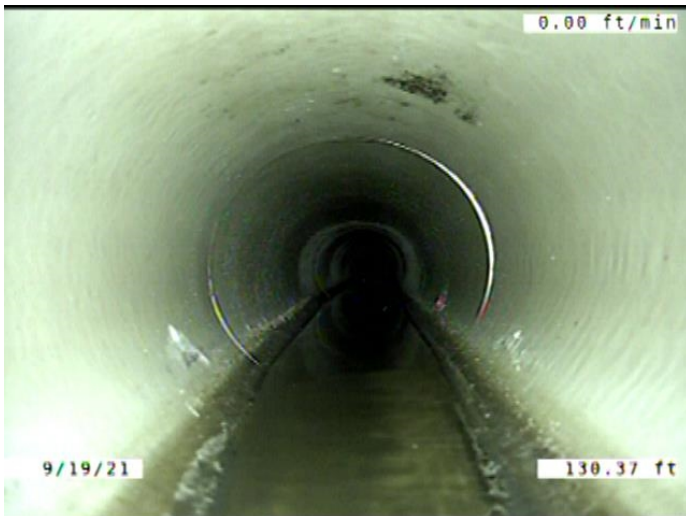
Code: **MWLS**
 Description: **Miscellaneous Water Level Sag**

Distance (ft): **130.4**
 Structural Grade: **2**
 O&M Grade: **0**
 Clock Start/From:
 Clock To:
 1st Value:
 2nd Value:
 Value Percent: **5.000**
 Continuous Index: **S06**
 Within 8" of Joint: **NO**
 Remarks:

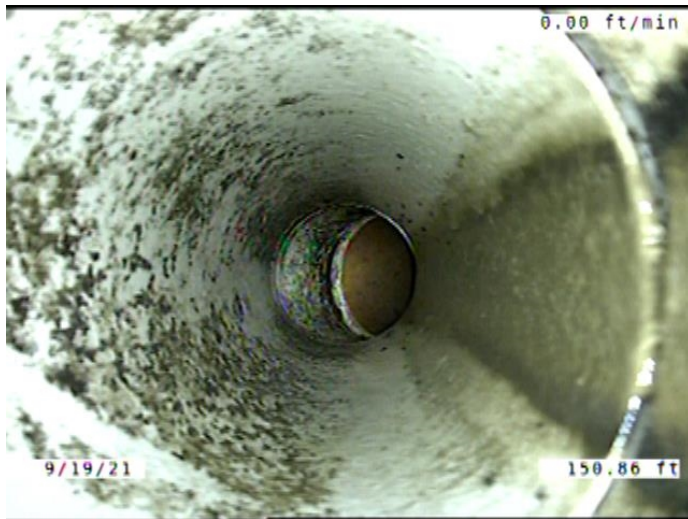
Code: **TF**
Description: **Tap Factory**

Distance (ft): **150.9**
Structural Grade: **0**
O&M Grade: **0**
Clock Start/From: **1**
Clock To:
1st Value: **4.000**
2nd Value:
Value Percent:
Continuous Index:
Within 8" of Joint: **YES**
Remarks: **CONSTANTLY RUNNING WATER**

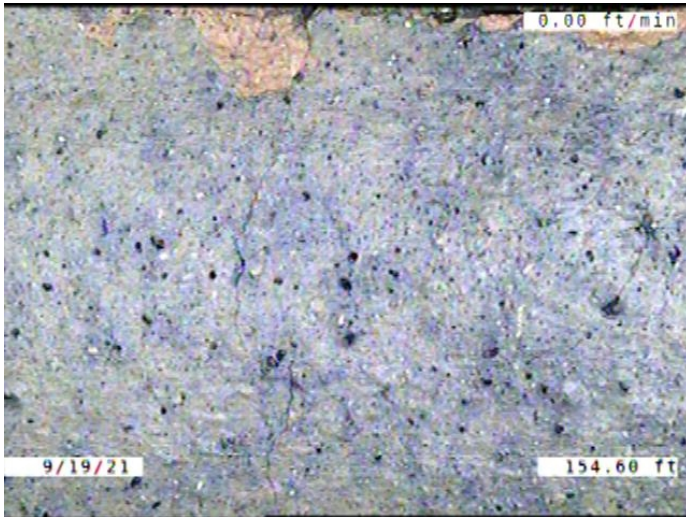
Code: **CL**
 Description: **Crack Longitudinal**

Distance (ft): **154.6**
 Structural Grade: **2**
 O&M Grade: **0**
 Clock Start/From: **12**
 Clock To:
 1st Value:
 2nd Value:
 Value Percent:
 Continuous Index:
 Within 8" of Joint: **YES**
 Remarks:

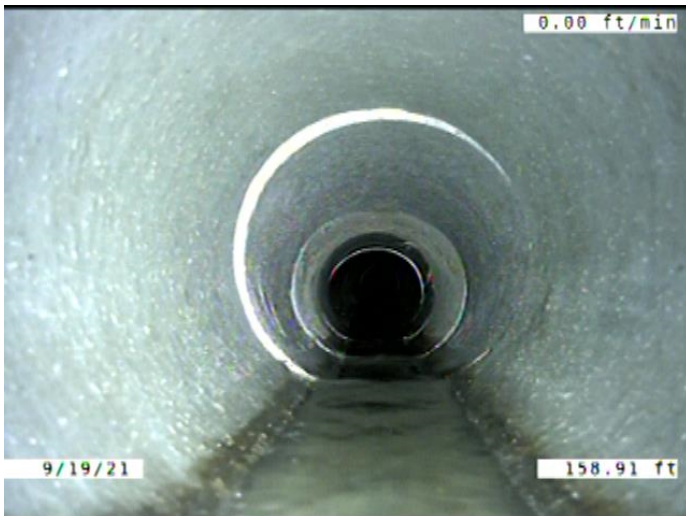
Code: **MWLS**
 Description: **Miscellaneous Water Level Sag**

Distance (ft): **158.9**
 Structural Grade: **2**
 O&M Grade: **0**
 Clock Start/From:
 Clock To:
 1st Value:
 2nd Value:
 Value Percent: **5.000**
 Continuous Index: **F06**
 Within 8" of Joint: **NO**
 Remarks:

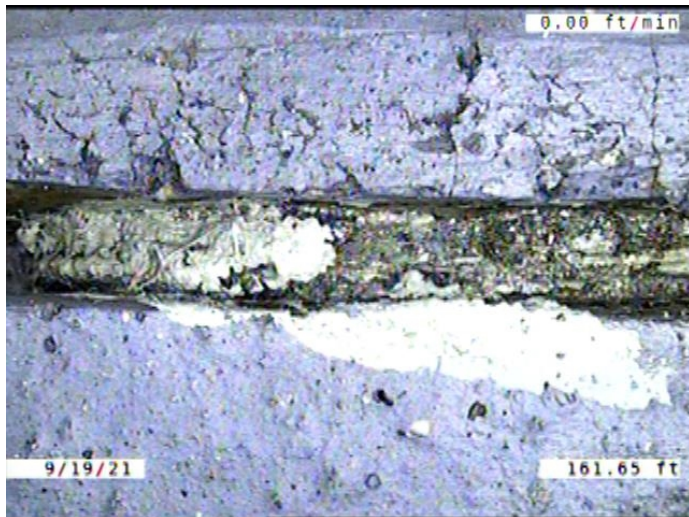
Code: **DAE**
 Description: **Deposits Attached Encrustation**

Distance (ft): **161.7**
 Structural Grade: **0**
 O&M Grade: **2**
 Clock Start/From: **3**
 Clock To: **8**
 1st Value:
 2nd Value:
 Value Percent: **5.000**
 Continuous Index:
 Within 8" of Joint: **YES**
 Remarks:

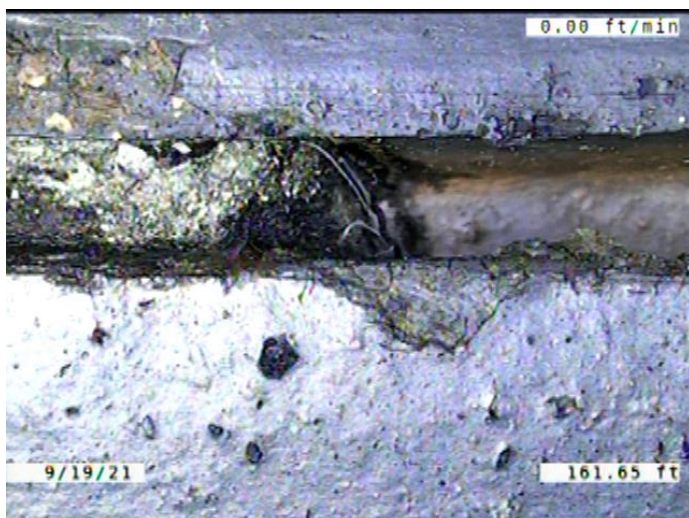
Code: **RFJ**
 Description: **Roots Fine Joint**

Distance (ft): **161.7**
 Structural Grade: **0**
 O&M Grade: **1**
 Clock Start/From: **3**
 Clock To: **8**
 1st Value:
 2nd Value:
 Value Percent:
 Continuous Index:
 Within 8" of Joint: **YES**
 Remarks:

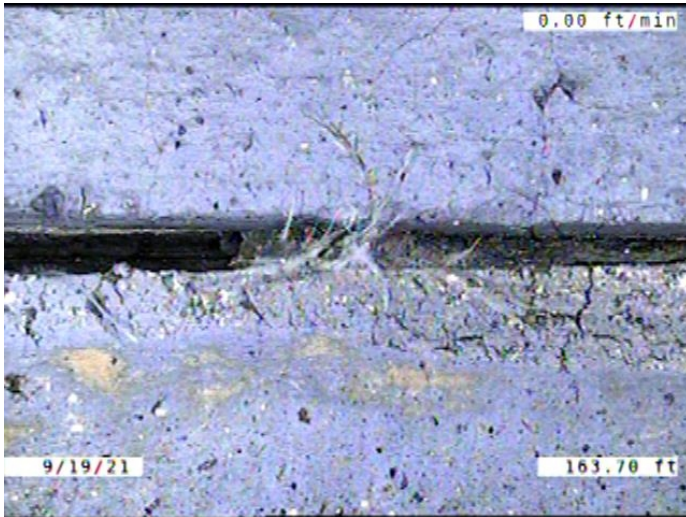
Code: **RFJ**
Description: **Roots Fine Joint**

Distance (ft): **163.7**
Structural Grade: **0**
O&M Grade: **1**
Clock Start/From: **9**
Clock To: **11**
1st Value:
2nd Value:
Value Percent:
Continuous Index:
Within 8" of Joint: **YES**
Remarks:

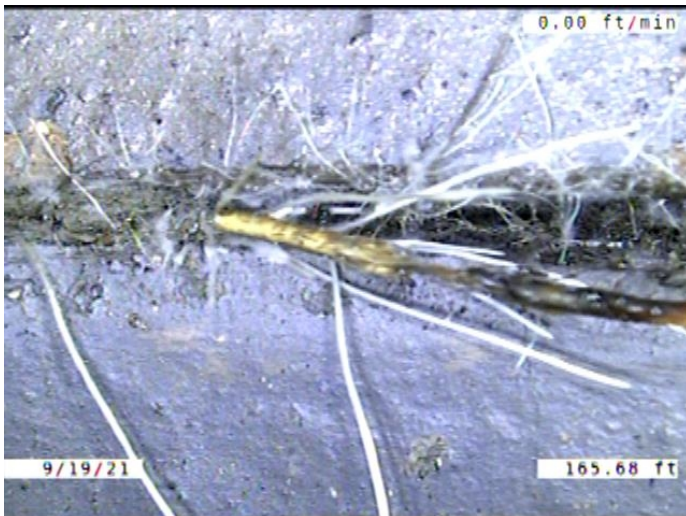
Code: **RFJ**
Description: **Roots Fine Joint**

Distance (ft): **165.7**
Structural Grade: **0**
O&M Grade: **1**
Clock Start/From: **9**
Clock To: **4**
1st Value:
2nd Value:
Value Percent:
Continuous Index:
Within 8" of Joint: **YES**
Remarks:

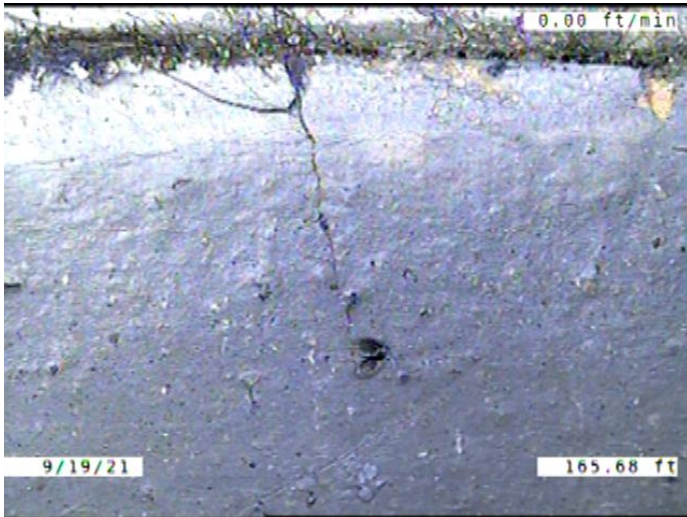
Code: **CL**
 Description: **Crack Longitudinal**

Distance (ft): **165.7**
 Structural Grade: **2**
 O&M Grade: **0**
 Clock Start/From: **10**
 Clock To:
 1st Value:
 2nd Value:
 Value Percent:
 Continuous Index:
 Within 8" of Joint: **YES**
 Remarks:

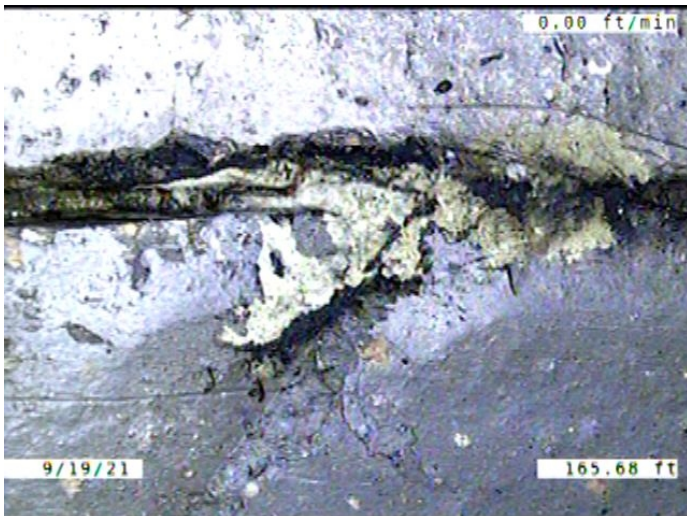
Code: **DAE**
 Description: **Deposits Attached Encrustation**

Distance (ft): **165.7**
 Structural Grade: **0**
 O&M Grade: **2**
 Clock Start/From: **7**
 Clock To: **9**
 1st Value:
 2nd Value:
 Value Percent: **5.000**
 Continuous Index:
 Within 8" of Joint: **YES**
 Remarks:

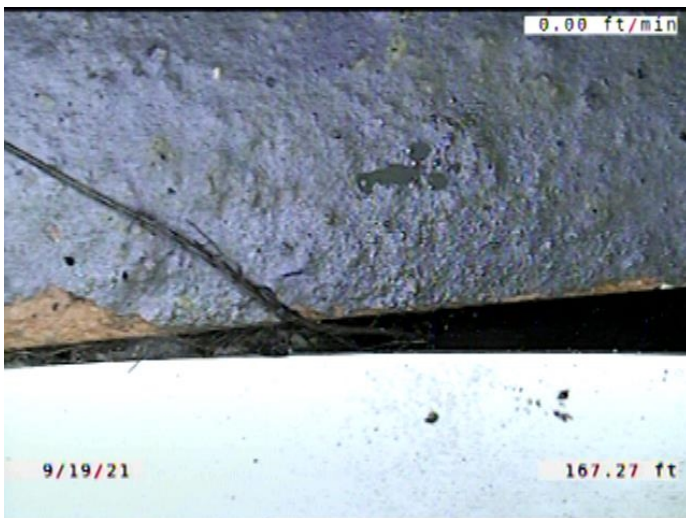
Code: **RFJ**
 Description: **Roots Fine Joint**

Distance (ft): **167.3**
 Structural Grade: **0**
 O&M Grade: **1**
 Clock Start/From: **3**
 Clock To: **9**
 1st Value:
 2nd Value:
 Value Percent:
 Continuous Index:
 Within 8" of Joint: **YES**
 Remarks:

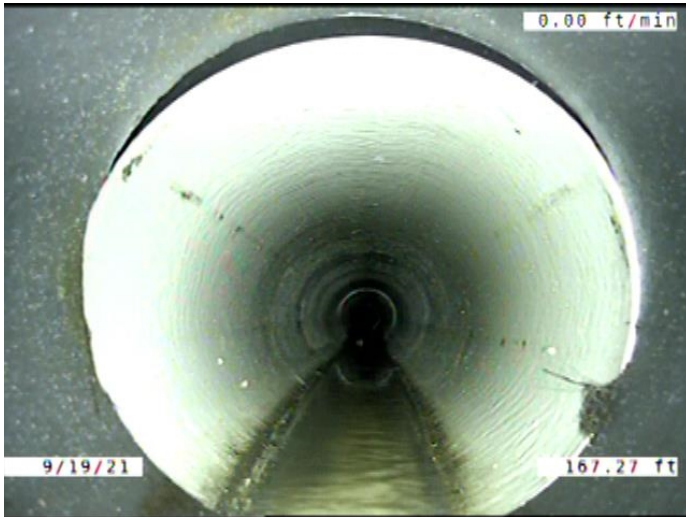
Code: **JOM**
 Description: **Joint Offset Medium**

Distance (ft): **167.3**
 Structural Grade: **3**
 O&M Grade: **0**
 Clock Start/From:
 Clock To:
 1st Value: **1.000**
 2nd Value:
 Value Percent:
 Continuous Index:
 Within 8" of Joint: **NO**
 Remarks:

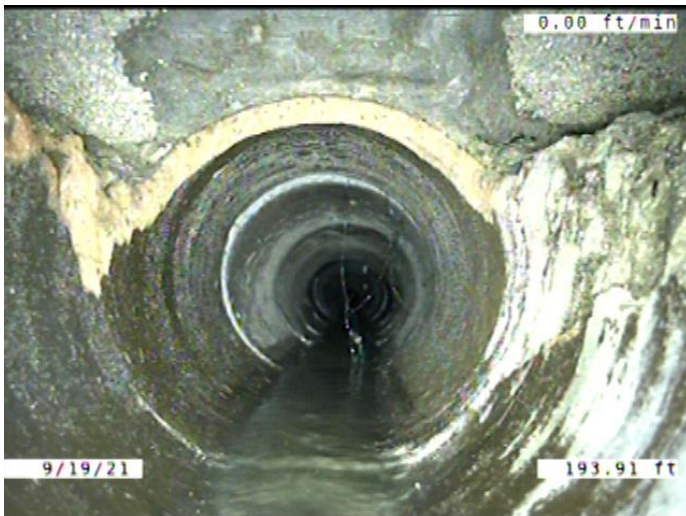
Code: **DSF**
 Description: **Deposits Settled Fine**

Distance (ft): **193.9**
 Structural Grade: **0**
 O&M Grade: **2**
 Clock Start/From: **5**
 Clock To: **7**
 1st Value:
 2nd Value:
 Value Percent: **5.000**
 Continuous Index: **F02**
 Within 8" of Joint: **YES**
 Remarks:
