## Profile/Photo Observation Report

Street:	<b>W 40th ave</b>	Flow Control:	<b>Not Controlled</b>
City:	<b>Hobart, IN</b>	Year Renewed:	
Location:	<b>Other</b>	Tape/Media #:	
Purpose:	<b>Not Known</b>	Dia/Height:	<b>10"</b>
Use:	<b>Sanitary</b>	Material:	<b>VCP</b>
Drain Area:	<b>NA</b>	Lining:	
Category:	<b>NA</b>		
Comment:

Location Details:		Direction of Survey:	<b>Upstream</b>
US MH:	<b>M-503-011</b>	DS MH:	<b>M-503-012</b>
		Total Length Surveyed (ft):	<b>25.9</b>

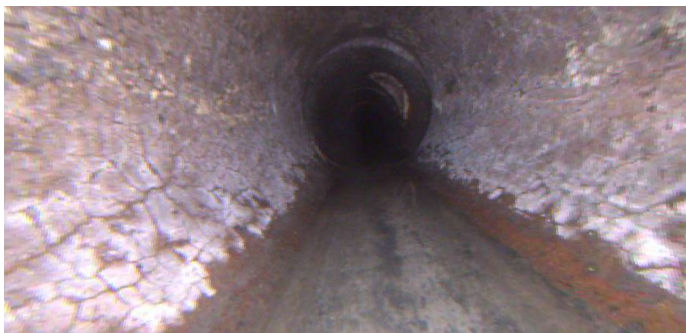
Code: **AMH**  
Description: **Manhole**

Distance (ft): **.0**  
Structural Grade: **0**  
O&M Grade: **0**  
Clock Start/From:  
Clock To:  
1st Value:  
2nd Value:  
Value Percent:  
Continuous Index:  
Within 8" of Joint: **NO**  
Remarks: **M-503-011**

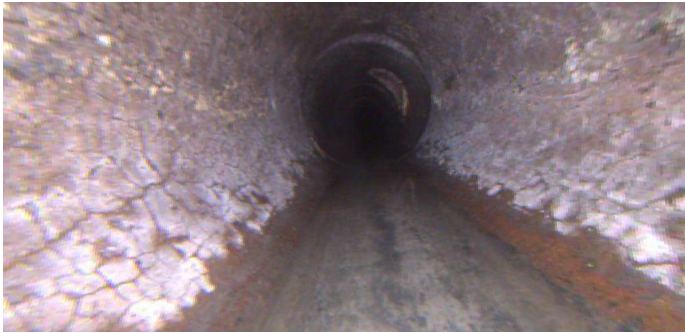
Code:	<b>MWL</b>
Description:	<b>Water Level</b>

Distance (ft):	<b>.0</b>
Structural Grade:	<b>0</b>
O&M Grade:	<b>0</b>
Clock Start/From:	
Clock To:	
1st Value:	
2nd Value:	
Value Percent:	<b>5.000</b>
Continuous Index:	
Within 8" of Joint:	<b>NO</b>
Remarks:

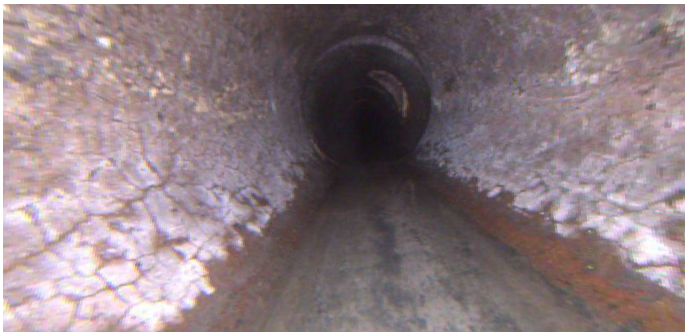
Code:	<b>CM</b>
Description:	<b>Crack Multiple</b>

Distance (ft):	<b>.0</b>
Structural Grade:	<b>3</b>
O&M Grade:	<b>0</b>
Clock Start/From:	<b>7</b>
Clock To:	<b>5</b>
1st Value:	
2nd Value:	
Value Percent:	
Continuous Index:	<b>S01</b>
Within 8" of Joint:	
Remarks:

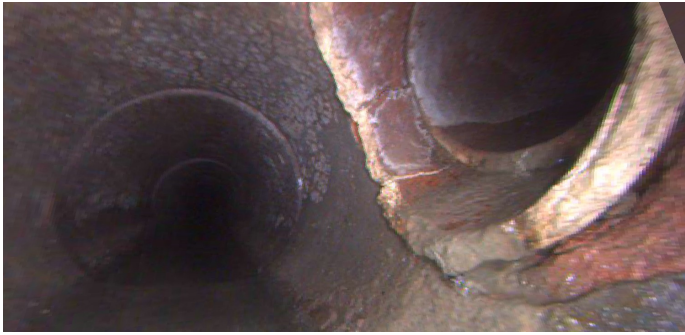
Code: **TB**  
Description: **Tap Break-in**

Distance (ft): **3.7**  
Structural Grade: **0**  
O&M Grade: **0**  
Clock Start/From: **2**  
Clock To:  
1st Value: **6.000**  
2nd Value:  
Value Percent:  
Continuous Index:  
Within 8" of Joint:  
Remarks:

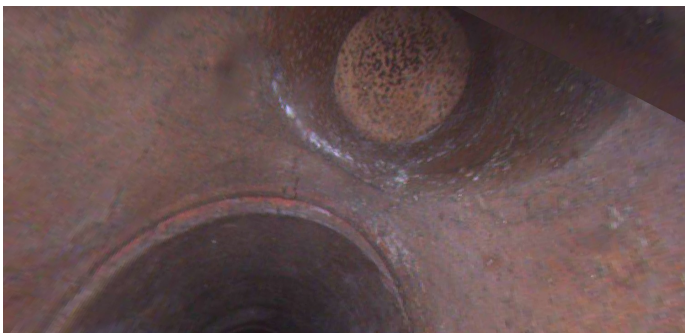
Code: **TFC**  
Description: **Tap Factory Capped**

Distance (ft): **12.2**  
Structural Grade: **0**  
O&M Grade: **0**  
Clock Start/From: **1**  
Clock To:  
1st Value: **4.000**  
2nd Value:  
Value Percent:  
Continuous Index:  
Within 8" of Joint: **YES**  
Remarks:

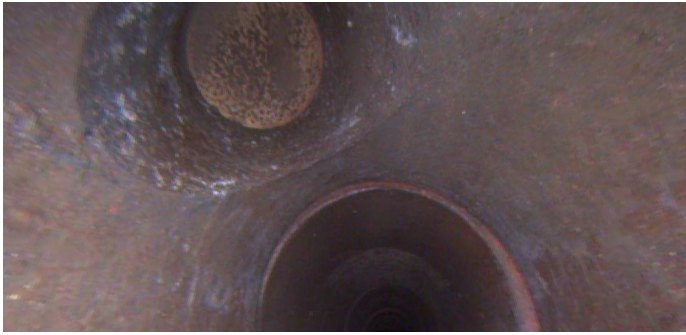
Code: **TFC**  
Description: **Tap Factory Capped**

Distance (ft): **14.1**  
Structural Grade: **0**  
O&M Grade: **0**  
Clock Start/From: **11**  
Clock To:  
1st Value: **4.000**  
2nd Value:  
Value Percent:  
Continuous Index:  
Within 8" of Joint: **YES**  
Remarks:

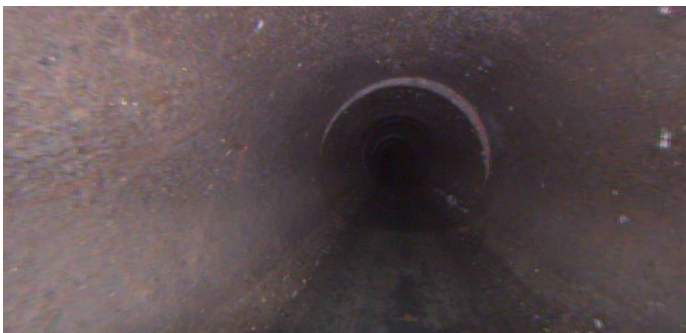
Code: **MSA**  
Description: **Abandoned Survey**

Distance (ft): **25.9**  
Structural Grade: **0**  
O&M Grade: **0**  
Clock Start/From:  
Clock To:  
1st Value:  
2nd Value:  
Value Percent:  
Continuous Index:  
Within 8" of Joint: **NO**  
Remarks: **no blockage**

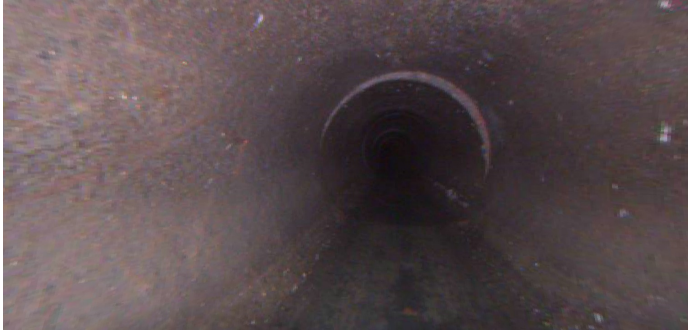
Code:	<b>CM</b>
Description:	<b>Crack Multiple</b>
Distance (ft):	<b>25.9</b>
Structural Grade:	<b>3</b>
O&M Grade:	<b>0</b>
Clock Start/From:	<b>7</b>
Clock To:	<b>5</b>
1st Value:	
2nd Value:	
Value Percent:	
Continuous Index:	<b>F01</b>
Within 8" of Joint:	
Remarks:
