RedZone  
ROBOTICS

Street:	North Virginia Street		Flow Control:	Not Controlled	
City:	Hobart, IN		Year Renewed:		
Location:	Local rural streets with light traffic, t		Tape/Media #:		
Purpose:	Routine Assessment		Dia/Height:	10"	
Use:	Sanitary Sewage Pipe		Material:	PVC	
Drain Area:			Lining:	None	
Category:	NA				
Comment:					
Location Details:			Direction of Survey:	Downstream	
US MH:	M-503-011	DS MH:	M-503-012	Total Length Surveyed (ft):	197.3

**Tuesday, April 25, 2023**

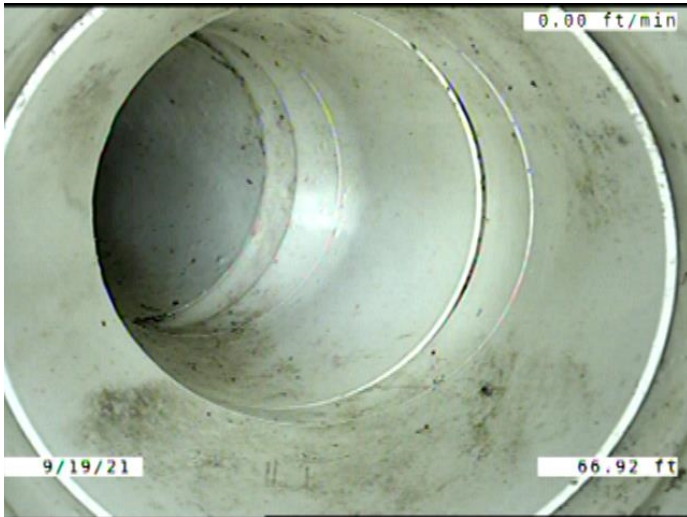
Code: **TF**  
Description: **Tap Factory**

Distance (ft): **66.9**  
Structural Grade: **0**  
O&M Grade: **0**  
Clock Start/From: **11**  
Clock To:  
1st Value: **4.000**  
2nd Value:  
Value Percent:  
Continuous Index:  
Within 8" of Joint: **YES**  
Remarks:

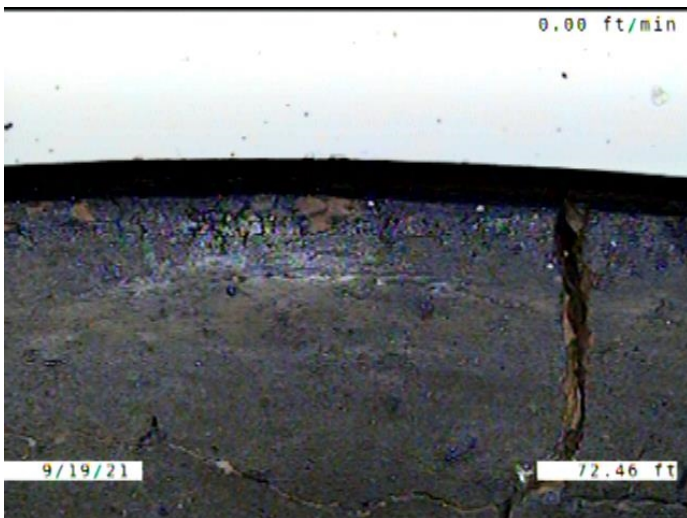
Code: **MMC**  
Description: **Miscellaneous Material Change**

Distance (ft): **72.5**  
Structural Grade: **0**  
O&M Grade: **0**  
Clock Start/From:  
Clock To:  
1st Value:  
2nd Value:  
Value Percent:  
Continuous Index:  
Within 8" of Joint: **NO**  
Remarks: **PVC TO VCP**

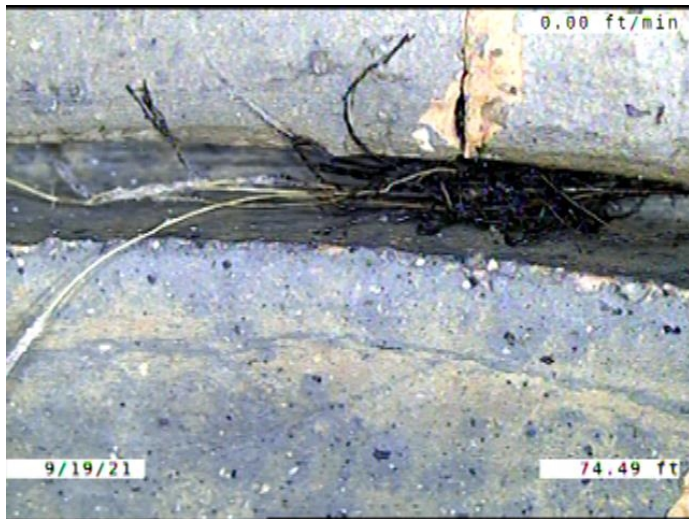
Code: **RFJ**  
 Description: **Roots Fine Joint**

Distance (ft): **74.5**  
 Structural Grade: **0**  
 O&M Grade: **1**  
 Clock Start/From: **12**  
 Clock To: **3**  
 1st Value:  
 2nd Value:  
 Value Percent:  
 Continuous Index:  
 Within 8" of Joint: **YES**  
 Remarks:

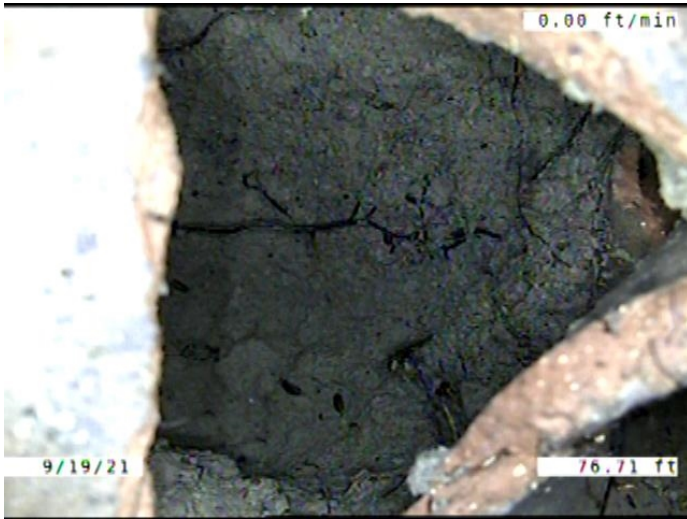
Code: **HVV**  
Description: **Hole Void Visible**

Distance (ft): **76.7**  
Structural Grade: **5**  
O&M Grade: **0**  
Clock Start/From: **12**  
Clock To: **2**  
1st Value:  
2nd Value:  
Value Percent:  
Continuous Index:  
Within 8" of Joint: **YES**  
Remarks: **SOIL VISIBLE TOO**

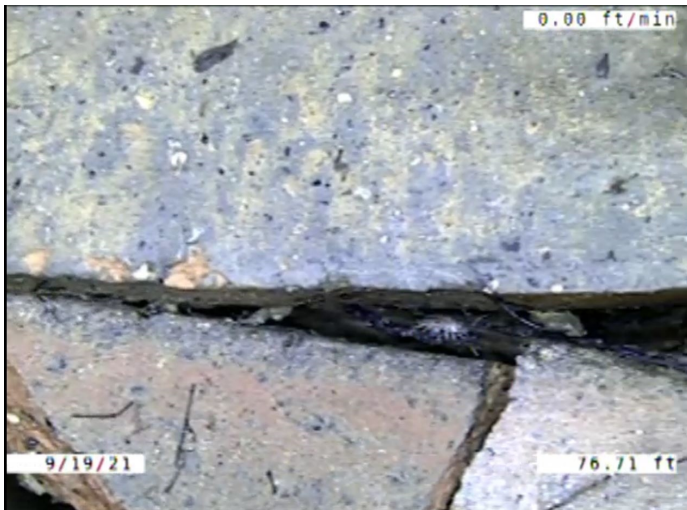
Code: **B**  
Description: **Broken**

Distance (ft): **76.7**  
Structural Grade: **4**  
O&M Grade: **0**  
Clock Start/From: **2**  
Clock To: **4**  
1st Value:  
2nd Value:  
Value Percent:  
Continuous Index:  
Within 8" of Joint: **NO**  
Remarks:

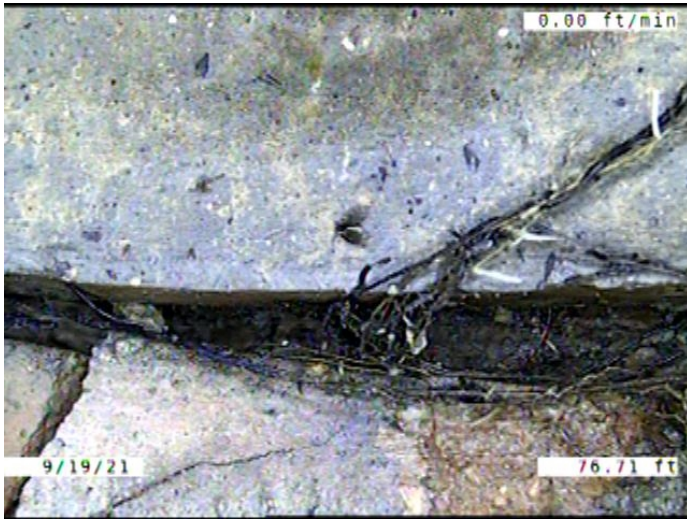
Code: **RFJ**  
Description: **Roots Fine Joint**

Distance (ft): **76.7**  
Structural Grade: **0**  
O&M Grade: **1**  
Clock Start/From: **12**  
Clock To: **3**  
1st Value:  
2nd Value:  
Value Percent:  
Continuous Index:  
Within 8" of Joint: **YES**  
Remarks:

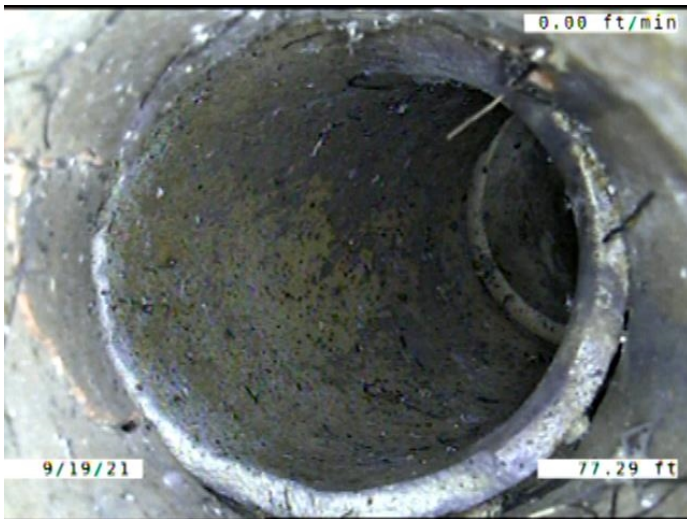
Code: **TFD**  
Description: **Tap Factory Defective**

Distance (ft): **77.3**  
Structural Grade: **0**  
O&M Grade: **3**  
Clock Start/From: **2**  
Clock To:  
1st Value: **4.000**  
2nd Value:  
Value Percent:  
Continuous Index:  
Within 8" of Joint: **YES**  
Remarks: **Defective**

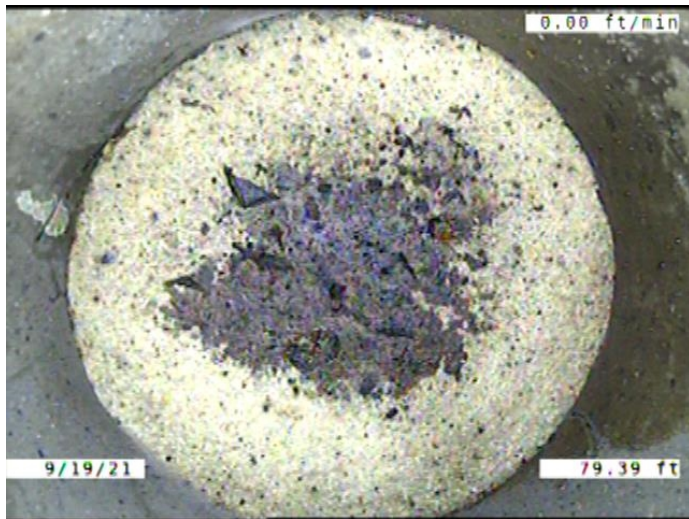
Code: **TFD**  
 Description: **Tap Factory Defective**

Distance (ft): **79.4**  
 Structural Grade: **0**  
 O&M Grade: **3**  
 Clock Start/From: **11**  
 Clock To:  
 1st Value: **4.000**  
 2nd Value:  
 Value Percent:  
 Continuous Index:  
 Within 8" of Joint: **YES**  
 Remarks: **CAPPED**

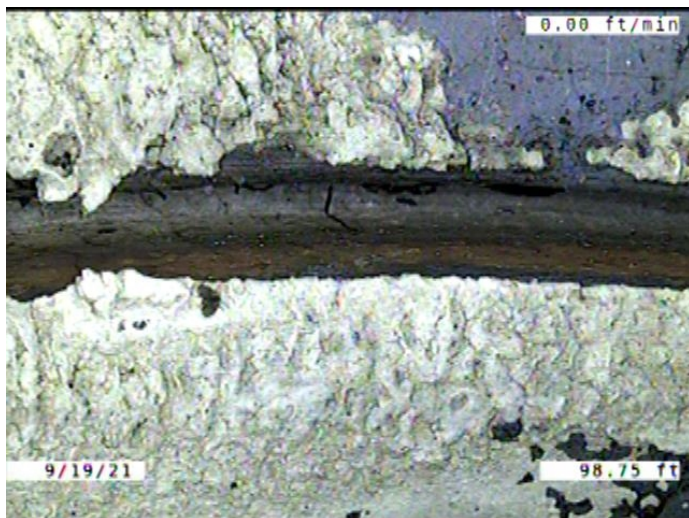
Code: **DAE**  
 Description: **Deposits Attached Encrustation**

Distance (ft): **98.8**  
 Structural Grade: **0**  
 O&M Grade: **2**  
 Clock Start/From: **9**  
 Clock To: **11**  
 1st Value:  
 2nd Value:  
 Value Percent: **5.000**  
 Continuous Index:  
 Within 8" of Joint: **YES**  
 Remarks:

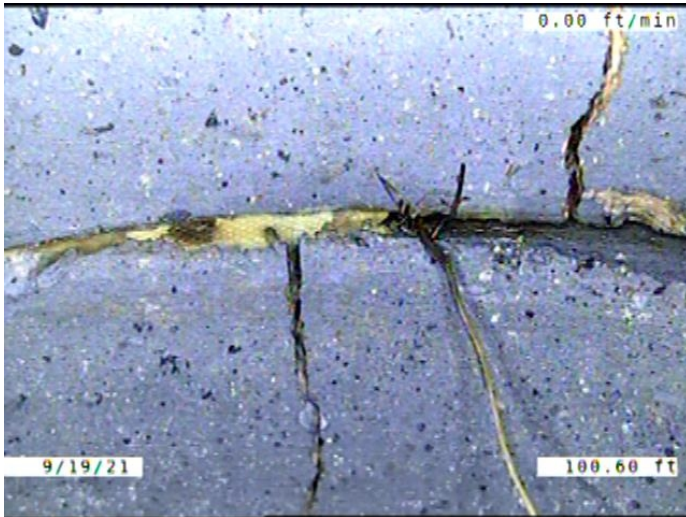
Code: **RFJ**  
Description: **Roots Fine Joint**

Distance (ft): **100.6**  
Structural Grade: **0**  
O&M Grade: **1**  
Clock Start/From: **9**  
Clock To: **3**  
1st Value:  
2nd Value:  
Value Percent:  
Continuous Index: **S03**  
Within 8" of Joint: **YES**  
Remarks:

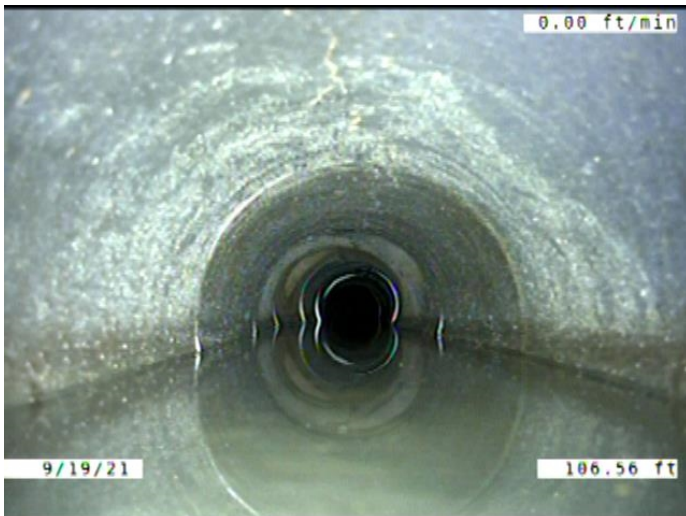
Code: **RFJ**  
Description: **Roots Fine Joint**

Distance (ft): **106.6**  
Structural Grade: **0**  
O&M Grade: **1**  
Clock Start/From: **9**  
Clock To: **3**  
1st Value:  
2nd Value:  
Value Percent:  
Continuous Index: **F03**  
Within 8" of Joint: **YES**  
Remarks:

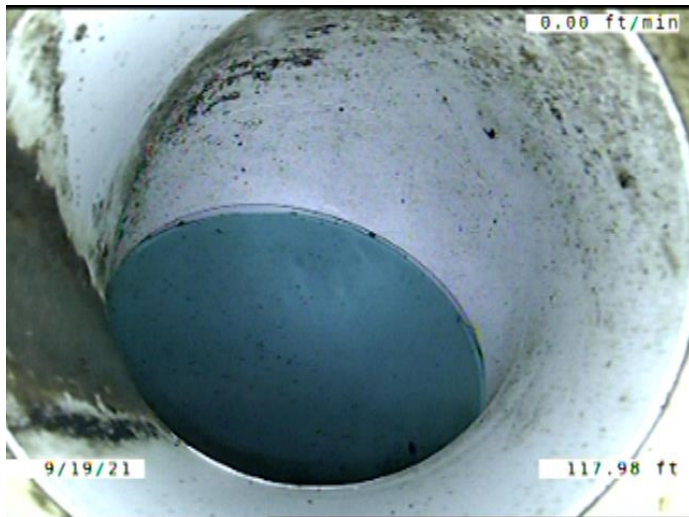
Code: **TF**  
 Description: **Tap Factory**

Distance (ft): **118.0**  
 Structural Grade: **0**  
 O&M Grade: **0**  
 Clock Start/From: **11**  
 Clock To:  
 1st Value: **4.000**  
 2nd Value:  
 Value Percent:  
 Continuous Index:  
 Within 8" of Joint: **YES**  
 Remarks:

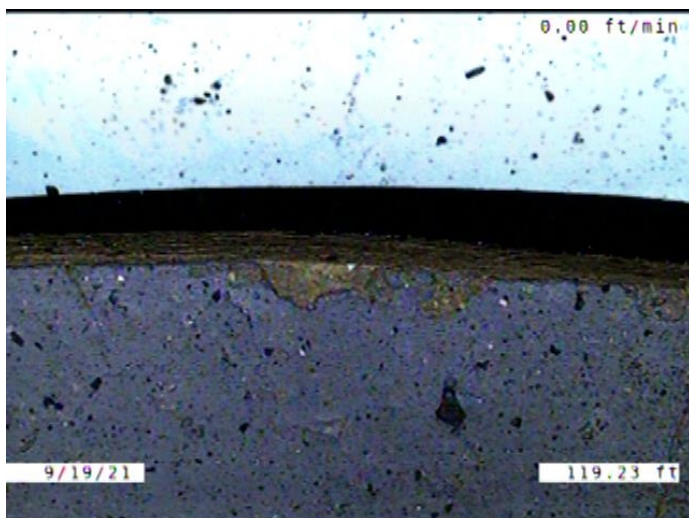
Code: **MMC**  
 Description: **Miscellaneous Material Change**

Distance (ft): **119.2**  
 Structural Grade: **0**  
 O&M Grade: **0**  
 Clock Start/From:  
 Clock To:  
 1st Value:  
 2nd Value:  
 Value Percent:  
 Continuous Index:  
 Within 8" of Joint: **NO**  
 Remarks: **PVC TO VCP**

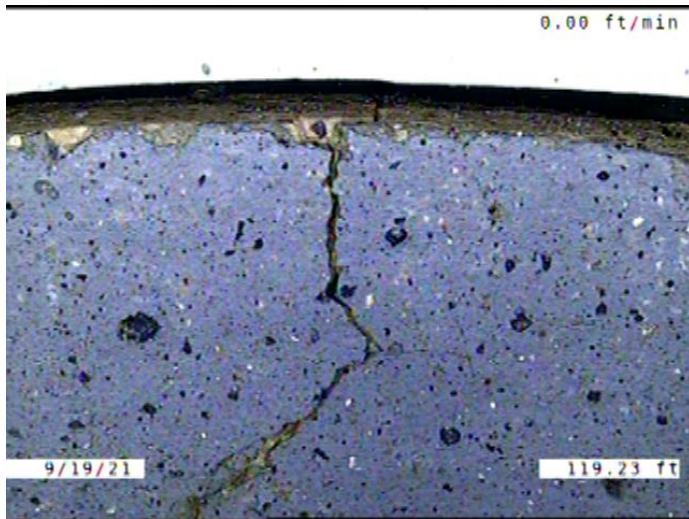
119.2	FM(S05)	Fracture Multiple	1243	S 4
146.5	TFD	Tap Factory Defective	1461	M 3
148.6	TFC	Tap Factory Capped	1495	NA
149.7	FM(F05)	Fracture Multiple	1523	S 4

Code: **FM**  
Description: **Fracture Multiple**

Distance (ft): **119.2**  
Structural Grade: **4**  
O&M Grade: **0**  
Clock Start/From: **12**  
Clock To: **12**  
1st Value:  
2nd Value:  
Value Percent:  
Continuous Index: **S05**  
Within 8" of Joint: **YES**  
Remarks:

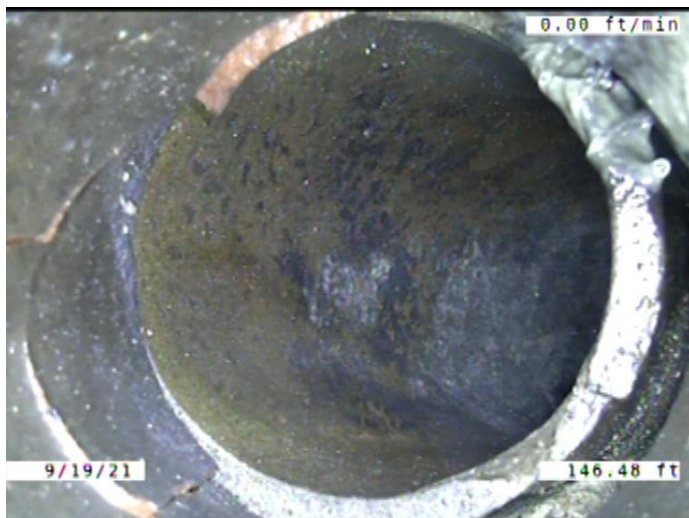
Code: **TFD**  
Description: **Tap Factory Defective**

Distance (ft): **146.5**  
Structural Grade: **0**  
O&M Grade: **3**  
Clock Start/From: **1**  
Clock To:  
1st Value: **4.000**  
2nd Value:  
Value Percent:  
Continuous Index:  
Within 8" of Joint: **YES**  
Remarks: **CONSTANTLY RUNNING WATER**

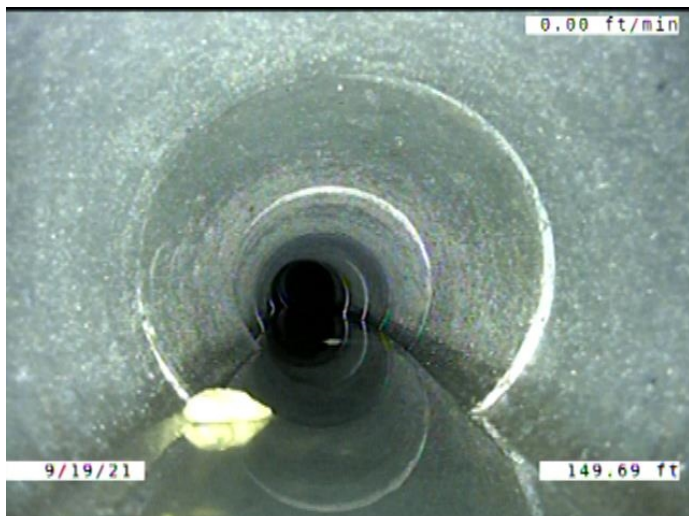
Code: **FM**  
 Description: **Fracture Multiple**

Distance (ft): **149.7**  
 Structural Grade: **4**  
 O&M Grade: **0**  
 Clock Start/From: **12**  
 Clock To: **12**  
 1st Value:  
 2nd Value:  
 Value Percent:  
 Continuous Index: **F05**  
 Within 8" of Joint: **YES**  
 Remarks:

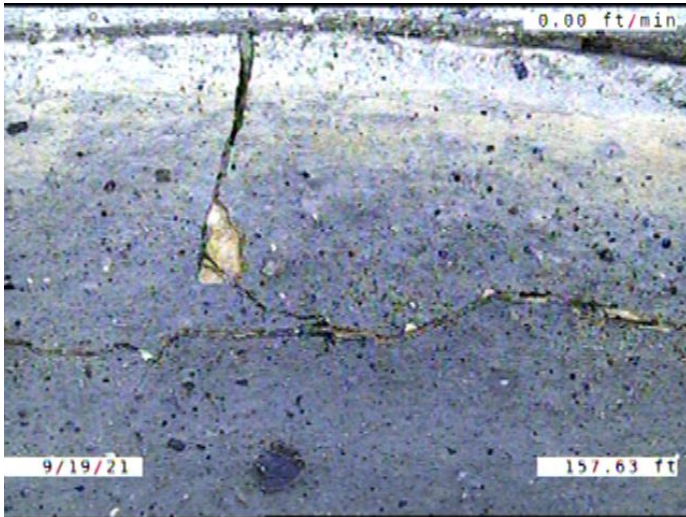
Code: **FM**  
 Description: **Fracture Multiple**

Distance (ft): **157.6**  
 Structural Grade: **4**  
 O&M Grade: **0**  
 Clock Start/From: **10**  
 Clock To: **2**  
 1st Value:  
 2nd Value:  
 Value Percent:  
 Continuous Index:  
 Within 8" of Joint: **YES**  
 Remarks:

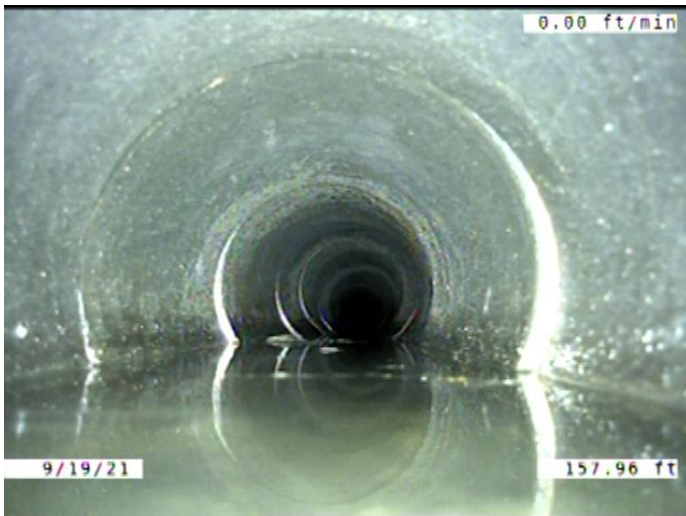
Code: **MWLS**  
 Description: **Miscellaneous Water Level Sag**

Distance (ft): **158.0**  
 Structural Grade: **2**  
 O&M Grade: **0**  
 Clock Start/From:  
 Clock To:  
 1st Value:  
 2nd Value:  
 Value Percent: **10.000**  
 Continuous Index:  
 Within 8" of Joint: **NO**  
 Remarks:

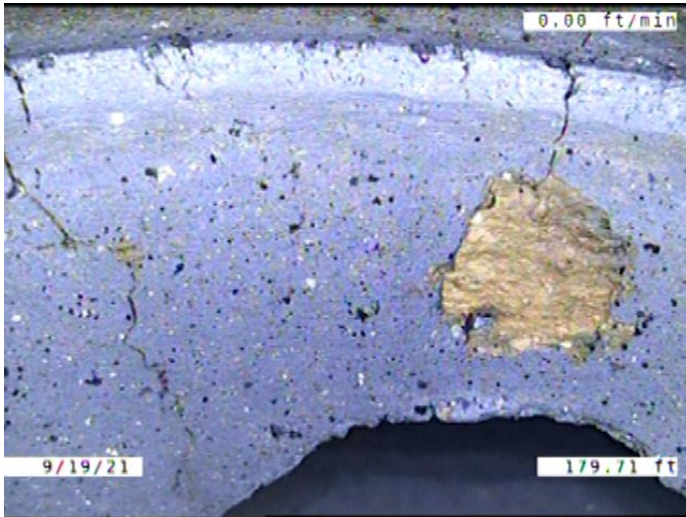
Code: **FM**  
 Description: **Fracture Multiple**

Distance (ft): **179.7**  
 Structural Grade: **4**  
 O&M Grade: **0**  
 Clock Start/From: **5**  
 Clock To: **1**  
 1st Value:  
 2nd Value:  
 Value Percent:  
 Continuous Index: **S06**  
 Within 8" of Joint: **YES**  
 Remarks:

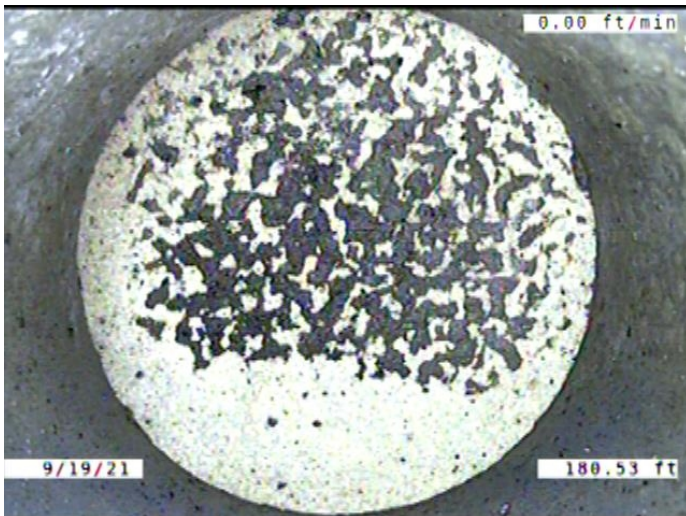
Code: **TFC**  
 Description: **Tap Factory Capped**

Distance (ft): **180.5**  
 Structural Grade: **0**  
 O&M Grade: **0**  
 Clock Start/From: **1**  
 Clock To:  
 1st Value: **4.000**  
 2nd Value:  
 Value Percent:  
 Continuous Index:  
 Within 8" of Joint: **YES**  
 Remarks:

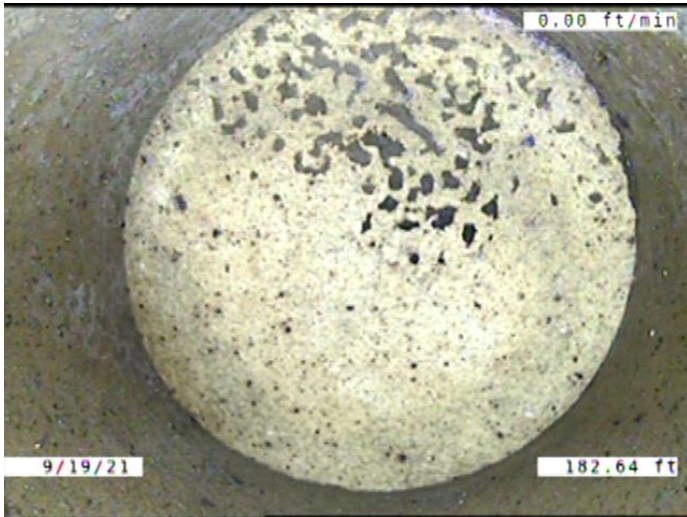
Code: **TFC**  
 Description: **Tap Factory Capped**

Distance (ft): **182.6**  
 Structural Grade: **0**  
 O&M Grade: **0**  
 Clock Start/From: **11**  
 Clock To:  
 1st Value: **4.000**  
 2nd Value:  
 Value Percent:  
 Continuous Index:  
 Within 8" of Joint: **YES**  
 Remarks:

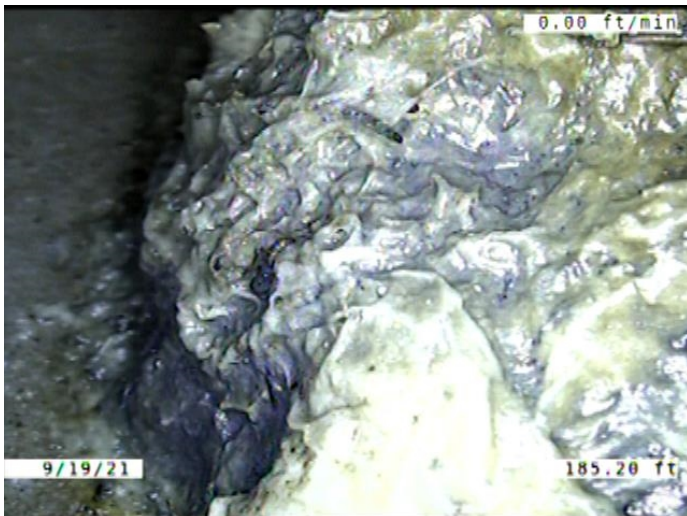
Code: **OBZ**  
 Description: **Obstruction Other**

Distance (ft): **185.2**  
 Structural Grade: **0**  
 O&M Grade: **2**  
 Clock Start/From: **6**  
 Clock To: **8**  
 1st Value:  
 2nd Value:  
 Value Percent: **10.000**  
 Continuous Index:  
 Within 8" of Joint: **YES**  
 Remarks: **TP, RAGS, AND SEWER DEBRIS**

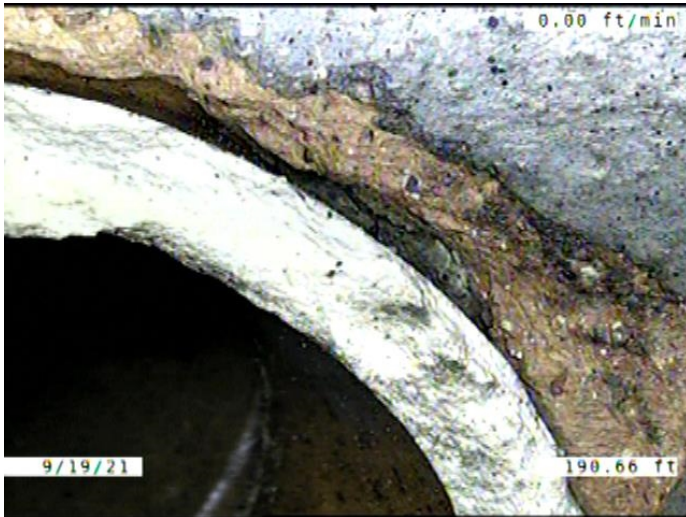
Code: **FM**  
 Description: **Fracture Multiple**

Distance (ft): **190.7**  
 Structural Grade: **4**  
 O&M Grade: **0**  
 Clock Start/From: **9**  
 Clock To: **12**  
 1st Value:  
 2nd Value:  
 Value Percent:  
 Continuous Index:  
 Within 8" of Joint: **YES**  
 Remarks:

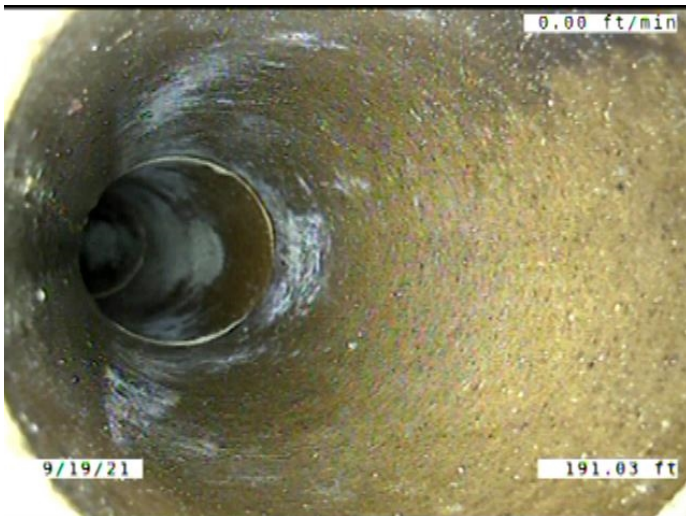
Code: **TBI**  
 Description: **Tap Break-in Intruding**

Distance (ft): **191.0**  
 Structural Grade: **0**  
 O&M Grade: **2**  
 Clock Start/From: **10**  
 Clock To:  
 1st Value: **4.000**  
 2nd Value: **1.000**  
 Value Percent:  
 Continuous Index:  
 Within 8" of Joint: **YES**  
 Remarks:
