# Profile/Photo Observation Report

Date:	<b>09/19/2021</b>	Weather:		Coding:	<b>PACP 7.0</b>
Pipe Length (ft):	<b>197.3</b>	Owner:	<b>City of Hobart</b>	Pre Clean:	<b>Light Cleaning</b>
P.O.#:	<b>YES502259</b>	Surveyor:	<b>S. Bucklin</b>	PSR:	<b>P-503-012-011</b>
Customer:	<b>City of Hobart</b>	Clean Date:	<b>09/06/2021</b>	Shape:	<b>C</b>

Street:	<b>North Virginia Street</b>	Flow Control:	<b>Not Controlled</b>
City:	<b>Hobart, IN</b>	Year Renewed:	
Location:	<b>Local rural streets with light traffic, t</b>	Tape/Media #:	
Purpose:	<b>Routine Assessment</b>	Dia/Height:	<b>10"</b>
Use:	<b>Sanitary Sewage Pipe</b>	Material:	<b>PVC</b>
Drain Area:		Lining:	<b>None</b>
Category:	<b>NA</b>		
Comment:			
Location Details:		Direction of Survey:	<b>Downstream</b>
US MH:	<b>M-503-011</b>	DS MH:	<b>M-503-012</b>
		Total Length Surveyed (ft):	<b>197.3</b>

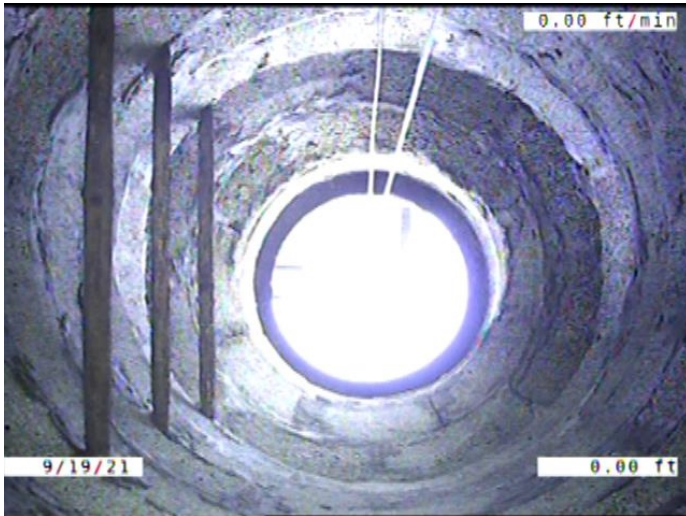
Code: **AMH**  
Description: **Manhole**

Distance (ft): **.0**  
Structural Grade: **0**  
O&M Grade: **0**  
Clock Start/From:  
Clock To:  
1st Value:  
2nd Value:  
Value Percent:  
Continuous Index:  
Within 8" of Joint: **NO**  
Remarks: **M-503-011**

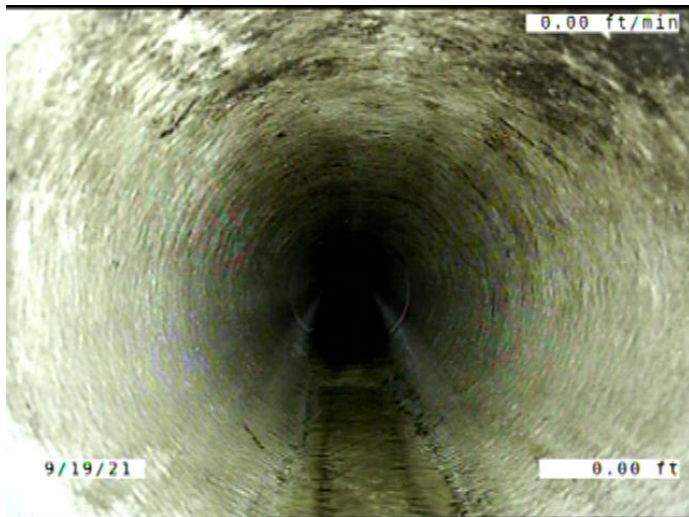
Code: **MWL**  
 Description: **Miscellaneous Water Level**

Distance (ft): **.0**  
 Structural Grade: **0**  
 O&M Grade: **0**  
 Clock Start/From:  
 Clock To:  
 1st Value:  
 2nd Value:  
 Value Percent: **5.000**  
 Continuous Index:  
 Within 8" of Joint: **NO**  
 Remarks:

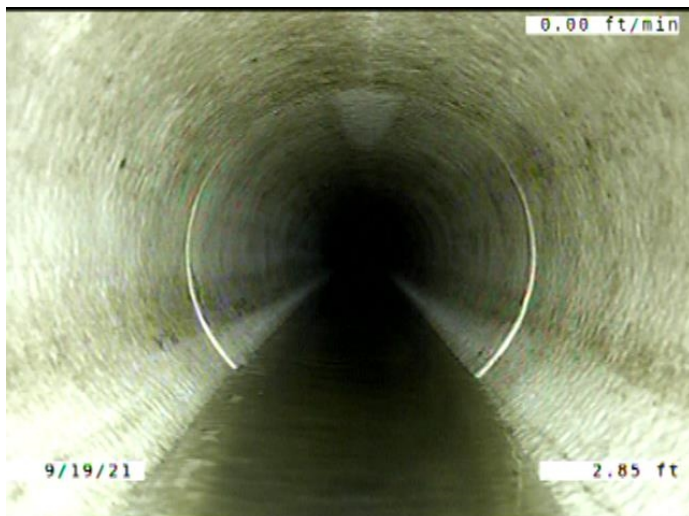
Code: **DSF**  
 Description: **Deposits Settled Fine**

Distance (ft): **2.8**  
 Structural Grade: **0**  
 O&M Grade: **2**  
 Clock Start/From: **5**  
 Clock To: **7**  
 1st Value:  
 2nd Value:  
 Value Percent: **5.000**  
 Continuous Index: **S01**  
 Within 8" of Joint: **YES**  
 Remarks:

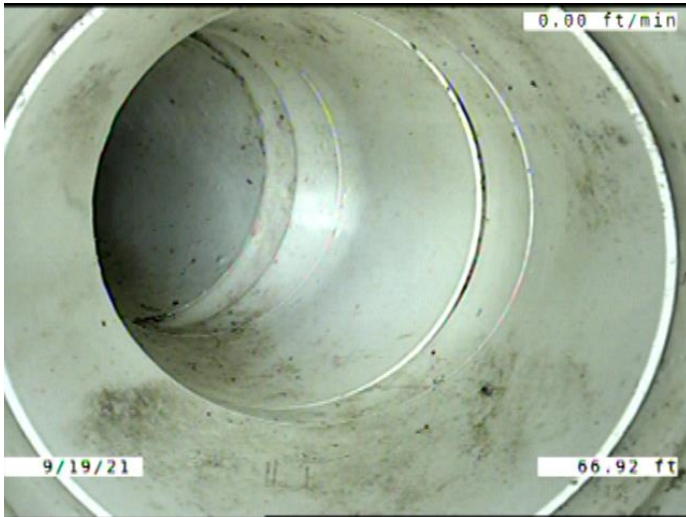
Code: **TF**  
 Description: **Tap Factory**

Distance (ft): **66.9**  
 Structural Grade: **0**  
 O&M Grade: **0**  
 Clock Start/From: **11**  
 Clock To:  
 1st Value: **4.000**  
 2nd Value:  
 Value Percent:  
 Continuous Index:  
 Within 8" of Joint: **YES**  
 Remarks:

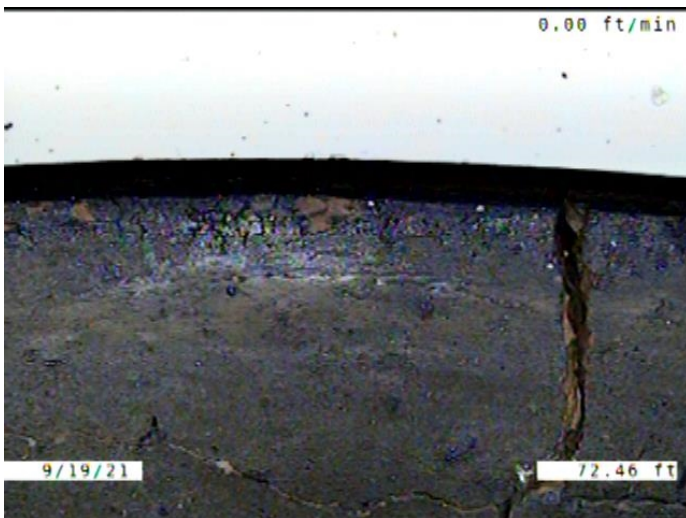
Code: **MMC**  
 Description: **Miscellaneous Material Change**

Distance (ft): **72.5**  
 Structural Grade: **0**  
 O&M Grade: **0**  
 Clock Start/From:  
 Clock To:  
 1st Value:  
 2nd Value:  
 Value Percent:  
 Continuous Index:  
 Within 8" of Joint: **NO**  
 Remarks: **PVC TO VCP**

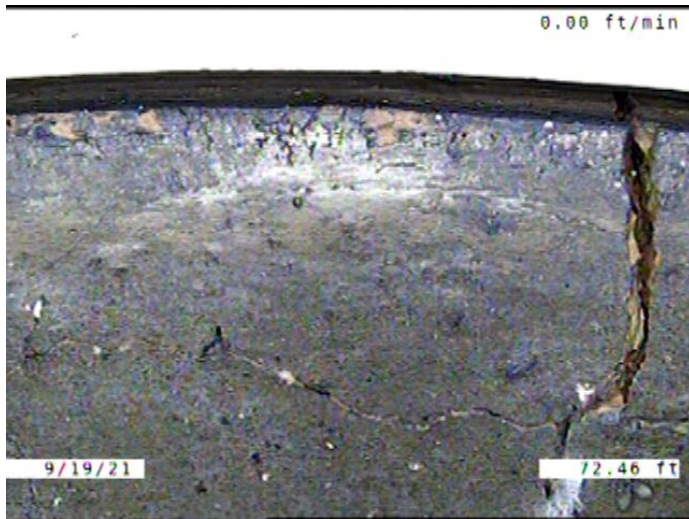
Code: **FM**  
Description: **Fracture Multiple**

Distance (ft): **72.5**  
Structural Grade: **4**  
O&M Grade: **0**  
Clock Start/From: **12**  
Clock To: **12**  
1st Value:  
2nd Value:  
Value Percent:  
Continuous Index: **S02**  
Within 8" of Joint: **YES**  
Remarks:

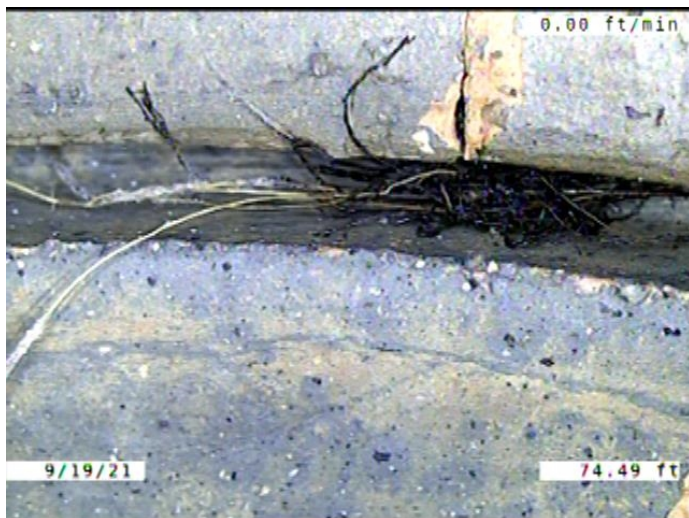
Code: **RFJ**  
Description: **Roots Fine Joint**

Distance (ft): **74.5**  
Structural Grade: **0**  
O&M Grade: **1**  
Clock Start/From: **12**  
Clock To: **3**  
1st Value:  
2nd Value:  
Value Percent:  
Continuous Index:  
Within 8" of Joint: **YES**  
Remarks:

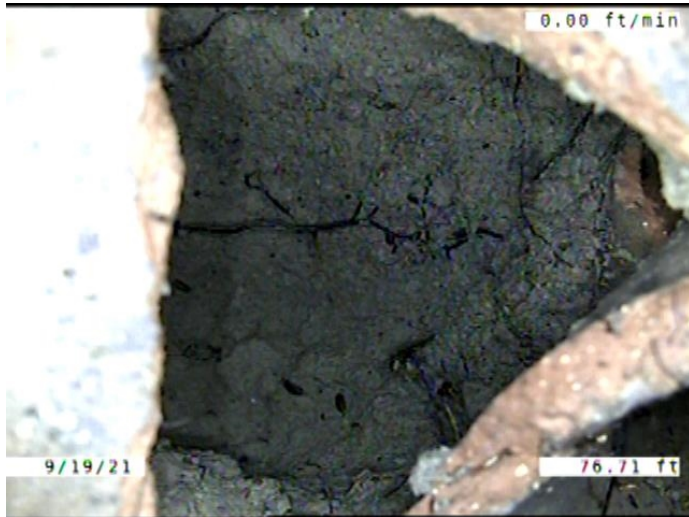
Code: **HVV**  
 Description: **Hole Void Visible**

Distance (ft): **76.7**  
 Structural Grade: **5**  
 O&M Grade: **0**  
 Clock Start/From: **12**  
 Clock To: **2**  
 1st Value:  
 2nd Value:  
 Value Percent:  
 Continuous Index:  
 Within 8" of Joint: **YES**  
 Remarks: **SOIL VISIBLE TOO**

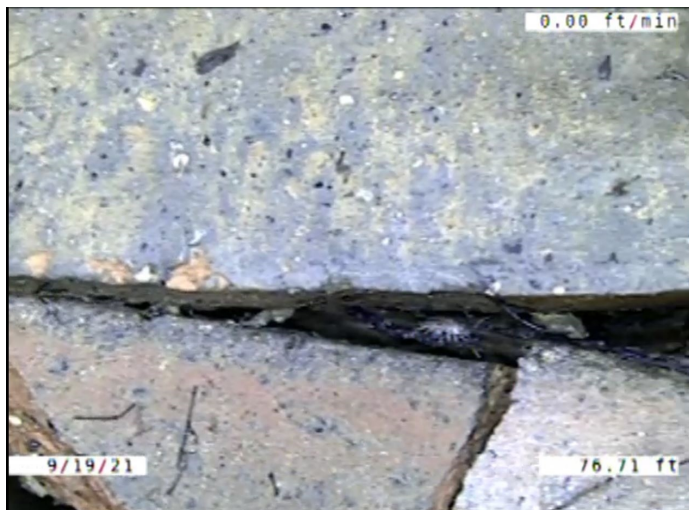
Code: **B**  
 Description: **Broken**

Distance (ft): **76.7**  
 Structural Grade: **4**  
 O&M Grade: **0**  
 Clock Start/From: **2**  
 Clock To: **4**  
 1st Value:  
 2nd Value:  
 Value Percent:  
 Continuous Index:  
 Within 8" of Joint: **NO**  
 Remarks:

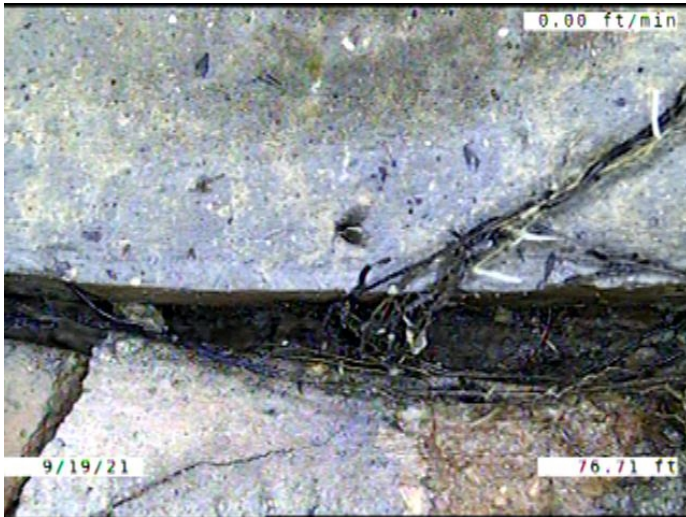
Code: **RFJ**  
 Description: **Roots Fine Joint**

Distance (ft): **76.7**  
 Structural Grade: **0**  
 O&M Grade: **1**  
 Clock Start/From: **12**  
 Clock To: **3**  
 1st Value:  
 2nd Value:  
 Value Percent:  
 Continuous Index:  
 Within 8" of Joint: **YES**  
 Remarks:

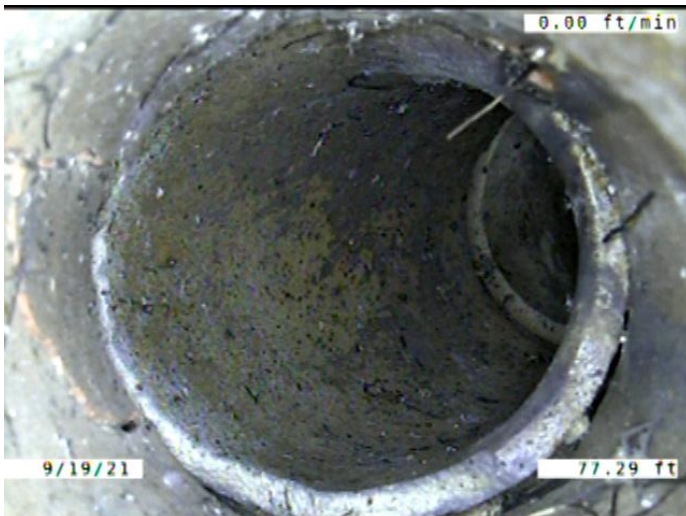
Code: **TFD**  
 Description: **Tap Factory Defective**

Distance (ft): **77.3**  
 Structural Grade: **0**  
 O&M Grade: **3**  
 Clock Start/From: **2**  
 Clock To:  
 1st Value: **4.000**  
 2nd Value:  
 Value Percent:  
 Continuous Index:  
 Within 8" of Joint: **YES**  
 Remarks: **Defective**

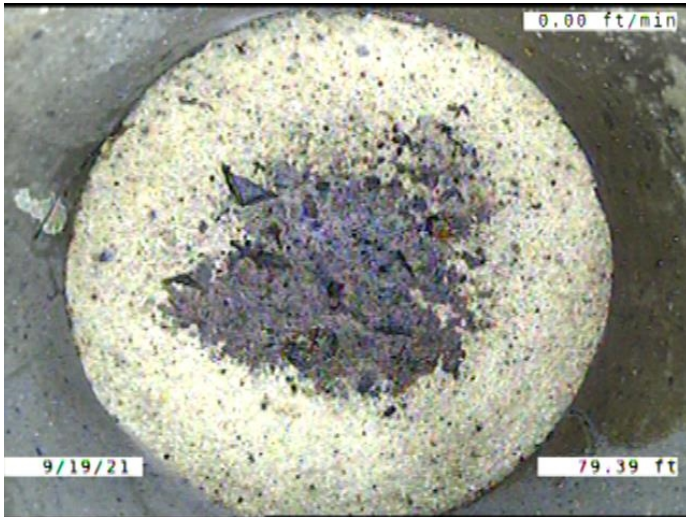
Code: **TFD**  
 Description: **Tap Factory Defective**

Distance (ft): **79.4**  
 Structural Grade: **0**  
 O&M Grade: **3**  
 Clock Start/From: **11**  
 Clock To:  
 1st Value: **4.000**  
 2nd Value:  
 Value Percent:  
 Continuous Index:  
 Within 8" of Joint: **YES**  
 Remarks: **CAPPED**

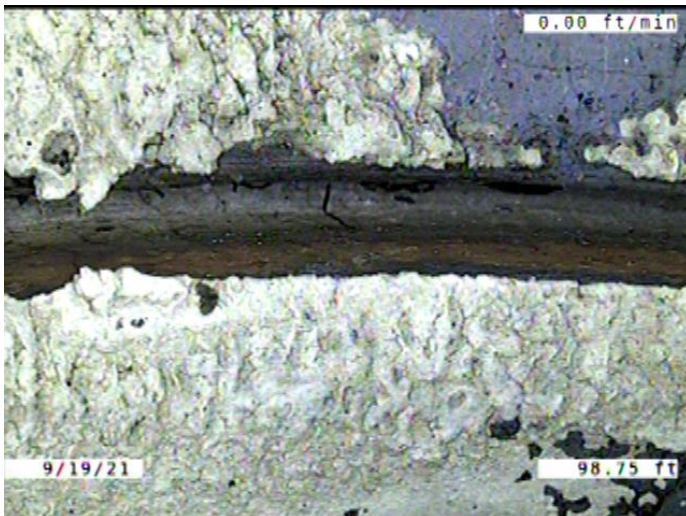
Code: **DAE**  
 Description: **Deposits Attached Encrustation**

Distance (ft): **98.8**  
 Structural Grade: **0**  
 O&M Grade: **2**  
 Clock Start/From: **9**  
 Clock To: **11**  
 1st Value:  
 2nd Value:  
 Value Percent: **5.000**  
 Continuous Index:  
 Within 8" of Joint: **YES**  
 Remarks:

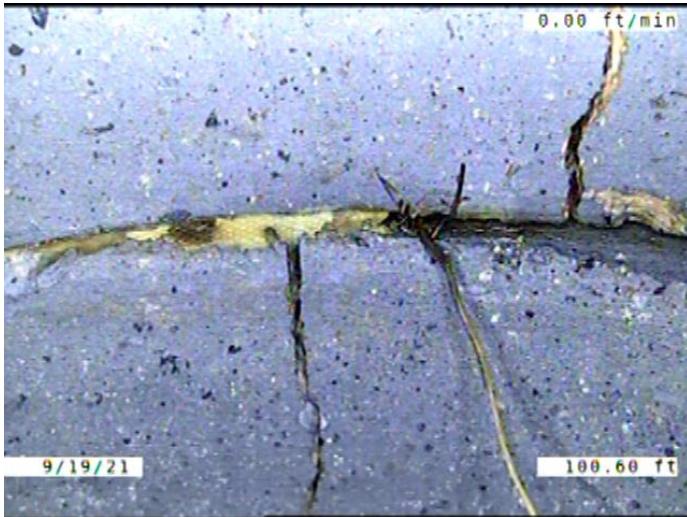
Code: **RFJ**  
 Description: **Roots Fine Joint**

Distance (ft): **100.6**  
 Structural Grade: **0**  
 O&M Grade: **1**  
 Clock Start/From: **9**  
 Clock To: **3**  
 1st Value:  
 2nd Value:  
 Value Percent:  
 Continuous Index: **S03**  
 Within 8" of Joint: **YES**  
 Remarks:

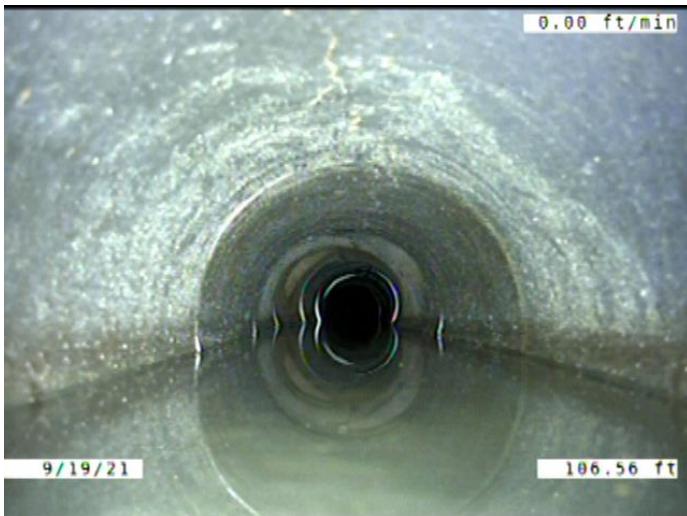
Code: **RFJ**  
 Description: **Roots Fine Joint**

Distance (ft): **106.6**  
 Structural Grade: **0**  
 O&M Grade: **1**  
 Clock Start/From: **9**  
 Clock To: **3**  
 1st Value:  
 2nd Value:  
 Value Percent:  
 Continuous Index: **F03**  
 Within 8" of Joint: **YES**  
 Remarks:

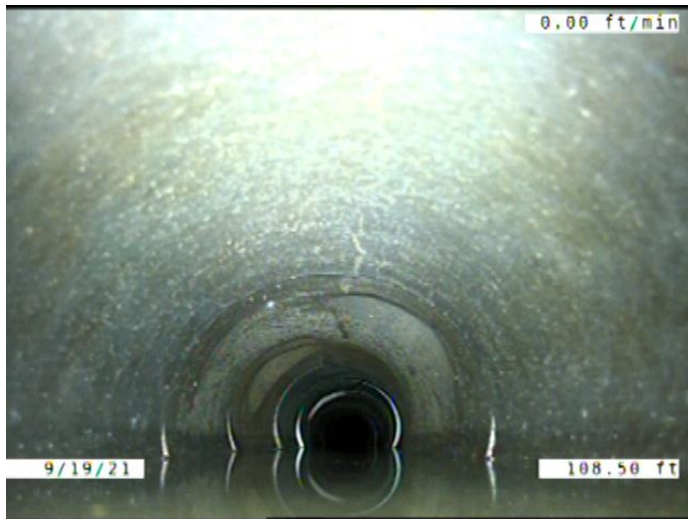
Code: **MWLS**  
 Description: **Miscellaneous Water Level Sag**

Distance (ft): **108.5**  
 Structural Grade: **2**  
 O&M Grade: **0**  
 Clock Start/From:  
 Clock To:  
 1st Value:  
 2nd Value:  
 Value Percent: **15.000**  
 Continuous Index: **S04**  
 Within 8" of Joint: **NO**  
 Remarks:

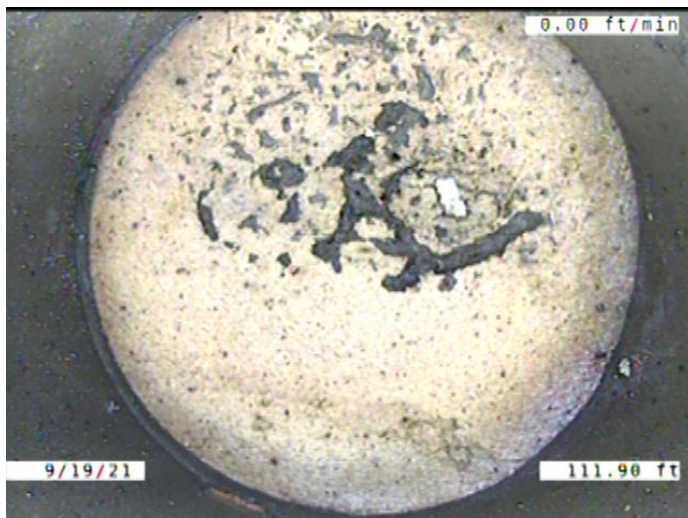
Code: **TFD**  
 Description: **Tap Factory Defective**

Distance (ft): **111.9**  
 Structural Grade: **0**  
 O&M Grade: **3**  
 Clock Start/From: **1**  
 Clock To:  
 1st Value: **4.000**  
 2nd Value:  
 Value Percent:  
 Continuous Index:  
 Within 8" of Joint: **YES**  
 Remarks: **CAPPED**

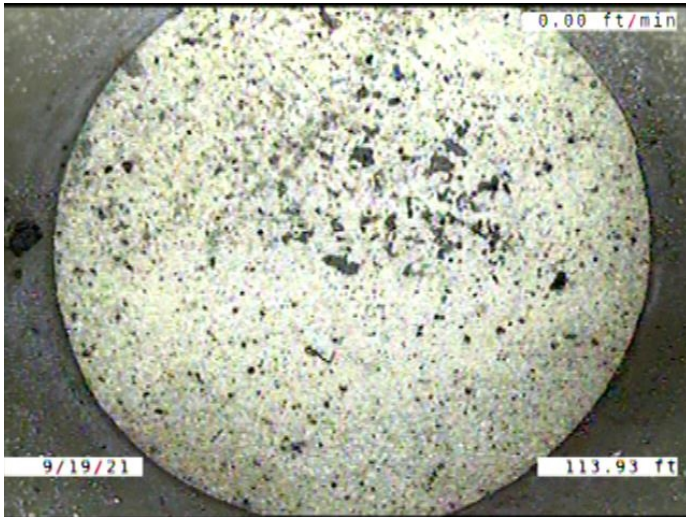
Code: **TFD**  
 Description: **Tap Factory Defective**

Distance (ft): **113.9**  
 Structural Grade: **0**  
 O&M Grade: **3**  
 Clock Start/From: **11**  
 Clock To:  
 1st Value: **4.000**  
 2nd Value:  
 Value Percent:  
 Continuous Index:  
 Within 8" of Joint: **YES**  
 Remarks: **CAPPED**

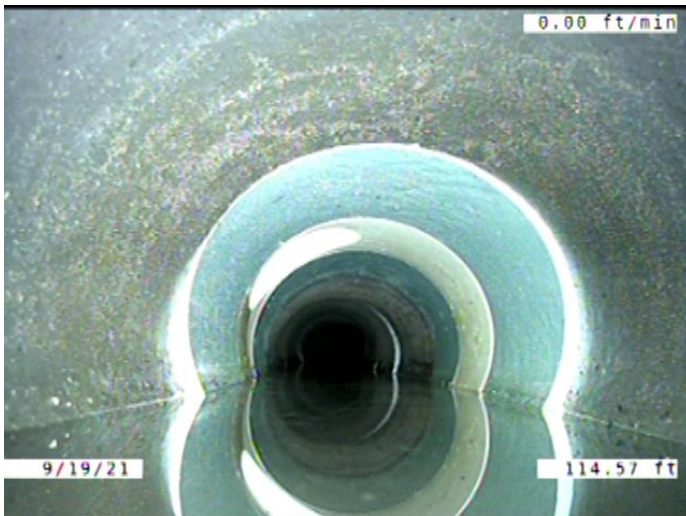
Code: **MWLS**  
 Description: **Miscellaneous Water Level Sag**

Distance (ft): **114.6**  
 Structural Grade: **2**  
 O&M Grade: **0**  
 Clock Start/From:  
 Clock To:  
 1st Value:  
 2nd Value:  
 Value Percent: **15.000**  
 Continuous Index: **F04**  
 Within 8" of Joint: **NO**  
 Remarks:

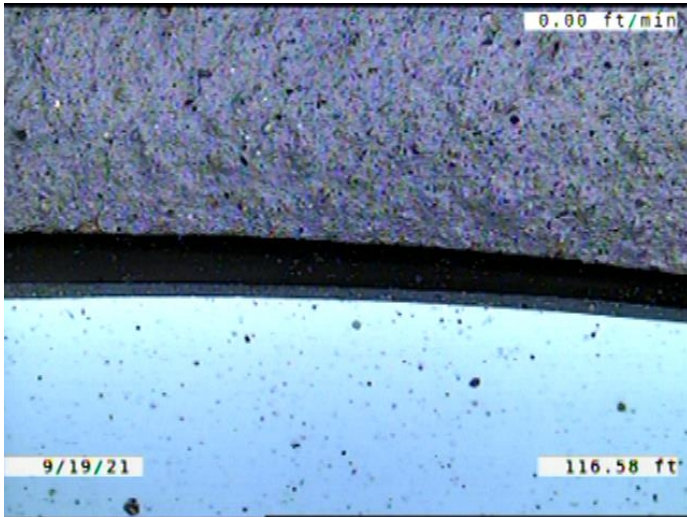
Code: **MMC**  
 Description: **Miscellaneous Material Change**

Distance (ft): **116.6**  
 Structural Grade: **0**  
 O&M Grade: **0**  
 Clock Start/From:  
 Clock To:  
 1st Value:  
 2nd Value:  
 Value Percent:  
 Continuous Index:  
 Within 8" of Joint: **NO**  
 Remarks: **VCP TO PVC**

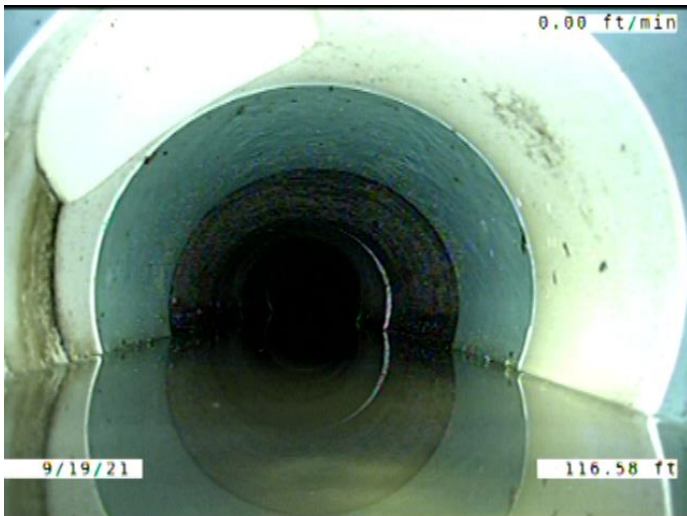
Code: **FM**  
 Description: **Fracture Multiple**

Distance (ft): **116.6**  
 Structural Grade: **4**  
 O&M Grade: **0**  
 Clock Start/From: **12**  
 Clock To: **12**  
 1st Value:  
 2nd Value:  
 Value Percent:  
 Continuous Index: **F02**  
 Within 8" of Joint: **YES**  
 Remarks:

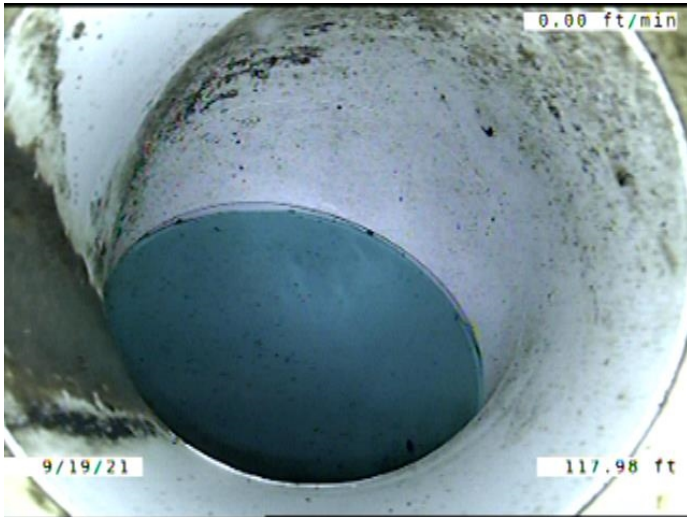
Code: **TF**  
 Description: **Tap Factory**

Distance (ft): **118.0**  
 Structural Grade: **0**  
 O&M Grade: **0**  
 Clock Start/From: **11**  
 Clock To:  
 1st Value: **4.000**  
 2nd Value:  
 Value Percent:  
 Continuous Index:  
 Within 8" of Joint: **YES**  
 Remarks:

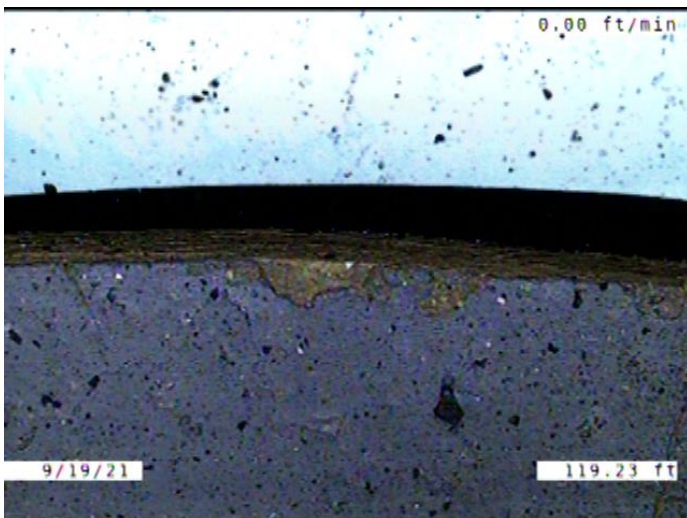
Code: **MMC**  
 Description: **Miscellaneous Material Change**

Distance (ft): **119.2**  
 Structural Grade: **0**  
 O&M Grade: **0**  
 Clock Start/From:  
 Clock To:  
 1st Value:  
 2nd Value:  
 Value Percent:  
 Continuous Index:  
 Within 8" of Joint: **NO**  
 Remarks: **PVC TO VCP**

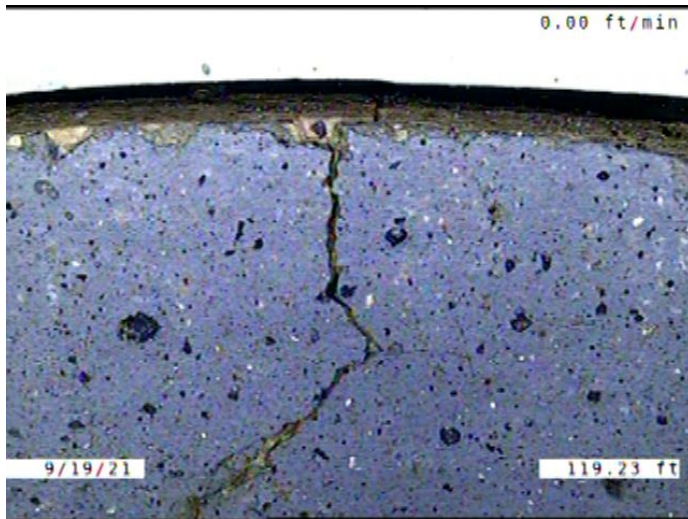
Code: **FM**  
 Description: **Fracture Multiple**

Distance (ft): **119.2**  
 Structural Grade: **4**  
 O&M Grade: **0**  
 Clock Start/From: **12**  
 Clock To: **12**  
 1st Value:  
 2nd Value:  
 Value Percent:  
 Continuous Index: **S05**  
 Within 8" of Joint: **YES**  
 Remarks:

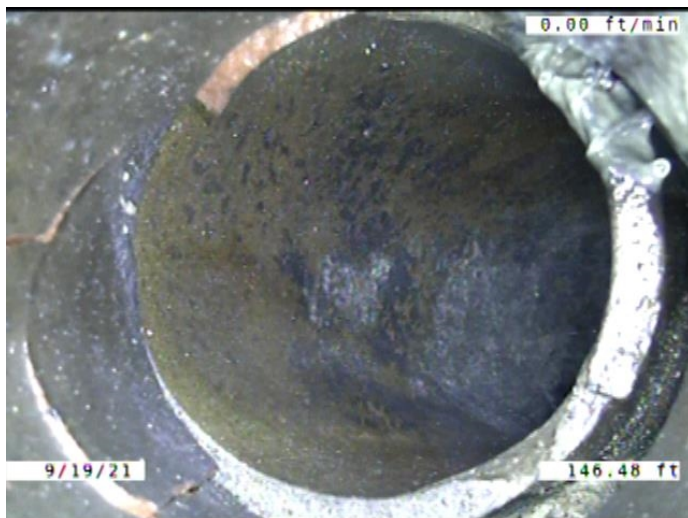
Code: **TFD**  
 Description: **Tap Factory Defective**

Distance (ft): **146.5**  
 Structural Grade: **0**  
 O&M Grade: **3**  
 Clock Start/From: **1**  
 Clock To:  
 1st Value: **4.000**  
 2nd Value:  
 Value Percent:  
 Continuous Index:  
 Within 8" of Joint: **YES**  
 Remarks: **CONSTANTLY RUNNING WATER**

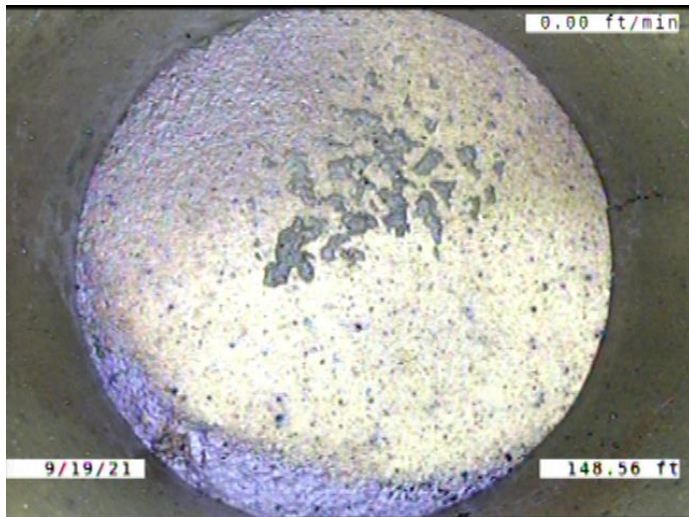
Code: **TFC**  
 Description: **Tap Factory Capped**

Distance (ft): **148.6**  
 Structural Grade: **0**  
 O&M Grade: **0**  
 Clock Start/From: **11**  
 Clock To:  
 1st Value: **4.000**  
 2nd Value:  
 Value Percent:  
 Continuous Index:  
 Within 8" of Joint: **YES**  
 Remarks: **CRACKED BACK BY THE CAP**

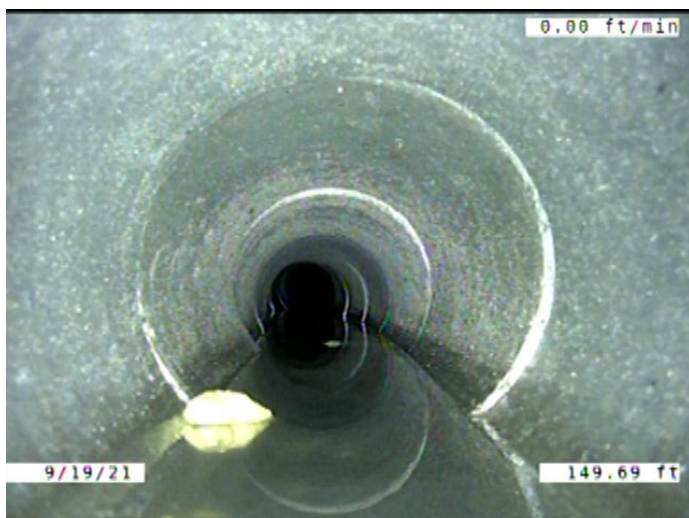
Code: **FM**  
 Description: **Fracture Multiple**

Distance (ft): **149.7**  
 Structural Grade: **4**  
 O&M Grade: **0**  
 Clock Start/From: **12**  
 Clock To: **12**  
 1st Value:  
 2nd Value:  
 Value Percent:  
 Continuous Index: **F05**  
 Within 8" of Joint: **YES**  
 Remarks:

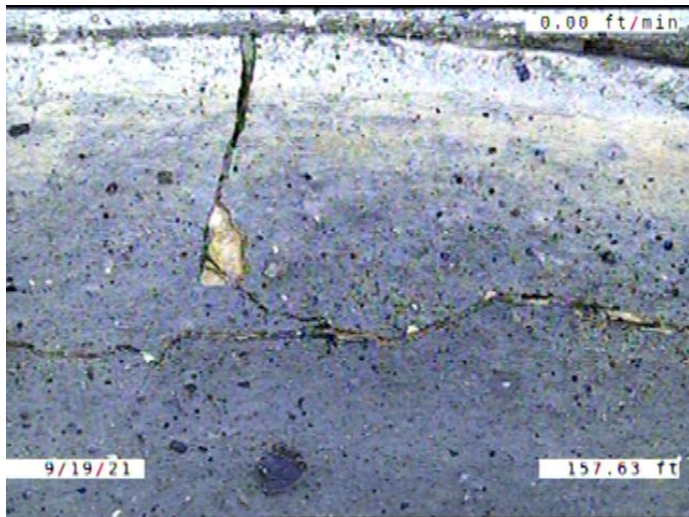
Code: **FM**  
 Description: **Fracture Multiple**

Distance (ft): **157.6**  
 Structural Grade: **4**  
 O&M Grade: **0**  
 Clock Start/From: **10**  
 Clock To: **2**  
 1st Value:  
 2nd Value:  
 Value Percent:  
 Continuous Index:  
 Within 8" of Joint: **YES**  
 Remarks:

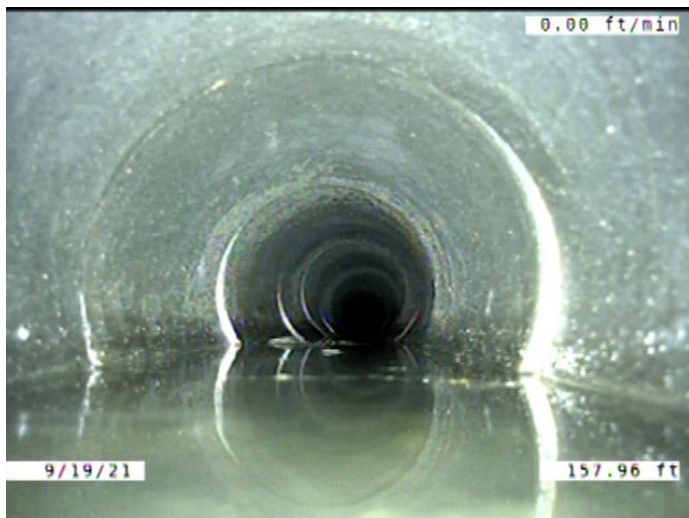
Code: **MWLS**  
 Description: **Miscellaneous Water Level Sag**

Distance (ft): **158.0**  
 Structural Grade: **2**  
 O&M Grade: **0**  
 Clock Start/From:  
 Clock To:  
 1st Value:  
 2nd Value:  
 Value Percent: **10.000**  
 Continuous Index:  
 Within 8" of Joint: **NO**  
 Remarks:

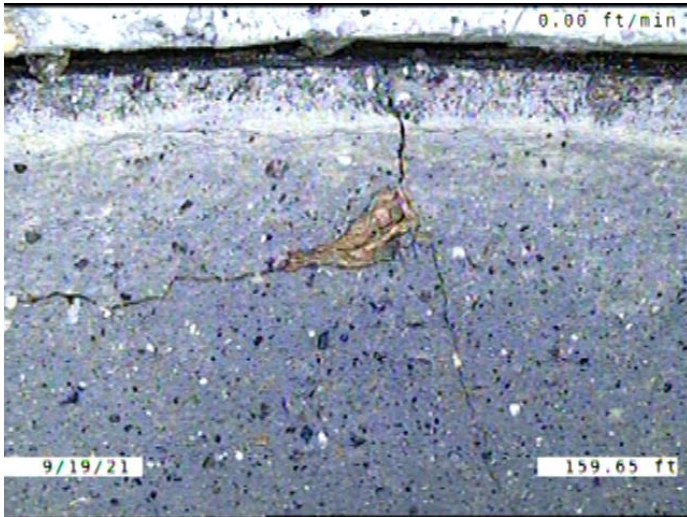
Code: **CM**  
 Description: **Crack Multiple**

Distance (ft): **159.6**  
 Structural Grade: **3**  
 O&M Grade: **0**  
 Clock Start/From: **10**  
 Clock To: **12**  
 1st Value:  
 2nd Value:  
 Value Percent:  
 Continuous Index:  
 Within 8" of Joint: **YES**  
 Remarks:

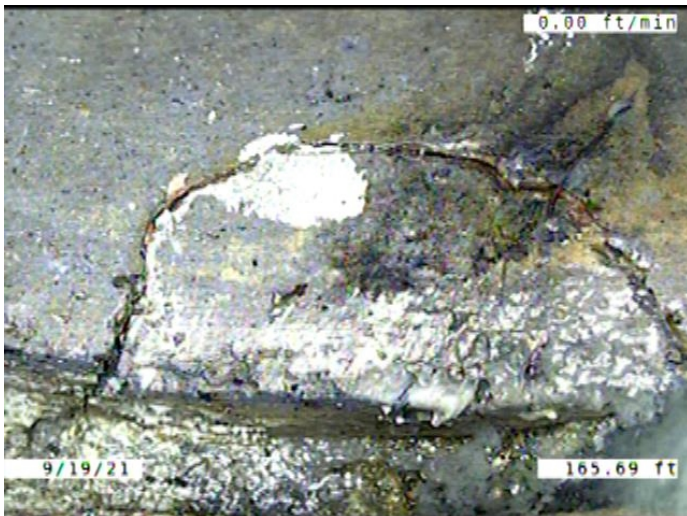
Code: **FM**  
 Description: **Fracture Multiple**

Distance (ft): **165.7**  
 Structural Grade: **4**  
 O&M Grade: **0**  
 Clock Start/From: **7**  
 Clock To: **8**  
 1st Value:  
 2nd Value:  
 Value Percent:  
 Continuous Index:  
 Within 8" of Joint: **YES**  
 Remarks:

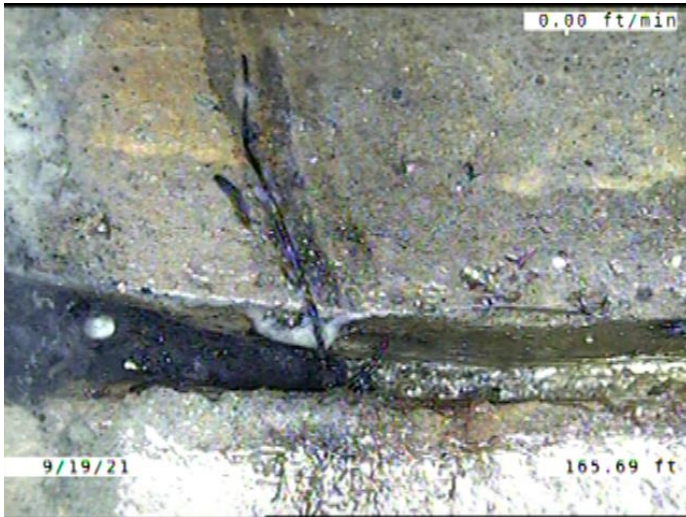
Code: **RFJ**  
Description: **Roots Fine Joint**

Distance (ft): **165.7**  
Structural Grade: **0**  
O&M Grade: **1**  
Clock Start/From: **4**  
Clock To: **5**  
1st Value:  
2nd Value:  
Value Percent:  
Continuous Index:  
Within 8" of Joint: **YES**  
Remarks:

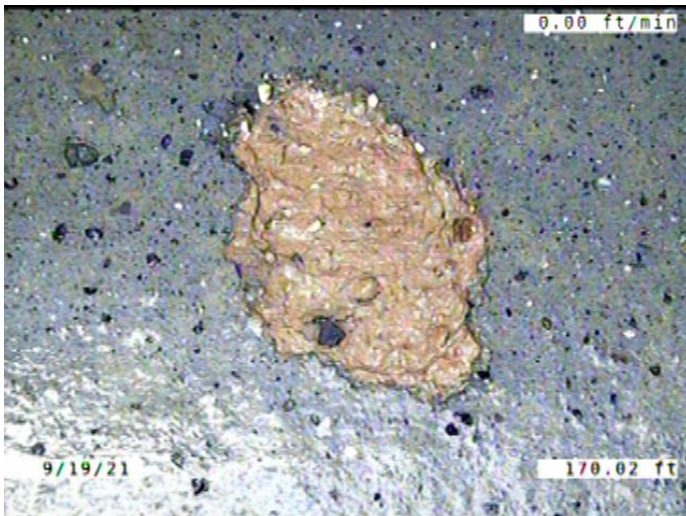
Code: **SSS**  
Description: **Surface Damage Surface Spalling**

Distance (ft): **170.0**  
Structural Grade: **2**  
O&M Grade: **0**  
Clock Start/From: **4**  
Clock To:  
1st Value:  
2nd Value:  
Value Percent:  
Continuous Index:  
Within 8" of Joint: **YES**  
Remarks:

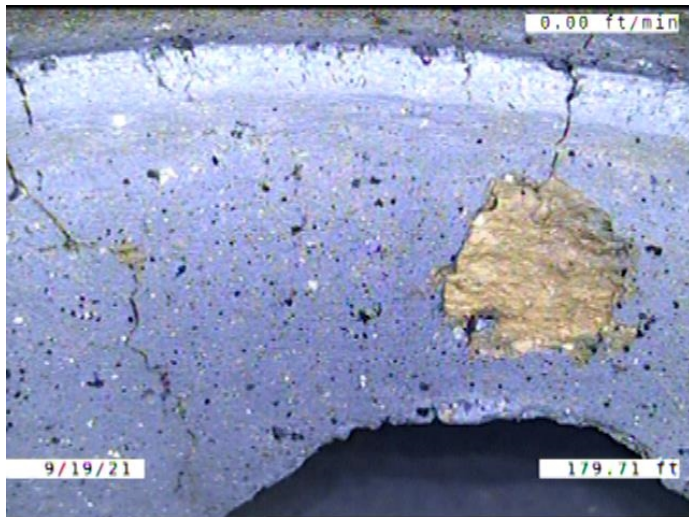
Code: **FM**  
 Description: **Fracture Multiple**

Distance (ft): **179.7**  
 Structural Grade: **4**  
 O&M Grade: **0**  
 Clock Start/From: **5**  
 Clock To: **1**  
 1st Value:  
 2nd Value:  
 Value Percent:  
 Continuous Index: **S06**  
 Within 8" of Joint: **YES**  
 Remarks:

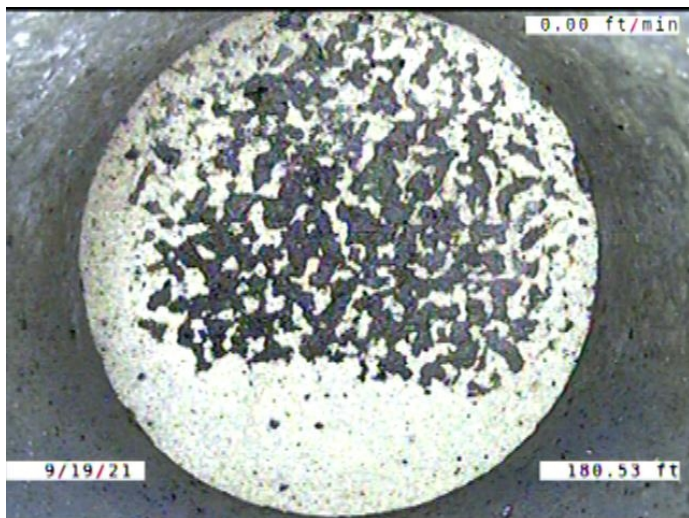
Code: **TFC**  
 Description: **Tap Factory Capped**

Distance (ft): **180.5**  
 Structural Grade: **0**  
 O&M Grade: **0**  
 Clock Start/From: **1**  
 Clock To:  
 1st Value: **4.000**  
 2nd Value:  
 Value Percent:  
 Continuous Index:  
 Within 8" of Joint: **YES**  
 Remarks:

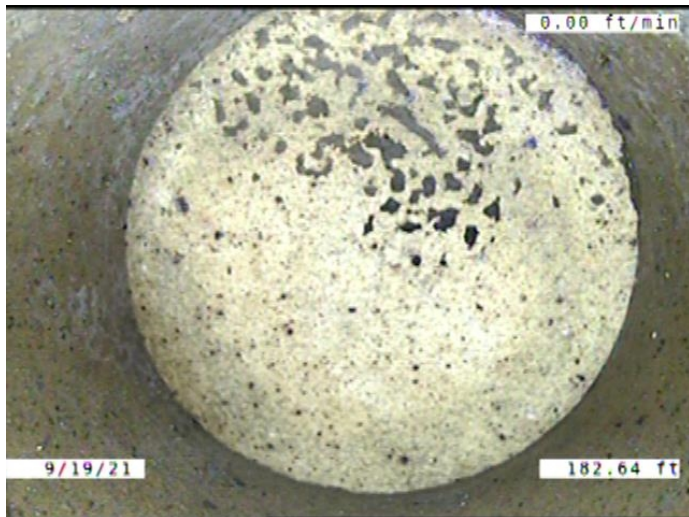
Code: **TFC**  
 Description: **Tap Factory Capped**

Distance (ft): **182.6**  
 Structural Grade: **0**  
 O&M Grade: **0**  
 Clock Start/From: **11**  
 Clock To:  
 1st Value: **4.000**  
 2nd Value:  
 Value Percent:  
 Continuous Index:  
 Within 8" of Joint: **YES**  
 Remarks:

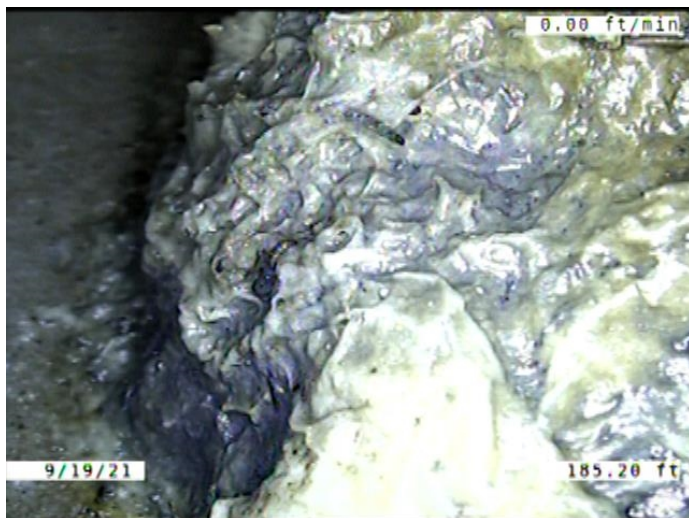
Code: **OBZ**  
 Description: **Obstruction Other**

Distance (ft): **185.2**  
 Structural Grade: **0**  
 O&M Grade: **2**  
 Clock Start/From: **6**  
 Clock To: **8**  
 1st Value:  
 2nd Value:  
 Value Percent: **10.000**  
 Continuous Index:  
 Within 8" of Joint: **YES**  
 Remarks: **TP, RAGS, AND SEWER DEBRIS**

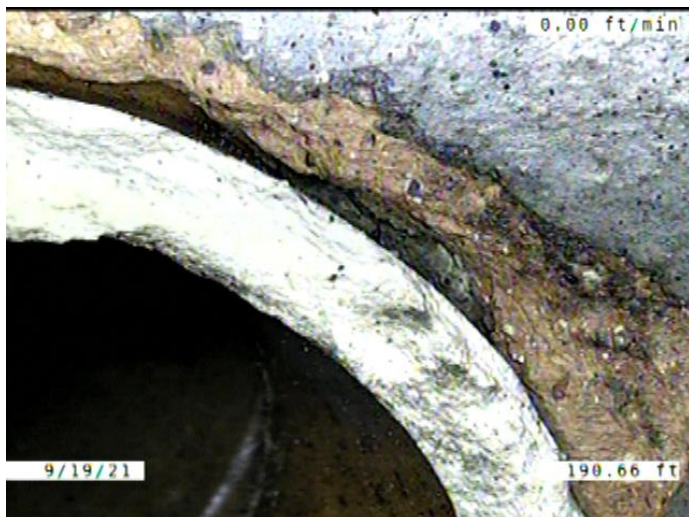
Code: **FM**  
 Description: **Fracture Multiple**

Distance (ft): **190.7**  
 Structural Grade: **4**  
 O&M Grade: **0**  
 Clock Start/From: **9**  
 Clock To: **12**  
 1st Value:  
 2nd Value:  
 Value Percent:  
 Continuous Index:  
 Within 8" of Joint: **YES**  
 Remarks:

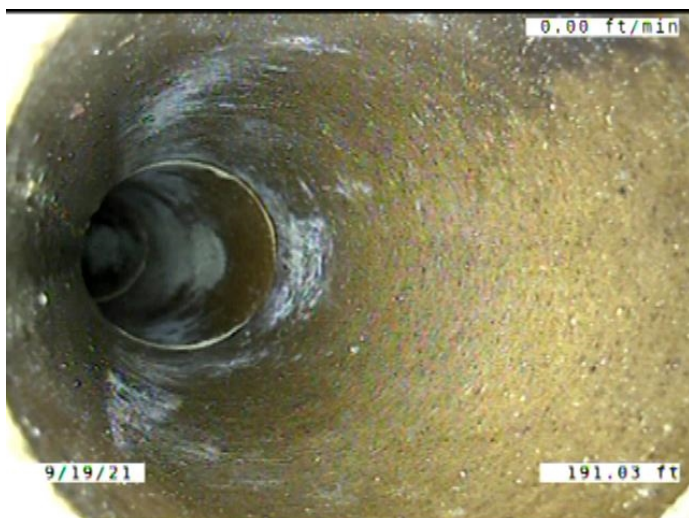
Code: **TBI**  
 Description: **Tap Break-in Intruding**

Distance (ft): **191.0**  
 Structural Grade: **0**  
 O&M Grade: **2**  
 Clock Start/From: **10**  
 Clock To:  
 1st Value: **4.000**  
 2nd Value: **1.000**  
 Value Percent:  
 Continuous Index:  
 Within 8" of Joint: **YES**  
 Remarks:

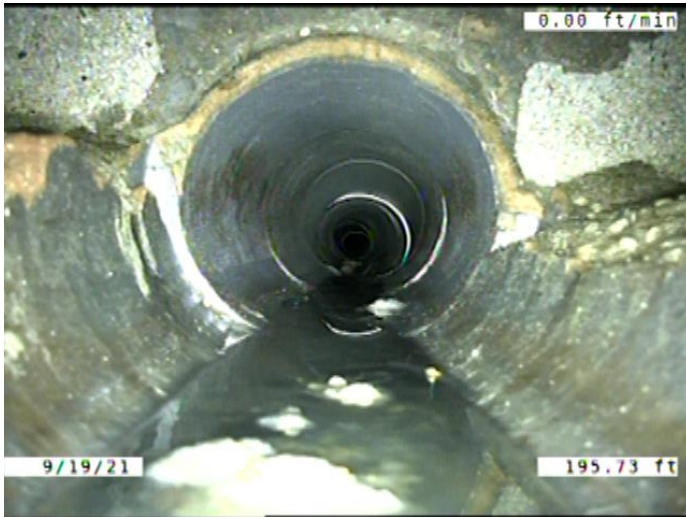
Code: **DSF**  
 Description: **Deposits Settled Fine**

Distance (ft): **195.7**  
 Structural Grade: **0**  
 O&M Grade: **2**  
 Clock Start/From: **5**  
 Clock To: **7**  
 1st Value:  
 2nd Value:  
 Value Percent: **5.000**  
 Continuous Index: **F01**  
 Within 8" of Joint: **YES**  
 Remarks:

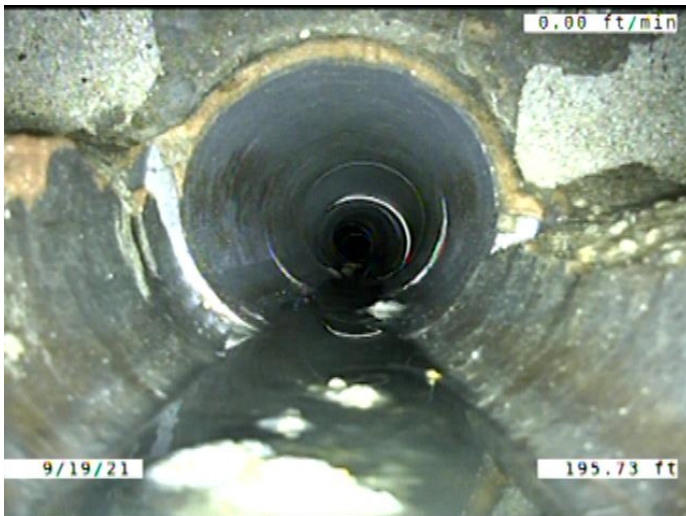
Code: **FM**  
 Description: **Fracture Multiple**

Distance (ft): **195.7**  
 Structural Grade: **4**  
 O&M Grade: **0**  
 Clock Start/From: **5**  
 Clock To: **1**  
 1st Value:  
 2nd Value:  
 Value Percent:  
 Continuous Index: **F06**  
 Within 8" of Joint: **YES**  
 Remarks:

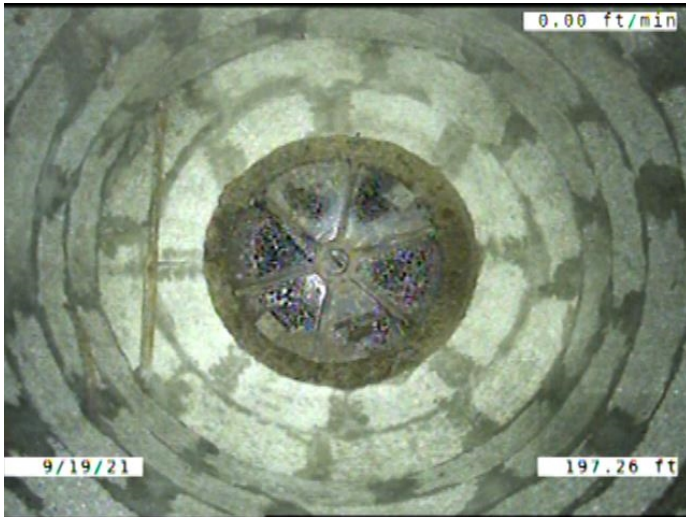
Code:	<b>AMH</b>
Description:	<b>Manhole</b>
Distance (ft):	<b>197.3</b>
Structural Grade:	<b>0</b>
O&M Grade:	<b>0</b>
Clock Start/From:	
Clock To:	
1st Value:	
2nd Value:	
Value Percent:	
Continuous Index:	
Within 8" of Joint:	<b>NO</b>
Remarks:	<b>M-503-012</b>
