Profile/Photo Observation Report

Street:	N VIRGINIA ST	Flow Control:	Not Controlled
City:	Hobart, IN	Year Renewed:	
Location:	Other	Tape/Media #:	
Purpose:	Not Known	Dia/Height:	10"
Use:	Sanitary	Material:	VCP
Drain Area:	NA	Lining:	
Category:	NA		
Comment:

Location Details:		Direction of Survey:	Downstream
US MH:	M-503-012	DS MH:	M-503-013
		Total Length Surveyed (ft):	71.5

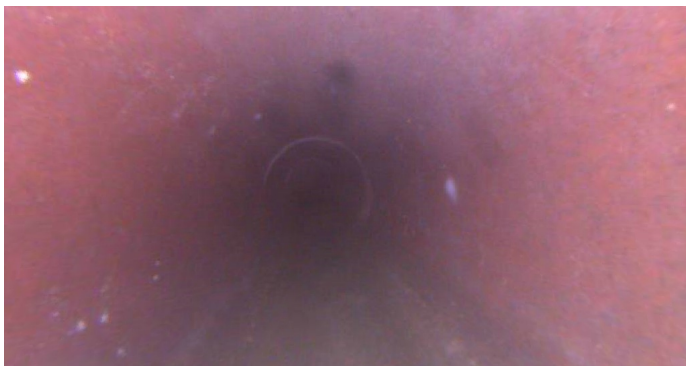
Code:	MWL
Description:	Water Level

Distance (ft):	.0
Structural Grade:	0
O&M Grade:	0
Clock Start/From:	
Clock To:	
1st Value:	
2nd Value:	
Value Percent:	10.000
Continuous Index:	
Within 8" of Joint:	NO
Remarks:

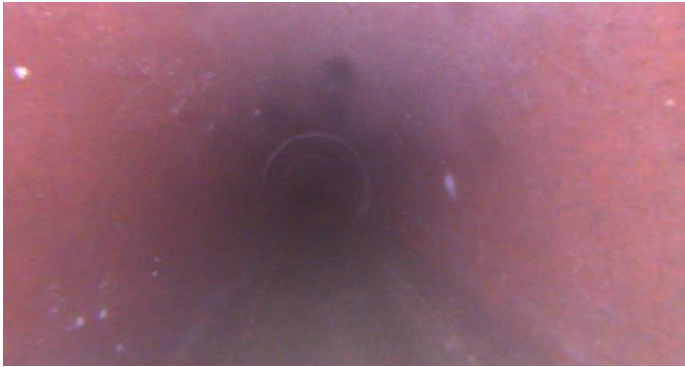
Code:	DAE
Description:	Deposits Attached Encrustation

Distance (ft):	2.9
Structural Grade:	0
O&M Grade:	2
Clock Start/From:	2
Clock To:	4
1st Value:	
2nd Value:	
Value Percent:	5.000
Continuous Index:	
Within 8" of Joint:	YES
Remarks:

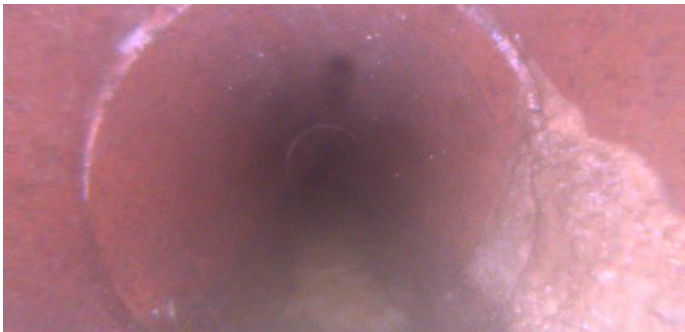
Code: **TB**
Description: **Tap Break-in**

Distance (ft): **25.8**
Structural Grade: **0**
O&M Grade: **0**
Clock Start/From: **2**
Clock To:
1st Value: **4.000**
2nd Value:
Value Percent:
Continuous Index:
Within 8" of Joint:
Remarks:

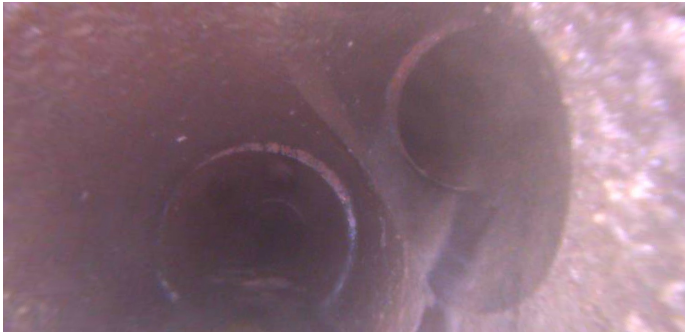
Code: **MMC**
Description: **Material Change**

Distance (ft): **50.4**
Structural Grade: **0**
O&M Grade: **0**
Clock Start/From:
Clock To:
1st Value:
2nd Value:
Value Percent:
Continuous Index:
Within 8" of Joint: **NO**
Remarks: **PVC**

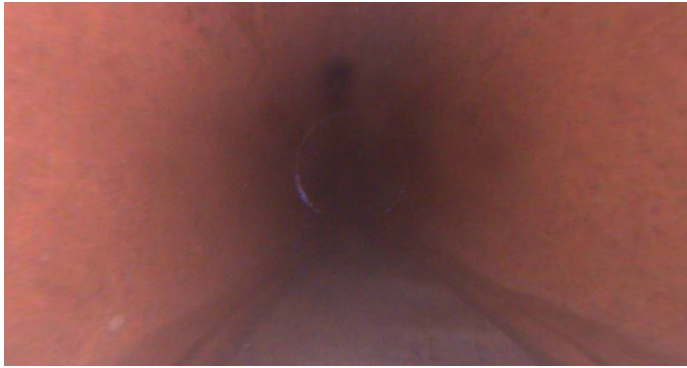
Code: **MMC**
Description: **Material Change**

Distance (ft): **64.8**
Structural Grade: **0**
O&M Grade: **0**
Clock Start/From:
Clock To:
1st Value:
2nd Value:
Value Percent:
Continuous Index:
Within 8" of Joint: **NO**
Remarks: **VCP**
