Profile/Photo Observation Report

Date:	04/10/2018	Weather:		Coding:	PACP 6.0
Pipe Length (ft):	241.0	Owner:	NA	Pre Clean:	Not Known
P.O.#:		Surveyor:	Mark Ruby	PSR:	P-503-014-012
Customer:		Clean Date:	01/01/1900	Shape:	C

Street:	W 40th ave	Flow Control:	Not Controlled
City:	Hobart, IN	Year Renewed:	
Location:	Other	Tape/Media #:	
Purpose:	Not Known	Dia/Height:	10"
Use:	Sanitary	Material:	VCP
Drain Area:	NA	Lining:	
Category:	NA		
Comment:			
Location Details:		Direction of Survey:	Downstream
US MH:	M-503-012	DS MH:	M-503-014
		Total Length Surveyed (ft):	76.8

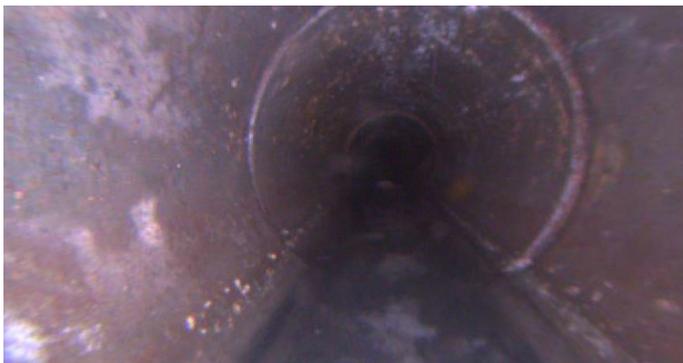
Code: **AMH**
Description: **Manhole**
Distance (ft): **.0**
Structural Grade: **0**
O&M Grade: **0**
Clock Start/From:
Clock To:
1st Value:
2nd Value:
Value Percent:
Continuous Index:
Within 8" of Joint: **NO**
Remarks: **M-503-012**

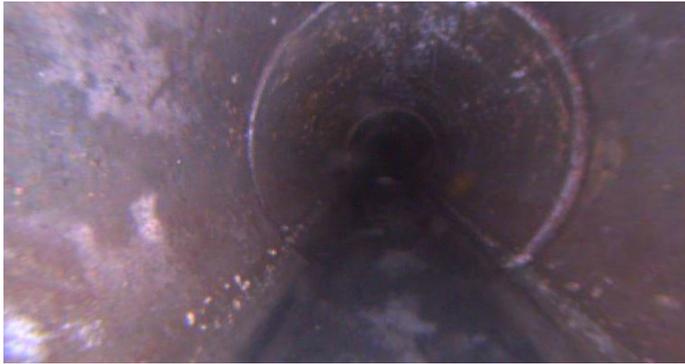
Code: **MWL**
Description: **Water Level**

Distance (ft): **.0**
Structural Grade: **0**
O&M Grade: **0**
Clock Start/From:
Clock To:
1st Value:
2nd Value:
Value Percent: **10.000**
Continuous Index:
Within 8" of Joint: **NO**
Remarks:

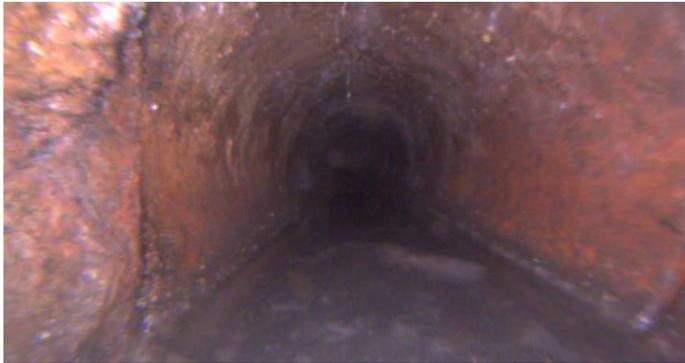
Code: **DAE**
Description: **Deposits Attached Encrustation**

Distance (ft): **5.4**
Structural Grade: **0**
O&M Grade: **2**
Clock Start/From: **7**
Clock To: **5**
1st Value:
2nd Value:
Value Percent: **5.000**
Continuous Index: **S01**
Within 8" of Joint: **YES**
Remarks:

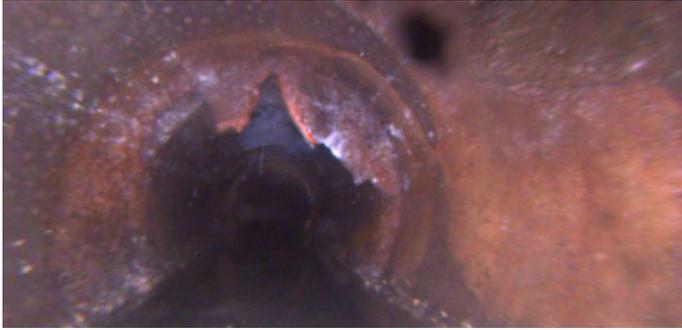
Code: **ID**
Description: **Infil Dripper**

Distance (ft): **29.0**
Structural Grade: **0**
O&M Grade: **3**
Clock Start/From: **11**
Clock To: **1**
1st Value:
2nd Value:
Value Percent:
Continuous Index:
Within 8" of Joint: **YES**
Remarks:

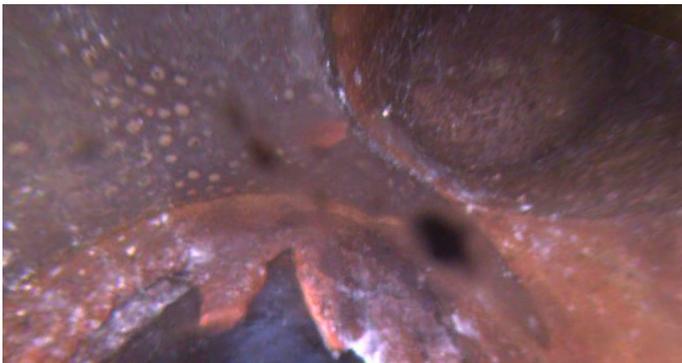
Code: **TFC**
Description: **Tap Factory Capped**

Distance (ft): **29.2**
Structural Grade: **0**
O&M Grade: **0**
Clock Start/From: **2**
Clock To:
1st Value: **4.000**
2nd Value:
Value Percent:
Continuous Index:
Within 8" of Joint:
Remarks:

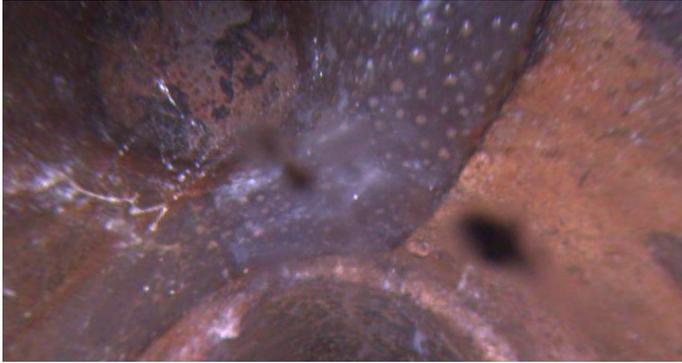
Code: **TFC**
Description: **Tap Factory Capped**

Distance (ft): **31.2**
Structural Grade: **0**
O&M Grade: **0**
Clock Start/From: **11**
Clock To:
1st Value: **4.000**
2nd Value:
Value Percent:
Continuous Index:
Within 8" of Joint:
Remarks:

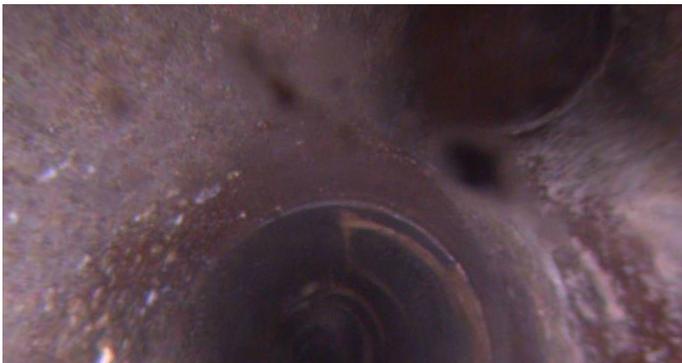
Code: **TF**
Description: **Tap Factory**

Distance (ft): **49.1**
Structural Grade: **0**
O&M Grade: **0**
Clock Start/From: **2**
Clock To:
1st Value: **4.000**
2nd Value:
Value Percent:
Continuous Index:
Within 8" of Joint:
Remarks:

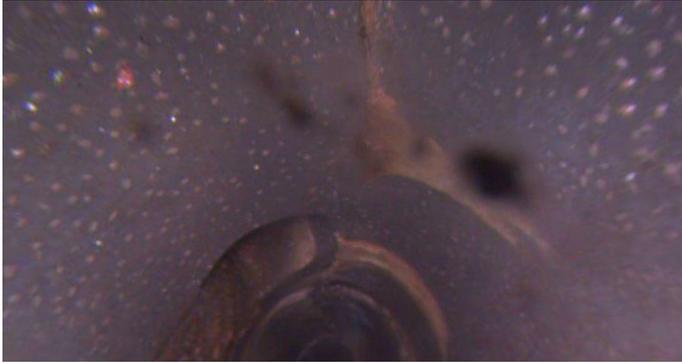
Code: **FL**
Description: **Fracture Longitudinal**

Distance (ft): **50.3**
Structural Grade: **3**
O&M Grade: **0**
Clock Start/From: **1**
Clock To:
1st Value:
2nd Value:
Value Percent:
Continuous Index:
Within 8" of Joint:
Remarks:

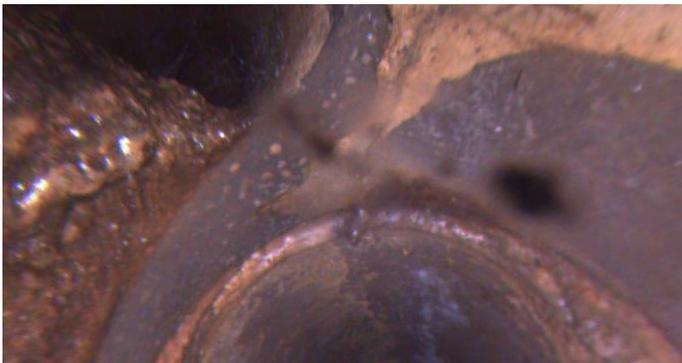
Code: **TF**
Description: **Tap Factory**

Distance (ft): **51.4**
Structural Grade: **0**
O&M Grade: **0**
Clock Start/From: **10**
Clock To:
1st Value: **4.000**
2nd Value:
Value Percent:
Continuous Index:
Within 8" of Joint:
Remarks:

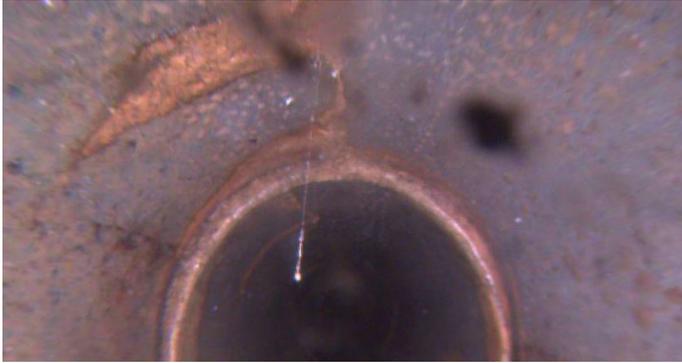
Code: **CL**
Description: **Crack Longitudinal**

Distance (ft): **55.3**
Structural Grade: **2**
O&M Grade: **0**
Clock Start/From: **12**
Clock To:
1st Value:
2nd Value:
Value Percent:
Continuous Index:
Within 8" of Joint: **YES**
Remarks:

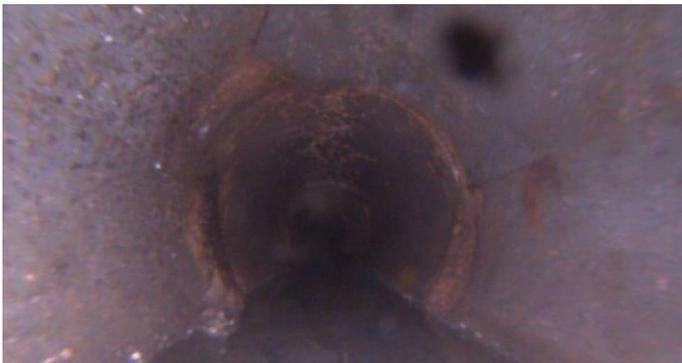
Code: **FM**
Description: **Fracture Multiple**

Distance (ft): **57.2**
Structural Grade: **4**
O&M Grade: **0**
Clock Start/From: **11**
Clock To: **3**
1st Value:
2nd Value:
Value Percent:
Continuous Index:
Within 8" of Joint: **YES**
Remarks:

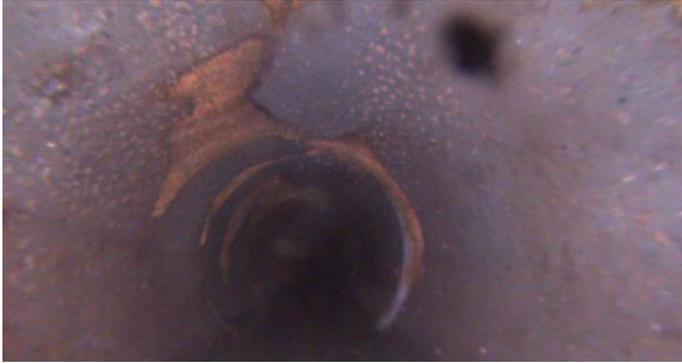
Code: **CM**
Description: **Crack Multiple**

Distance (ft): **66.9**
Structural Grade: **3**
O&M Grade: **0**
Clock Start/From: **10**
Clock To: **3**
1st Value:
2nd Value:
Value Percent:
Continuous Index:
Within 8" of Joint:
Remarks:

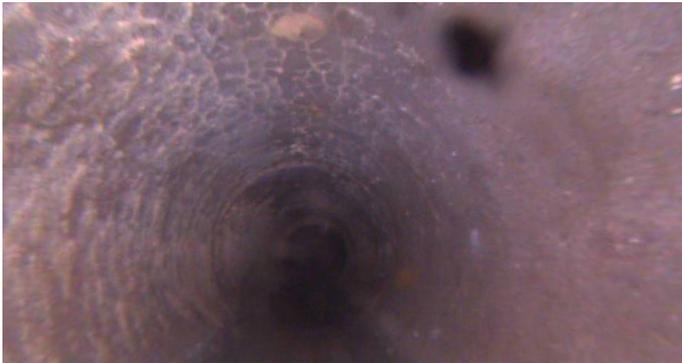
Code: **DAE**
Description: **Deposits Attached Encrustation**

Distance (ft): **76.8**
Structural Grade: **0**
O&M Grade: **2**
Clock Start/From: **7**
Clock To: **5**
1st Value:
2nd Value:
Value Percent: **5.000**
Continuous Index: **F01**
Within 8" of Joint: **YES**
Remarks:

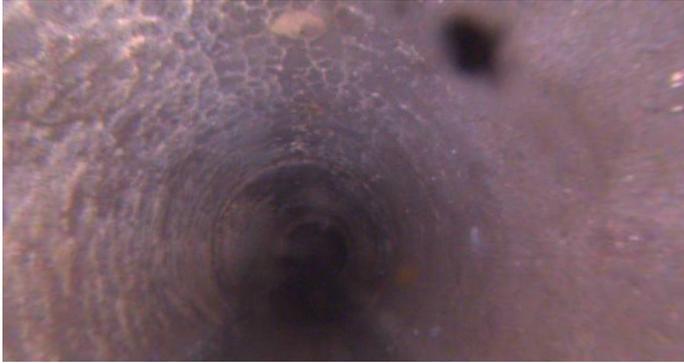
Code: **MSA**
Description: **Abandoned Survey**

Distance (ft): **76.8**
Structural Grade: **0**
O&M Grade: **0**
Clock Start/From:
Clock To:
1st Value:
2nd Value:
Value Percent:
Continuous Index:
Within 8" of Joint: **NO**
Remarks: **DAE**
