## Profile/Photo Observation Report

Street:	<b>W 39TH PL</b>	Flow Control:	<b>Not Controlled</b>
City:	<b>Hobart, IN</b>	Year Renewed:	
Location:	<b>Other</b>	Tape/Media #:	
Purpose:	<b>Not Known</b>	Dia/Height:	<b>12"</b>
Use:	<b>Sanitary</b>	Material:	<b>VCP</b>
Drain Area:	<b>NA</b>	Lining:	
Category:	<b>NA</b>		
Comment:

Location Details:		Direction of Survey:	<b>Downstream</b>
US MH:	<b>M-503-016</b>	DS MH:	<b>M-503-017</b>
		Total Length Surveyed (ft):	<b>2.5</b>

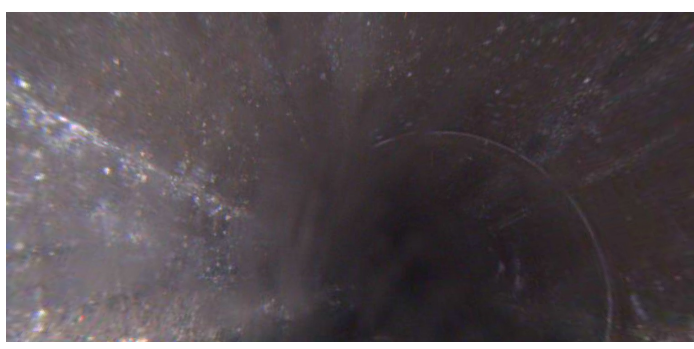
Code: **AMH**  
Description: **Manhole**

Distance (ft): **.0**  
Structural Grade: **0**  
O&M Grade: **0**  
Clock Start/From:  
Clock To:  
1st Value:  
2nd Value:  
Value Percent:  
Continuous Index:  
Within 8" of Joint: **NO**  
Remarks: **M-503-016**

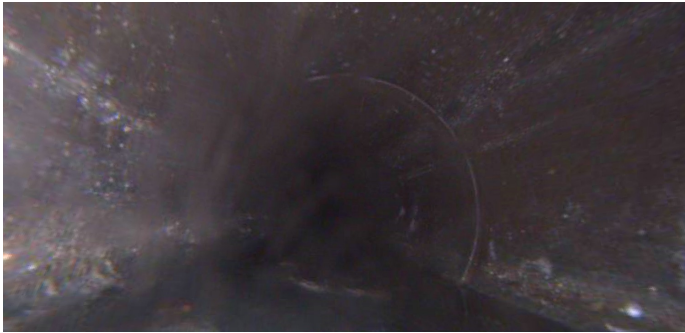
Code:	<b>MWL</b>
Description:	<b>Water Level</b>

Distance (ft):	<b>.0</b>
Structural Grade:	<b>0</b>
O&M Grade:	<b>0</b>
Clock Start/From:	
Clock To:	
1st Value:	
2nd Value:	
Value Percent:	<b>20.000</b>
Continuous Index:	
Within 8" of Joint:	<b>NO</b>
Remarks:

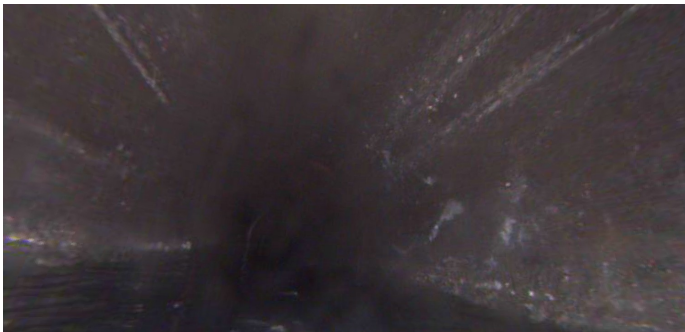
Code:	<b>MSA</b>
Description:	<b>Abandoned Survey</b>

Distance (ft):	<b>2.5</b>
Structural Grade:	<b>0</b>
O&M Grade:	<b>0</b>
Clock Start/From:	
Clock To:	
1st Value:	
2nd Value:	
Value Percent:	
Continuous Index:	
Within 8" of Joint:	<b>NO</b>
Remarks:	<b>DEBRIS UNDER WATER</b>
