## Profile/Photo Observation Report

Date:	<b>04/11/2018</b>	Weather:		Coding:	<b>PACP 6.0</b>
Pipe Length (ft):	<b>162.6</b>	Owner:	<b>NA</b>	Pre Clean:	<b>Not Known</b>
P.O.#:		Surveyor:	<b>Jen Costello</b>	PSR:	<b>P-503-017-016</b>
Customer:		Clean Date:	<b>01/01/1900</b>	Shape:	<b>C</b>

Street:	<b>W 40th ave</b>	Flow Control:	<b>Not Controlled</b>
City:	<b>Hobart, IN</b>	Year Renewed:	
Location:	<b>Other</b>	Tape/Media #:	
Purpose:	<b>Not Known</b>	Dia/Height:	<b>12"</b>
Use:	<b>Sanitary</b>	Material:	<b>VCP</b>
Drain Area:	<b>NA</b>	Lining:	
Category:	<b>NA</b>		
Comment:

Location Details:		Direction of Survey:	<b>Downstream</b>
US MH:	<b>M-503-016</b>	DS MH:	<b>M-503-017</b>
		Total Length Surveyed (ft):	<b>2.5</b>

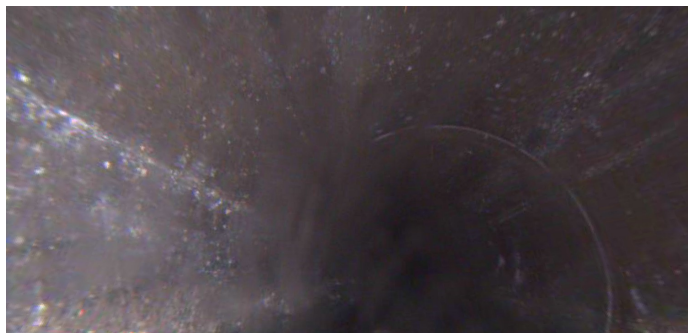
Code: **AMH**  
Description: **Manhole**

Distance (ft): **.0**  
Structural Grade: **0**  
O&M Grade: **0**  
Clock Start/From:  
Clock To:  
1st Value:  
2nd Value:  
Value Percent:  
Continuous Index:  
Within 8" of Joint: **NO**  
Remarks: **M-503-016**

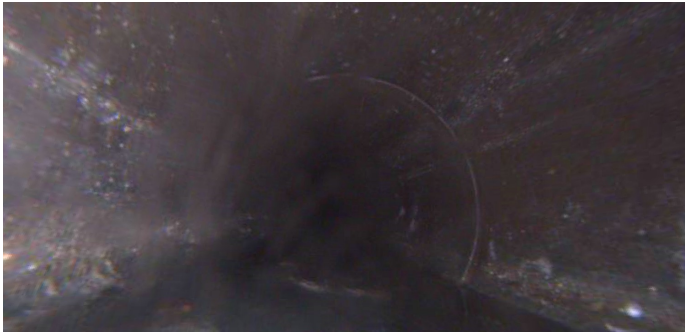
Code:	<b>MWL</b>
Description:	<b>Water Level</b>

Distance (ft):	<b>.0</b>
Structural Grade:	<b>0</b>
O&M Grade:	<b>0</b>
Clock Start/From:	
Clock To:	
1st Value:	
2nd Value:	
Value Percent:	<b>20.000</b>
Continuous Index:	
Within 8" of Joint:	<b>NO</b>
Remarks:

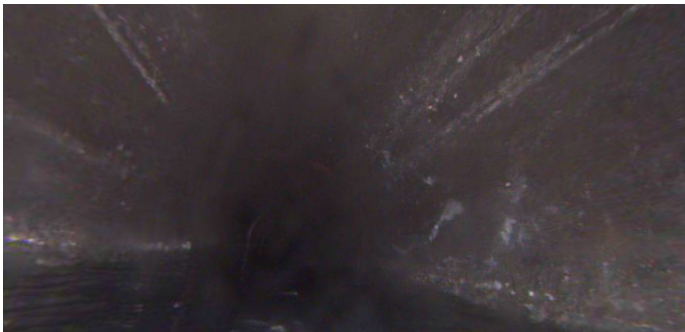
Code:	<b>MSA</b>
Description:	<b>Abandoned Survey</b>

Distance (ft):	<b>2.5</b>
Structural Grade:	<b>0</b>
O&M Grade:	<b>0</b>
Clock Start/From:	
Clock To:	
1st Value:	
2nd Value:	
Value Percent:	
Continuous Index:	
Within 8" of Joint:	<b>NO</b>
Remarks:	<b>DEBRIS UNDER WATER</b>
