Profile/Photo Observation Report

| Street: | W 39TH PL | Flow Control: | Not Controlled |
| City: | Hobart, IN | Year Renewed: | |
| US MH: | M-503-016 | DS MH: | M-503-017 |

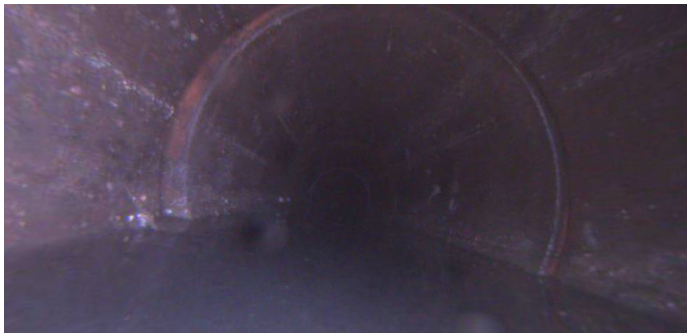
Code: **AMH**
Description: **Manhole**

Distance (ft): **.0**
Structural Grade: **0**
O&M Grade: **0**
Clock Start/From:
Clock To:
1st Value:
2nd Value:
Value Percent:
Continuous Index:
Within 8" of Joint: **NO**
Remarks: **M-503-016**

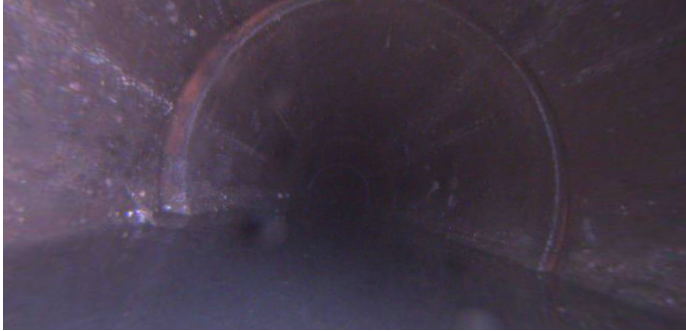
Code: **MWL**
Description: **Water Level**

Distance (ft): **.0**
Structural Grade: **0**
O&M Grade: **0**
Clock Start/From:
Clock To:
1st Value:
2nd Value:
Value Percent: **30.000**
Continuous Index:
Within 8" of Joint: **NO**
Remarks:

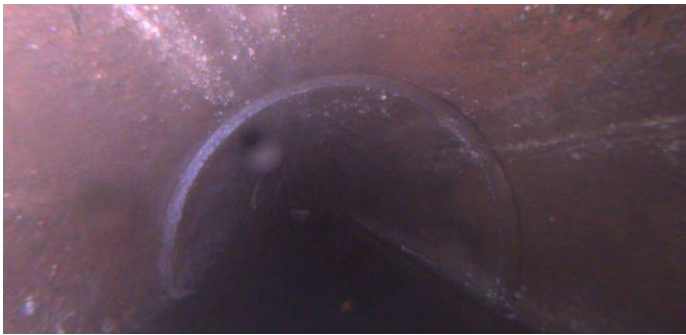
Code: **MSA**
Description: **Abandoned Survey**

Distance (ft): **5.4**
Structural Grade: **0**
O&M Grade: **0**
Clock Start/From:
Clock To:
1st Value:
2nd Value:
Value Percent:
Continuous Index:
Within 8" of Joint: **NO**
Remarks: **debris under water**
