## Profile/Photo Observation Report

Street:	<b>W 40th ave</b>	Flow Control:	<b>Not Controlled</b>
City:	<b>Hobart, IN</b>	Year Renewed:	
Location:	<b>Other</b>	Tape/Media #:	
Purpose:	<b>Not Known</b>	Dia/Height:	<b>12"</b>
Use:	<b>Sanitary</b>	Material:	<b>VCP</b>
Drain Area:	<b>NA</b>	Lining:	
Category:	<b>NA</b>		
Comment:

Location Details:		Direction of Survey:	<b>Downstream</b>
US MH:	<b>M-503-016</b>	DS MH:	<b>M-503-017</b>
		Total Length Surveyed (ft):	<b>5.4</b>

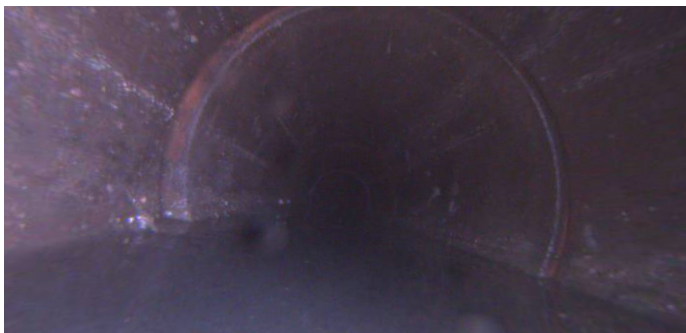
Code: **AMH**  
Description: **Manhole**

Distance (ft): **.0**  
Structural Grade: **0**  
O&M Grade: **0**  
Clock Start/From:  
Clock To:  
1st Value:  
2nd Value:  
Value Percent:  
Continuous Index:  
Within 8" of Joint: **NO**  
Remarks: **M-503-016**

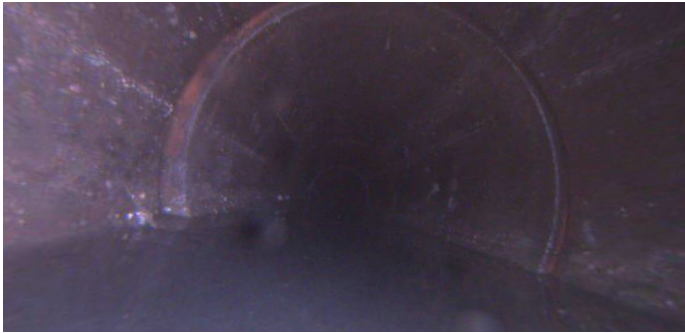
Code:	<b>MWL</b>
Description:	<b>Water Level</b>

Distance (ft):	<b>.0</b>
Structural Grade:	<b>0</b>
O&M Grade:	<b>0</b>
Clock Start/From:	
Clock To:	
1st Value:	
2nd Value:	
Value Percent:	<b>30.000</b>
Continuous Index:	
Within 8" of Joint:	<b>NO</b>
Remarks:

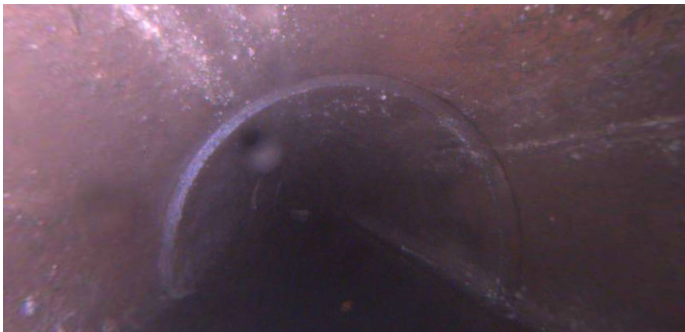
Code:	<b>MSA</b>
Description:	<b>Abandoned Survey</b>

Distance (ft):	<b>5.4</b>
Structural Grade:	<b>0</b>
O&M Grade:	<b>0</b>
Clock Start/From:	
Clock To:	
1st Value:	
2nd Value:	
Value Percent:	
Continuous Index:	
Within 8" of Joint:	<b>NO</b>
Remarks:	<b>debris under water</b>
