## Profile/Photo Observation Report

Street:	<b>W 39TH PL</b>	Flow Control:	<b>Not Controlled</b>
City:	<b>Hobart, IN</b>	Year Renewed:	
Location:	<b>Other</b>	Tape/Media #:	
Purpose:	<b>Not Known</b>	Dia/Height:	<b>12"</b>
Use:	<b>Sanitary</b>	Material:	<b>VCP</b>
Drain Area:	<b>NA</b>	Lining:	
Category:	<b>NA</b>		
Comment:

Location Details:		Direction of Survey:	<b>Upstream</b>
US MH:	<b>M-503-016</b>	DS MH:	<b>M-503-017</b>
		Total Length Surveyed (ft):	<b>24.3</b>

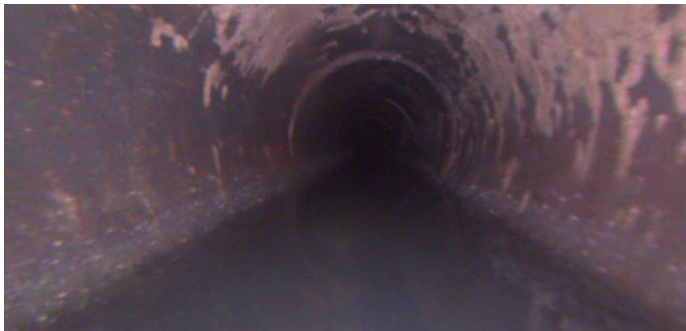
Code: **AMH**  
Description: **Manhole**

Distance (ft): **.0**  
Structural Grade: **0**  
O&M Grade: **0**  
Clock Start/From:  
Clock To:  
1st Value:  
2nd Value:  
Value Percent:  
Continuous Index:  
Within 8" of Joint: **NO**  
Remarks: **M-503-016**

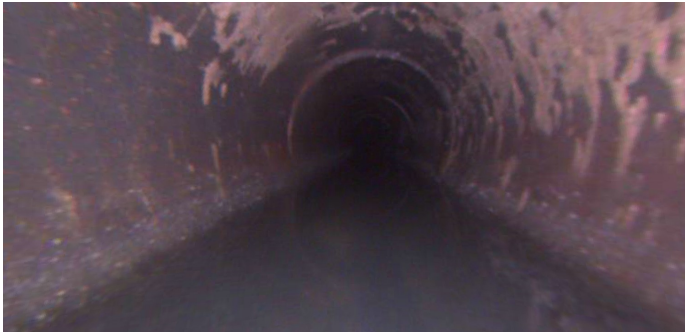
Code:	<b>MWL</b>
Description:	<b>Water Level</b>

Distance (ft):	<b>.0</b>
Structural Grade:	<b>0</b>
O&M Grade:	<b>0</b>
Clock Start/From:	
Clock To:	
1st Value:	
2nd Value:	
Value Percent:	<b>20.000</b>
Continuous Index:	
Within 8" of Joint:	<b>NO</b>
Remarks:

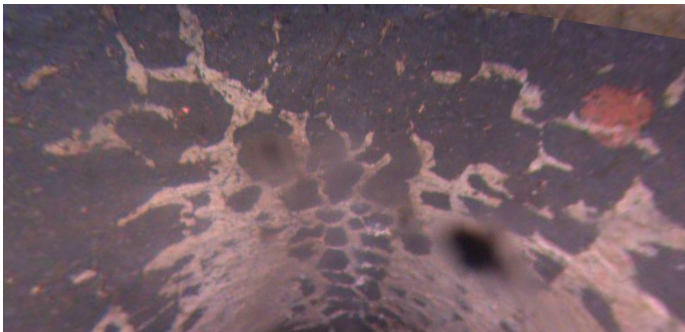
Code:	<b>FM</b>
Description:	<b>Fracture Multiple</b>

Distance (ft):	<b>.0</b>
Structural Grade:	<b>4</b>
O&M Grade:	<b>0</b>
Clock Start/From:	<b>8</b>
Clock To:	<b>4</b>
1st Value:	
2nd Value:	
Value Percent:	
Continuous Index:	<b>S01</b>
Within 8" of Joint:	
Remarks:

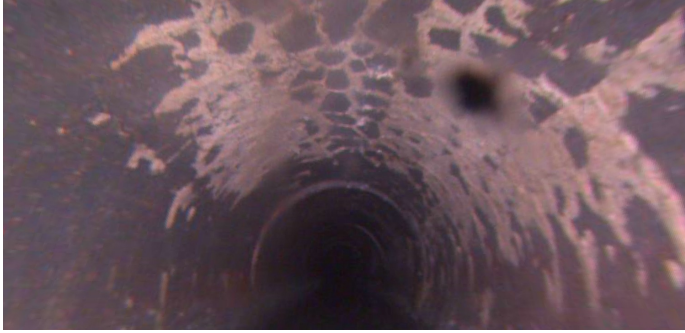
Code: **DAGS**  
Description: **Deposits Attached Grease**

Distance (ft): **.0**  
Structural Grade: **0**  
O&M Grade: **2**  
Clock Start/From: **8**  
Clock To: **4**  
1st Value:  
2nd Value:  
Value Percent: **5.000**  
Continuous Index: **S02**  
Within 8" of Joint: **NO**  
Remarks:

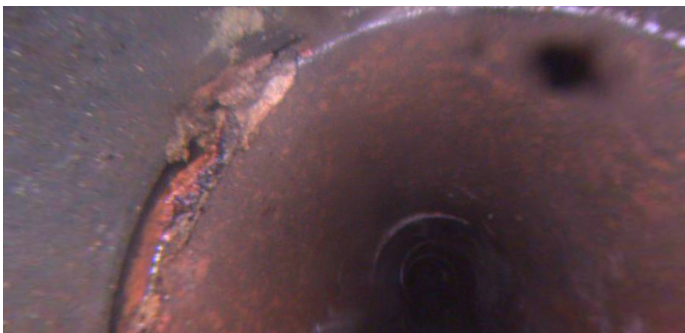
Code: **SSS**  
Description: **Surface Spalling**

Distance (ft): **12.5**  
Structural Grade: **2**  
O&M Grade: **0**  
Clock Start/From: **8**  
Clock To: **11**  
1st Value:  
2nd Value:  
Value Percent:  
Continuous Index:  
Within 8" of Joint: **YES**  
Remarks:

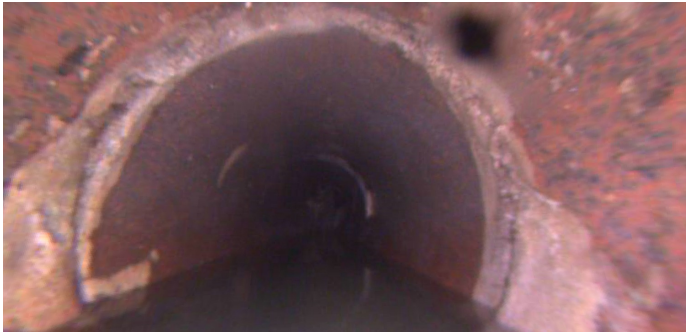
Code: **DAE**  
Description: **Deposits Attached Encrustation**

Distance (ft): **18.3**  
Structural Grade: **0**  
O&M Grade: **2**  
Clock Start/From: **8**  
Clock To: **4**  
1st Value:  
2nd Value:  
Value Percent: **5.000**  
Continuous Index:  
Within 8" of Joint: **YES**  
Remarks:

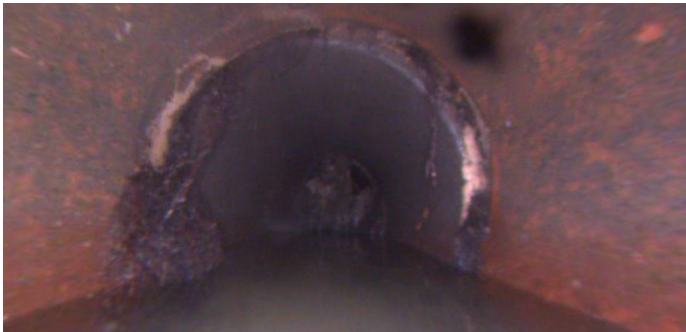
Code: **RMJ**  
Description: **Roots Medium Joint**

Distance (ft): **20.0**  
Structural Grade: **0**  
O&M Grade: **3**  
Clock Start/From: **8**  
Clock To: **4**  
1st Value:  
2nd Value:  
Value Percent: **5.000**  
Continuous Index:  
Within 8" of Joint: **YES**  
Remarks:

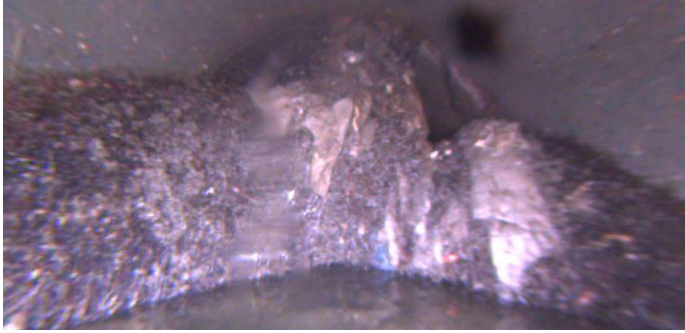
Code: **RBJ**  
Description: **Roots Ball Joint**

Distance (ft): **22.3**  
Structural Grade: **0**  
O&M Grade: **4**  
Clock Start/From: **12**  
Clock To: **12**  
1st Value:  
2nd Value:  
Value Percent: **95.000**  
Continuous Index:  
Within 8" of Joint: **YES**  
Remarks:
