## Profile/Photo Observation Report

Street:	<b>W 40th ave</b>	Flow Control:	<b>Not Controlled</b>
City:	<b>Hobart, IN</b>	Year Renewed:	
Location:	<b>Other</b>	Tape/Media #:	
Purpose:	<b>Not Known</b>	Dia/Height:	<b>12"</b>
Use:	<b>Sanitary</b>	Material:	<b>VCP</b>
Drain Area:	<b>NA</b>	Lining:	
Category:	<b>NA</b>		
Comment:

Location Details:		Direction of Survey:	<b>Upstream</b>
US MH:	<b>M-503-016</b>	DS MH:	<b>M-503-017</b>
		Total Length Surveyed (ft):	<b>24.3</b>

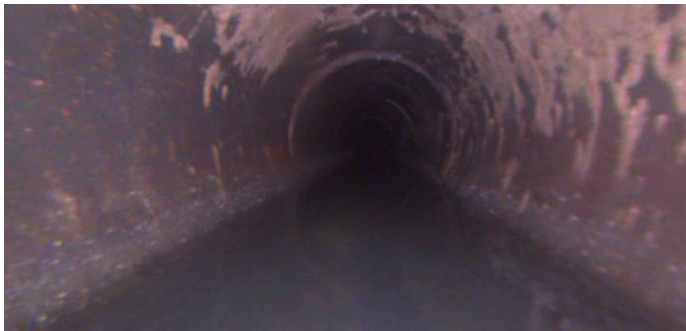
Code: **AMH**  
Description: **Manhole**

Distance (ft): **.0**  
Structural Grade: **0**  
O&M Grade: **0**  
Clock Start/From:  
Clock To:  
1st Value:  
2nd Value:  
Value Percent:  
Continuous Index:  
Within 8" of Joint: **NO**  
Remarks: **M-503-016**

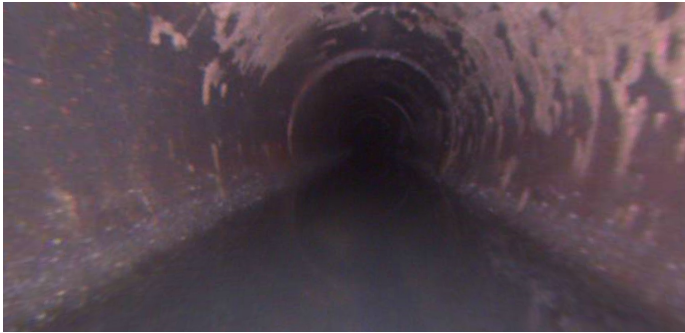
Code:	<b>MWL</b>
Description:	<b>Water Level</b>

Distance (ft):	<b>.0</b>
Structural Grade:	<b>0</b>
O&M Grade:	<b>0</b>
Clock Start/From:	
Clock To:	
1st Value:	
2nd Value:	
Value Percent:	<b>20.000</b>
Continuous Index:	
Within 8" of Joint:	<b>NO</b>
Remarks:

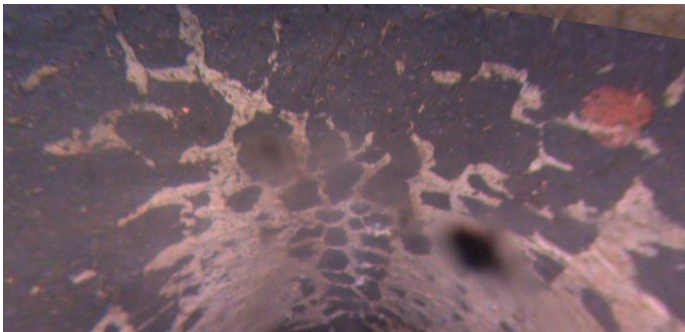
Code:	<b>FM</b>
Description:	<b>Fracture Multiple</b>

Distance (ft):	<b>.0</b>
Structural Grade:	<b>4</b>
O&M Grade:	<b>0</b>
Clock Start/From:	<b>8</b>
Clock To:	<b>4</b>
1st Value:	
2nd Value:	
Value Percent:	
Continuous Index:	<b>S01</b>
Within 8" of Joint:	
Remarks:

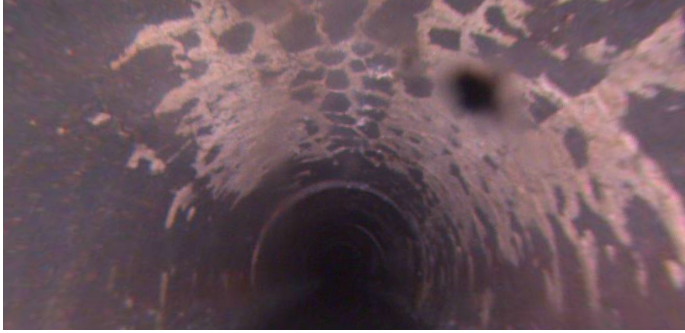
Code: **DAGS**  
Description: **Deposits Attached Grease**

Distance (ft): **.0**  
Structural Grade: **0**  
O&M Grade: **2**  
Clock Start/From: **8**  
Clock To: **4**  
1st Value:  
2nd Value:  
Value Percent: **5.000**  
Continuous Index: **S02**  
Within 8" of Joint: **NO**  
Remarks:

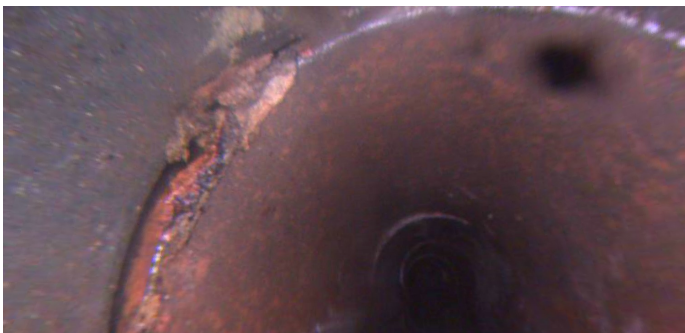
Code: **SSS**  
Description: **Surface Spalling**

Distance (ft): **12.5**  
Structural Grade: **2**  
O&M Grade: **0**  
Clock Start/From: **8**  
Clock To: **11**  
1st Value:  
2nd Value:  
Value Percent:  
Continuous Index:  
Within 8" of Joint: **YES**  
Remarks:

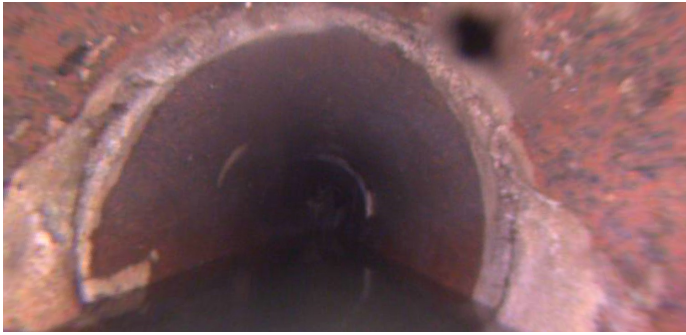
Code: **DAE**  
Description: **Deposits Attached Encrustation**

Distance (ft): **18.3**  
Structural Grade: **0**  
O&M Grade: **2**  
Clock Start/From: **8**  
Clock To: **4**  
1st Value:  
2nd Value:  
Value Percent: **5.000**  
Continuous Index:  
Within 8" of Joint: **YES**  
Remarks:

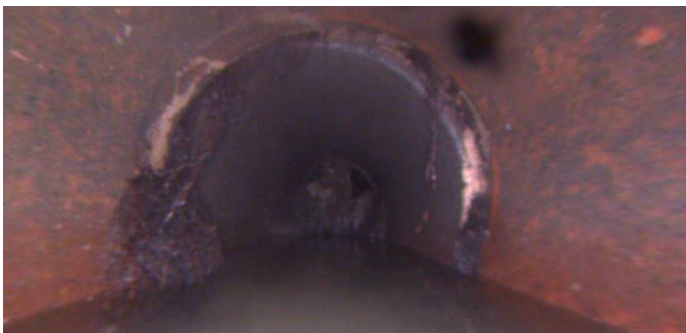
Code: **RMJ**  
Description: **Roots Medium Joint**

Distance (ft): **20.0**  
Structural Grade: **0**  
O&M Grade: **3**  
Clock Start/From: **8**  
Clock To: **4**  
1st Value:  
2nd Value:  
Value Percent: **5.000**  
Continuous Index:  
Within 8" of Joint: **YES**  
Remarks:

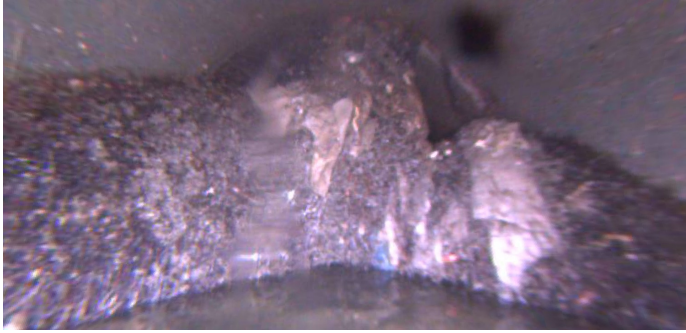
Code: **RBJ**  
Description: **Roots Ball Joint**

Distance (ft): **22.3**  
Structural Grade: **0**  
O&M Grade: **4**  
Clock Start/From: **12**  
Clock To: **12**  
1st Value:  
2nd Value:  
Value Percent: **95.000**  
Continuous Index:  
Within 8" of Joint: **YES**  
Remarks:
