Profile/Photo Observation Report

Date:	10/19/2021	Weather:		Coding:	PACP 7.0
Pipe Length (ft):	165.3	Owner:	City of Hobart	Pre Clean:	Heavy Cleaning
P.O.#:	YES502259	Surveyor:	S. Bucklin	PSR:	P-503-017-016
Customer:	City of Hobart	Clean Date:	09/06/2021	Shape:	C

Street:	West 39th Place	Flow Control:	Not Controlled
City:	Hobart, IN	Year Renewed:	
Location:	Alley	Tape/Media #:	
Purpose:	Routine Assessment	Dia/Height:	12"
Use:	Sanitary Sewage Pipe	Material:	VCP
Drain Area:		Lining:	
Category:	NA		
Comment:			
Location Details:		Direction of Survey:	Downstream
US MH:	M-503-016	DS MH:	M-503-017
		Total Length Surveyed (ft):	165.3

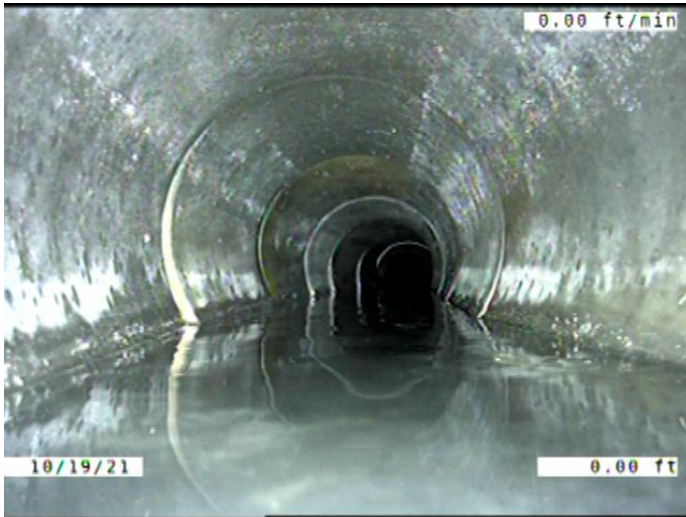
Code: **DSF**
 Description: **Deposits Settled Fine**

Distance (ft): **.0**
 Structural Grade: **0**
 O&M Grade: **2**
 Clock Start/From: **5**
 Clock To: **7**
 1st Value:
 2nd Value:
 Value Percent: **5.000**
 Continuous Index: **S01**
 Within 8" of Joint: **YES**
 Remarks:

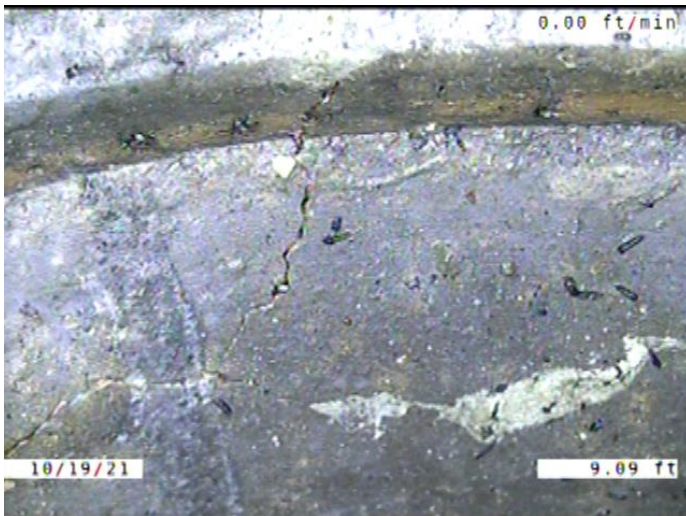
Code: **FM**
 Description: **Fracture Multiple**

Distance (ft): **9.1**
 Structural Grade: **4**
 O&M Grade: **0**
 Clock Start/From: **9**
 Clock To: **1**
 1st Value:
 2nd Value:
 Value Percent:
 Continuous Index:
 Within 8" of Joint: **YES**
 Remarks:

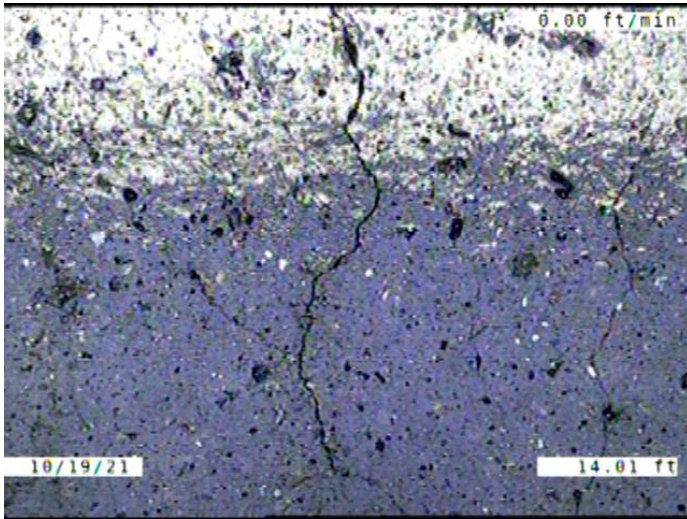
Code: **FM**
Description: **Fracture Multiple**

Distance (ft): **14.0**
Structural Grade: **4**
O&M Grade: **0**
Clock Start/From: **11**
Clock To: **1**
1st Value:
2nd Value:
Value Percent:
Continuous Index:
Within 8" of Joint: **YES**
Remarks:

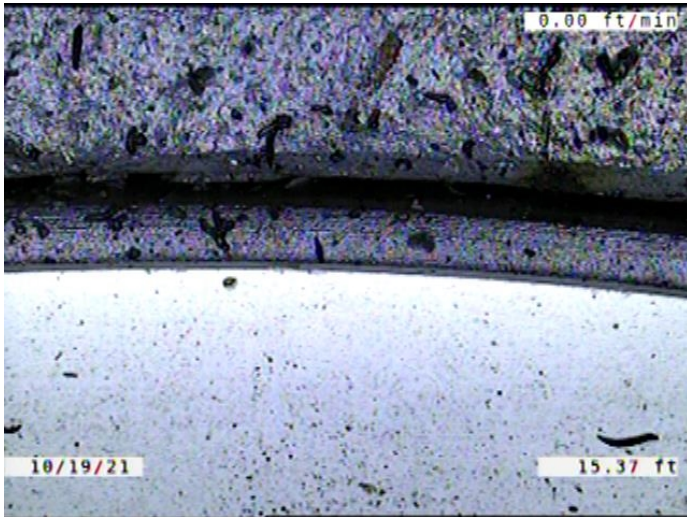
Code: **MMC**
Description: **Miscellaneous Material Change**

Distance (ft): **15.4**
Structural Grade: **0**
O&M Grade: **0**
Clock Start/From:
Clock To:
1st Value:
2nd Value:
Value Percent:
Continuous Index:
Within 8" of Joint: **NO**
Remarks: **VCP TO PVC**

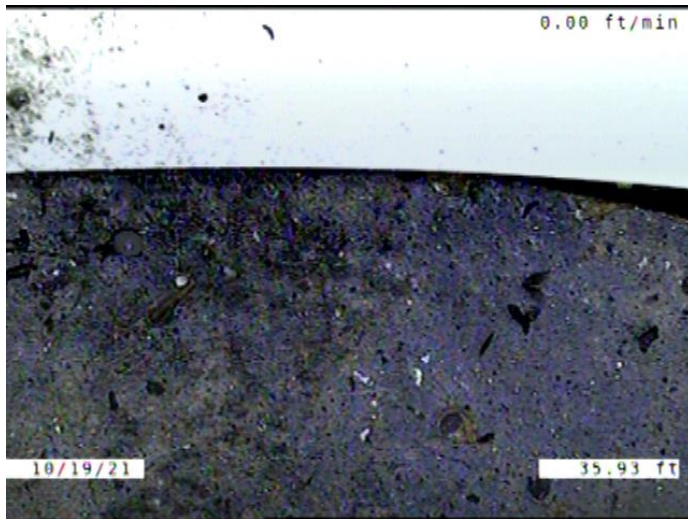
Code: **MMC**
Description: **Miscellaneous Material Change**

Distance (ft): **35.9**
Structural Grade: **0**
O&M Grade: **0**
Clock Start/From:
Clock To:
1st Value:
2nd Value:
Value Percent:
Continuous Index:
Within 8" of Joint: **NO**
Remarks: **PVC TO VCP**

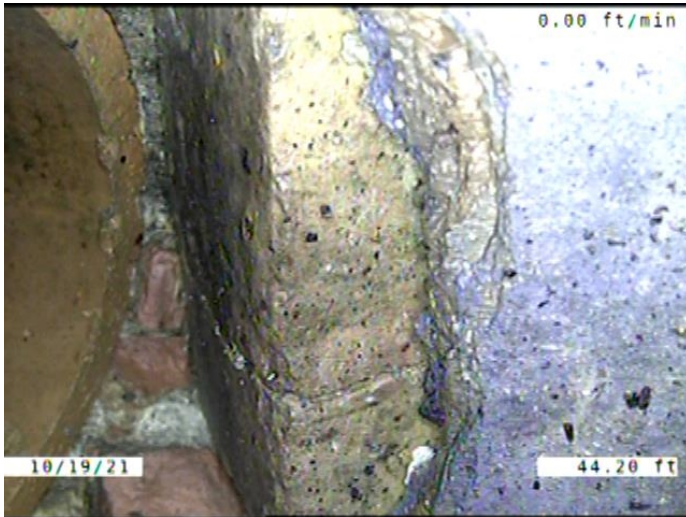
Code: **FM**
Description: **Fracture Multiple**

Distance (ft): **44.2**
Structural Grade: **4**
O&M Grade: **0**
Clock Start/From: **8**
Clock To: **4**
1st Value:
2nd Value:
Value Percent:
Continuous Index: **S02**
Within 8" of Joint: **YES**
Remarks:

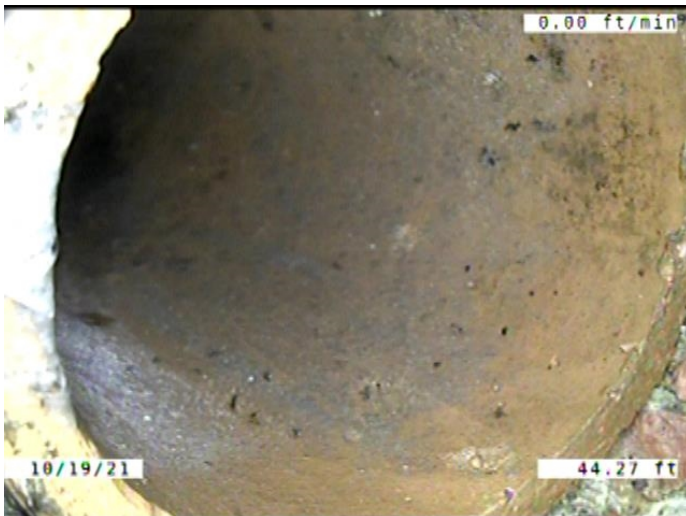
Code: **TB**
Description: **Tap Break-in/Hammer**

Distance (ft): **44.3**
Structural Grade: **0**
O&M Grade: **0**
Clock Start/From: **11**
Clock To:
1st Value: **4.000**
2nd Value:
Value Percent:
Continuous Index:
Within 8" of Joint: **YES**
Remarks: **CONSTANTLY RUNNING WATER**

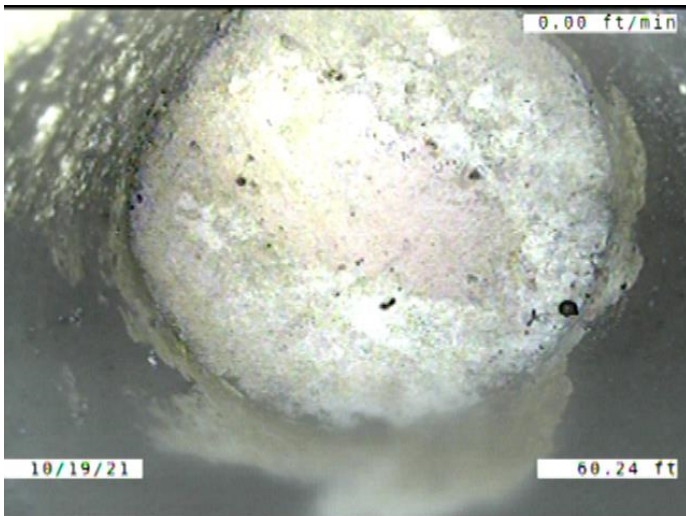
Code: **TFC**
 Description: **Tap Factory Capped**

Distance (ft): **60.2**
 Structural Grade: **0**
 O&M Grade: **0**
 Clock Start/From: **11**
 Clock To:
 1st Value: **4.000**
 2nd Value:
 Value Percent:
 Continuous Index:
 Within 8" of Joint: **YES**
 Remarks: **ENCUSTATION AROUND THE CAP**

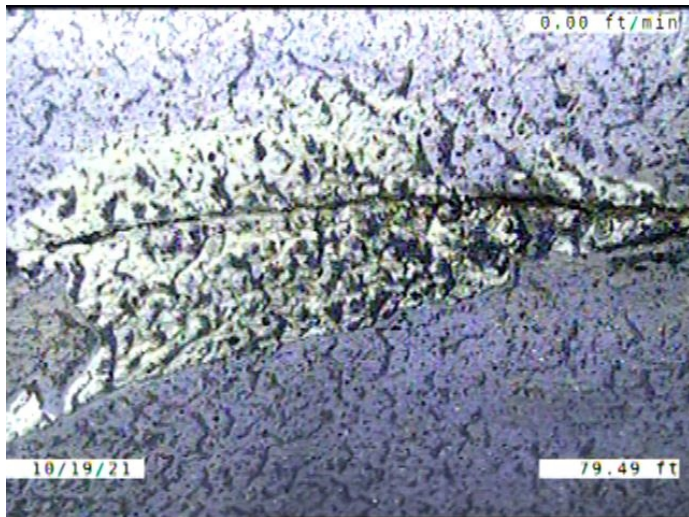
Code: **DAE**
 Description: **Deposits Attached Encrustation**

Distance (ft): **79.5**
 Structural Grade: **0**
 O&M Grade: **2**
 Clock Start/From: **9**
 Clock To: **11**
 1st Value:
 2nd Value:
 Value Percent: **5.000**
 Continuous Index:
 Within 8" of Joint: **YES**
 Remarks:

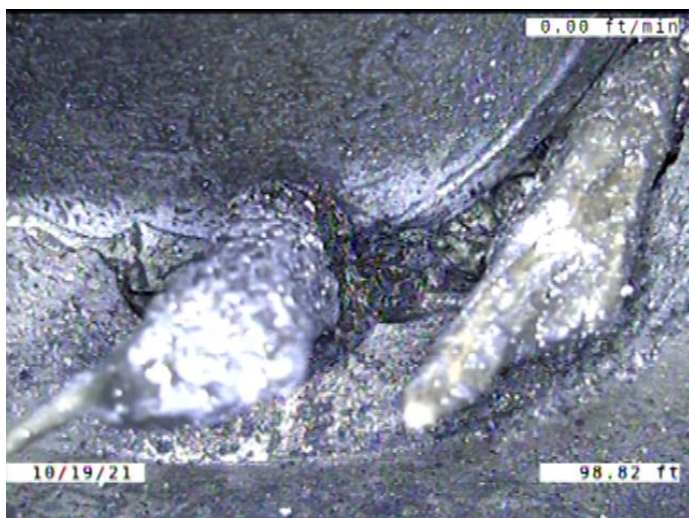
Code: **RTC**
 Description: **Roots Tap Connection**

Distance (ft): **98.8**
 Structural Grade: **0**
 O&M Grade: **2**
 Clock Start/From: **11**
 Clock To: **12**
 1st Value:
 2nd Value:
 Value Percent: **5.000**
 Continuous Index:
 Within 8" of Joint: **NO**
 Remarks:

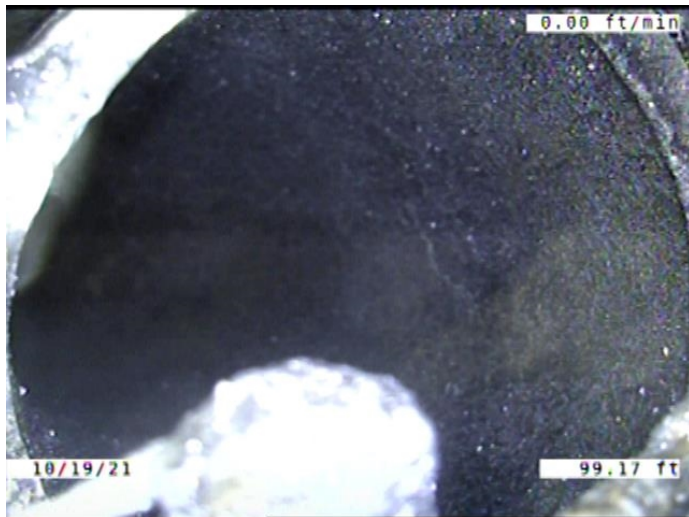
Code:	TFD
Description:	Tap Factory Defective
Distance (ft):	99.2
Structural Grade:	0
O&M Grade:	3
Clock Start/From:	11
Clock To:	
1st Value:	4.000
2nd Value:	
Value Percent:	
Continuous Index:	
Within 8" of Joint:	YES
Remarks:	CONSTANTLY RUNNING WATER

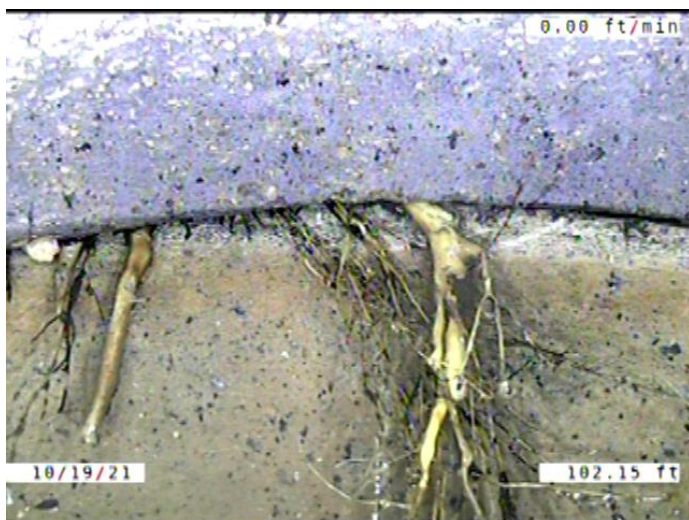
Code:	RFJ
Description:	Roots Fine Joint
Distance (ft):	102.1
Structural Grade:	0
O&M Grade:	1
Clock Start/From:	9
Clock To:	3
1st Value:	
2nd Value:	
Value Percent:	
Continuous Index:	
Within 8" of Joint:	YES
Remarks:

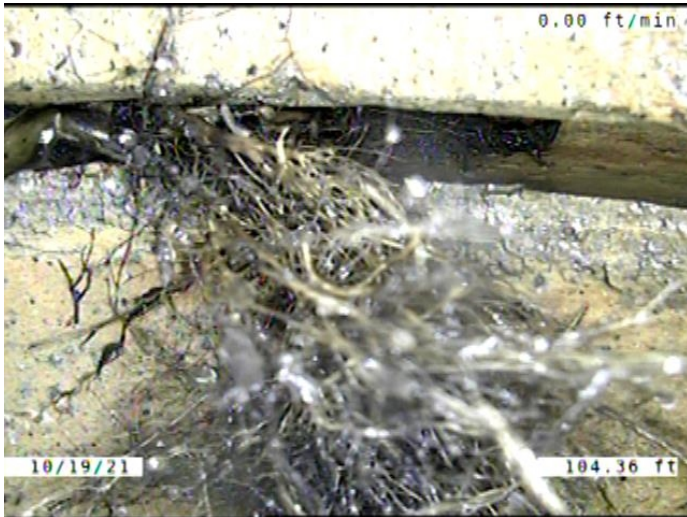
Code: **RMJ**
 Description: **Roots Medium Joint**

Distance (ft): **104.4**
 Structural Grade: **0**
 O&M Grade: **3**
 Clock Start/From: **8**
 Clock To: **3**
 1st Value:
 2nd Value:
 Value Percent: **5.000**
 Continuous Index:
 Within 8" of Joint: **YES**
 Remarks:

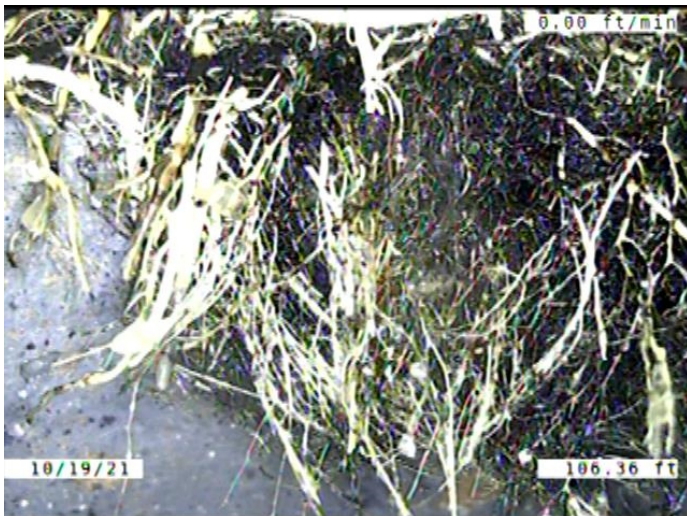
Code: **RMJ**
 Description: **Roots Medium Joint**

Distance (ft): **106.4**
 Structural Grade: **0**
 O&M Grade: **3**
 Clock Start/From: **9**
 Clock To: **3**
 1st Value:
 2nd Value:
 Value Percent: **5.000**
 Continuous Index:
 Within 8" of Joint: **YES**
 Remarks:

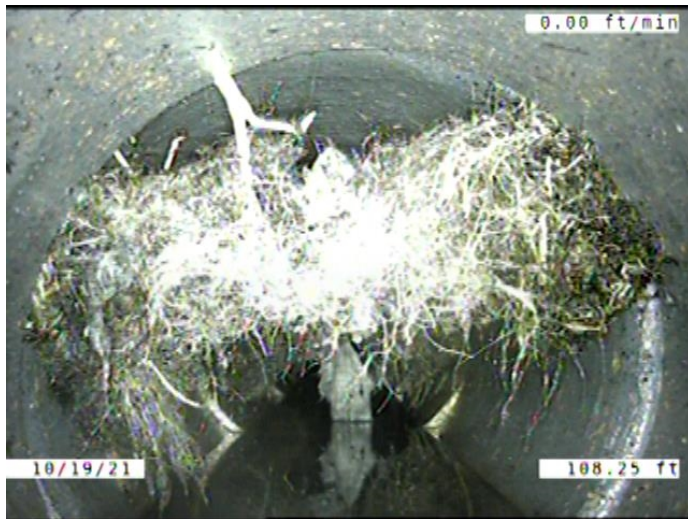
Code: **RMJ**
 Description: **Roots Medium Joint**

Distance (ft): **108.3**
 Structural Grade: **0**
 O&M Grade: **3**
 Clock Start/From: **9**
 Clock To: **2**
 1st Value:
 2nd Value:
 Value Percent: **25.000**
 Continuous Index:
 Within 8" of Joint: **YES**
 Remarks:

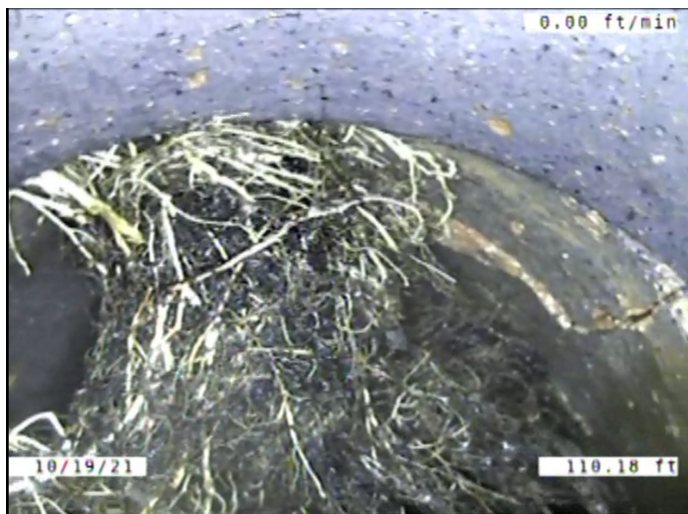
Code: **B**
 Description: **Broken**

Distance (ft): **110.2**
 Structural Grade: **4**
 O&M Grade: **0**
 Clock Start/From: **12**
 Clock To: **3**
 1st Value:
 2nd Value:
 Value Percent:
 Continuous Index:
 Within 8" of Joint: **NO**
 Remarks:

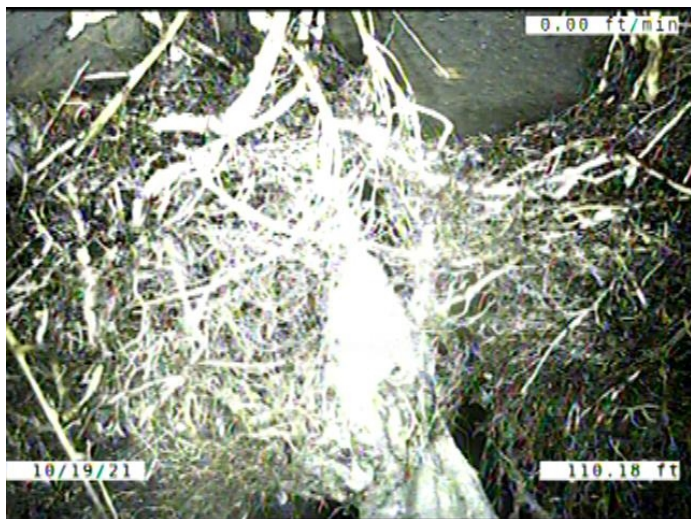
Code: **RBJ**
 Description: **Roots Ball Joint**

Distance (ft): **110.2**
 Structural Grade: **0**
 O&M Grade: **4**
 Clock Start/From: **8**
 Clock To: **4**
 1st Value:
 2nd Value:
 Value Percent: **65.000**
 Continuous Index:
 Within 8" of Joint: **YES**
 Remarks:

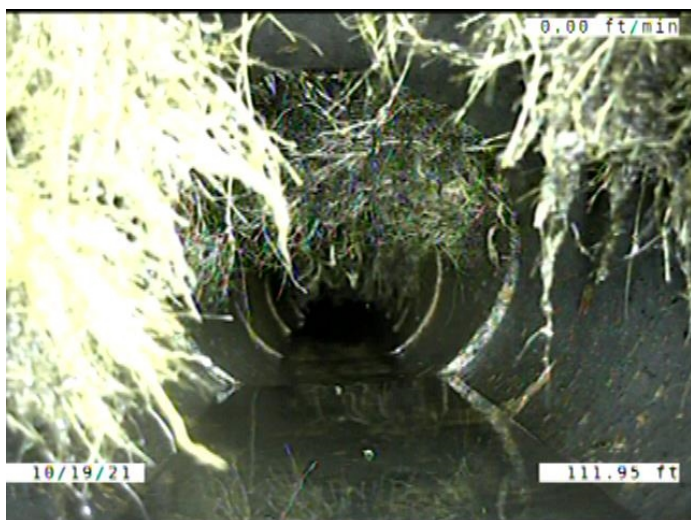
Code: **RMJ**
 Description: **Roots Medium Joint**

Distance (ft): **112.0**
 Structural Grade: **0**
 O&M Grade: **3**
 Clock Start/From: **8**
 Clock To: **4**
 1st Value:
 2nd Value:
 Value Percent: **35.000**
 Continuous Index: **S03**
 Within 8" of Joint: **YES**
 Remarks:

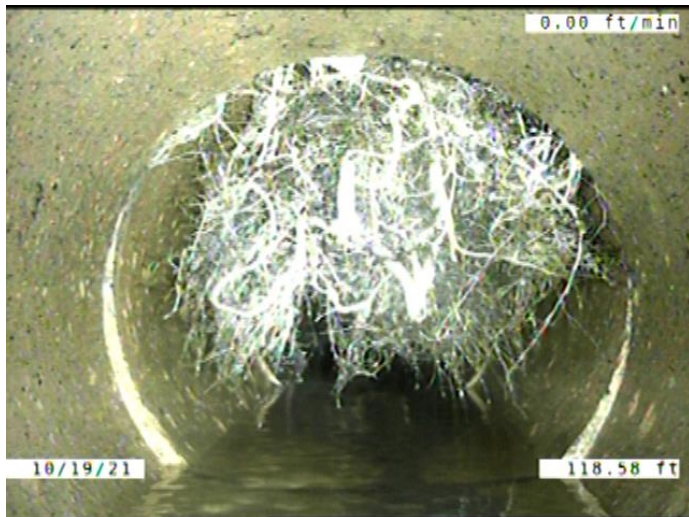
Code: **RBJ**
 Description: **Roots Ball Joint**

Distance (ft): **118.6**
 Structural Grade: **0**
 O&M Grade: **4**
 Clock Start/From: **10**
 Clock To: **3**
 1st Value:
 2nd Value:
 Value Percent: **65.000**
 Continuous Index:
 Within 8" of Joint: **YES**
 Remarks:

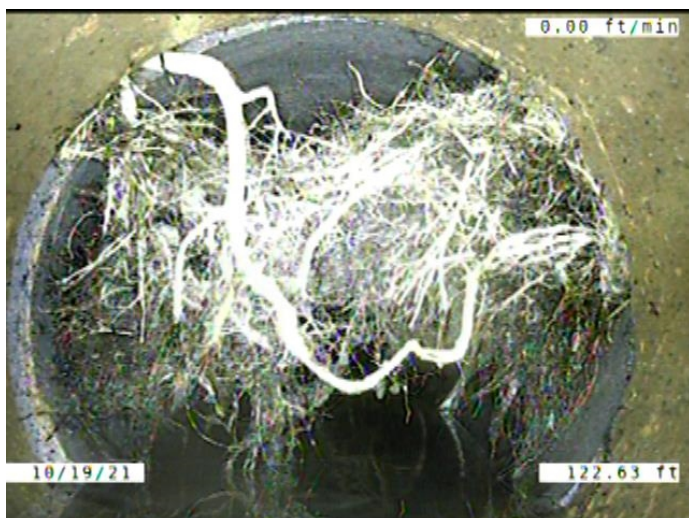
Code: **RTJ**
 Description: **Roots Tap Joint**

Distance (ft): **122.6**
 Structural Grade: **0**
 O&M Grade: **2**
 Clock Start/From: **8**
 Clock To: **4**
 1st Value:
 2nd Value:
 Value Percent: **50.000**
 Continuous Index:
 Within 8" of Joint: **YES**
 Remarks:

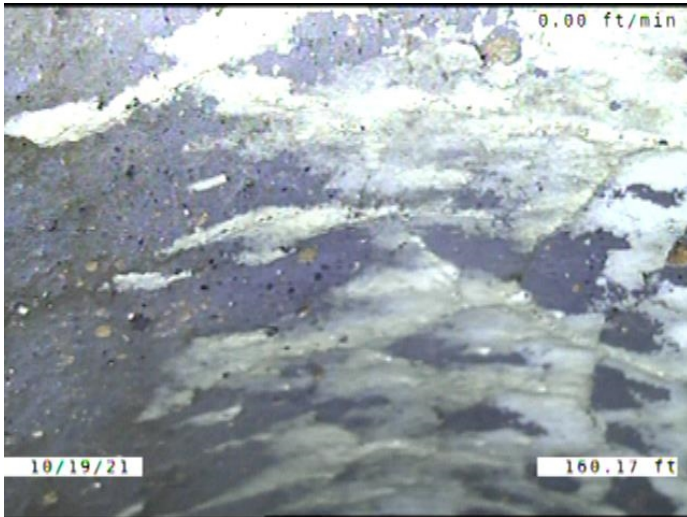
Code: **DAE**
 Description: **Deposits Attached Encrustation**

Distance (ft): **160.2**
 Structural Grade: **0**
 O&M Grade: **2**
 Clock Start/From: **9**
 Clock To: **2**
 1st Value:
 2nd Value:
 Value Percent: **5.000**
 Continuous Index:
 Within 8" of Joint: **YES**
 Remarks:

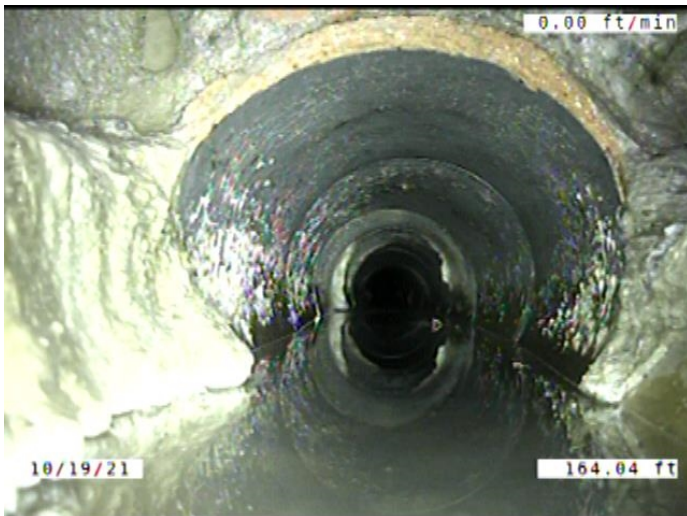
Code: **DSF**
 Description: **Deposits Settled Fine**

Distance (ft): **164.0**
 Structural Grade: **0**
 O&M Grade: **2**
 Clock Start/From: **5**
 Clock To: **7**
 1st Value:
 2nd Value:
 Value Percent: **5.000**
 Continuous Index: **F01**
 Within 8" of Joint: **YES**
 Remarks:
