Profile/Photo Observation Report

Date:	10/19/2021	Weather:		Coding:	PACP 7.0
Pipe Length (ft):	165.3	Owner:	City of Hobart	Pre Clean:	Heavy Cleaning
P.O.#:	YES502259	Surveyor:	S. Bucklin	PSR:	P-503-017-016
Customer:	City of Hobart	Clean Date:	09/06/2021	Shape:	C

Street:	West 39th Place	Flow Control:	Not Controlled
City:	Hobart, IN	Year Renewed:	
Location:	Alley	Tape/Media #:	
Purpose:	Routine Assessment	Dia/Height:	12"
Use:	Sanitary Sewage Pipe	Material:	VCP
Drain Area:		Lining:	
Category:	NA		
Comment:			
Location Details:		Direction of Survey:	Downstream
US MH:	M-503-016	DS MH:	M-503-017
		Total Length Surveyed (ft):	165.3

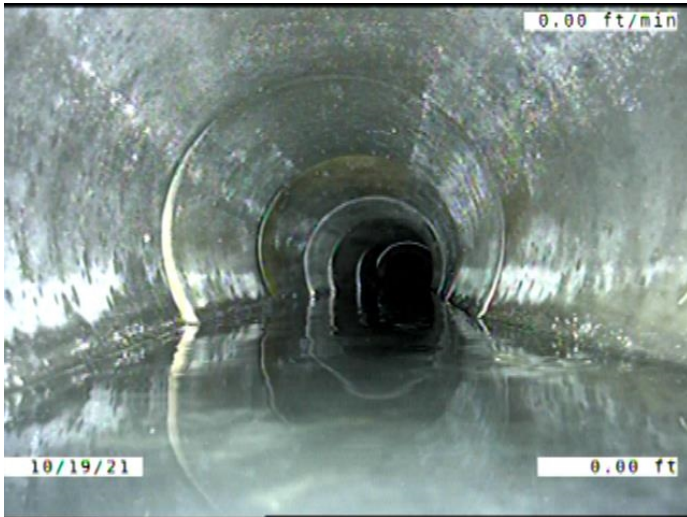
Code: **DSF**
 Description: **Deposits Settled Fine**

Distance (ft): **.0**
 Structural Grade: **0**
 O&M Grade: **2**
 Clock Start/From: **5**
 Clock To: **7**
 1st Value:
 2nd Value:
 Value Percent: **5.000**
 Continuous Index: **S01**
 Within 8" of Joint: **YES**
 Remarks:

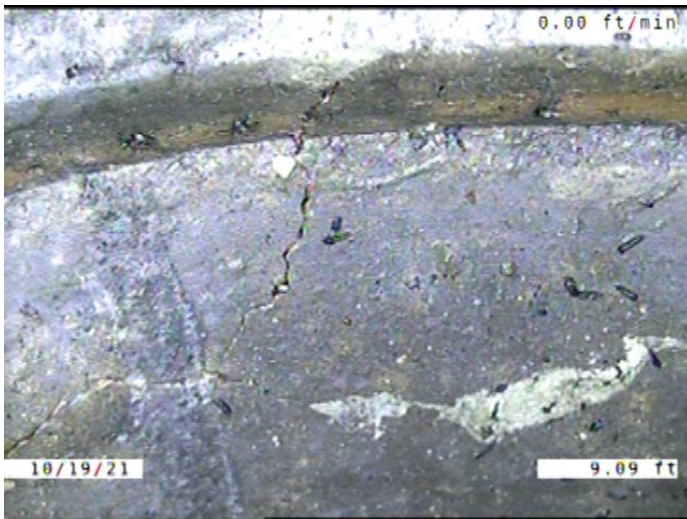
Code: **FM**
 Description: **Fracture Multiple**

Distance (ft): **9.1**
 Structural Grade: **4**
 O&M Grade: **0**
 Clock Start/From: **9**
 Clock To: **1**
 1st Value:
 2nd Value:
 Value Percent:
 Continuous Index:
 Within 8" of Joint: **YES**
 Remarks:

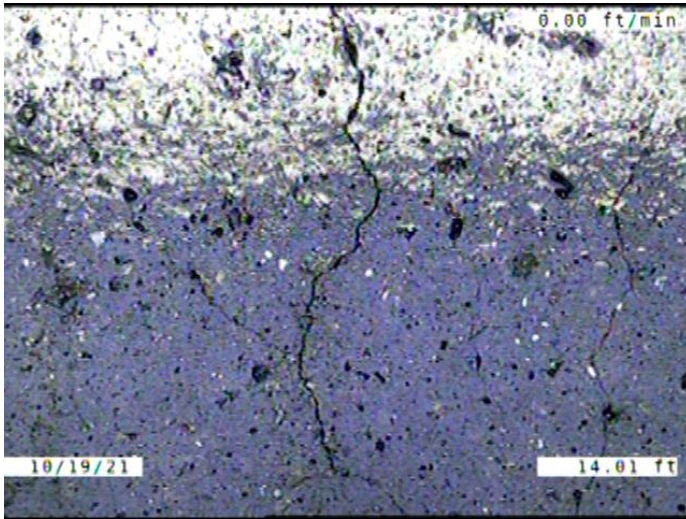
Code: **FM**
 Description: **Fracture Multiple**

Distance (ft): **14.0**
 Structural Grade: **4**
 O&M Grade: **0**
 Clock Start/From: **11**
 Clock To: **1**
 1st Value:
 2nd Value:
 Value Percent:
 Continuous Index:
 Within 8" of Joint: **YES**
 Remarks:

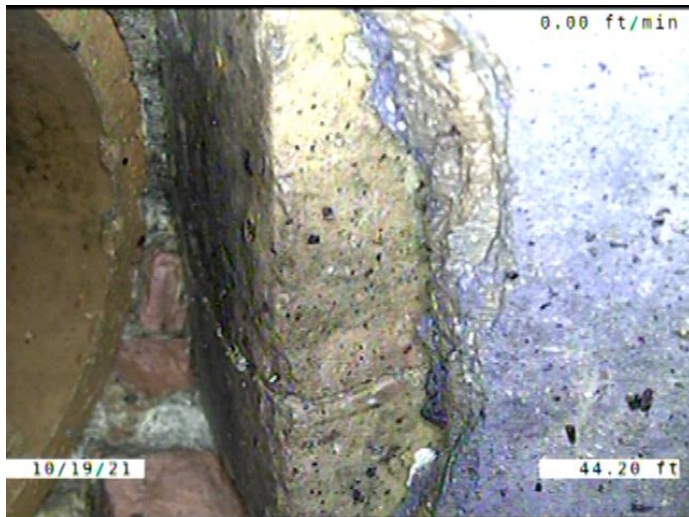
Code: **FM**
 Description: **Fracture Multiple**

Distance (ft): **44.2**
 Structural Grade: **4**
 O&M Grade: **0**
 Clock Start/From: **8**
 Clock To: **4**
 1st Value:
 2nd Value:
 Value Percent:
 Continuous Index: **S02**
 Within 8" of Joint: **YES**
 Remarks:

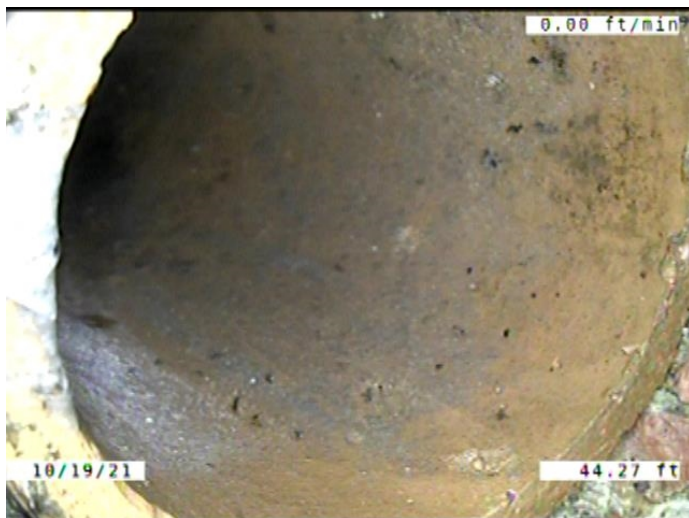
Code: **TB**
 Description: **Tap Break-in/Hammer**

Distance (ft): **44.3**
 Structural Grade: **0**
 O&M Grade: **0**
 Clock Start/From: **11**
 Clock To:
 1st Value: **4.000**
 2nd Value:
 Value Percent:
 Continuous Index:
 Within 8" of Joint: **YES**
 Remarks: **CONSTANTLY RUNNING WATER**

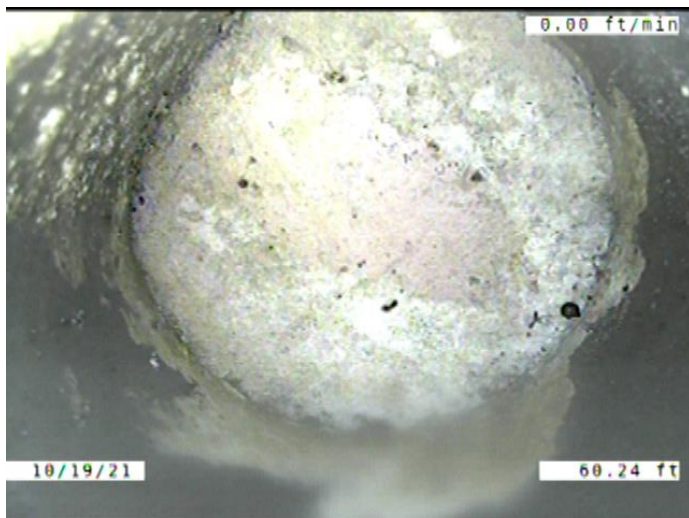
Code: **TFC**
 Description: **Tap Factory Capped**

Distance (ft): **60.2**
 Structural Grade: **0**
 O&M Grade: **0**
 Clock Start/From: **11**
 Clock To:
 1st Value: **4.000**
 2nd Value:
 Value Percent:
 Continuous Index:
 Within 8" of Joint: **YES**
 Remarks: **ENCUSTATION AROUND THE CAP**

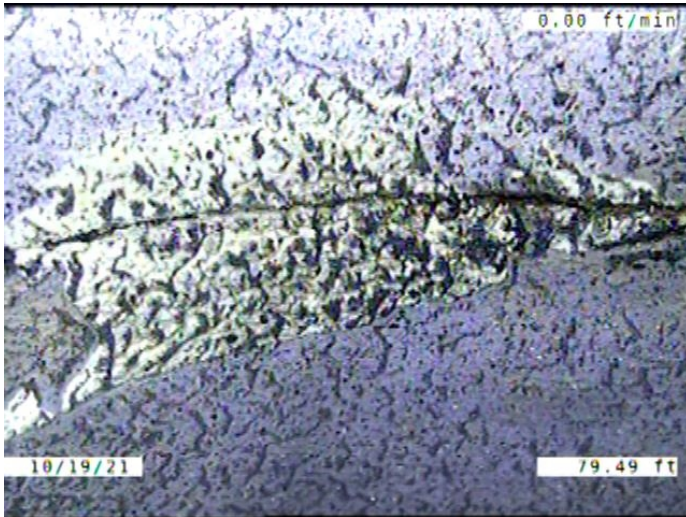
Code: **DAE**
 Description: **Deposits Attached Encrustation**

Distance (ft): **79.5**
 Structural Grade: **0**
 O&M Grade: **2**
 Clock Start/From: **9**
 Clock To: **11**
 1st Value:
 2nd Value:
 Value Percent: **5.000**
 Continuous Index:
 Within 8" of Joint: **YES**
 Remarks:

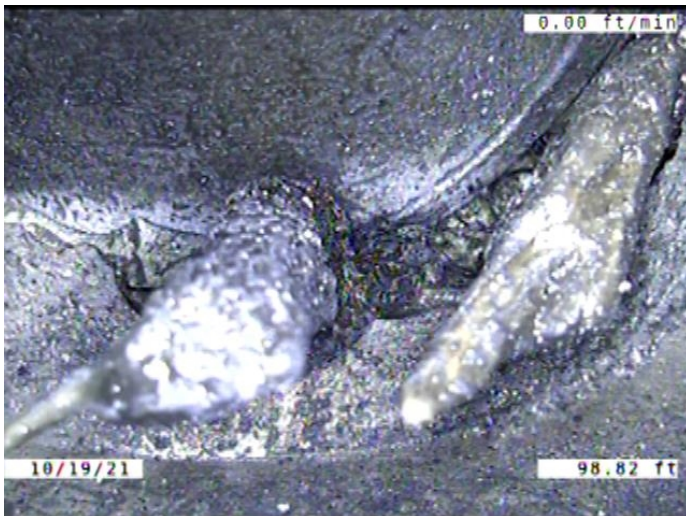
Code: **RTC**
 Description: **Roots Tap Connection**

Distance (ft): **98.8**
 Structural Grade: **0**
 O&M Grade: **2**
 Clock Start/From: **11**
 Clock To: **12**
 1st Value:
 2nd Value:
 Value Percent: **5.000**
 Continuous Index:
 Within 8" of Joint: **NO**
 Remarks:

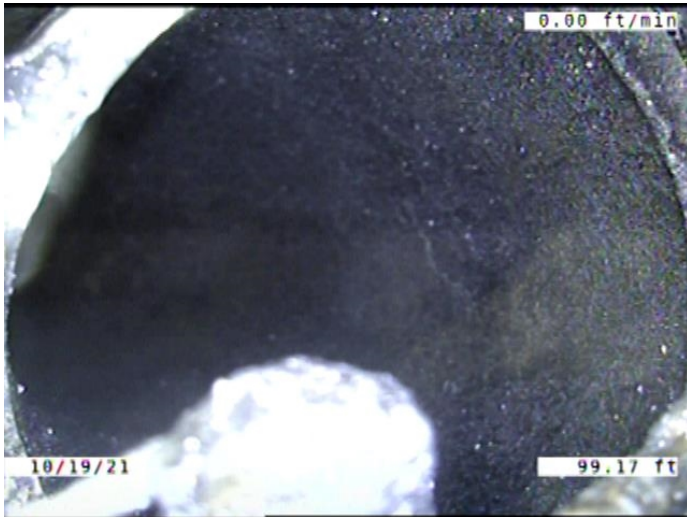
Code: **TFD**
 Description: **Tap Factory Defective**

Distance (ft): **99.2**
 Structural Grade: **0**
 O&M Grade: **3**
 Clock Start/From: **11**
 Clock To:
 1st Value: **4.000**
 2nd Value:
 Value Percent:
 Continuous Index:
 Within 8" of Joint: **YES**
 Remarks: **CONSTANTLY RUNNING WATER**

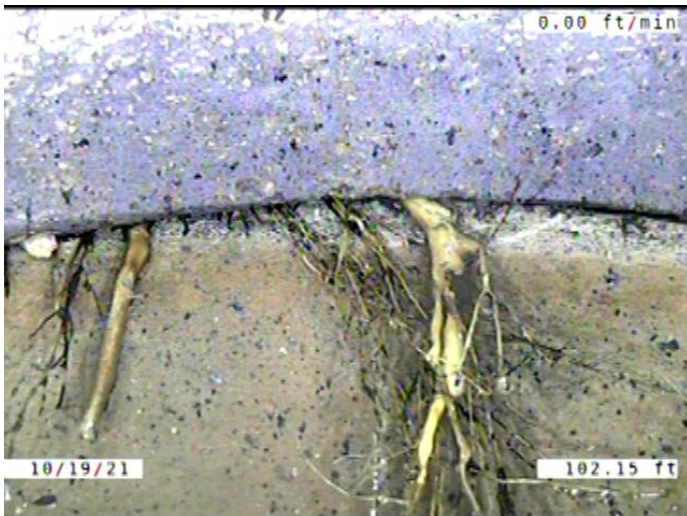
Code: **RFJ**
 Description: **Roots Fine Joint**

Distance (ft): **102.1**
 Structural Grade: **0**
 O&M Grade: **1**
 Clock Start/From: **9**
 Clock To: **3**
 1st Value:
 2nd Value:
 Value Percent:
 Continuous Index:
 Within 8" of Joint: **YES**
 Remarks:

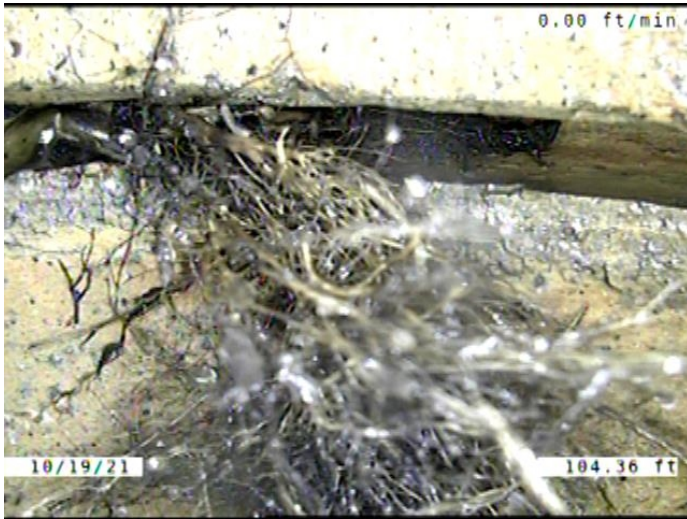
Code: **RMJ**
 Description: **Roots Medium Joint**

Distance (ft): **104.4**
 Structural Grade: **0**
 O&M Grade: **3**
 Clock Start/From: **8**
 Clock To: **3**
 1st Value:
 2nd Value:
 Value Percent: **5.000**
 Continuous Index:
 Within 8" of Joint: **YES**
 Remarks:

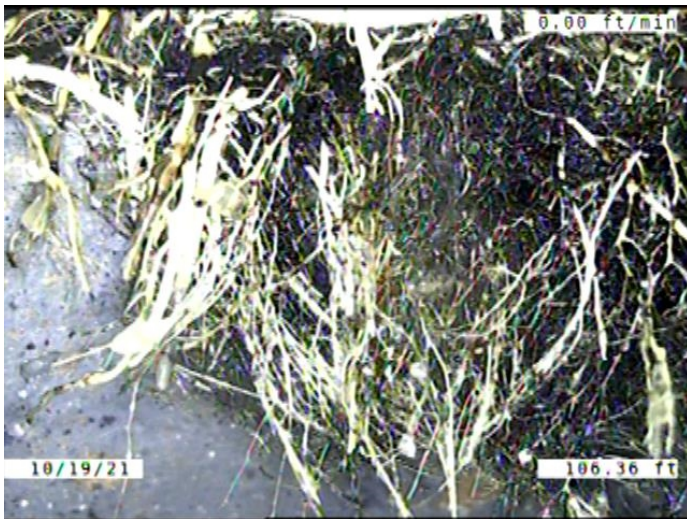
Code: **RMJ**
 Description: **Roots Medium Joint**

Distance (ft): **106.4**
 Structural Grade: **0**
 O&M Grade: **3**
 Clock Start/From: **9**
 Clock To: **3**
 1st Value:
 2nd Value:
 Value Percent: **5.000**
 Continuous Index:
 Within 8" of Joint: **YES**
 Remarks:

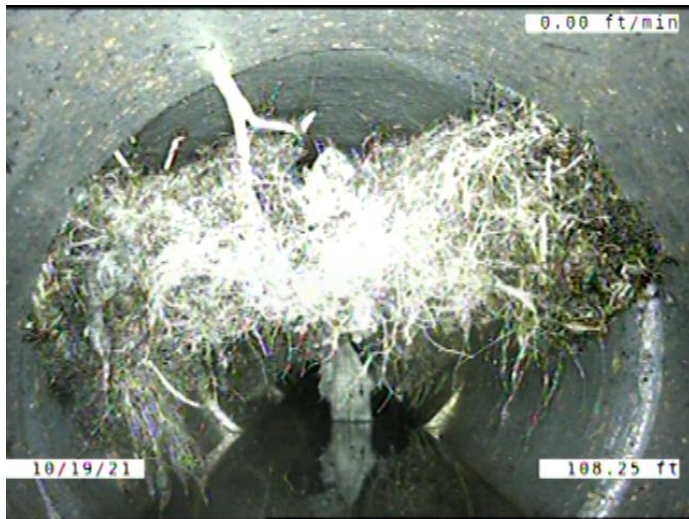
Code: **RMJ**
 Description: **Roots Medium Joint**

Distance (ft): **108.3**
 Structural Grade: **0**
 O&M Grade: **3**
 Clock Start/From: **9**
 Clock To: **2**
 1st Value:
 2nd Value:
 Value Percent: **25.000**
 Continuous Index:
 Within 8" of Joint: **YES**
 Remarks:

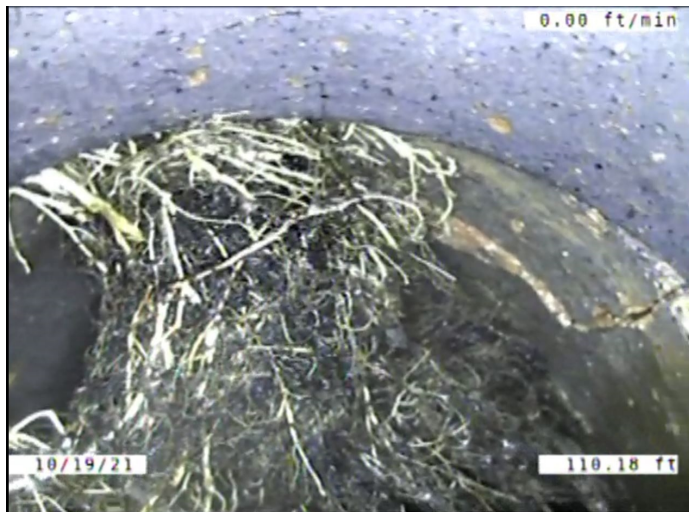
Code: **B**
 Description: **Broken**

Distance (ft): **110.2**
 Structural Grade: **4**
 O&M Grade: **0**
 Clock Start/From: **12**
 Clock To: **3**
 1st Value:
 2nd Value:
 Value Percent:
 Continuous Index:
 Within 8" of Joint: **NO**
 Remarks:

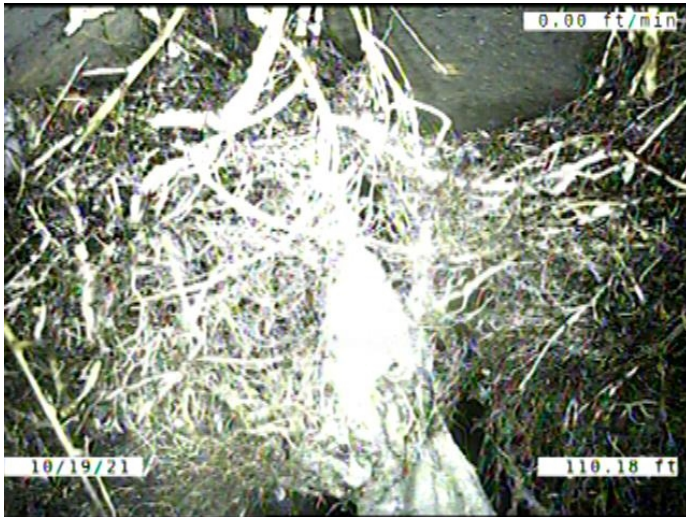
Code: **RBJ**
 Description: **Roots Ball Joint**

Distance (ft): **110.2**
 Structural Grade: **0**
 O&M Grade: **4**
 Clock Start/From: **8**
 Clock To: **4**
 1st Value:
 2nd Value:
 Value Percent: **65.000**
 Continuous Index:
 Within 8" of Joint: **YES**
 Remarks:

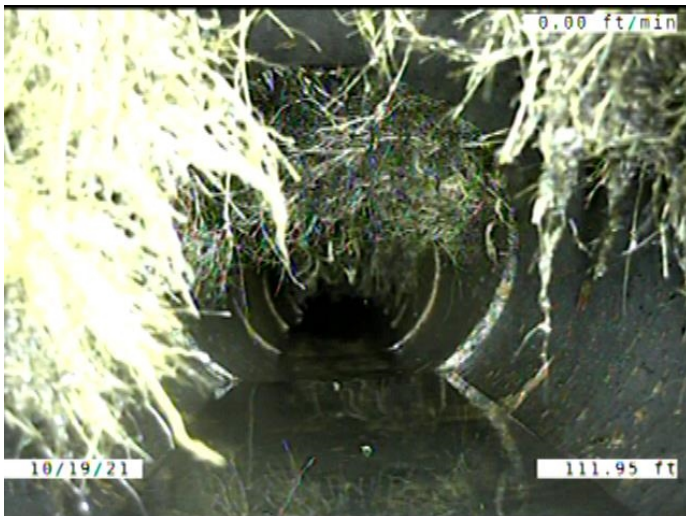
Code: **RMJ**
 Description: **Roots Medium Joint**

Distance (ft): **112.0**
 Structural Grade: **0**
 O&M Grade: **3**
 Clock Start/From: **8**
 Clock To: **4**
 1st Value:
 2nd Value:
 Value Percent: **35.000**
 Continuous Index: **S03**
 Within 8" of Joint: **YES**
 Remarks:

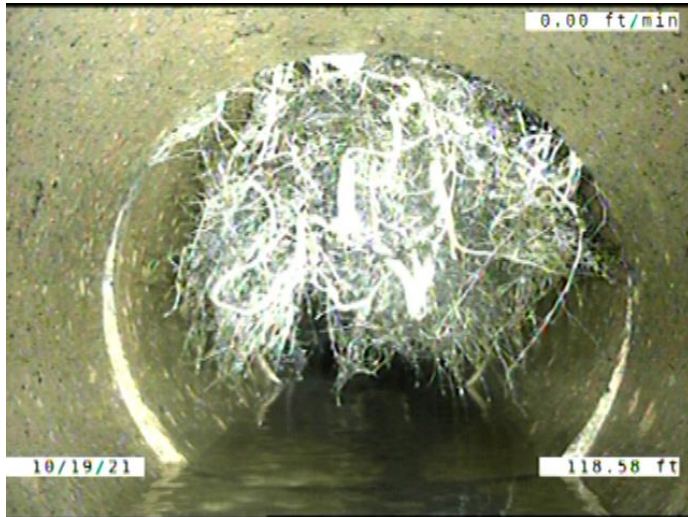
Code: **RBJ**
 Description: **Roots Ball Joint**

Distance (ft): **118.6**
 Structural Grade: **0**
 O&M Grade: **4**
 Clock Start/From: **10**
 Clock To: **3**
 1st Value:
 2nd Value:
 Value Percent: **65.000**
 Continuous Index:
 Within 8" of Joint: **YES**
 Remarks:

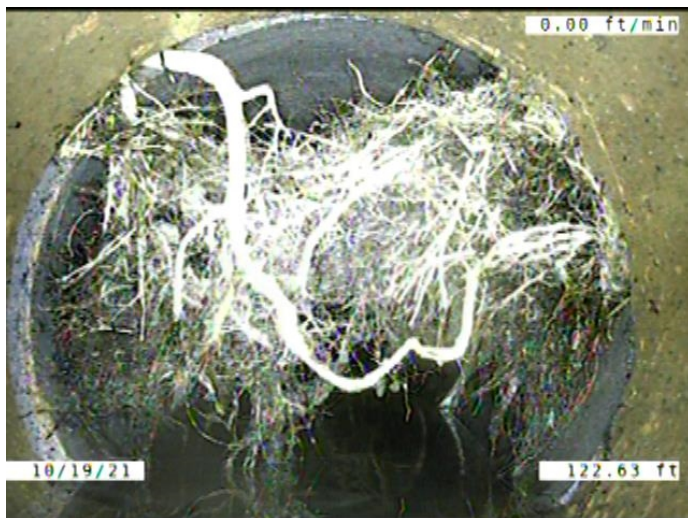
Code: **RTJ**
 Description: **Roots Tap Joint**

Distance (ft): **122.6**
 Structural Grade: **0**
 O&M Grade: **2**
 Clock Start/From: **8**
 Clock To: **4**
 1st Value:
 2nd Value:
 Value Percent: **50.000**
 Continuous Index:
 Within 8" of Joint: **YES**
 Remarks:

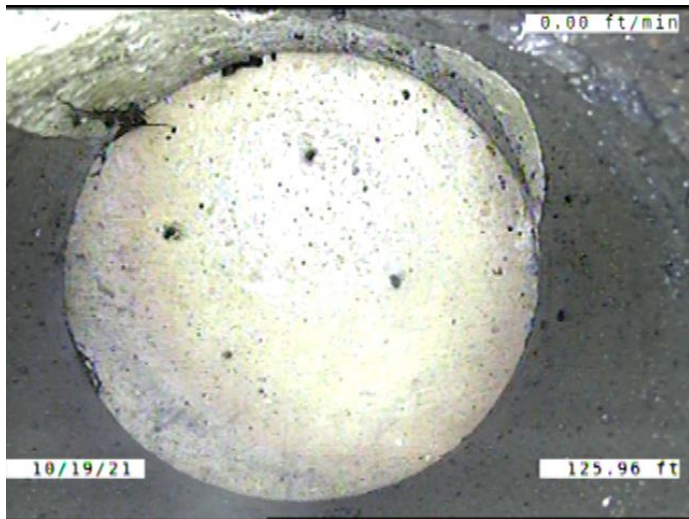
Code:	TFC
Description:	Tap Factory Capped
Distance (ft):	126.0
Structural Grade:	0
O&M Grade:	0
Clock Start/From:	11
Clock To:	
1st Value:	4.000
2nd Value:	
Value Percent:	
Continuous Index:	
Within 8" of Joint:	YES
Remarks:	ENCUSTATION AROUND THE CAP

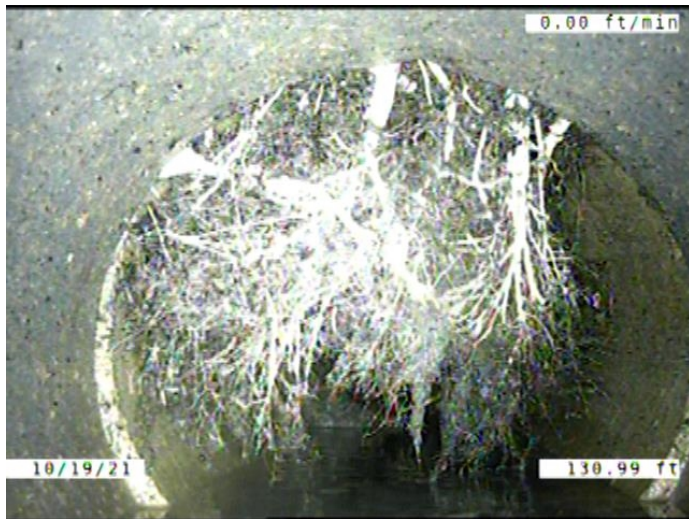
Code:	RTJ
Description:	Roots Tap Joint
Distance (ft):	131.0
Structural Grade:	0
O&M Grade:	2
Clock Start/From:	9
Clock To:	2
1st Value:	
2nd Value:	
Value Percent:	55.000
Continuous Index:	
Within 8" of Joint:	YES
Remarks:

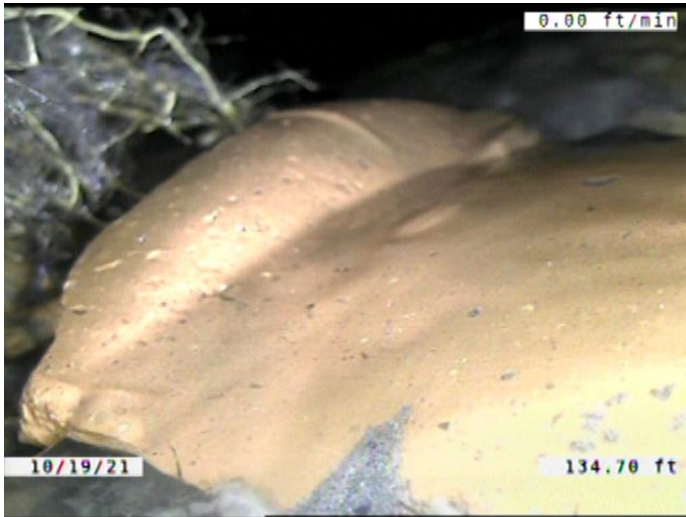
Code:	OBM
Description:	Obstruction Pipe Material in Invert
Distance (ft):	134.7
Structural Grade:	0
O&M Grade:	2
Clock Start/From:	4
Clock To:	7
1st Value:	
2nd Value:	
Value Percent:	10.000
Continuous Index:	
Within 8" of Joint:	YES
Remarks:

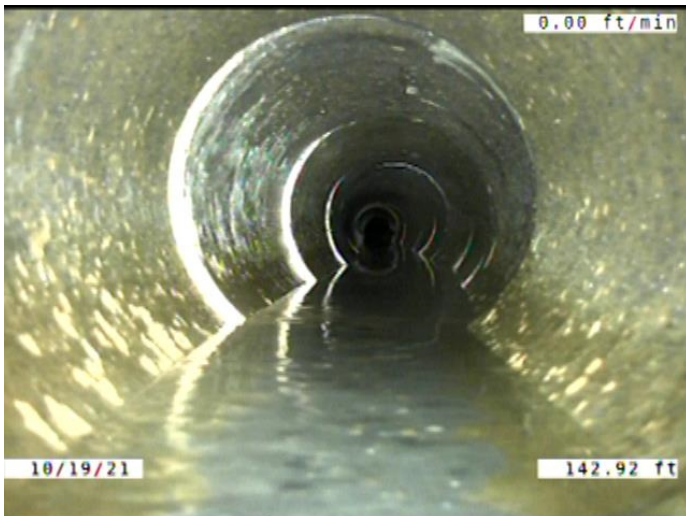
Code:	RMJ
Description:	Roots Medium Joint
Distance (ft):	142.9
Structural Grade:	0
O&M Grade:	3
Clock Start/From:	8
Clock To:	4
1st Value:	
2nd Value:	
Value Percent:	35.000
Continuous Index:	F03
Within 8" of Joint:	YES
Remarks:

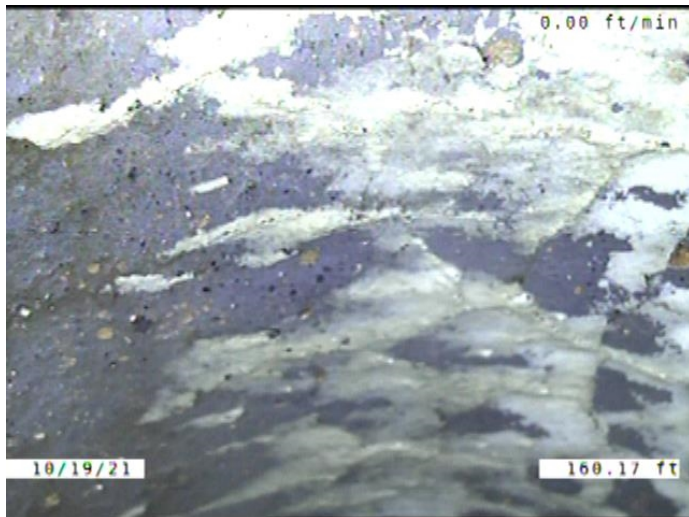
Code: **DAE**
 Description: **Deposits Attached Encrustation**

Distance (ft): **160.2**
 Structural Grade: **0**
 O&M Grade: **2**
 Clock Start/From: **9**
 Clock To: **2**
 1st Value:
 2nd Value:
 Value Percent: **5.000**
 Continuous Index:
 Within 8" of Joint: **YES**
 Remarks:

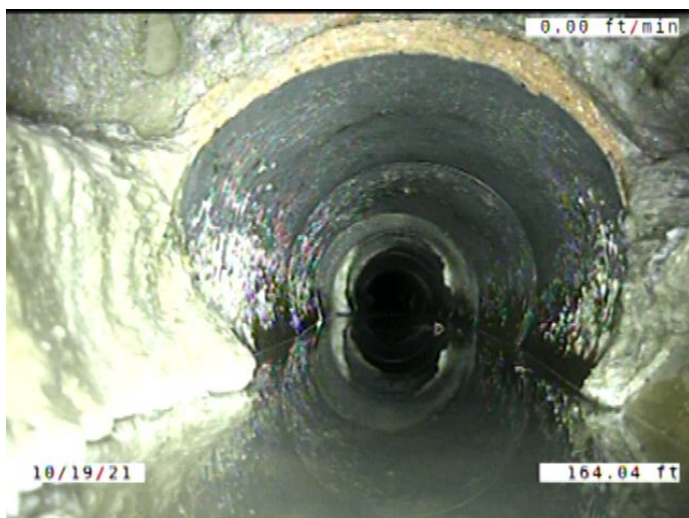
Code: **DSF**
 Description: **Deposits Settled Fine**

Distance (ft): **164.0**
 Structural Grade: **0**
 O&M Grade: **2**
 Clock Start/From: **5**
 Clock To: **7**
 1st Value:
 2nd Value:
 Value Percent: **5.000**
 Continuous Index: **F01**
 Within 8" of Joint: **YES**
 Remarks:

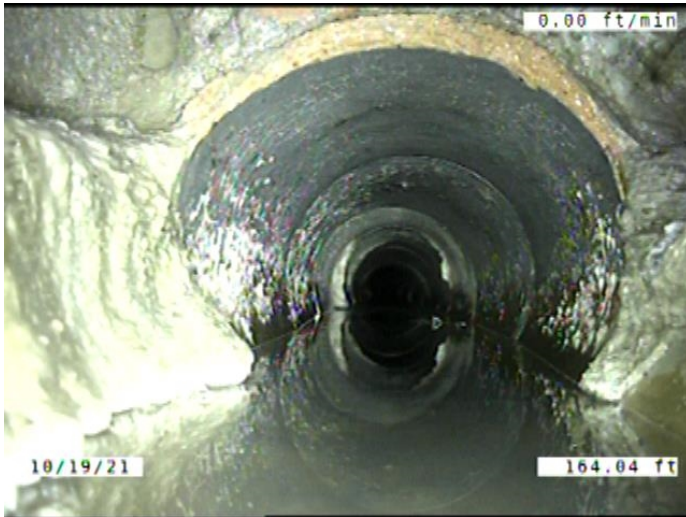
Code: **FM**
 Description: **Fracture Multiple**

Distance (ft): **164.0**
 Structural Grade: **4**
 O&M Grade: **0**
 Clock Start/From: **8**
 Clock To: **4**
 1st Value:
 2nd Value:
 Value Percent:
 Continuous Index: **F02**
 Within 8" of Joint: **YES**
 Remarks:
