## Profile/Photo Observation Report

Street:	<b>W 40th ave</b>	Flow Control:	<b>Not Controlled</b>
City:	<b>Hobart, IN</b>	Year Renewed:	
Location:	<b>Other</b>	Tape/Media #:	
Purpose:	<b>Not Known</b>	Dia/Height:	<b>12"</b>
Use:	<b>Sanitary</b>	Material:	<b>VCP</b>
Drain Area:	<b>NA</b>	Lining:	
Category:	<b>NA</b>		
Comment:

Location Details:		Direction of Survey:	<b>Downstream</b>
US MH:	<b>M-503-017</b>	DS MH:	<b>M-503-018</b>
		Total Length Surveyed (ft):	<b>16.0</b>

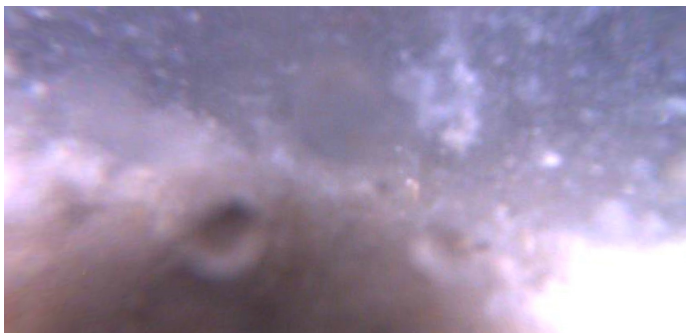
Code: **AMH**  
Description: **Manhole**

Distance (ft): **.0**  
Structural Grade: **0**  
O&M Grade: **0**  
Clock Start/From:  
Clock To:  
1st Value:  
2nd Value:  
Value Percent:  
Continuous Index:  
Within 8" of Joint: **NO**  
Remarks: **M-503-017**

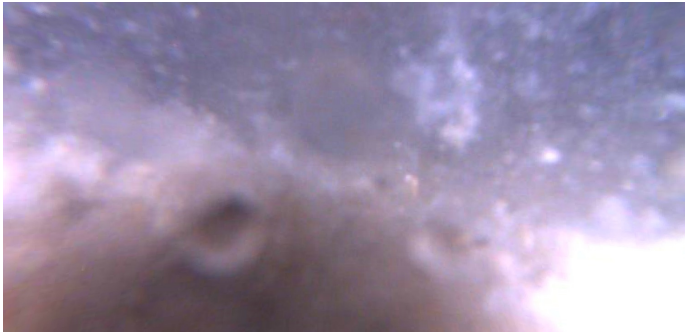
Code:	<b>MWL</b>
Description:	<b>Water Level</b>

Distance (ft):	<b>.0</b>
Structural Grade:	<b>0</b>
O&M Grade:	<b>0</b>
Clock Start/From:	
Clock To:	
1st Value:	
2nd Value:	
Value Percent:	<b>100.000</b>
Continuous Index:	
Within 8" of Joint:	<b>NO</b>
Remarks:

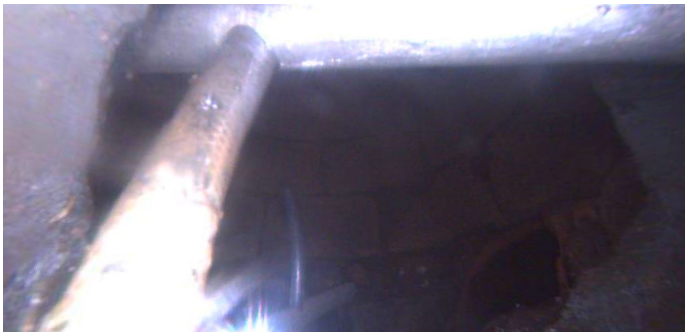
Code:	<b>MGO</b>
Description:	<b>General Observation</b>

Distance (ft):	<b>.0</b>
Structural Grade:	<b>0</b>
O&M Grade:	<b>0</b>
Clock Start/From:	
Clock To:	
1st Value:	
2nd Value:	
Value Percent:	
Continuous Index:	
Within 8" of Joint:	<b>NO</b>
Remarks:	<b>REAR CAMERA</b>

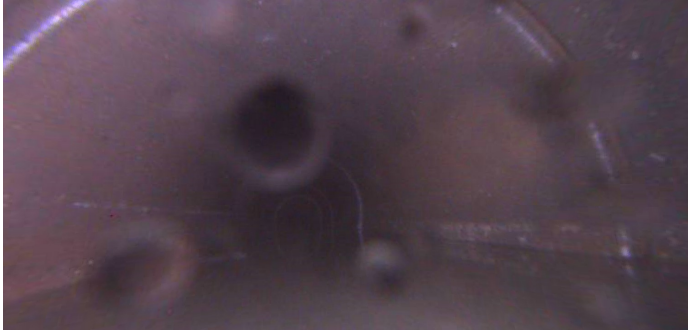
Code:	<b>MSA</b>
Description:	<b>Abandoned Survey</b>
Distance (ft):	<b>16.0</b>
Structural Grade:	<b>0</b>
O&M Grade:	<b>0</b>
Clock Start/From:	
Clock To:	
1st Value:	
2nd Value:	
Value Percent:	
Continuous Index:	
Within 8" of Joint:	<b>NO</b>
Remarks:	<b>DEBRIS UNDER WATER</b>
