## Profile/Photo Observation Report

Street:	<b>ALLEY BETWEEN W 39TH PL &amp; W 39</b>	Flow Control:	<b>Not Controlled</b>
City:	<b>Hobart, IN</b>	Year Renewed:	
Location:	<b>Other</b>	Tape/Media #:	
Purpose:	<b>Not Known</b>	Dia/Height:	<b>12"</b>
Use:	<b>Sanitary</b>	Material:	<b>VCP</b>
Drain Area:	<b>NA</b>	Lining:	
Category:	<b>NA</b>		
Comment:

Location Details:		Direction of Survey:	<b>Downstream</b>
US MH:	<b>M-503-017</b>	DS MH:	<b>M-503-018</b>
		Total Length Surveyed (ft):	<b>80.4</b>

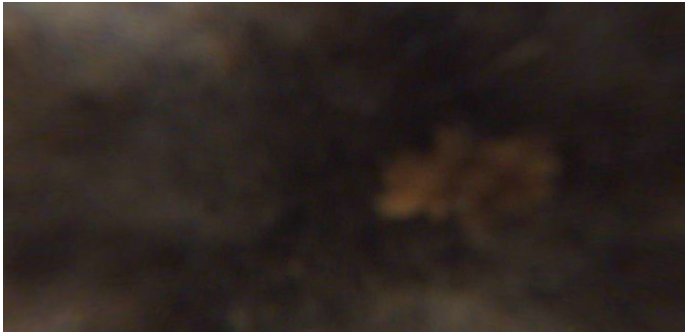
Code:	<b>MWL</b>
Description:	<b>Water Level</b>

Distance (ft):	<b>.0</b>
Structural Grade:	<b>0</b>
O&M Grade:	<b>0</b>
Clock Start/From:	
Clock To:	
1st Value:	
2nd Value:	
Value Percent:	<b>100.000</b>
Continuous Index:	
Within 8" of Joint:	<b>NO</b>
Remarks:

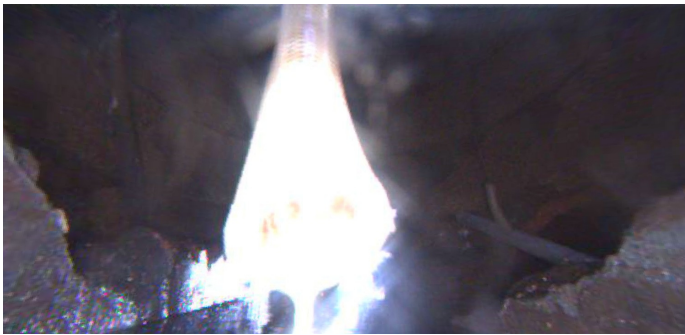
Code:	<b>MGO</b>
Description:	<b>General Observation</b>

Distance (ft):	<b>.0</b>
Structural Grade:	<b>0</b>
O&M Grade:	<b>0</b>
Clock Start/From:	
Clock To:	
1st Value:	
2nd Value:	
Value Percent:	
Continuous Index:	
Within 8" of Joint:	<b>NO</b>
Remarks:	<b>rear camera</b>

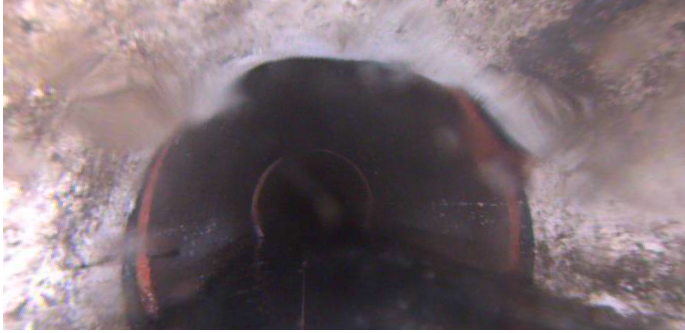
Code: **MMC**  
Description: **Material Change**

Distance (ft): **31.7**  
Structural Grade: **0**  
O&M Grade: **0**  
Clock Start/From:  
Clock To:  
1st Value:  
2nd Value:  
Value Percent:  
Continuous Index:  
Within 8" of Joint: **NO**  
Remarks: **PVC**

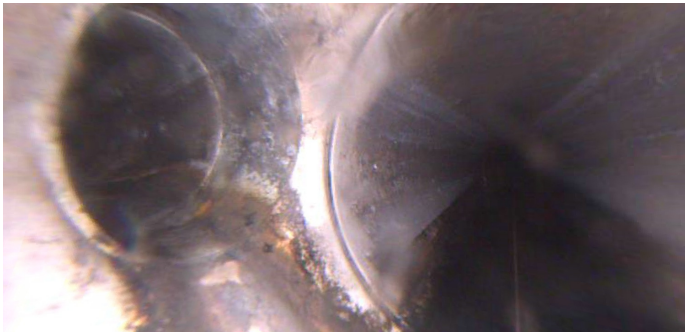
Code: **TFA**  
Description: **Tap Factory Active**

Distance (ft): **36.0**  
Structural Grade: **0**  
O&M Grade: **0**  
Clock Start/From: **3**  
Clock To:  
1st Value: **4.000**  
2nd Value:  
Value Percent:  
Continuous Index:  
Within 8" of Joint:  
Remarks:

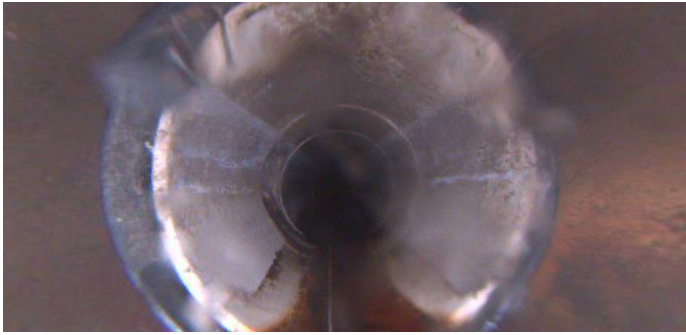
Code: **JSM**  
Description: **Joint Separated Medium**

Distance (ft): **37.8**  
Structural Grade: **1**  
O&M Grade: **0**  
Clock Start/From:  
Clock To:  
1st Value:  
2nd Value:  
Value Percent:  
Continuous Index:  
Within 8" of Joint: **NO**  
Remarks:

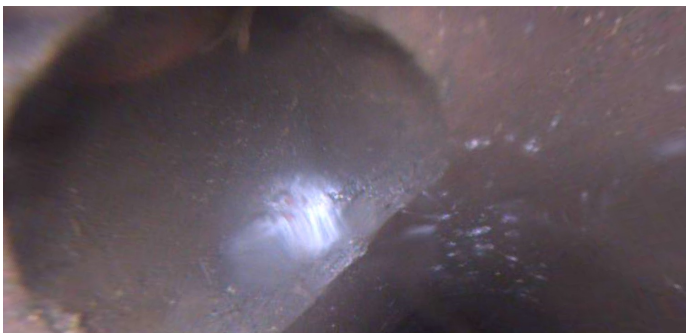
Code: **TF**  
Description: **Tap Factory**

Distance (ft): **63.4**  
Structural Grade: **0**  
O&M Grade: **0**  
Clock Start/From: **11**  
Clock To:  
1st Value: **4.000**  
2nd Value:  
Value Percent:  
Continuous Index:  
Within 8" of Joint:  
Remarks:

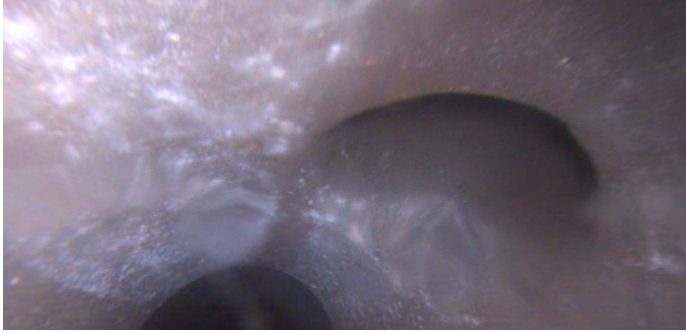
Code: **TF**  
Description: **Tap Factory**

Distance (ft): **71.7**  
Structural Grade: **0**  
O&M Grade: **0**  
Clock Start/From: **11**  
Clock To:  
1st Value: **4.000**  
2nd Value:  
Value Percent:  
Continuous Index:  
Within 8" of Joint:  
Remarks:

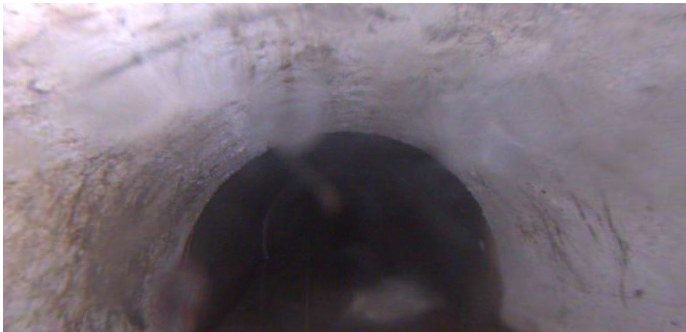
Code: **MMC**  
Description: **Material Change**

Distance (ft): **74.5**  
Structural Grade: **0**  
O&M Grade: **0**  
Clock Start/From:  
Clock To:  
1st Value:  
2nd Value:  
Value Percent:  
Continuous Index:  
Within 8" of Joint: **NO**  
Remarks: **pvc**

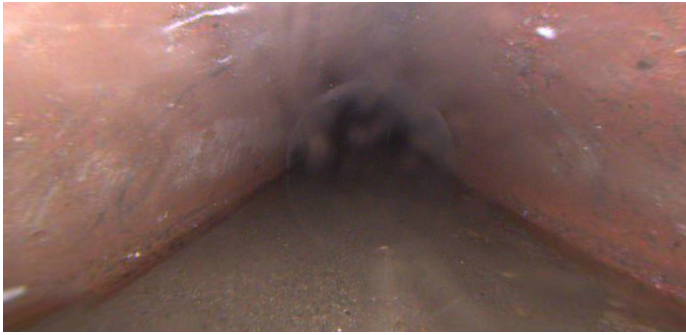
Code: **MMC**  
Description: **Material Change**

Distance (ft): **80.4**  
Structural Grade: **0**  
O&M Grade: **0**  
Clock Start/From:  
Clock To:  
1st Value:  
2nd Value:  
Value Percent:  
Continuous Index:  
Within 8" of Joint: **NO**  
Remarks: **VCP**

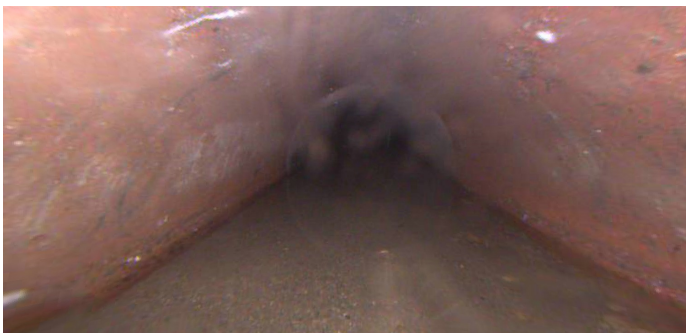
Code: **MSA**  
Description: **Abandoned Survey**

Distance (ft): **80.4**  
Structural Grade: **0**  
O&M Grade: **0**  
Clock Start/From:  
Clock To:  
1st Value:  
2nd Value:  
Value Percent:  
Continuous Index:  
Within 8" of Joint: **NO**  
Remarks: **DSF**
